RE: Investigation and Characterization Plan
Rice Operating Company – EME SWD System
State Q EOL (UL Q Sec 16 T 20S R 37E) / ペインナーバイ

Appendix A – Junction Box Disclosure Report

Appendix B – Photo chronology.

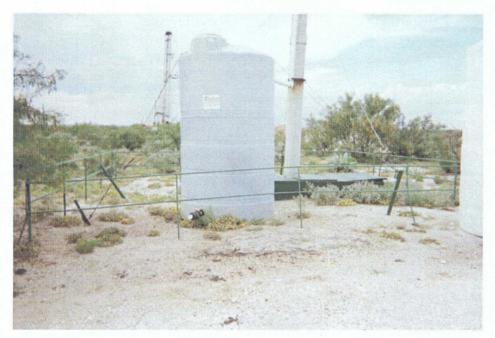
The surface (ecological) impact of this junction box was limited, as visual observation indicated that vegetation was not affected beyond approximately 25 ft from the former junction box; (Photograph 1). However, as some potential for groundwater contamination may exist, further evaluation is warranted for petroleum hydrocarbons, the primary constituent of concern. Therefore, ROC proposes additional investigative work, as outlined below, to determine if groundwater was impacted by the former junction box.

Photograph 1 – Undisturbed junction box with boot.

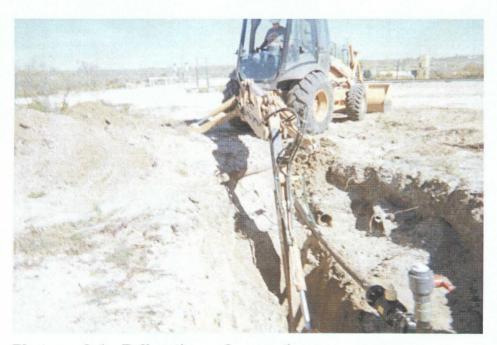
A grab soil sample taken 12 ft below the surface at the former junction box location found a diesel range organics (DRO) concentration of 2,730 ppm; (see Appendix A). OCD was notified that this site has potential for groundwater impacts, and subsequent site investigation was then planned. A photographic chronology of these activities is provided in Appendix B.

Photograph 1 – Delineation and excavation.

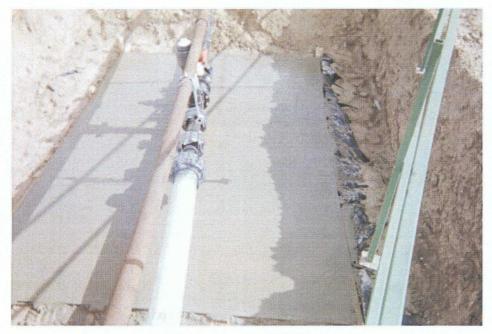
Photograph 2 – Floor of new concrete junction box.

As part of their on-going SWD facility upgrades, Rice removed a wooden junction box (associated with a boot) at this location, and replaced it with a concrete junction box in November of 2004. The site was re-graded to natural contours and seeded to native grasses in June of 2005.

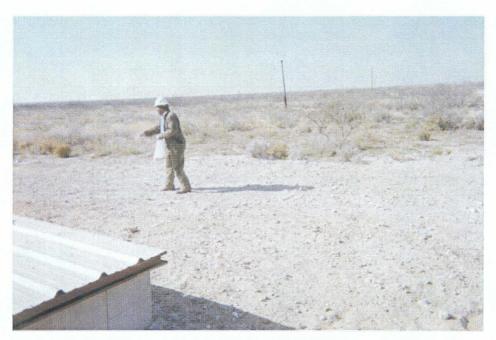
Photograph 3 – Reseeding around new junction box.
