RE: **INVESTIGATION & CHARACTERIZATION WORK PLAN
EME JCT. I-13
UNIT "I", SEC. 13, T20S, R36E
LEA COUNTY, NEW MEXICO
NMOCD #1R0427-171**

PHOTOGRAPHIC DOCUMENTATION
Rice Operating Company
EME jct. I-13, Lea County, New Mexico

RICE OPERATING COMPANY
JUNCTION BOX DISCLOSURE* REPORT

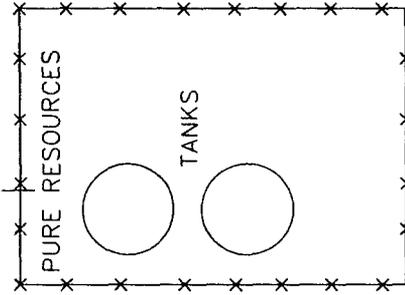
FIGURE NO. 3

FORMER 1-13 JCT BOX

EXCAVATION

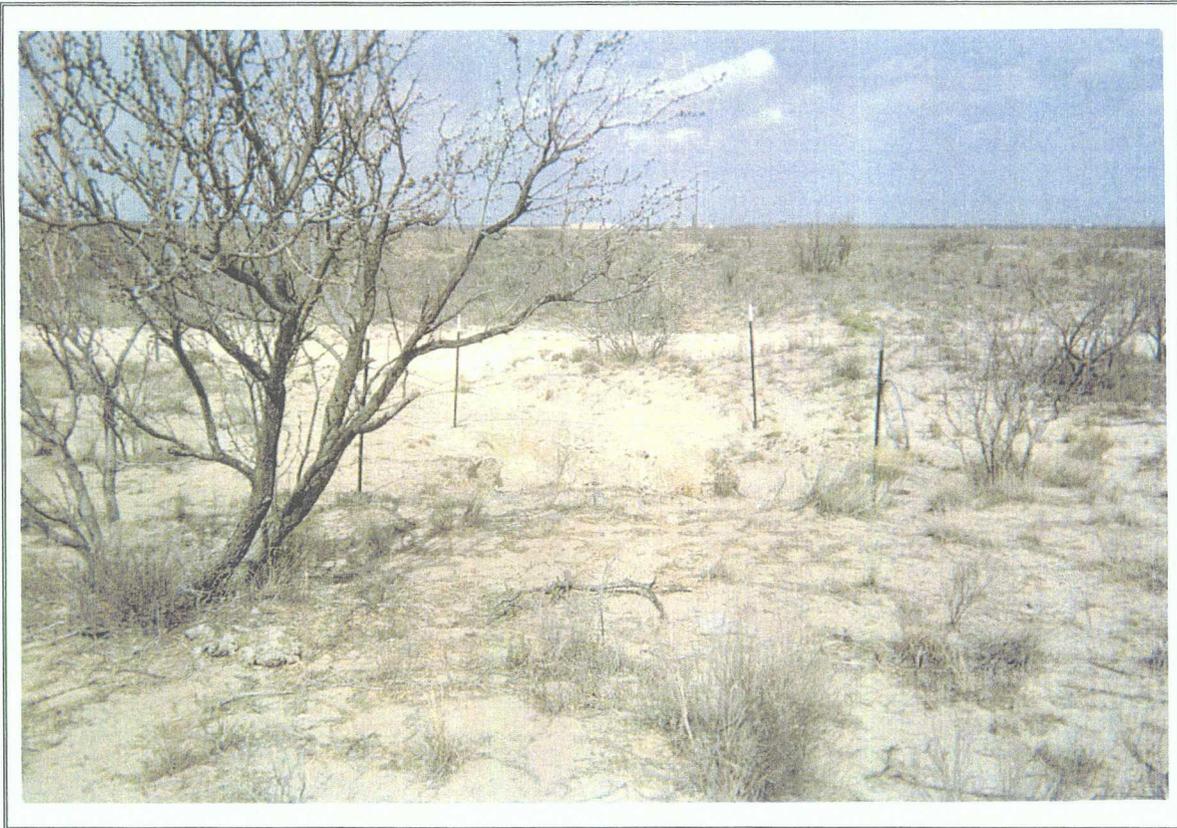
1. View of site after removal of junction box.

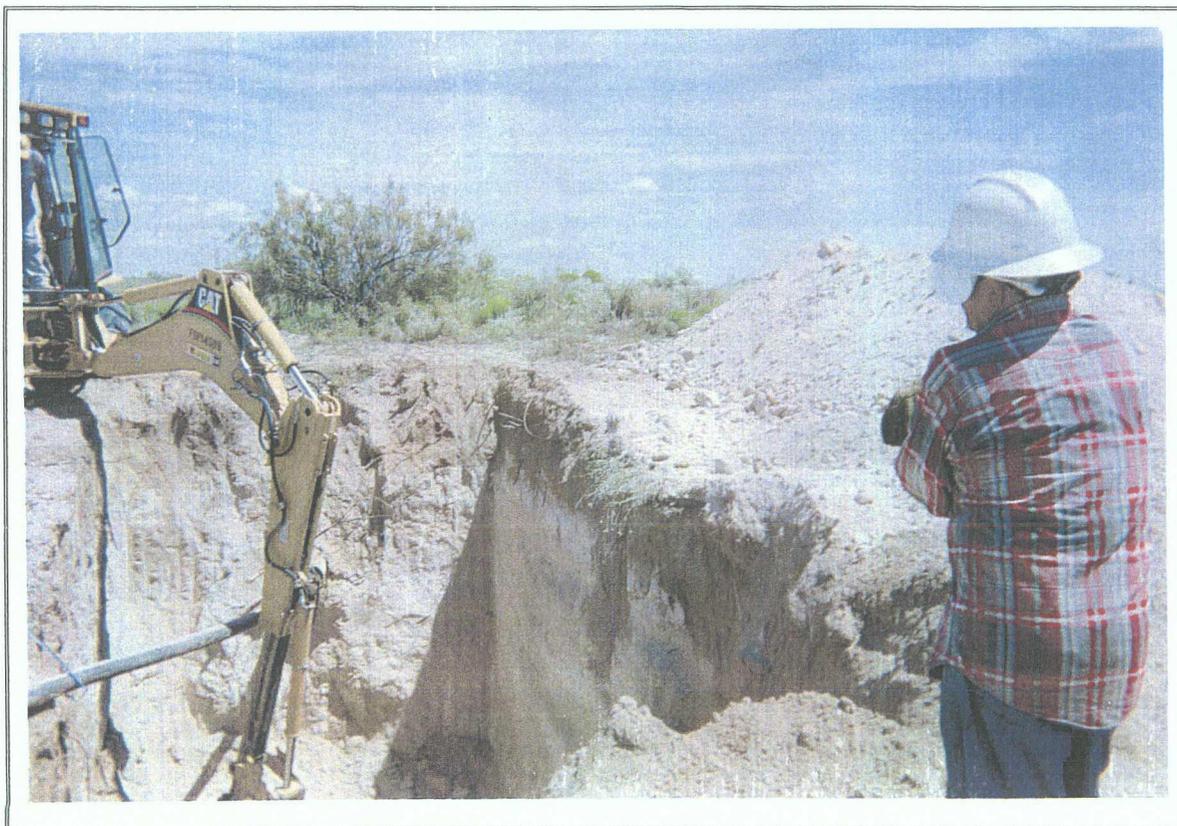
2. Excavation of soils around junction box.

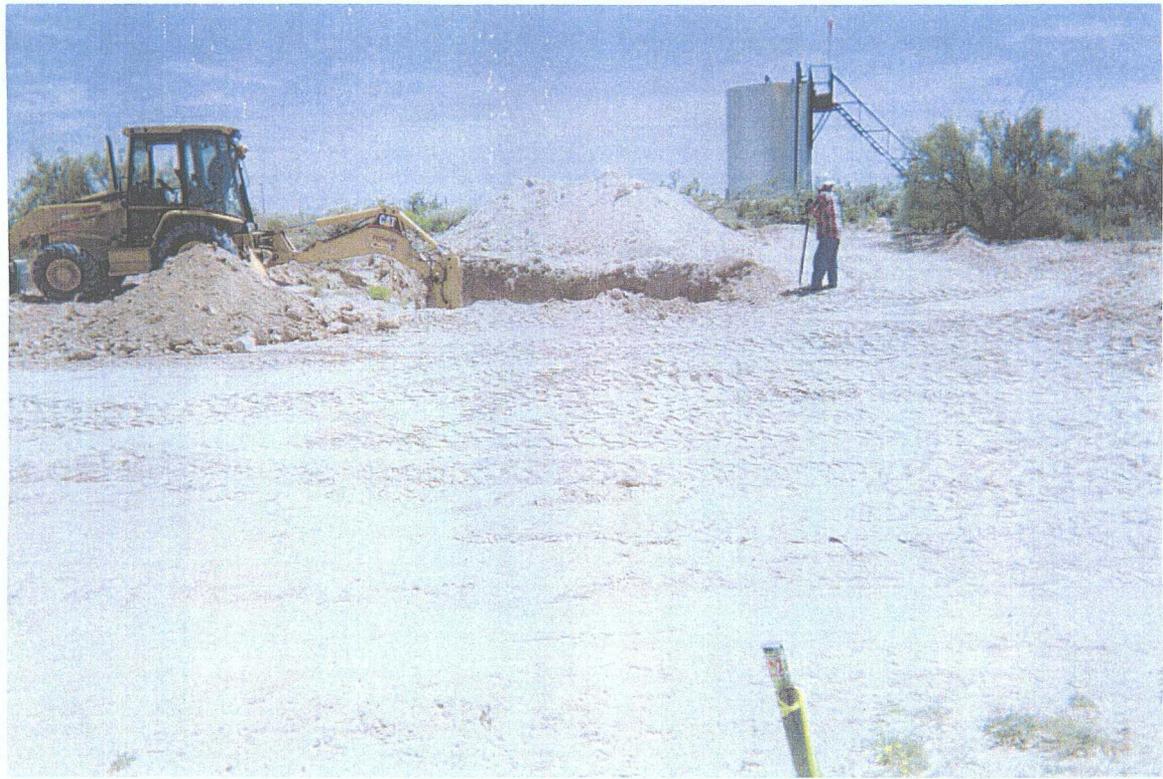
3. Excavation of soils around junction box.

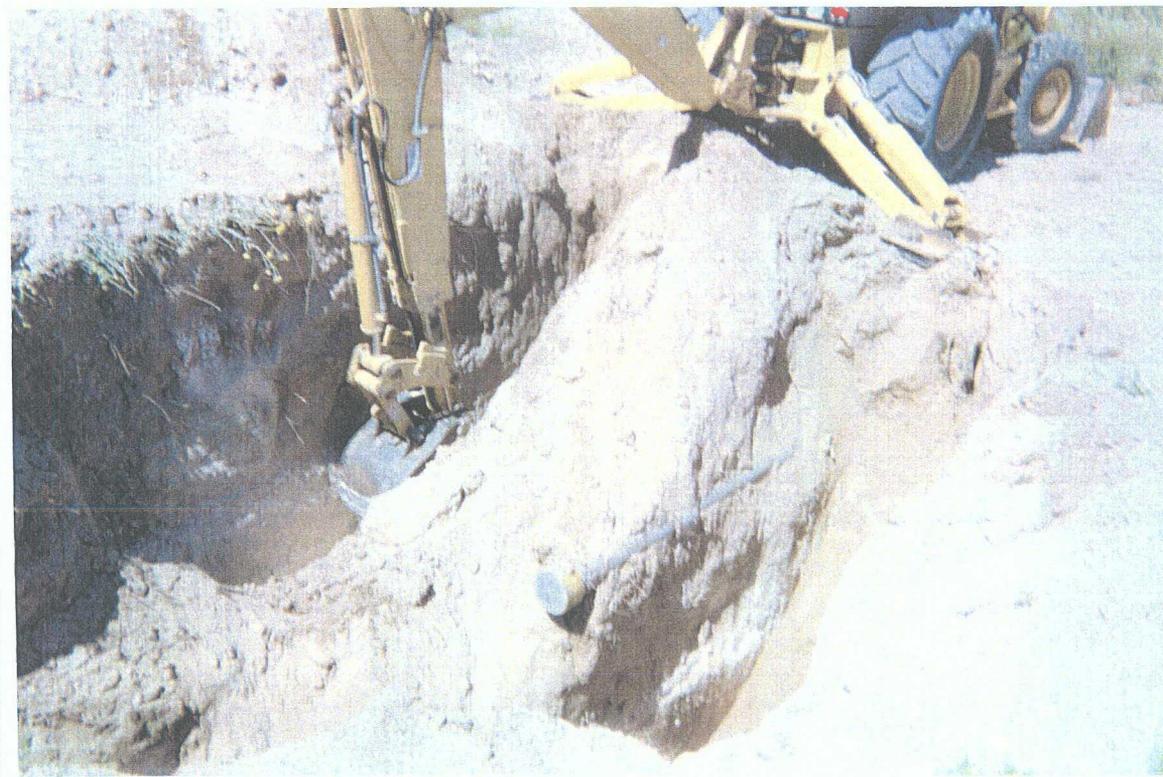
4. Excavation of soils around junction box.

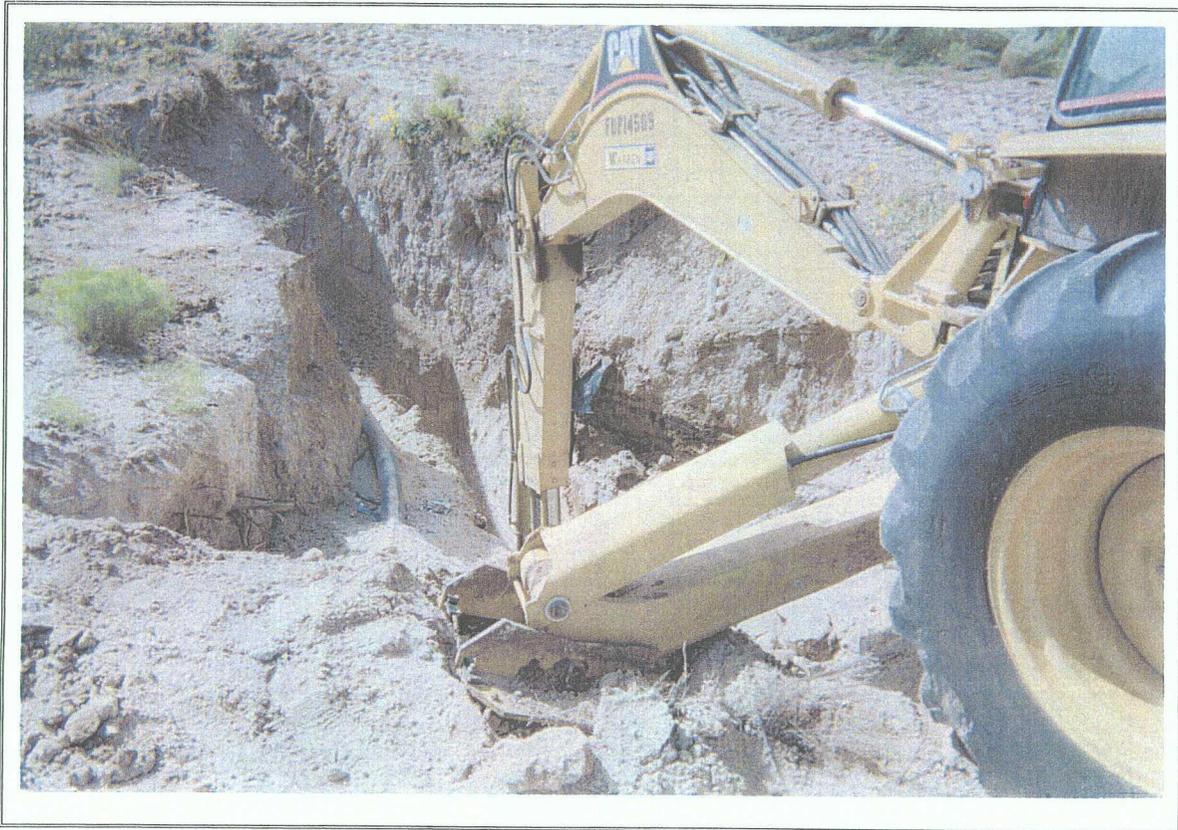
5. Excavation of soils around junction box.

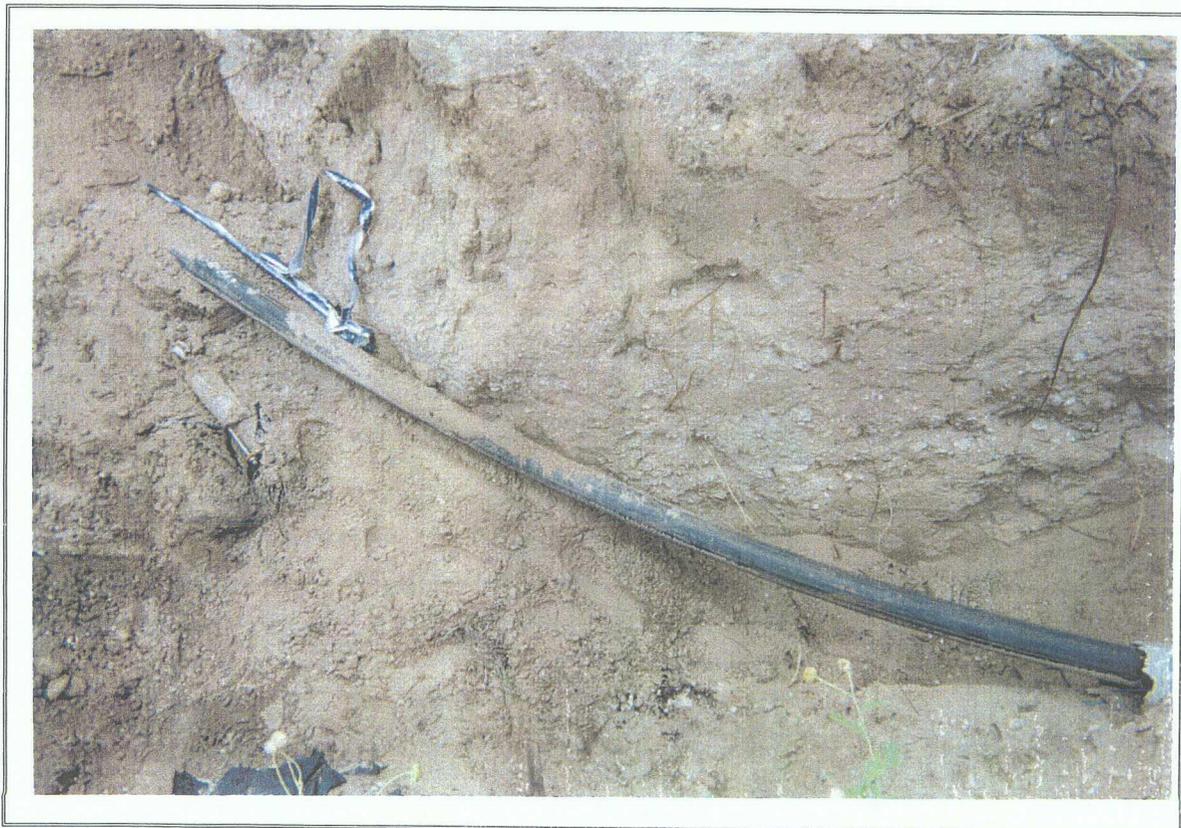
6. Bottom of excavation.

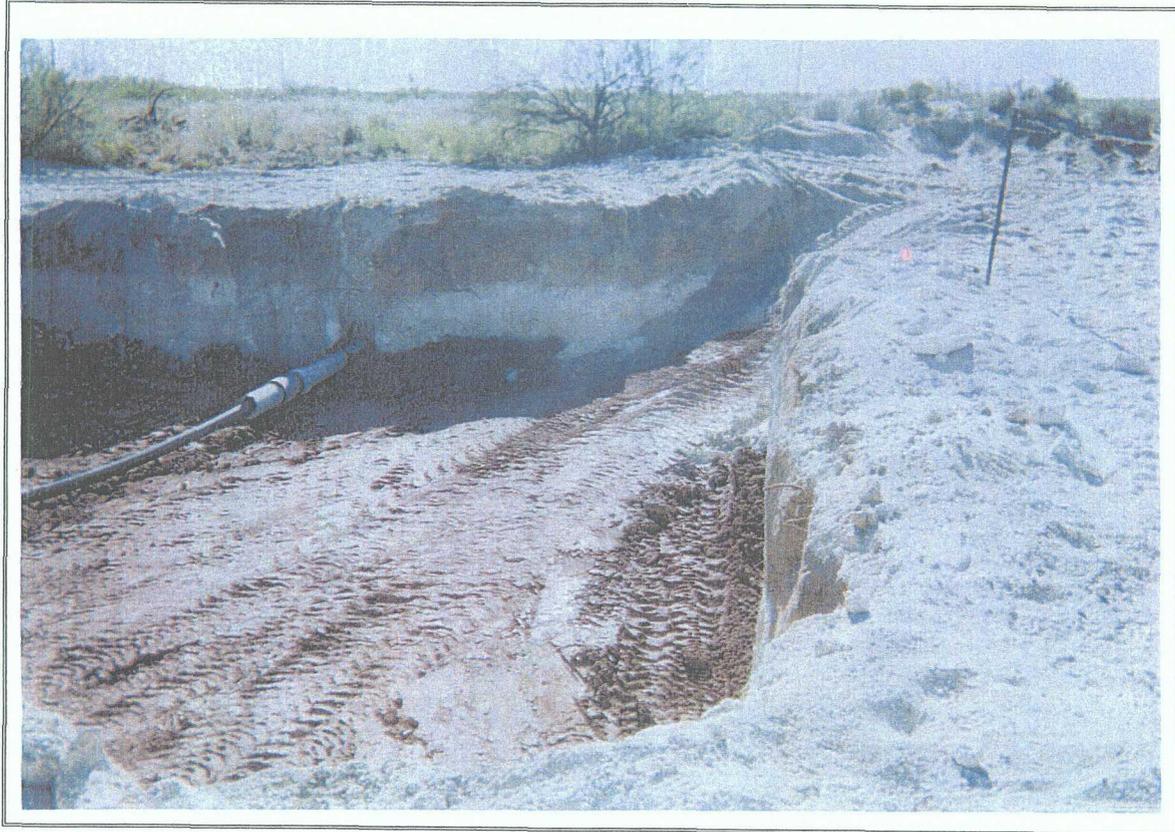
7. Clay liner at 6 feet bgs in excavation.

Upon completion of the excavation, the soils were blended on site and then backfilled within the excavation to a depth of 6 feet bgs. At 6 feet bgs, a 1 foot thick compacted clay barrier was installed to inhibit further downward migration of chlorides. The remaining soils were backfilled on top of the clay and brought up to surface grade, contoured and reseeded. On November 24, 2004, ROC submitted a Junction Box Disclosure Report to the NMOCD. A copy of the Junction Box Disclosure Report is included in Appendix A. A copy of the laboratory analysis is presented in Appendix B.

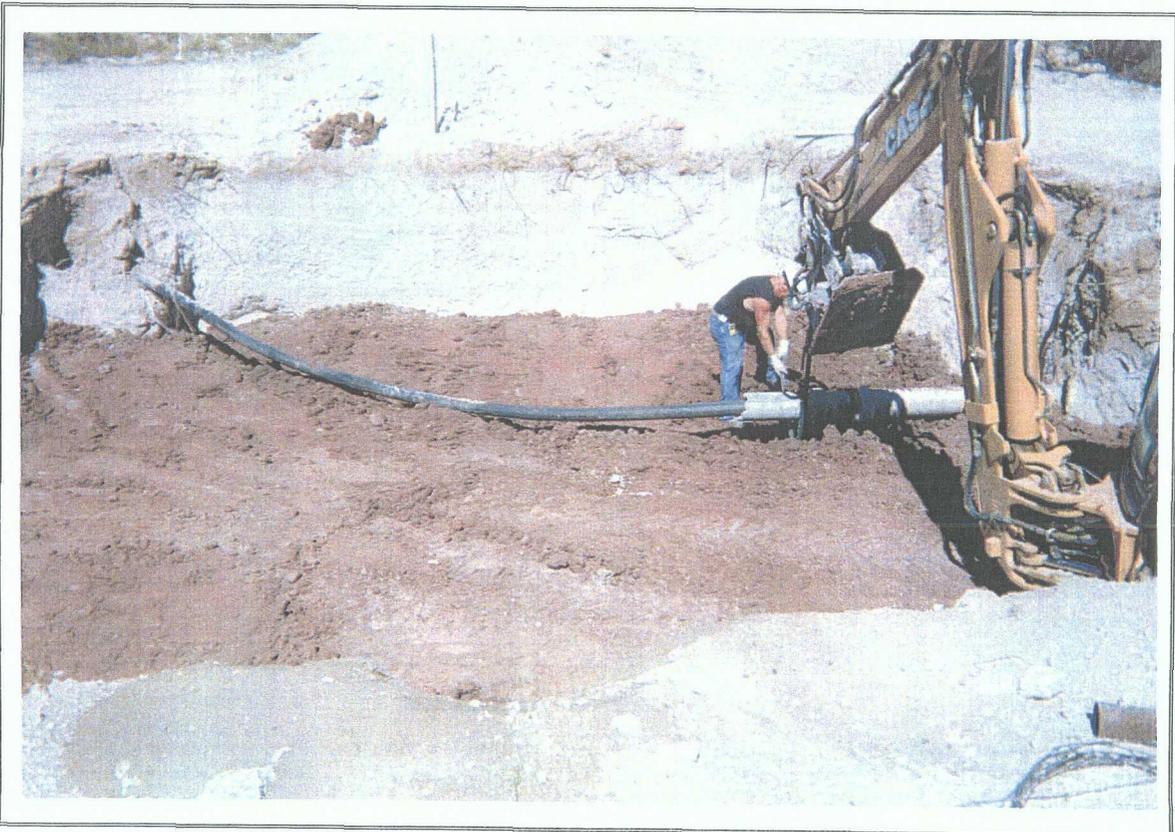
8. Clay liner at 6 feet bgs in excavation.

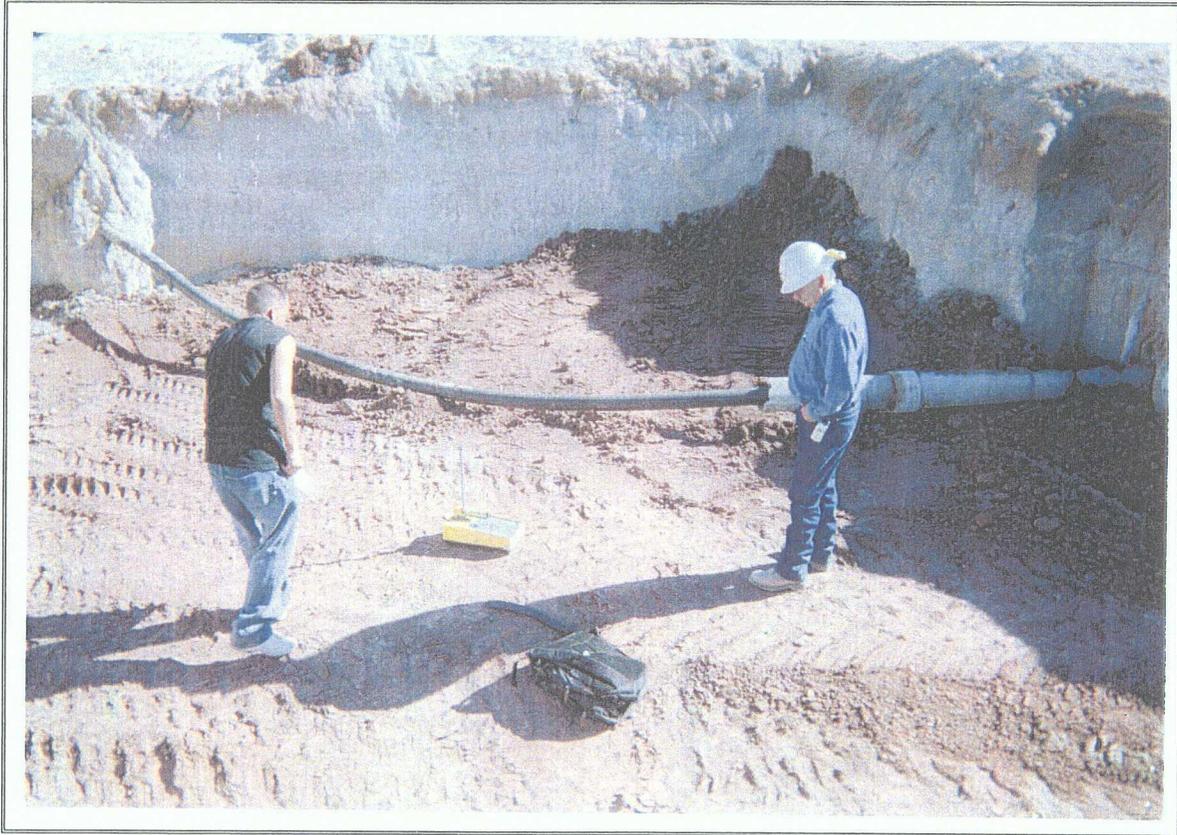
9. Nuclear density test being performed on clay liner.

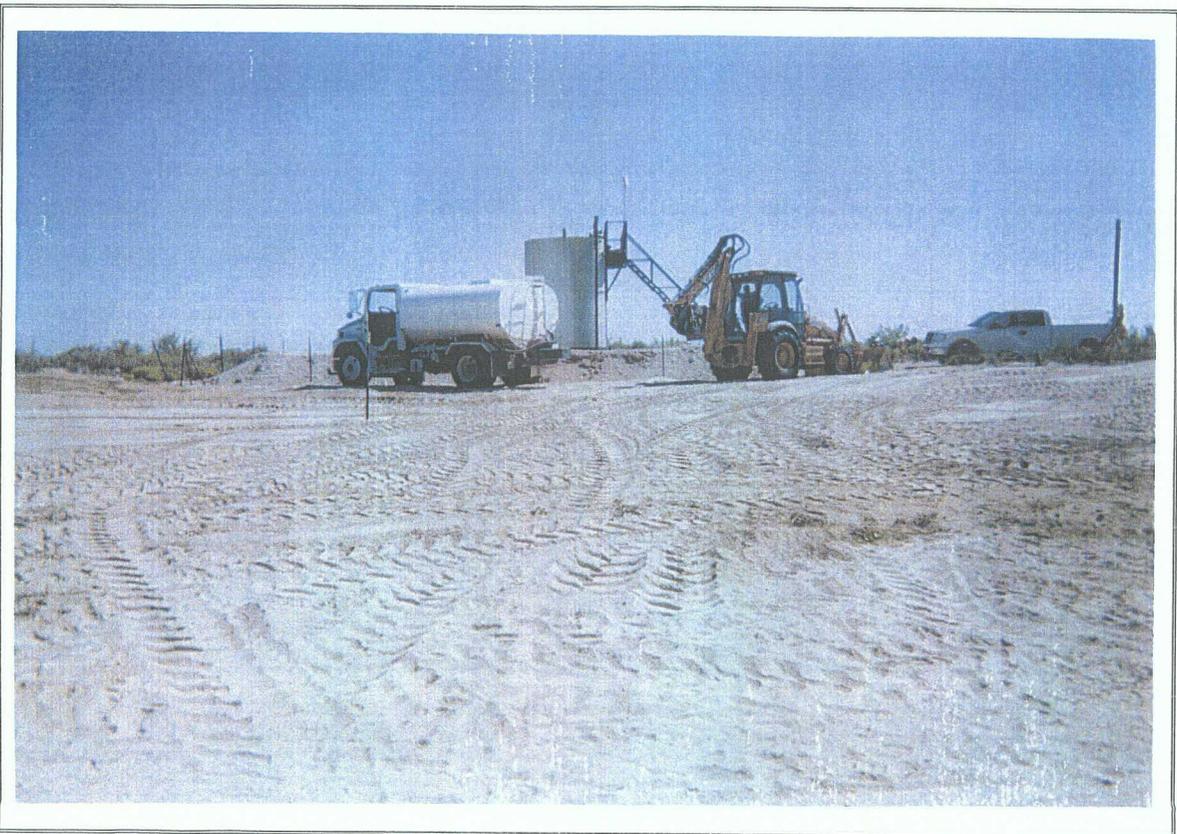
10. View of site after completion of backfilling.

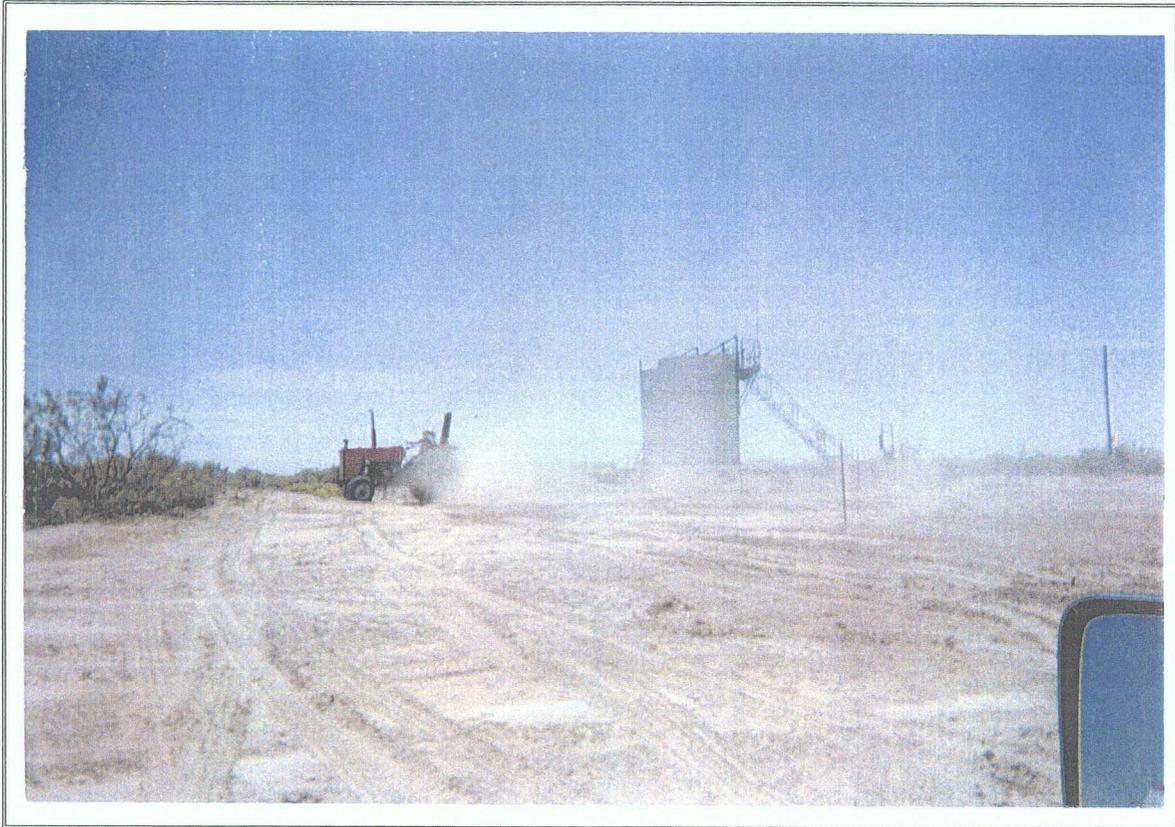
11. Site being reseeded after completion of backfilling.

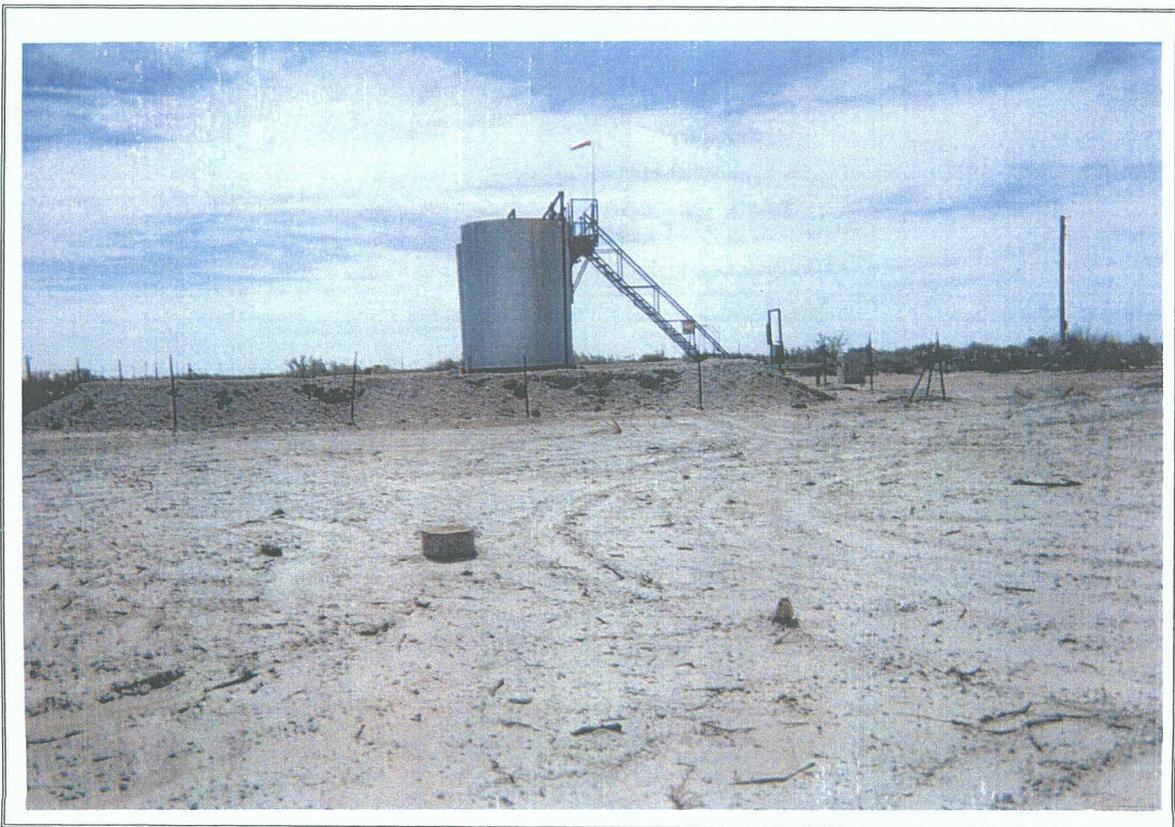
12. Concrete marker denoting center of former junction box location.
