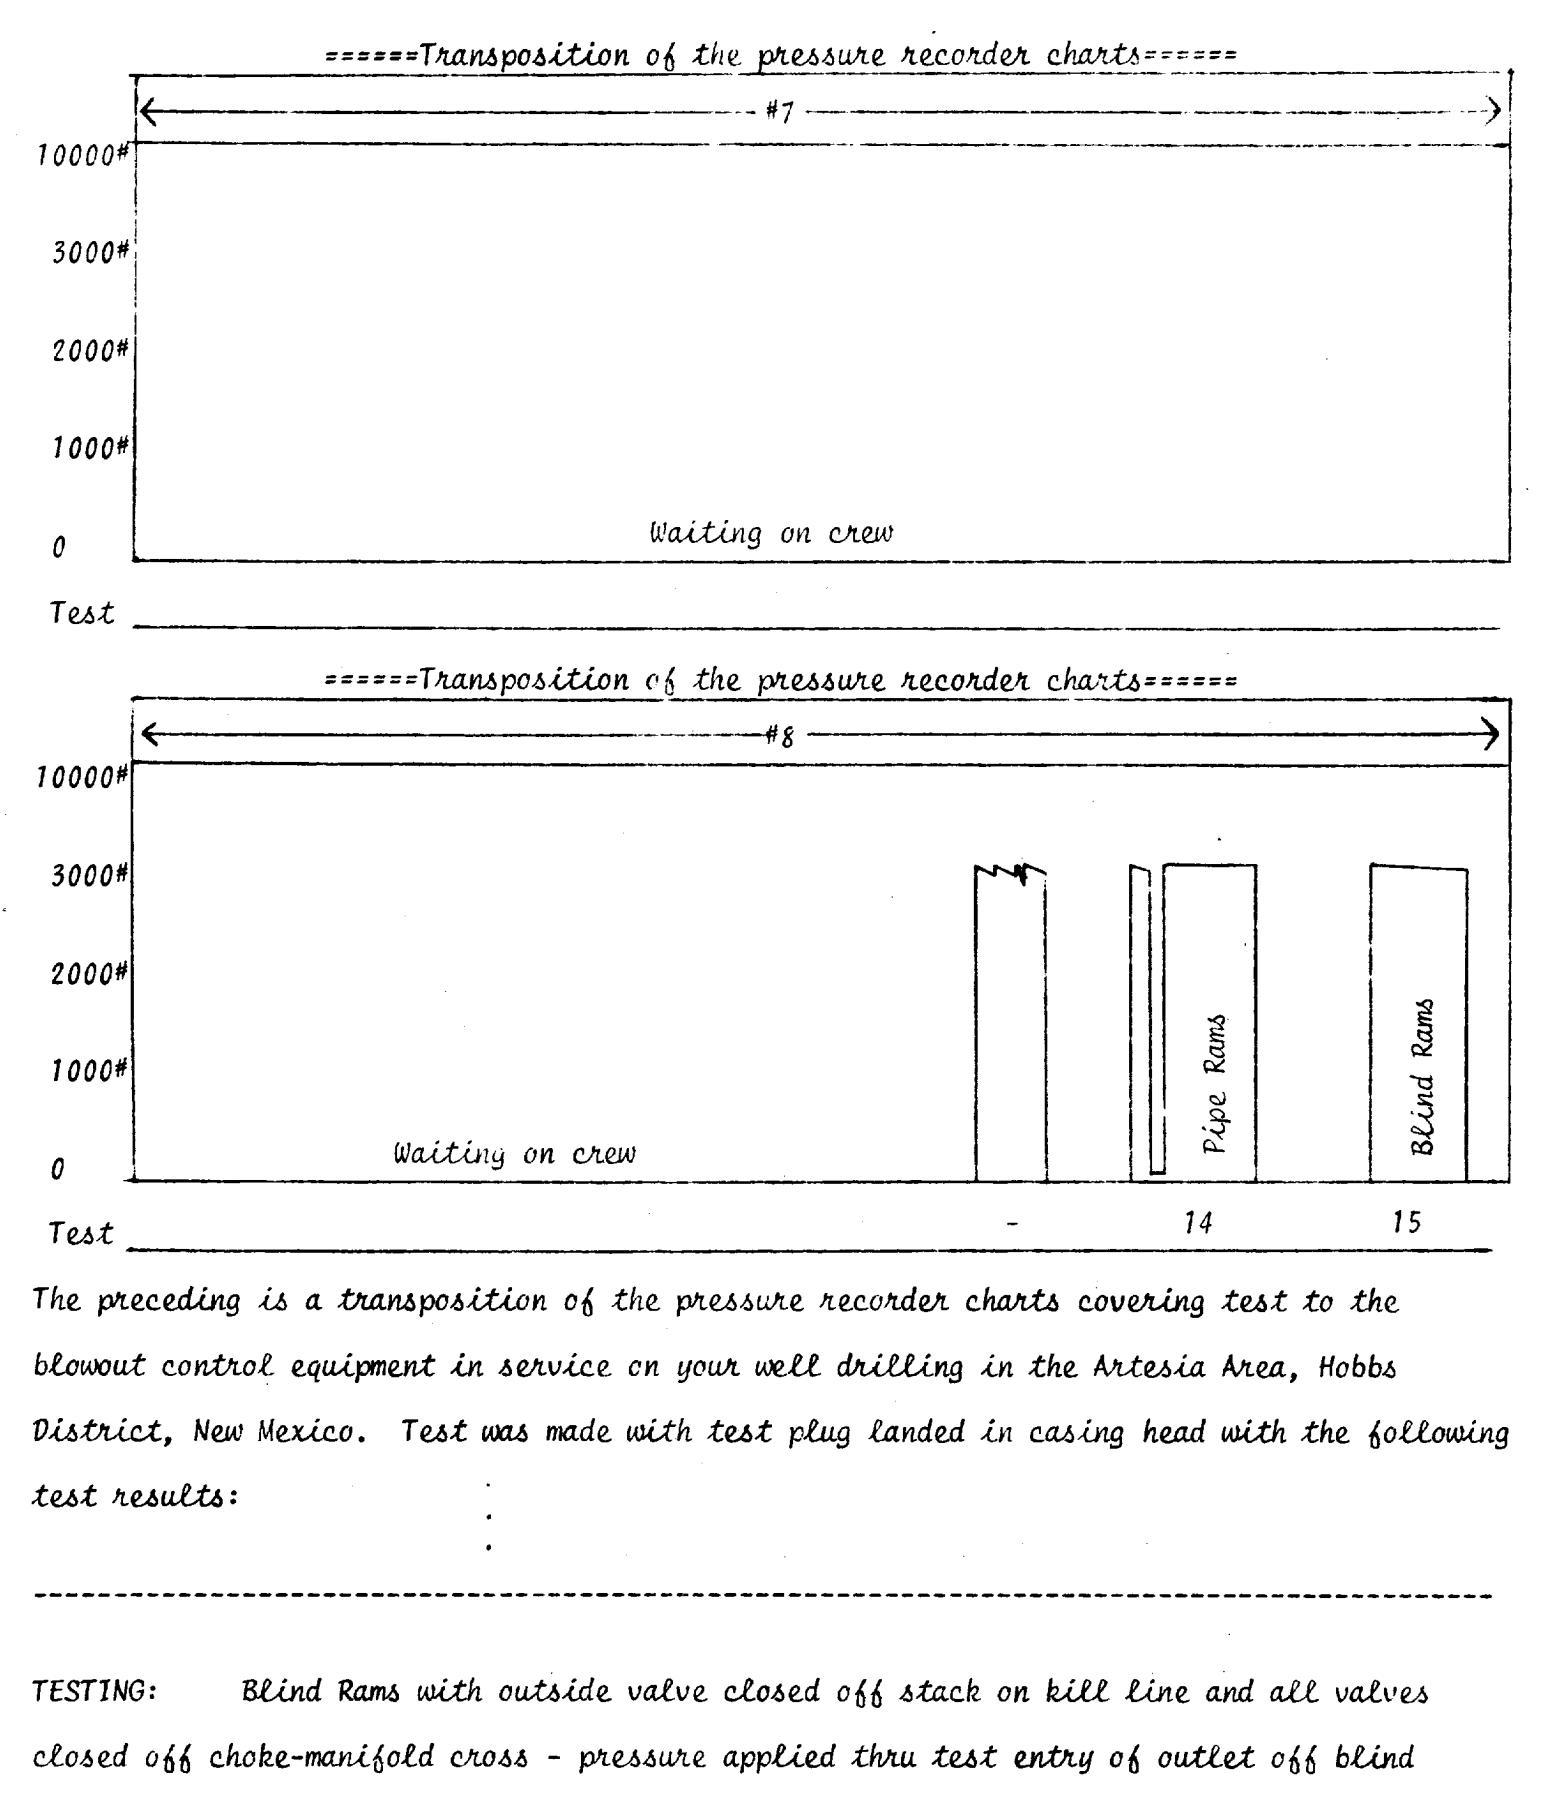
rams bop. Leak to flange between manifold cross and wing value off manifold cross (pipe

rack side) with no pressure being applied. Tightened.
