N Vember 1983) Formerly 9-331	DEPARTMENT OF THE INTER BURE OF LAND MANAGEMEN		Expires Addate 1 1.05 LEASE DESIGNATION AND SERIAL S LC. 029388-C
(Do not use thi	NDRY NOTICES AND REPORTS	back to a director OEINFD	IF INDIAN, ALLOTTEE OR TRIBE NAME
OIL GAS WELL WELL 2. NAME OF OPERATOR	A OTER Water Injection Well	<u>626 4 13 57 11 '89</u> 85	UNIT AGREEMENT NAME
	011 Company		Federal (Johnson "A"

3. ADDRESS OF OPERATO	£	ARE	WBLL NO.
P. 0. Box	552 Midland, Texas 79702		
4. LOCATION OF WELL (See also space 17 be At surface	Report location clearly and in accordance with an	State requiremRECEIVED (0.	2 FIELD AND POOL OR WILDCAT
660' FSL 8	1980' FEL, Sec. 10, T-18-S,	R-31-E	Shugart Yates, 7RO/Grbg
		APR 12'89	SUBVET OR ARDA

Re: Johnson A Fed #2 0-10-18-31

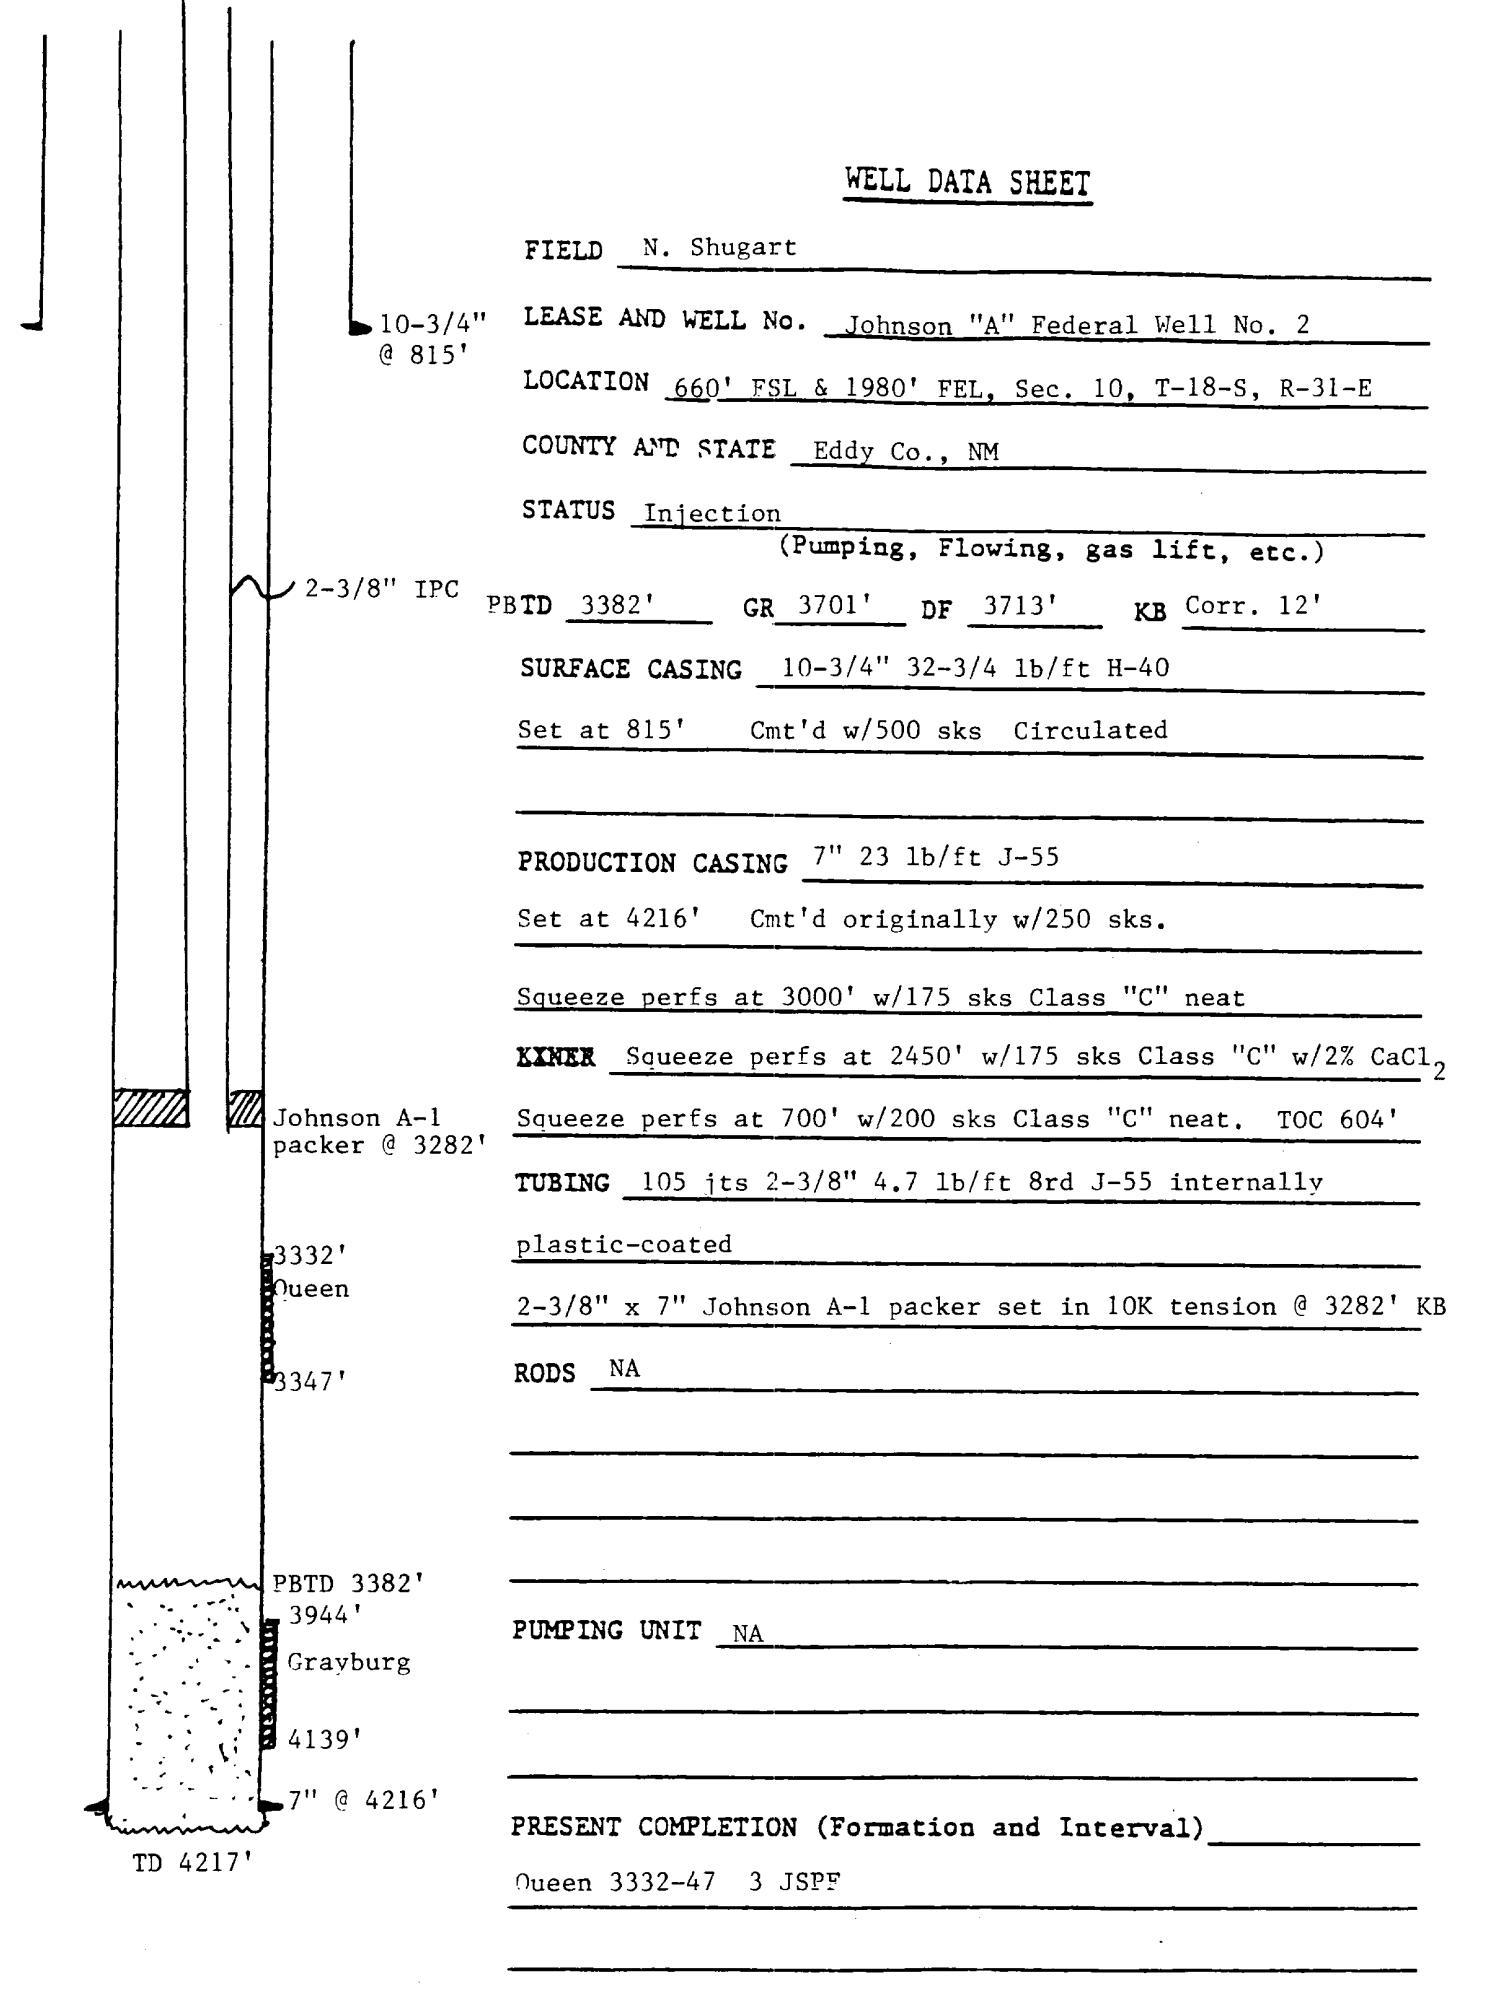
HISTORY: Drilled 1956. Originally completed in Gravburg. Grayburg plugged 1957. Perf'd Queen 1957. Set pumping unit in 1958. Converted to SVD in 1966. 1985 Shot squeeze holes at 3000', 2450' and 700' (cmt as above) to stop water flow. Failed bradenhead test 3-13-89.
