GCU 307 & 328-MIT Proposal L-30-29N-12W 2N-33-29N-12W

MEMORANDUM

Mechanical Integrity Testing of Dual Producing / Water

Disposal Wells -- GCU Wells No. 307 and No. 328

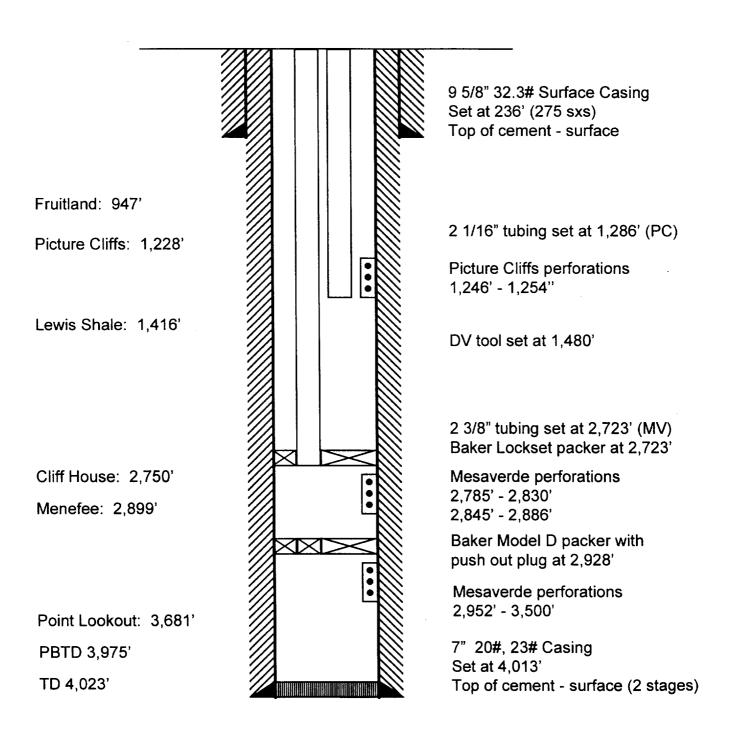
GCU 307 SWD L30 T29N-R12W, 1455' FSL, 510' FWL API 3004524248

Mechanical integrity testing of the subject dual producing / water disposal wells is effectively accomplished by monitoring the production of producing horizon. In these cases, the Fruitland or Pictured Cliffs (PC) formation is the producing zone and the Mesa Verde formation is the water disposal zone. A packer isolates the producing and water disposal zones. Water disposal and gas production are accomplished using individual tubing strings to each zone (Attachments).

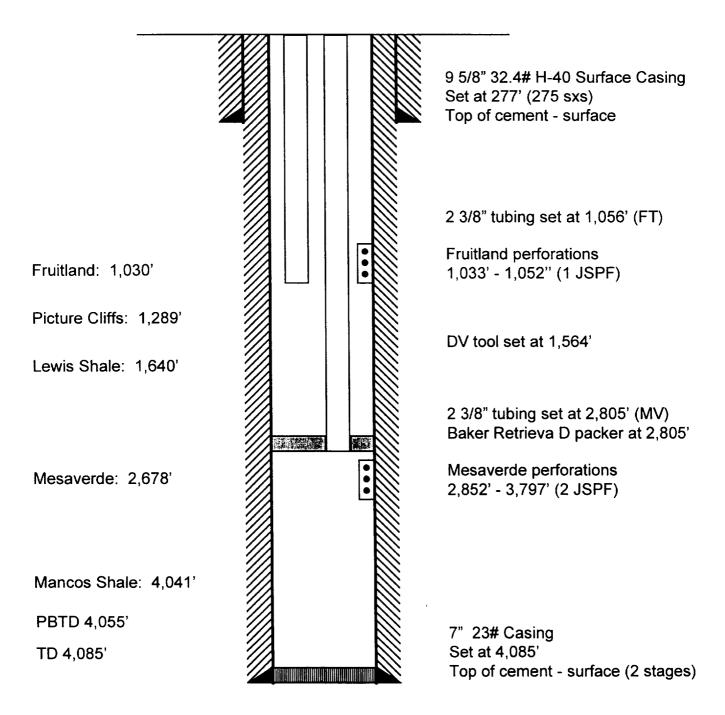
GCU 328 SWD (FT/MV)

An excellent example of using the upper Fruitland zone as a mechanical integrity monitor recently occurred on the GCU No. 328. In February 1999, our field people noticed that the Fruitland ceased producing and water from the producing side of the well was carrying over to the pipeline. Shutting down the water disposal pumps eliminated the carry over. As a result of these observations, the well was pulled, a tubing leak found, and the water disposal string was replaced.
