Release Notification and Corrective Action

OPERATOR	Initial Report	Final Report
Name of Company Occidental Permian Limited Partnership	Contact Steven M. Bishop		
Address 1017 West Stanolind Road, Hobbs, N.M. 88240	Telephone No. (505) 397-8251		
Facility Name South Hobbs Unit #39	Facility Type Production

RE: Remediation Plan South Hobbs Unit #39 3" Fiberglass Injection Line UL 'I', Sec. 6, T-19-S, R-38-E

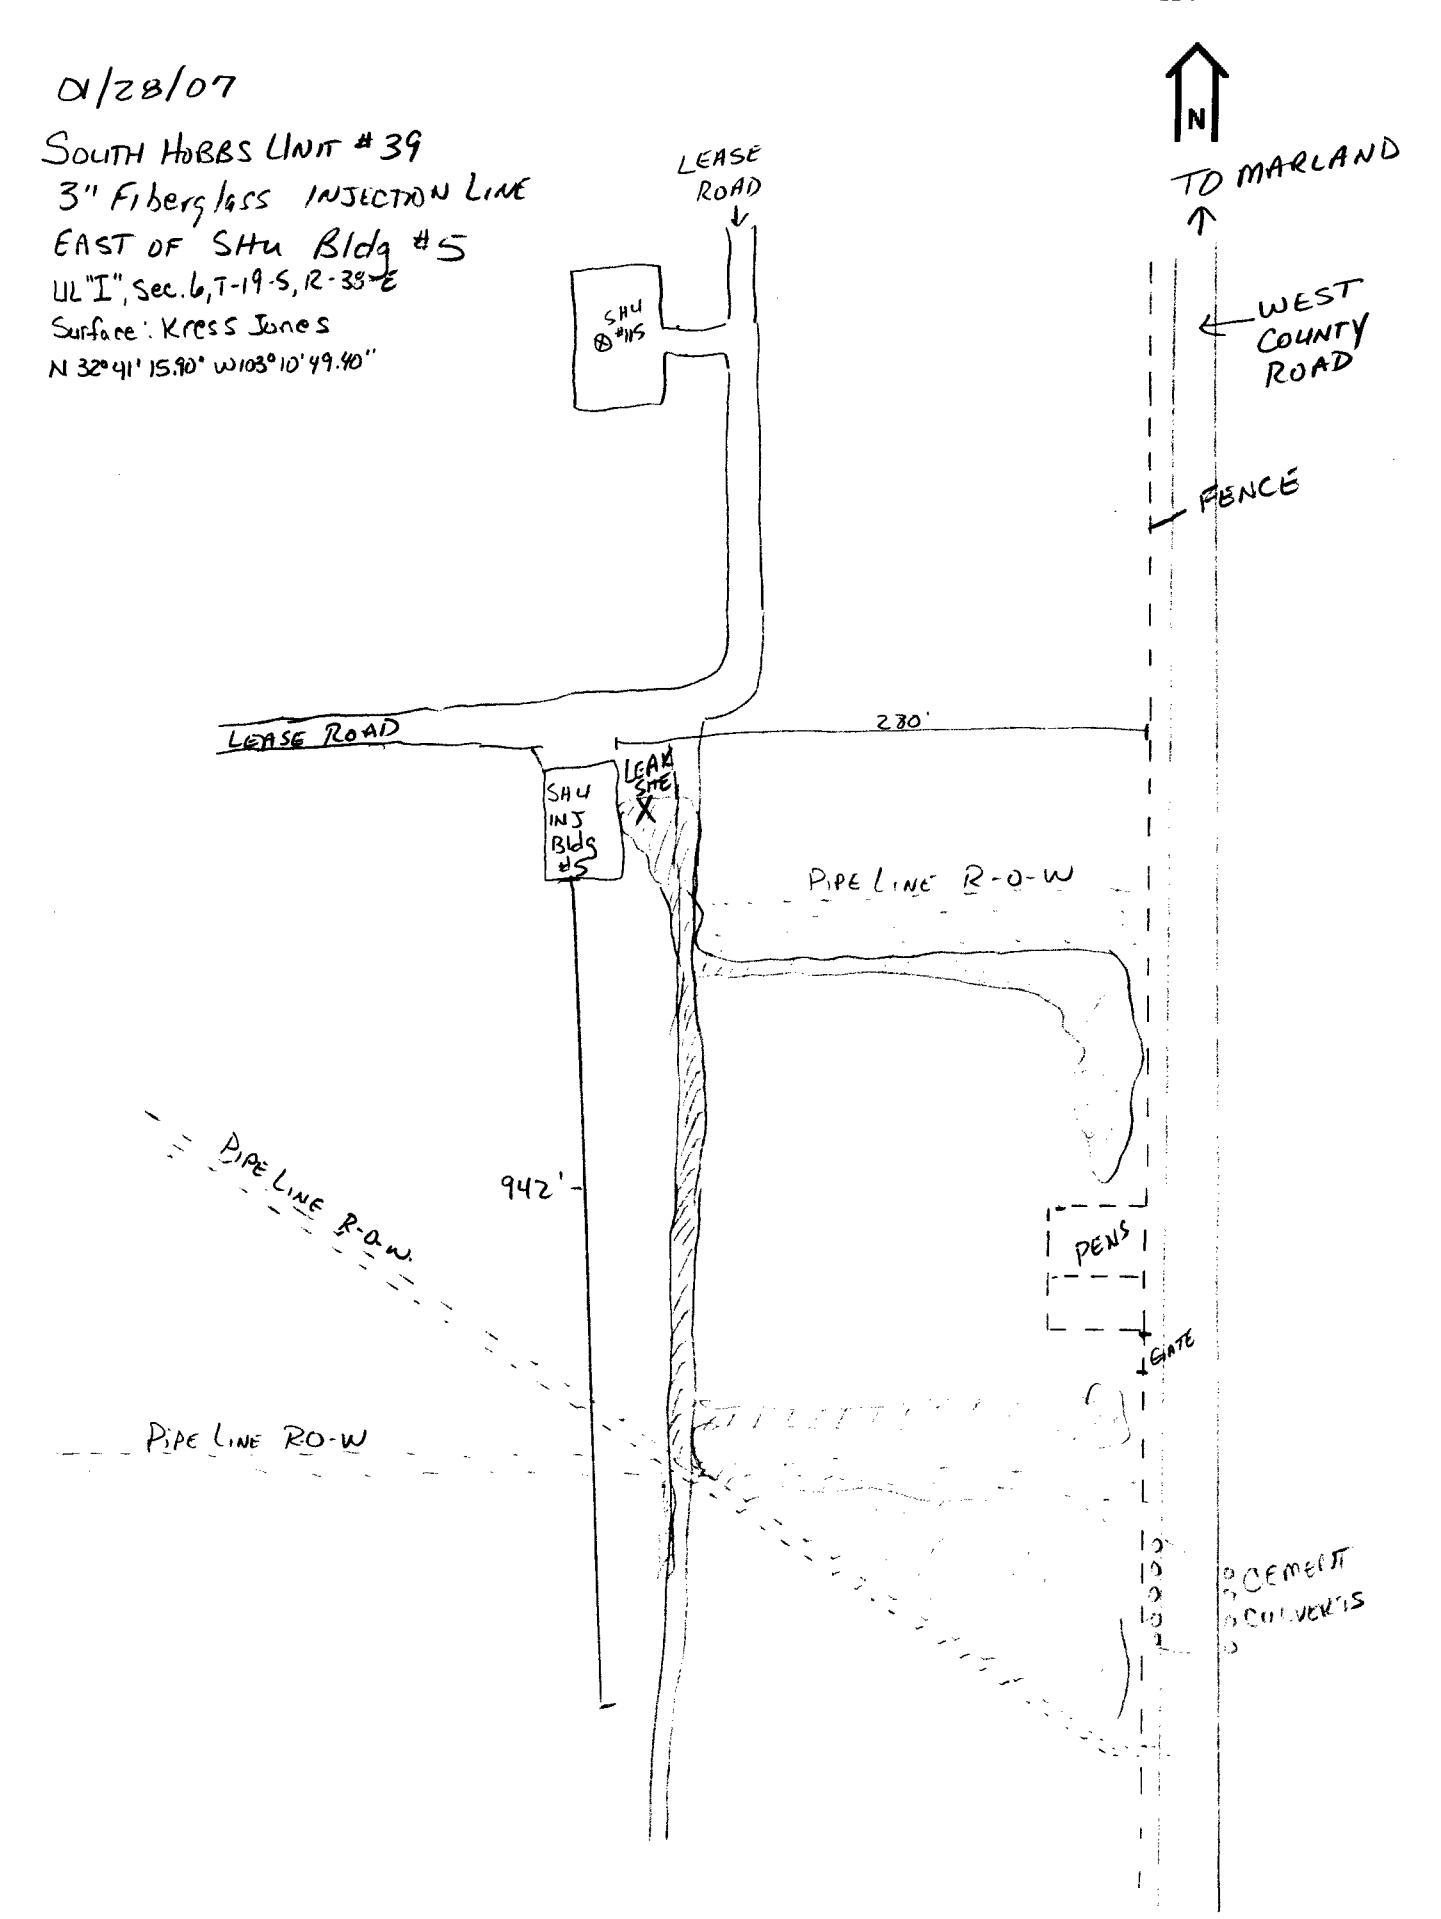
SPILL MAP PLEASE DRAW SKETCH OF SPILL AND INDICATE WHERE SPILL ORIGINATED.

soaked into pasture.				
Describe Area Affected and Cleanum Action Talon *			·····	
Describe Area Affected and Cleanup Action Taken.*			1 1	
Spilled fluid ran approximately 950' to the southeast of South Hol	bbs Unit Injection Building #5. F	luid ran dow	n a two track road	and
accumulated in a larger area on the southeast end of the spill area.	Unable to recover any spilled flu	iid. Area aff	ected is in grassy p	pasture
used for grazing. Area was saturated due to recent snow on groun	d. Area will be remediated to NN	4OCD spill g	guidelines.	
I hereby certify that the information given above is true and complete to t	he best of my knowledge and underst	and that pursu	ant to NMOCD rule	es and
regulations all operators are required to report and/or file certain release n	otifications and perform corrective a	ctions for relea	ases which may end	anger
public health or the environment. The acceptance of a C-141 report by th	e NMOCD marked as "Final Report"	does not relie	we the operator of li	ability

- 1. Piping will be excavated and repaired.
- 2. Affected area will be excavated and soil will be disposed of at Sundance Services, Parabo Faciltiy near Eunice, NM.
- 3. Soil samples will be gathered from affected area.
- 4. NMOCD guidelines will be used to insure entire site is in compliance with guidelines.
- 5. Any soils removed will be replaced with clean fresh soils, where needed.
- 6. Soil analysis data will be submitted with final closure letter.
