Subject: Chevron/Anadarko West Hugh Lease Railroad Conduit Remediation

OCD Case #: 1R0296

### REMEDIATION WORK PLAN AND CLOSURE REPORT

### WEST HUGH LEASE RAILROAD CONDUIT

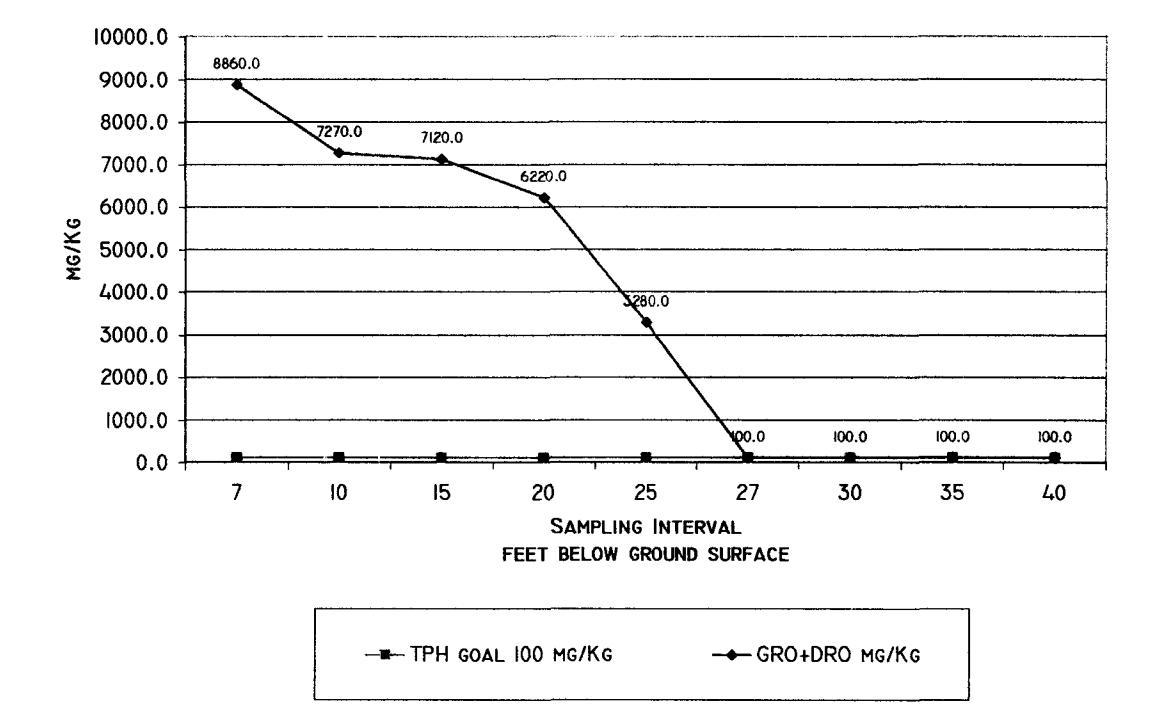
Laboratory results indicate that hydrocarbon contamination persists to - 27'bgs in the central part of the excavated area. Chloride decreases markedly from 25' to 35' bgs but increases at the 40' bgs interval. The charts below illustrate the concentrations relative to the subsurface interval.

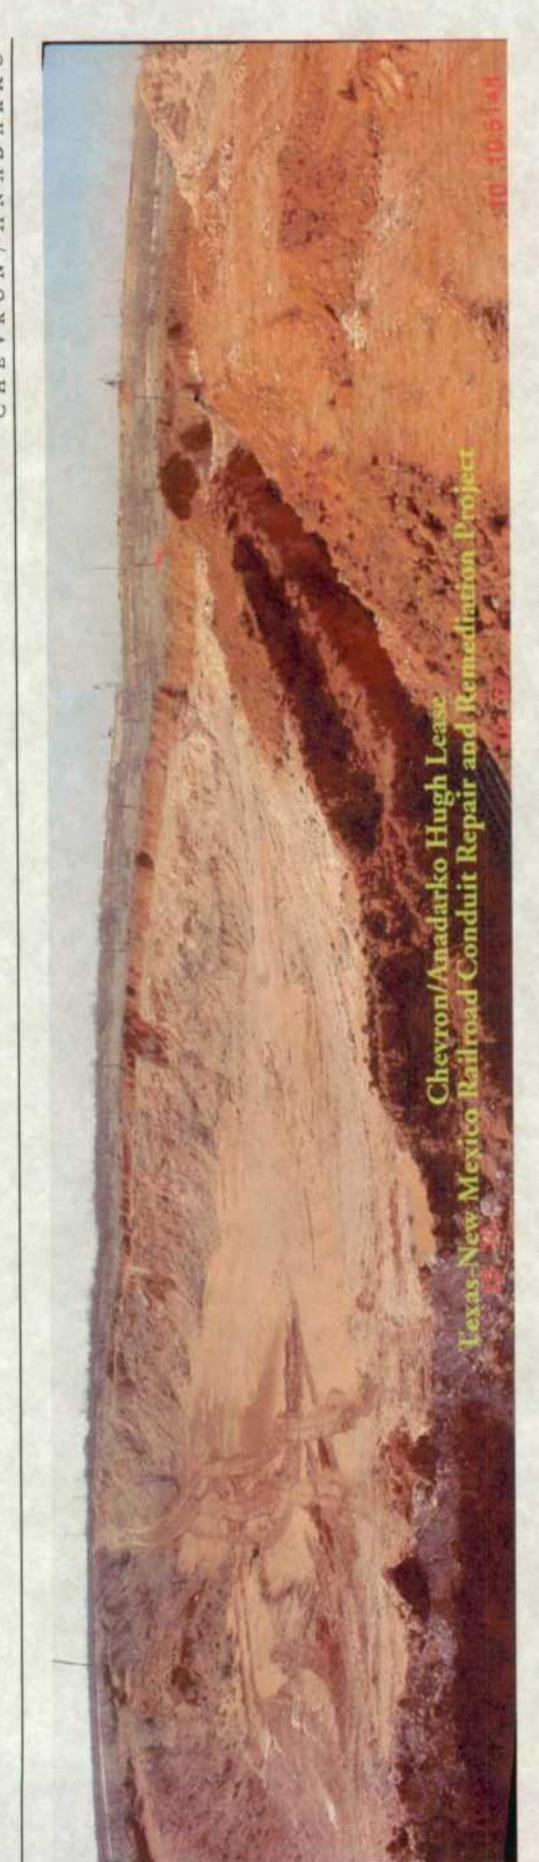
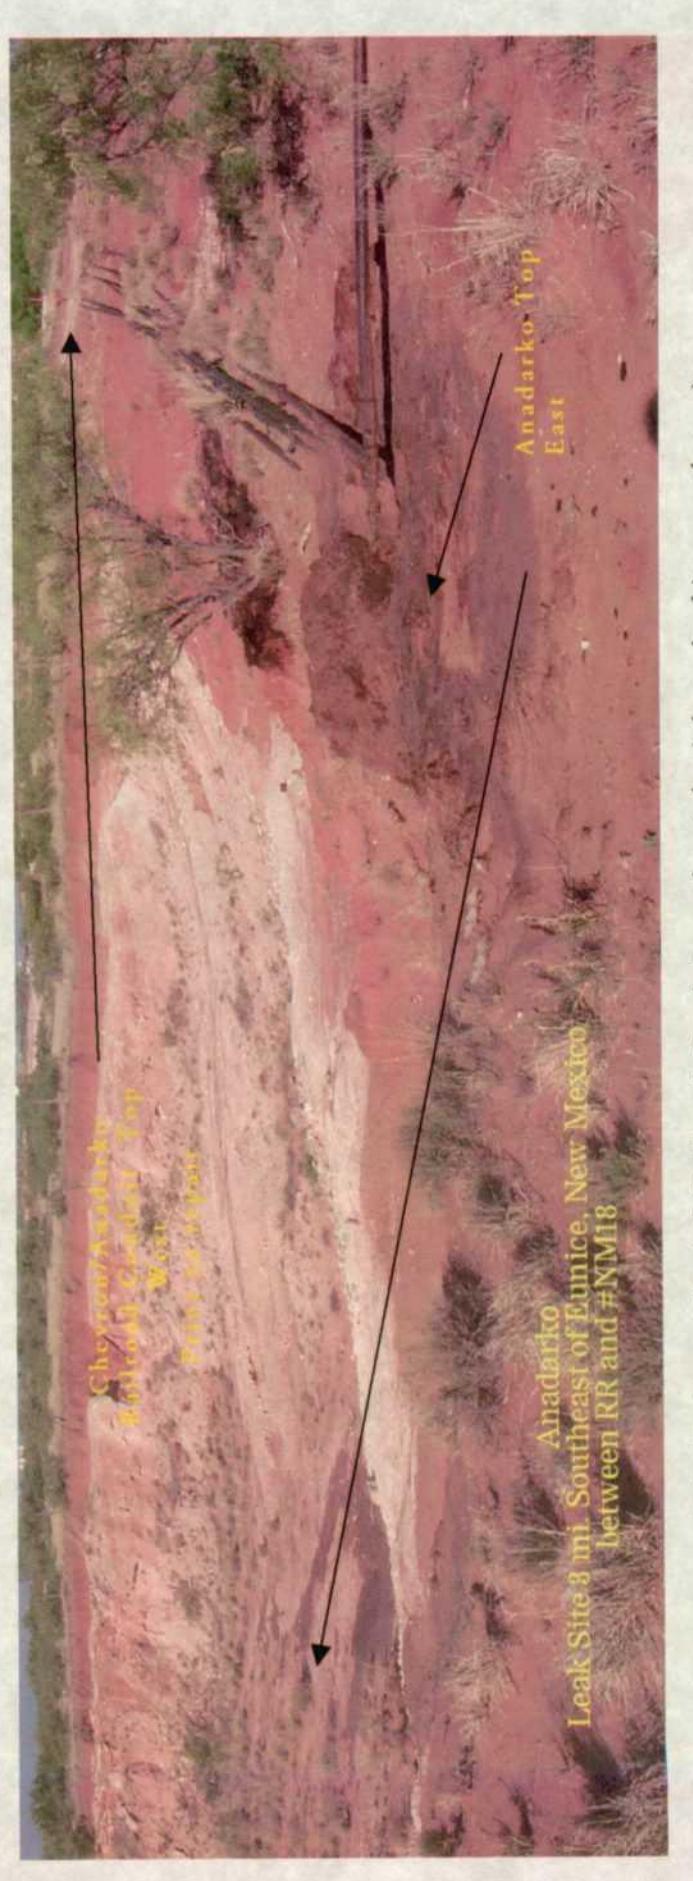
Caliche Pit to the left/Railroad Conduit to the right (photo looking southwest)

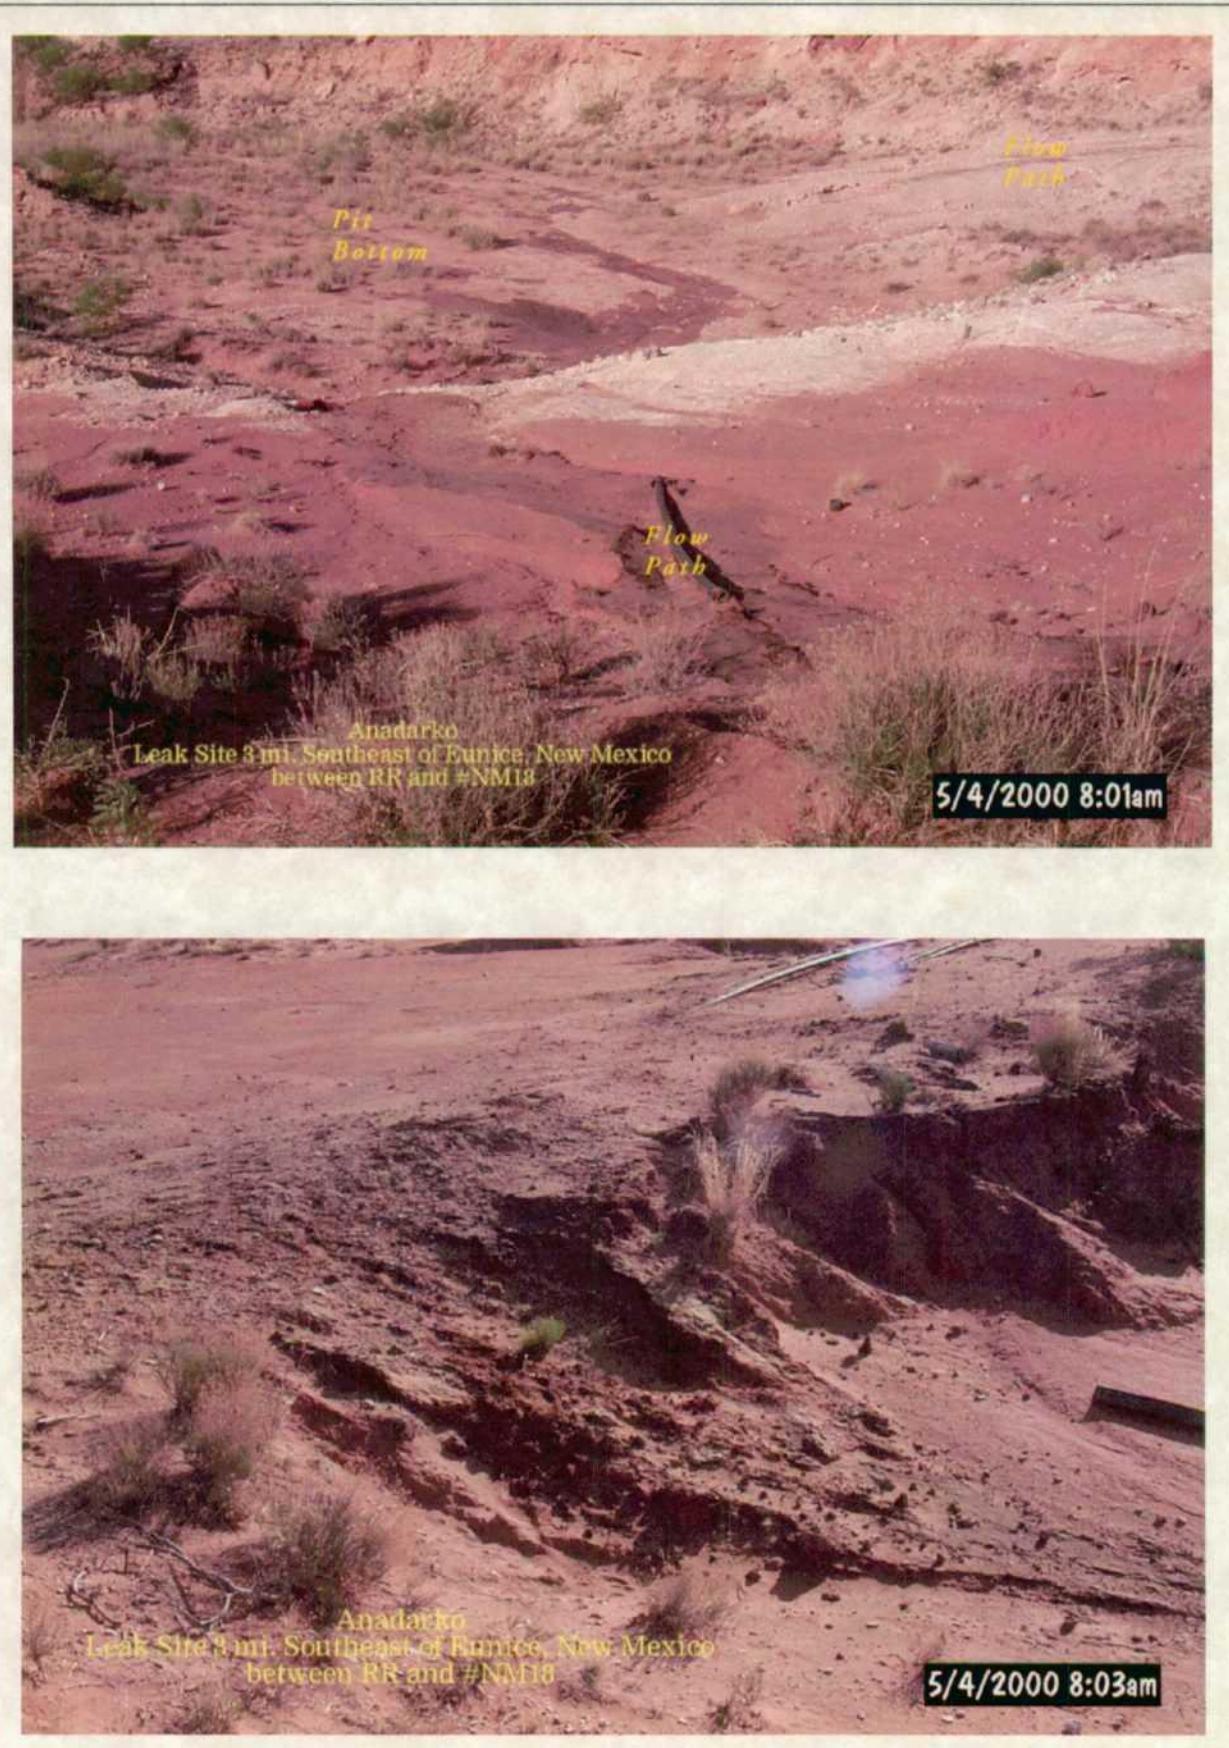
Run-in area from the Railroad Conduit showing historical hydrocarbon impact
