# 3R - 399

Subject: RE: Guidance on Pit Remediation - CDX Gas - Romero Com 1 30-039-22892

Romero Com 1 Sec 25, T26N, R6W Rio Arriba County, NM

**Excavation Images**

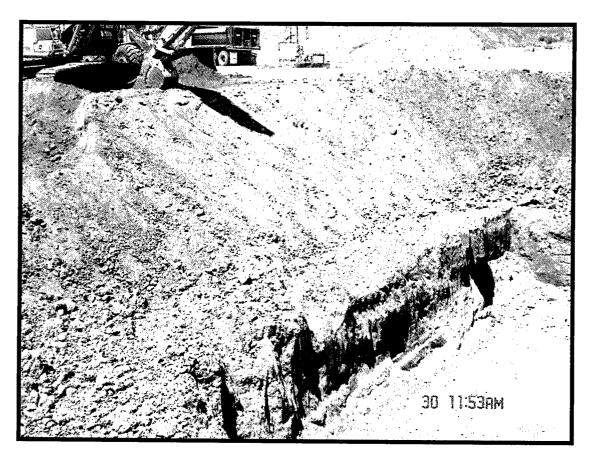
**Looking Southwest at Southern Edge of Sloped Excavation**

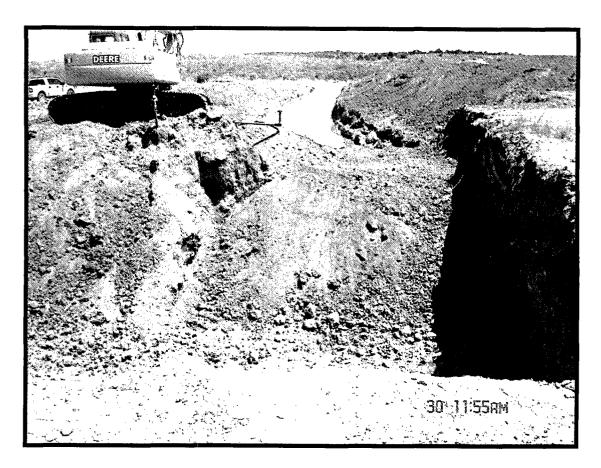
Looking North at Dividing Soil Wall Between Larger and Smaller Excavations

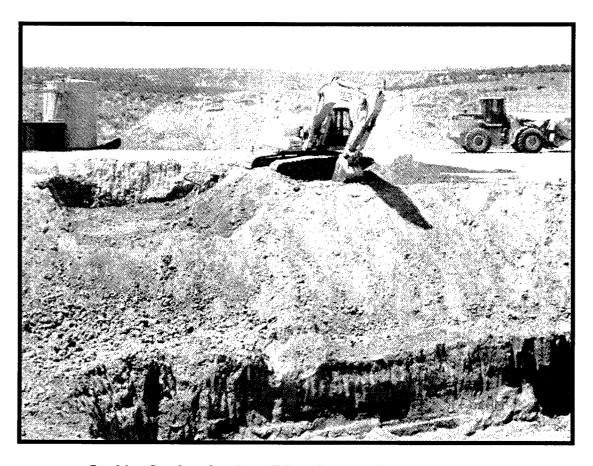
**Looking South at Southern Edge of Larger Sloped Excavation**

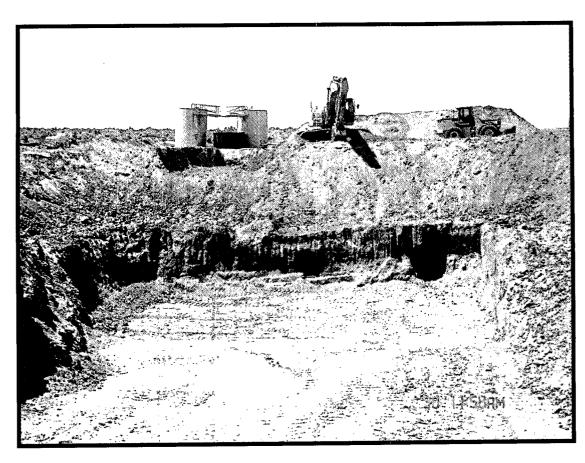
PID readings have varied from 250 to 370 ppm TPH in the larger northern excavation.

**Looking South at Larger Portion of the Sloped Excavation**

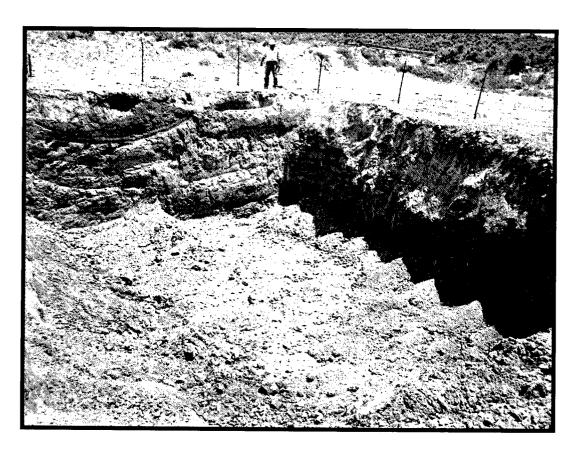
PID readings were zero in the southeast corner of the smaller southern excavation.

**Looking Southeast at the Smaller Excavation**
