**Pit or Below-Grade Tank Registration or Closure**

**RE: Remediation and Reclamation Reports  
Chevron MidContinent Alaska  
Marquardt Federal #3  
Marquardt Federal #6  
Eddy County, New Mexico**

**Re: Remediation and Reclamation Report  
Marquardt Federal #3  
Unit Letter K, Section 12, T25S, R26E  
Eddy County, New Mexico  
Lat. N 32° 08.526', Long. W 104° 14.974'  
(2RP # 24)**

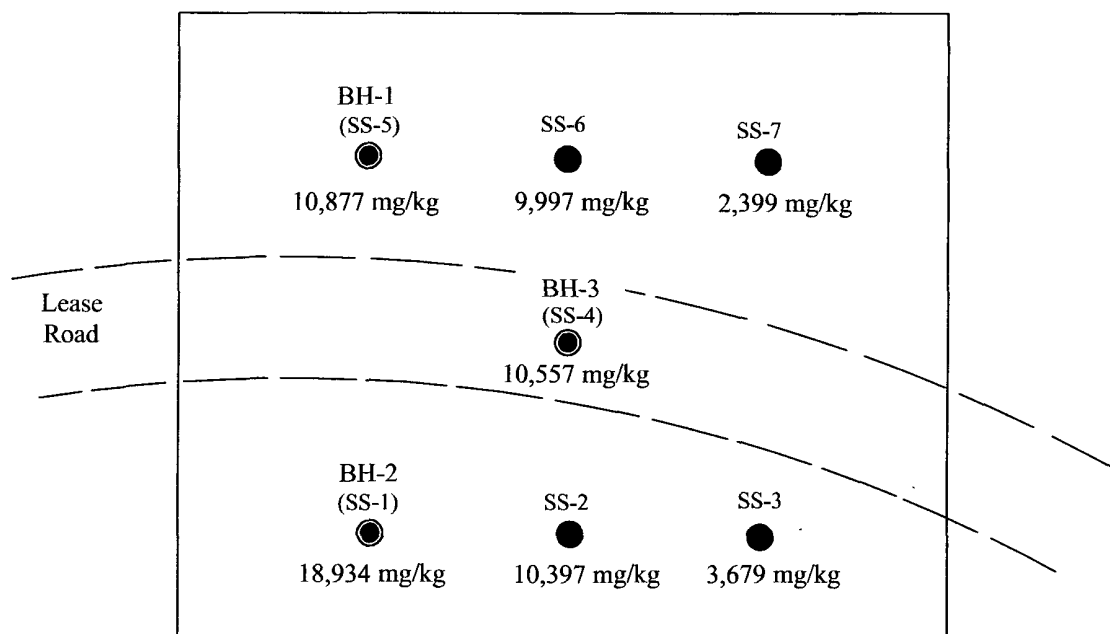
**FIGURE # 2**

On February 25, 2008, excavation of the pit contents was initiated at the Marquardt Federal #3 site. As the exact location of the pit was unknown, excavation began at the borehole locations BH-1 and BH-2, shown on Figure 2. Table 1 provides a summary of the chloride concentrations reported from soil samples collected at the surface and from soil borings installed during the initial investigation.

Site Drawing with Boring  
and Sample Locations

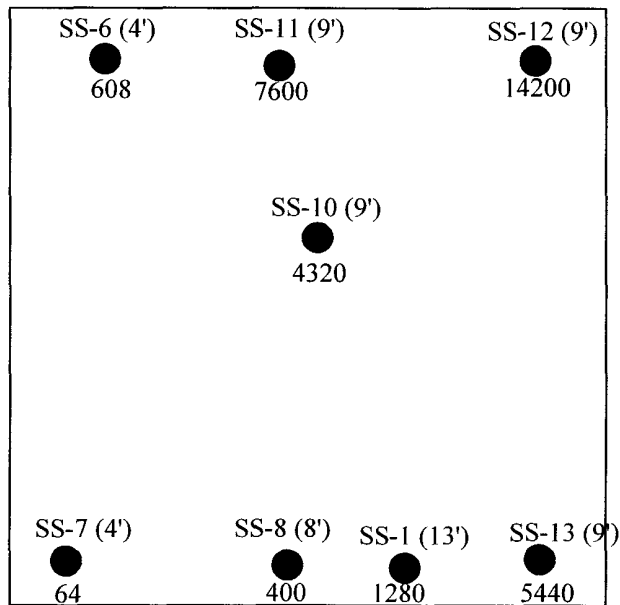
**FIGURE #3**

On March 11, 2008, soil samples (SS-1 through SS-9) were collected below the liner, at a depth of four (4) feet bgs at the west side of the pit (SS-6 and SS-7), sloping to a depth of nine (9) feet bgs to the east side of the excavated area (SS-1 and SS-2). Samples were collected in the center of the excavation at depths ranging from four (4) feet bgs (SS-4) to eight (8) feet bgs (SS-8). All soil samples were placed in clean glass sample jars and delivered under chain-of-custody control to Cardinal Laboratories (Cardinal), located in Hobbs, New Mexico, for chloride analysis. Figure 3 shows the sample locations. Table 2 provides a summary of the laboratory results. Appendix A provides laboratory documentation.

Referring to Table 2, samples collected from the southeast corner (SS-1), the west side (SS-6 and SS-7), and the south center (SS-8), reported chloride concentrations below 2,000 mg/kg.

On March 19, 2008, soil samples (SS-10 through SS-13) were collected from the center and east sides of the excavated area at a depth of approximately nine (9) feet bgs. The samples were placed in clean glass sample jars and submitted to Cardinal for chloride analysis. Figure 3 shows the sample locations. Table 2 provides a summary of the laboratory results. Appendix A provides laboratory documentation.

Referring to Table 2, soil samples SS-10 through SS-13, reported chloride concentrations above 2,000 mg/kg. On March 24, 2008, I spoke with Mike Bratcher (NMOCD, Artesia) and reported the rock conditions and analytical data that we had received from the soil samples. Mr. Bratcher said that, given the nature of the rock conditions, closure would be approved.

Site Drawing With Soil Sample  
Locations in Excavated Area

Upon speaking with Mr. Bratcher, the entire pit area (160' x 160') was excavated to a depth of approximately nine (9) feet bgs, and a double, 4 ounce felt liner was installed at the bottom of the excavation on April 8, 2008. Following installation of the felt liner, the entire pit was lined with 20 mil plastic, allowing enough overhang to encapsulate all excavated soil. Stockpiled soil was placed back in the excavation, to a depth of approximately three (3) feet bgs, and completely encapsulated with 20 mil plastic. Soil removed from the west side of the excavation (from a depth of 4' bgs to 9' bgs) was used to backfill the remainder of the area, from a depth of three (3) feet bgs to surface. The surface was contoured to native conditions, and the
