Caprock Maljamar Unit #038

CLOSURE REPORT

API No. 30-025-01485

NMOCD Case #: 1RP-3390

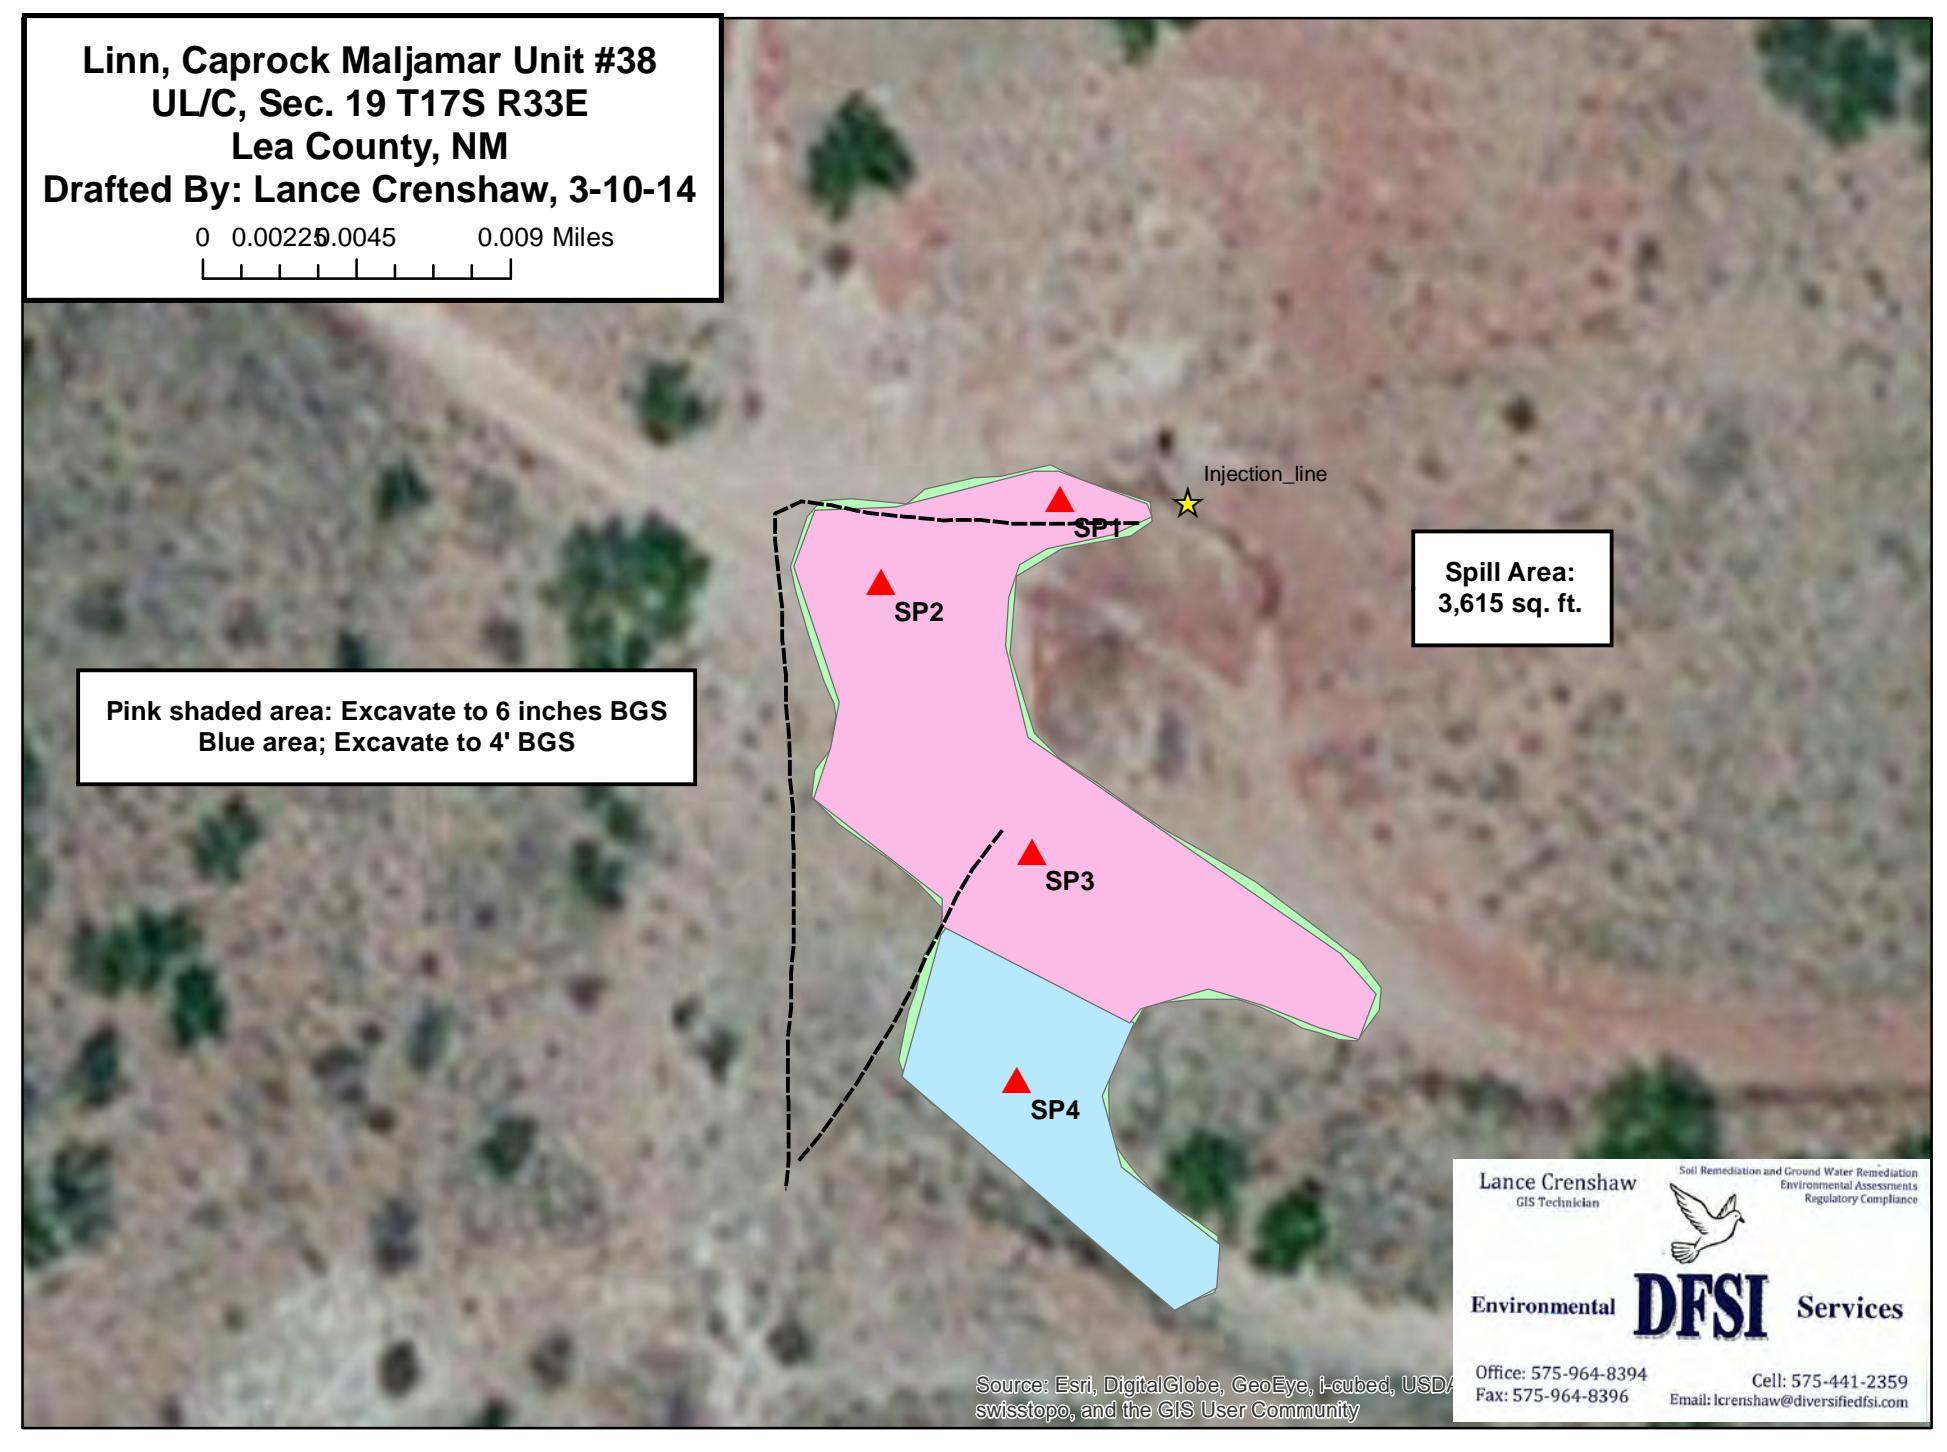
Site Diagram

On March 10, 2015, DFSI personnel were on site to obtain samples within the leak area (Figure 1). Four samples were obtained and field sampled for chloride levels, as well as BTEX. The BTEX samples were performed using a Mini Rae Photoionization Detector (PID). Field samples were submitted for analysis at Cardinal Laboratories of Hobbs, NM to obtain confirmation.

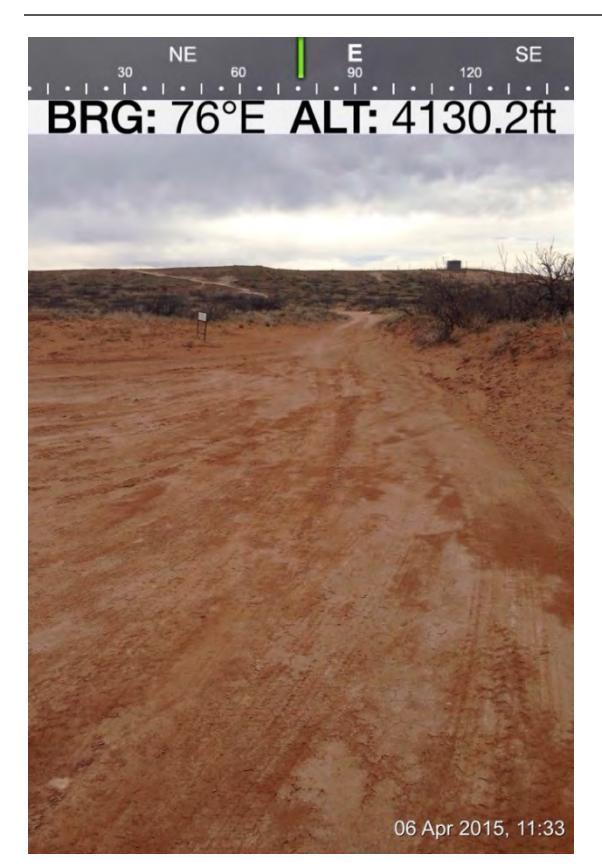
Spill area on caliche pad

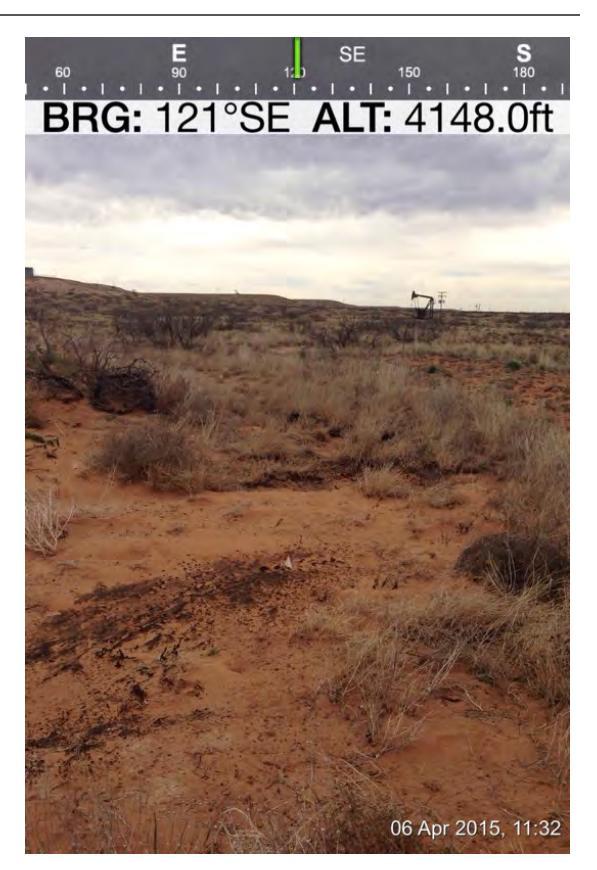
Spill area in pasture

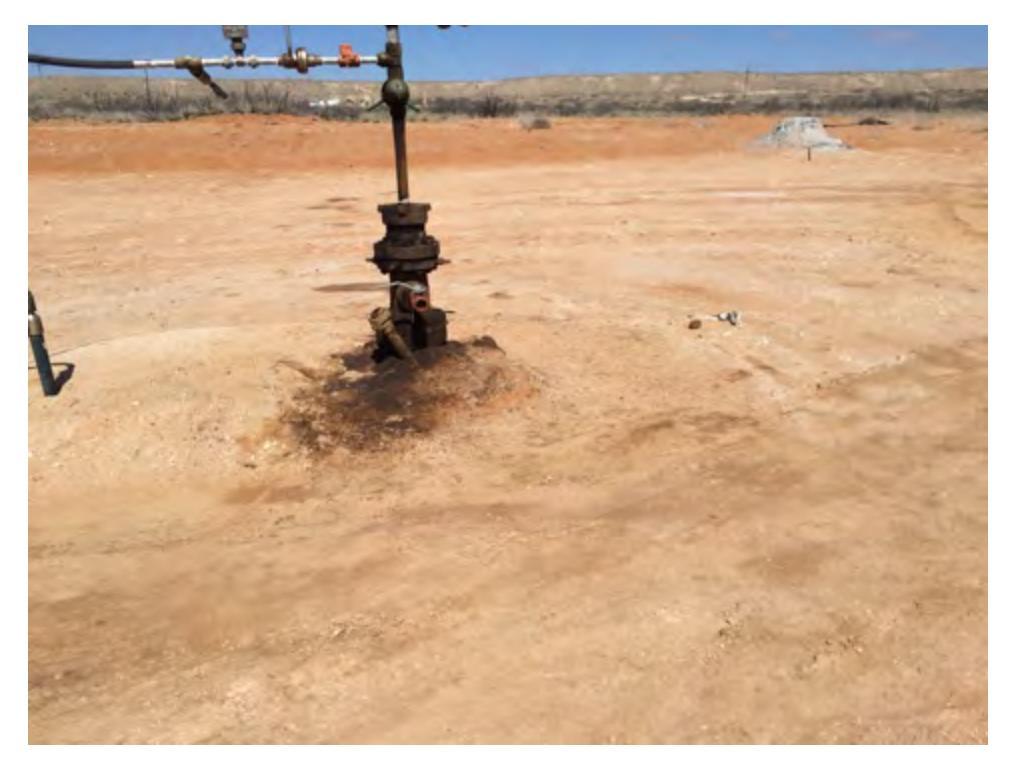
Contaminated area around wellhead

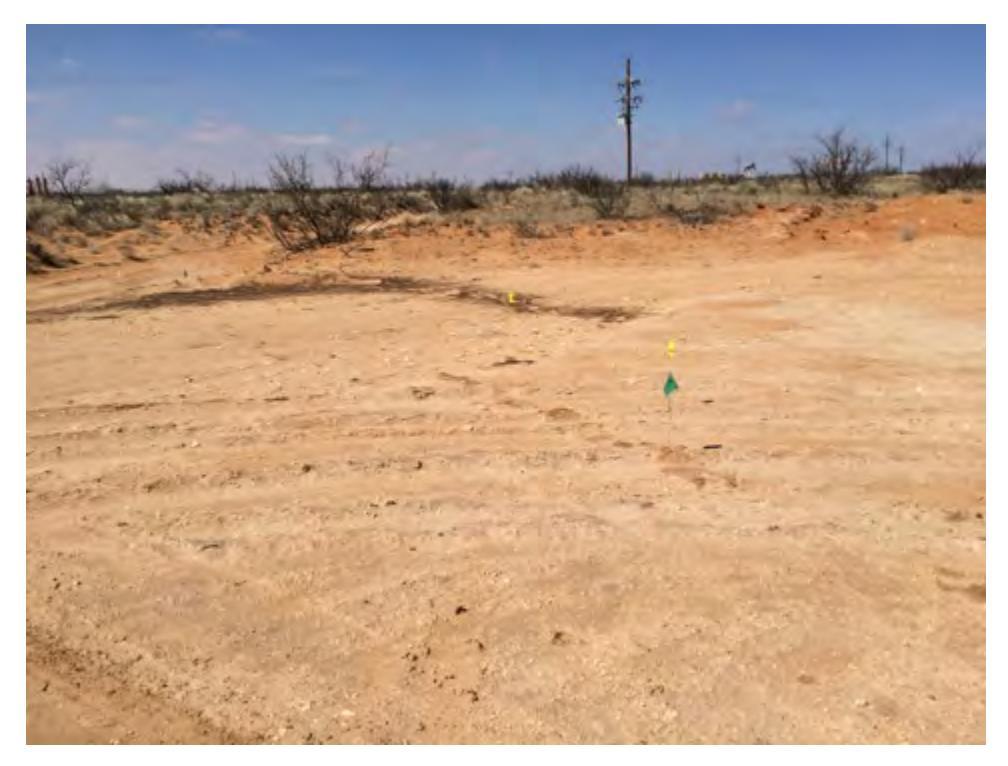
Contaminated area on caliche pad
