OXY USA Antelope Ridge 11 Unit E, Section 34, Township 23S, Range34E Lea County, New Mexico

Closure Report

June 4, 2009

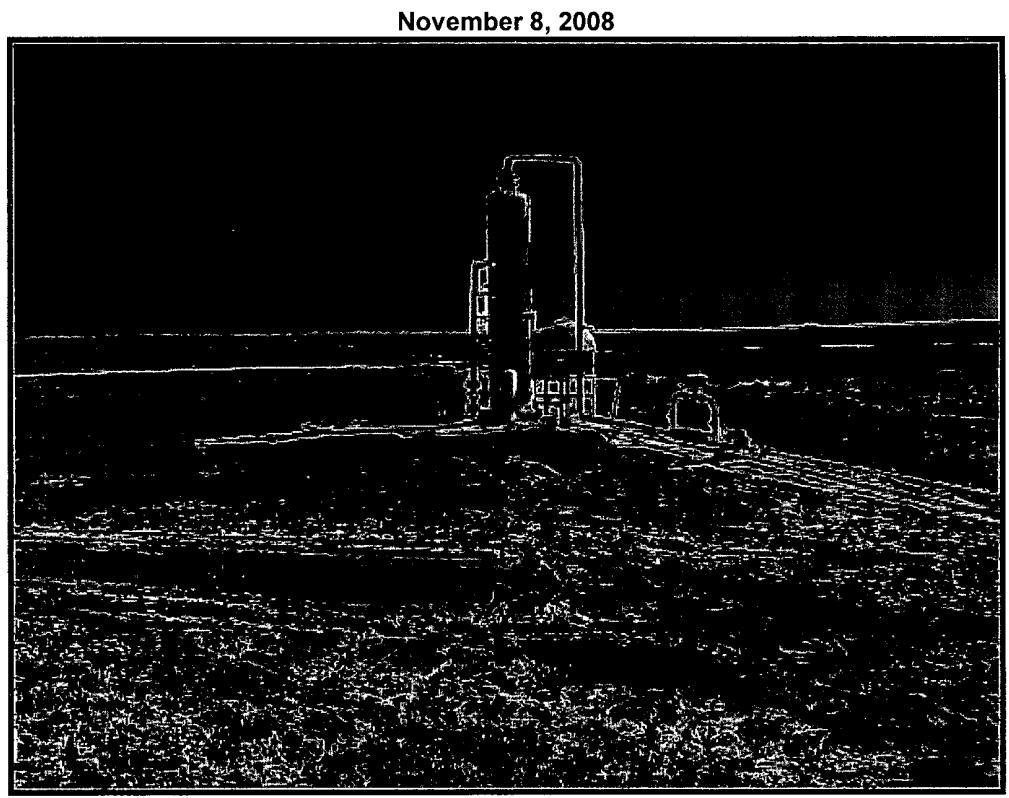
Release facing East

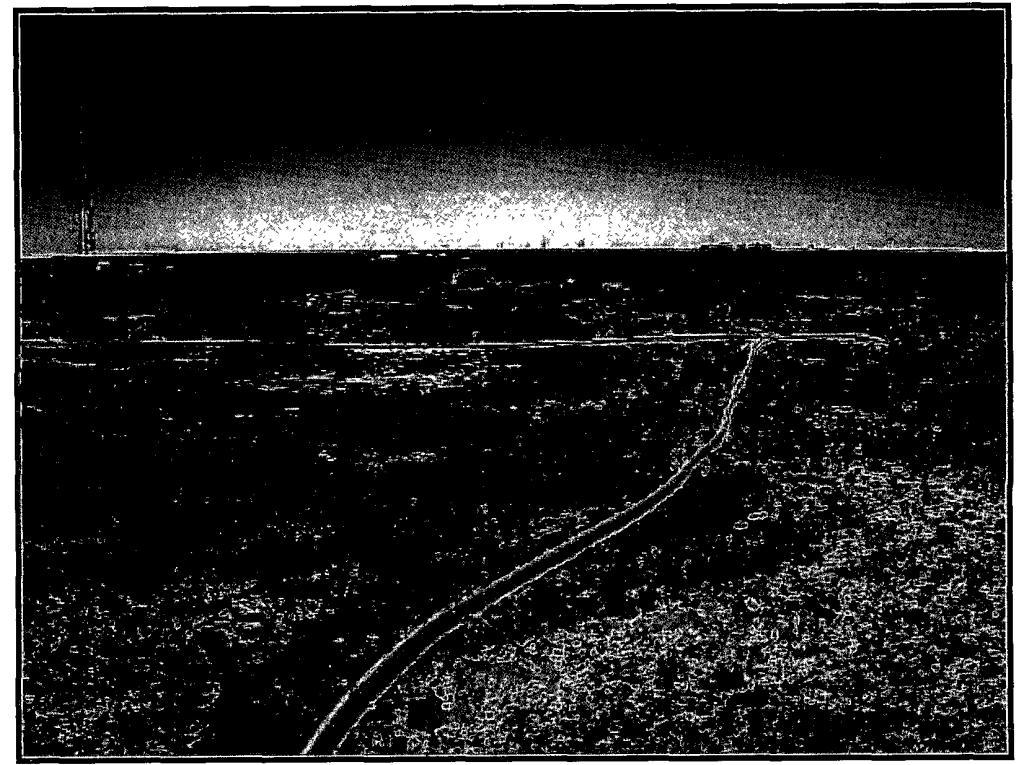
Rain water facing South

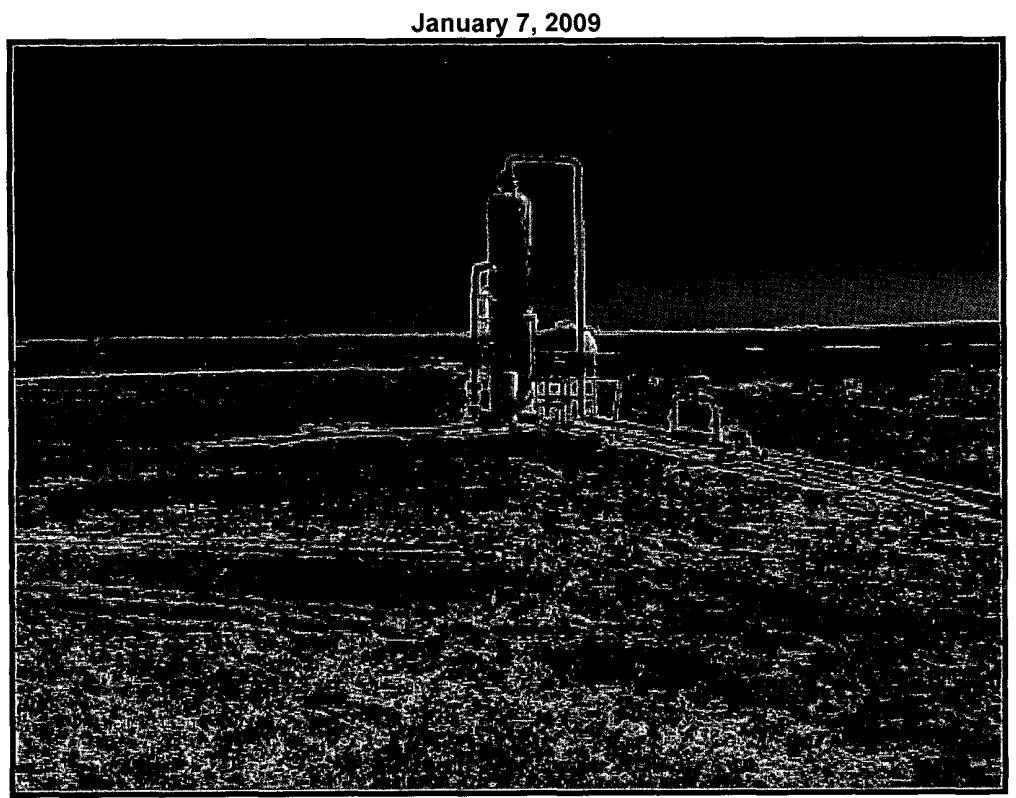
Antelope ridge spill facing East

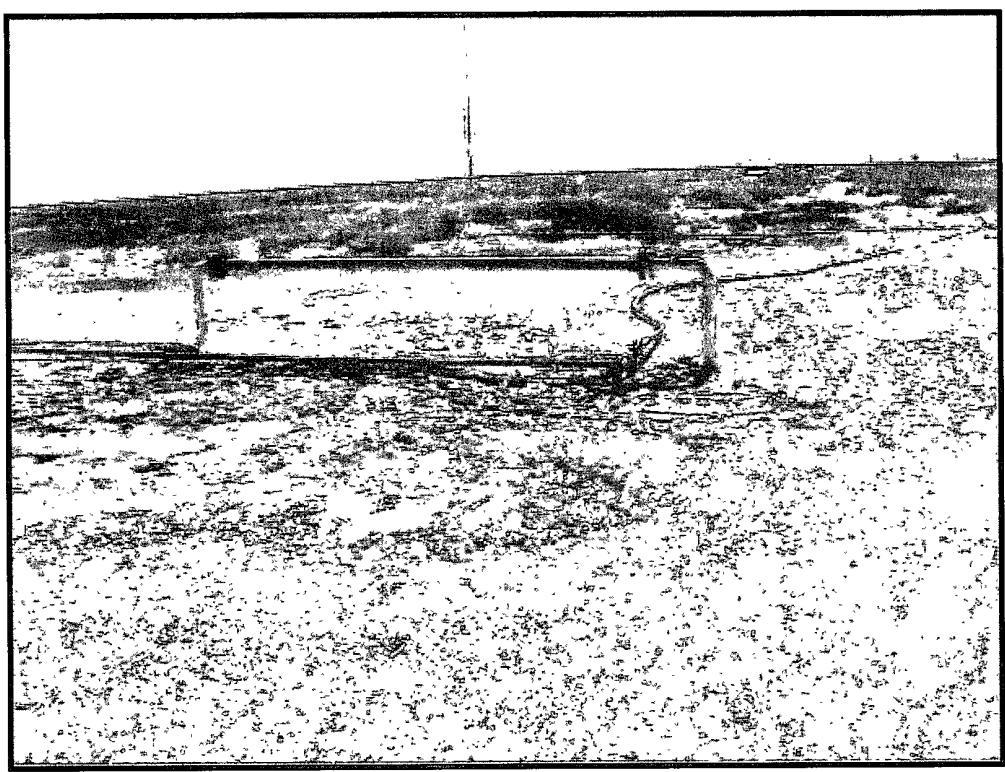
Spill area facing South

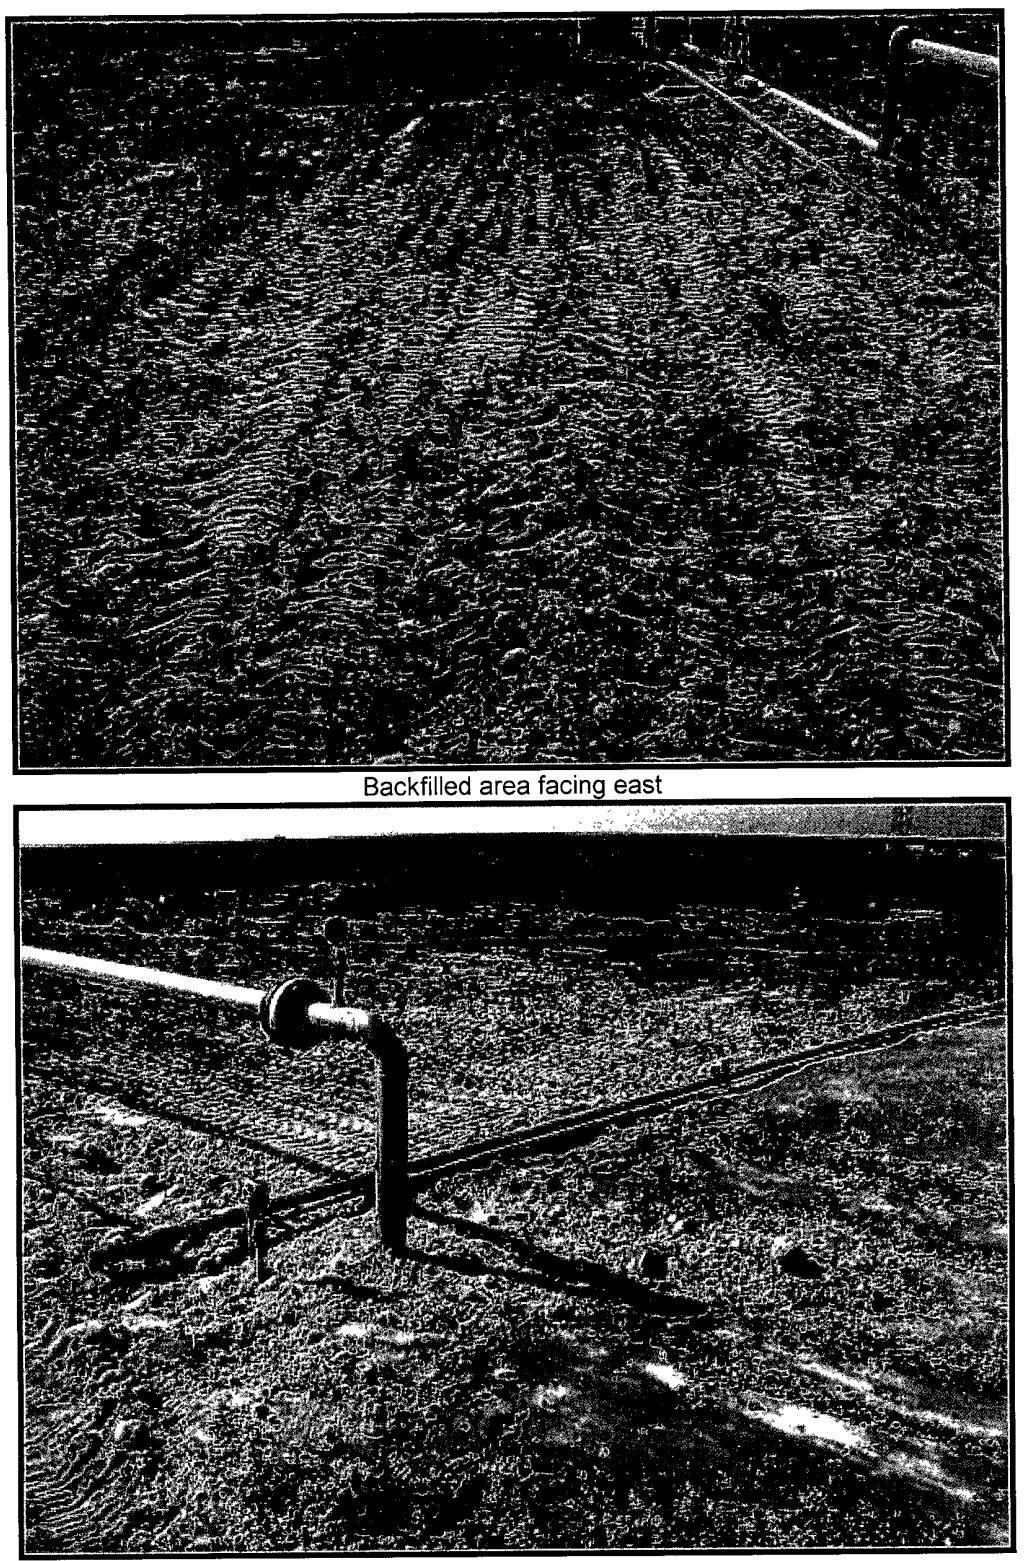
Backfilled area facing southeast

On June 4, 2009 SESI was onsite to perform clean-up services. The contaminated soils around the valve area of the seperator were removed to a depth of 36". All contaminated soil was excavated and disposed of at a NMOCD approved facility. The excavated area was then backfilled to a depth of 48" with approximately 4 yards of clean from an offsite facility.
