# H.E. West B #51

## Corrective Action Plan

API No. 30-015-27110

**RE: Corrective Action Plan  
Linn H.E. West B #51  
UL/G sec. 10 T17S R31E  
API No. 30-015-27110**

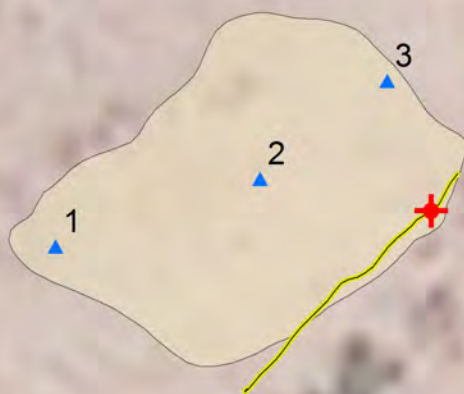
Figure 1

RECS personnel were on site beginning on July 28<sup>th</sup>, 2014 to assess the release. Three points within the release were field sampled at the surface and with depth (Figure 1). Representative samples from the points were taken to a commercial laboratory for analysis (Appendix B). Based on the laboratory analysis, Point 1 returned chloride, Gasoline Range Organics (GRO), Diesel Range Organics (DRO) and BTEX readings below regulatory standards at 3 ft bgs. Point 2 returned laboratory chloride, GRO, DRO and BTEX readings below regulatory standards at 2 ft bgs, and Point 3 returned laboratory chloride, GRO, DRO and BTEX readings below regulatory standards at 5 ft bgs.

CI-	PID	GRO	DRO	B	T	E	X	BTEX
Surface	1880	915	2840	20000	6.44	25.8	44	75.2	151
0.5'	3411	335							
1'	2320	44.9	<10	88.1	<0.05	<0.05	<0.05	<0.15	<0.3
2'	3038	115.7							
3'	368	17.4	<10	<10	<0.05	<0.05	<0.05	<0.15	<0.3
4'	80	52.1	<10	40.6	<0.05	<0.05	<0.05	<0.15	<0.3

CI-	PID	GRO	DRO	B	T	E	X	BTEX
Surface	1340	41	<50	2340	<0.05	0.104	0.135	0.29	0.529
0.5'	2080	69	<10	58.1	<0.05	<0.05	<0.05	<0.15	<0.3
1'	2309	17.8							
2'	64	11.3	<10	54	<0.05	<0.05	<0.05	<0.15	<0.3
3'	64	42.5	<10	48.8	<0.05	<0.05	<0.05	<0.15	<0.3

CI-	PID	GRO	DRO	B	T	E	X	BTEX
Surface	3360	396	837	8600	0.837	5.93	20	44.3	71
0.5'	3018	240.5							
1'	2960	97.3							
2'	3273	126.9							
3'	3462	19.4							
4'	5760	68.5	<10	30.8	<0.05	<0.05	<0.05	<0.15	<0.3
5'	240	20.4	<10	<10	<0.05	<0.05	<0.05	<0.15	<0.3
6'	224	54.8	<10	<10	<0.05	<0.05	<0.05	<0.15	<0.3

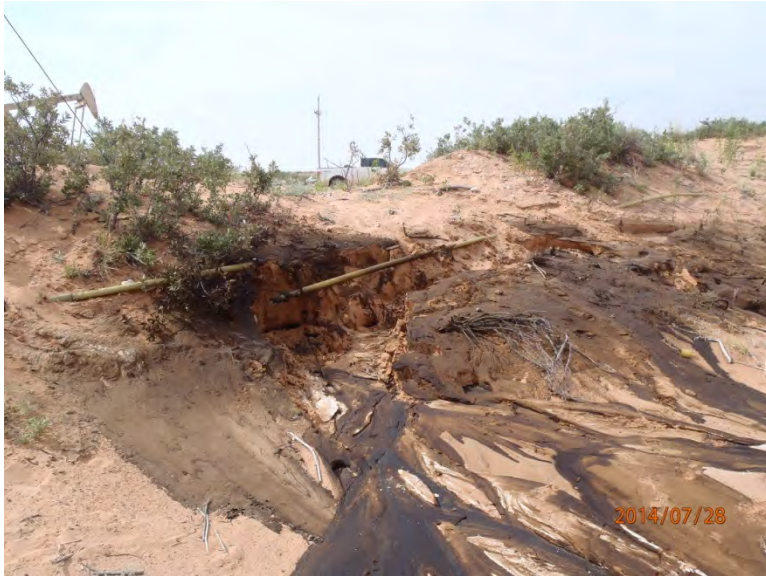
Describe Cause of Problem and Remedial Action Taken.\*: Fiberglass line was exposed due to erosion caused by wind and rain. The line then failed due to the lack of structural support in the area exposed. The line was isolated and the leak stopped. No recovered fluid due to absorption in the sandy location.

Source of release, facing southeast

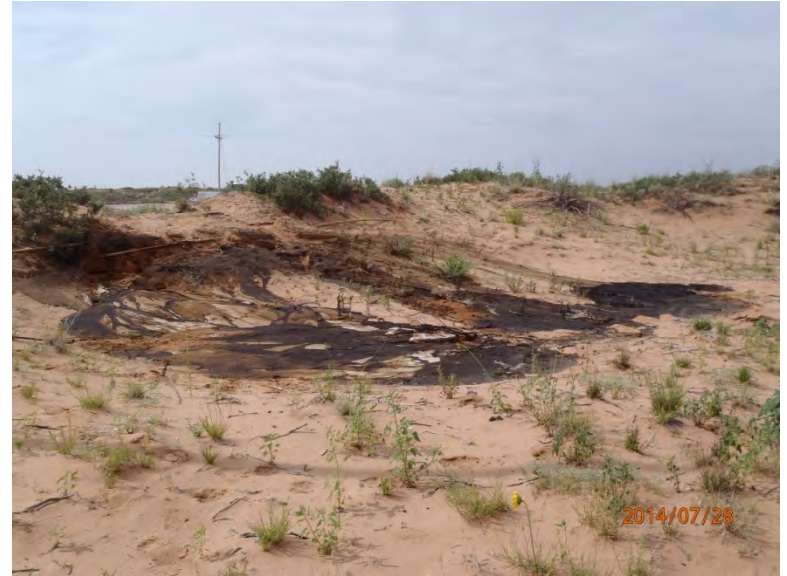
Initial release area, facing southeast

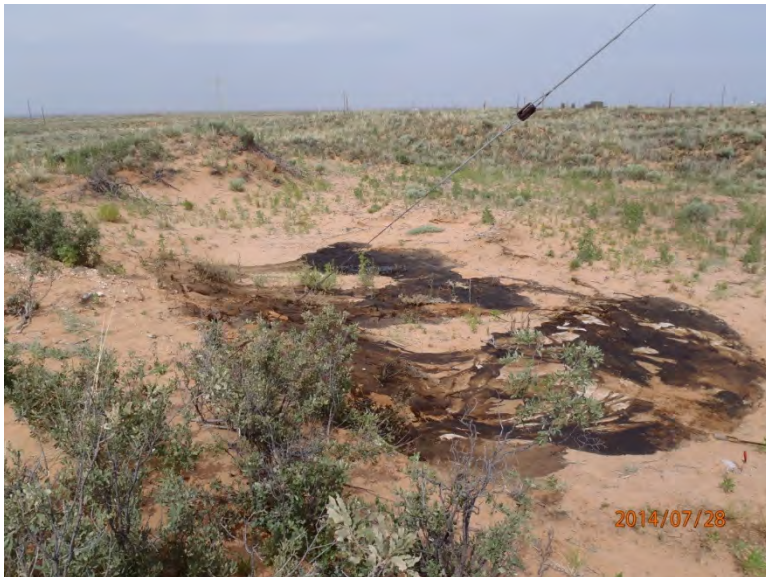
Initial release area, facing southwest

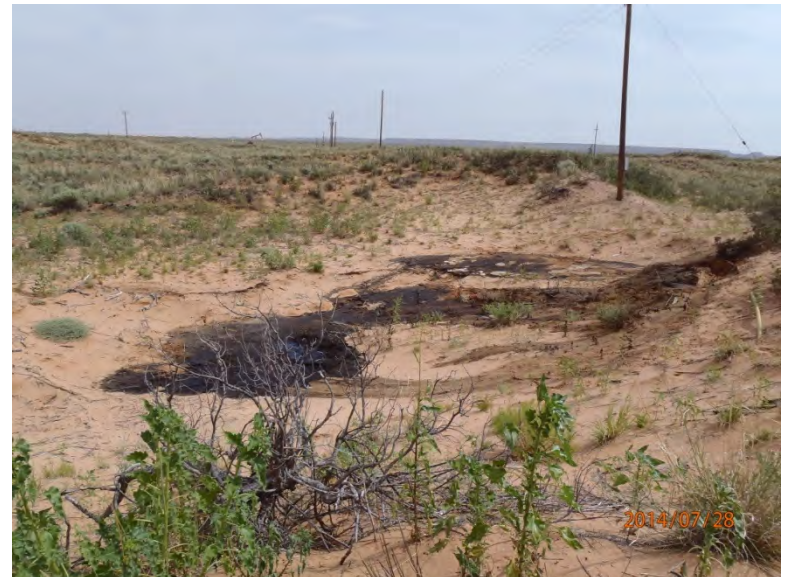
Initial release area, facing northwest
