REMEDIATION SUMMARY AND SITE CLOSURE REQUEST

**BOPCO, LP
JAMES RANCH UNIT #124H TANK BATTERY
Eddy County, New Mexico
Unit Letter "F" (SE/NW), Section 17, Township 23 South, Range 31 East
Latitude 32.305372° North, Longitude 103.802373° West
NMOCD Reference #2RP-2252**

July 2014

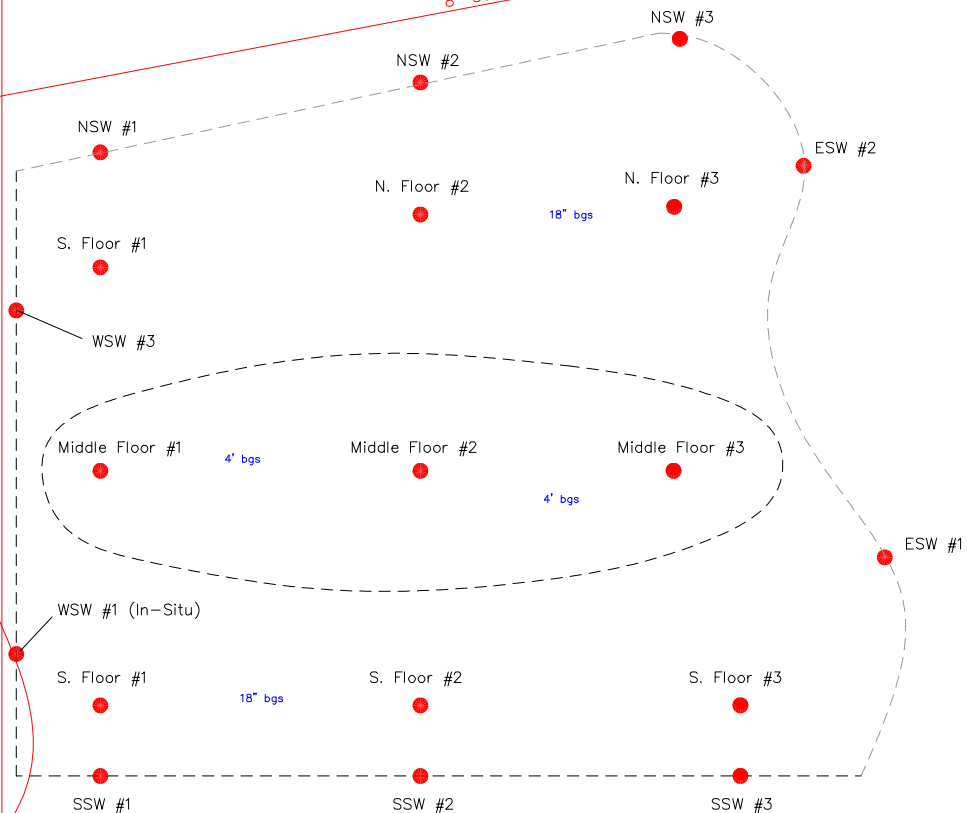
Figure 2
Site & Sample Location Map
BOPCO, L.P.
James Ranch Unit #124 Tank Battery
NMOCD Ref # 2RP-2252
Eddy County, New Mexico

On June 12, 2014, eight (8) confirmation soil sample (SSW #1, SSW #2, SSW #3, S. Floor #1, S. Floor #2, S. Floor #3, Middle Floor #1 and Middle Floor #2) were collected from the excavated area and submitted to the laboratory for analysis of chloride concentrations. Laboratory analytical results indicated the chloride concentrations ranged from 48.0 ppm for soil sample SSW #1 to 208 ppm for soil sample S. Floor #2. Soil samples South Floor #2 and Middle Floor #1 were also analyzed for concentrations of BTEX and TPH. Laboratory analytical results indicated BTEX and TPH concentrations were less than the appropriate laboratory method detection limit (MDL) in each of the samples. A summary of “Concentrations of Benzene, BTEX, TPH & Chloride in Soil” is provided in Table 1. A “Site & Sample Location Map” is provided as Figure 2. Laboratory analytical reports are provided as Appendix C.

On June 13, 2014, ten (10) confirmation soil samples (NSW #1, NSW #2, NSW #3, ESW #1, ESW #2, WSW #3, Middle Floor #3, N. Floor #1, N. Floor #2 and N. Floor #3) were collected from the excavated area and submitted to the laboratory for analysis of chloride concentrations. Laboratory analytical results indicated chloride concentrations ranged from 32.0 ppm for soil sample WSW #3 to 416 ppm for soil sample NSW #3. Soil samples Middle Floor #3, N. Floor #1, N. Floor #2 and N. Floor #3 were also analyzed for concentrations of BTEX and TPH. Laboratory analytical results indicated BTEX and TPH concentrations were less than the appropriate laboratory MDL in each of the samples.

In addition, one soil sample (WSW #1 In-Situ) was collected from the west side wall adjacent to the tank battery containment in an effort to characterize impacted soils left in-situ. Soil sample WSW #1 In-Situ was submitted to the laboratory for analysis of chloride concentrations, which were determined to be 1,100 ppm. Further advancement of the excavation in the area represented by soil sample WSW #1 In-Situ was limited by the presence of the tank battery containment and multiple active pipelines.

Between June 13 and 18, 2014, approximately nine hundred and sixty cubic yards (960 yd³) of impacted material was transported to Lea Land, Inc. (NMOCD Permit #WM-01-035), for disposal. The final dimensions of the excavation were one hundred and twenty-five feet (125') in width, one hundred and thirty feet (130') in length and eighteen inches (18") to four and one-half feet (4.5') in depth. Upon receiving laboratory analytical data from confirmation soil samples, the excavated area was backfilled with locally purchased, non-impacted soil. Following backfilling, areas affected by the remediation activities were compacted and contoured to match the surrounding topography.

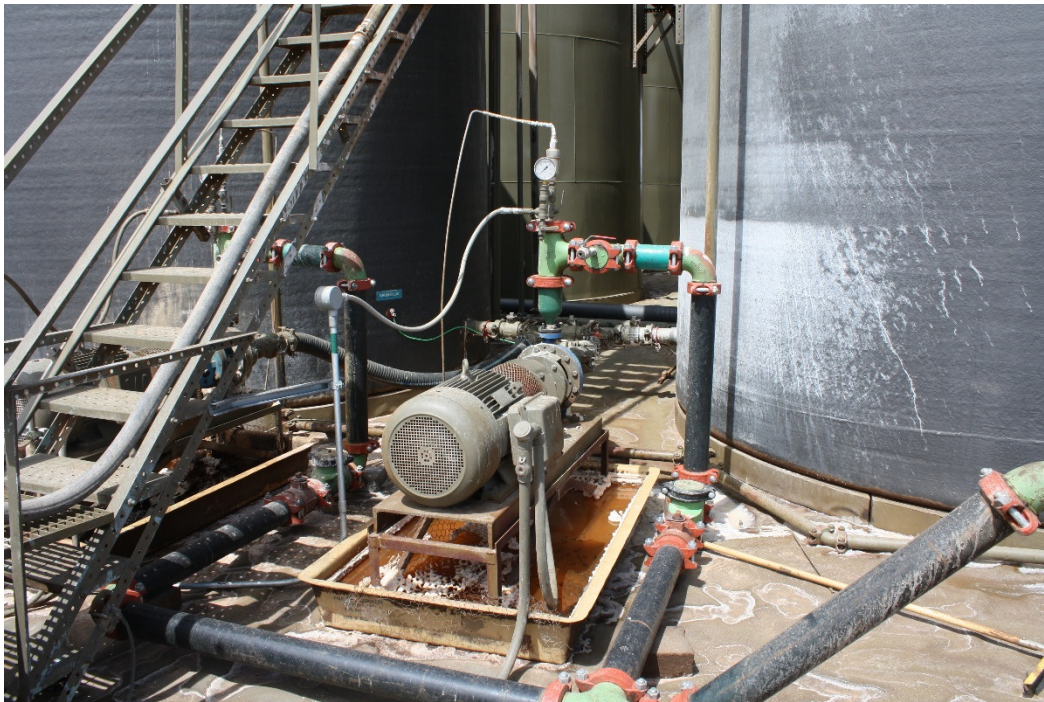
On March 27, 2014, BOPCO discovered a release had occurred at the JRU #124 Tank Battery. Failure of a three-inch (3") transfer pump resulted in the release of approximately twenty-five barrels (25 bbls) of produced water. The "Release Notification and Corrective Action" (Form C-141) indicated high winds spread the release over approximately 17,600 ft² of pasture land; the heavily impacted vegetated area measured approximately 4,000 ft². The New Mexico Oil Conservation Division (NMOCD) Artesia District Office was notified of the release immediately upon discovery. During initial response activities, a vacuum truck was used to recovery approximately ten barrels (10 bbls) of produced water from the containment area. The affected pump has since been repaired. The Form C-141 is provided as Appendix A. General photographs of the release site are provided as Appendix B.

Photograph of the initial release at the JRU #124H Tank Battery Release Site.

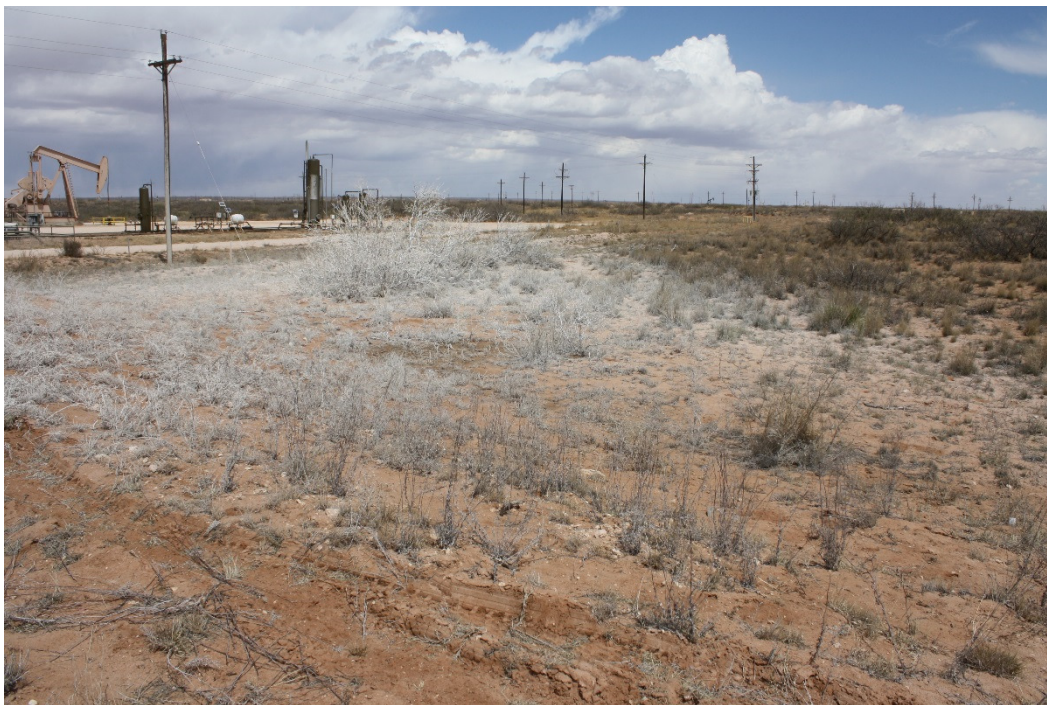
Photograph of the initial release at the JRU #124H Tank Battery Release Site.

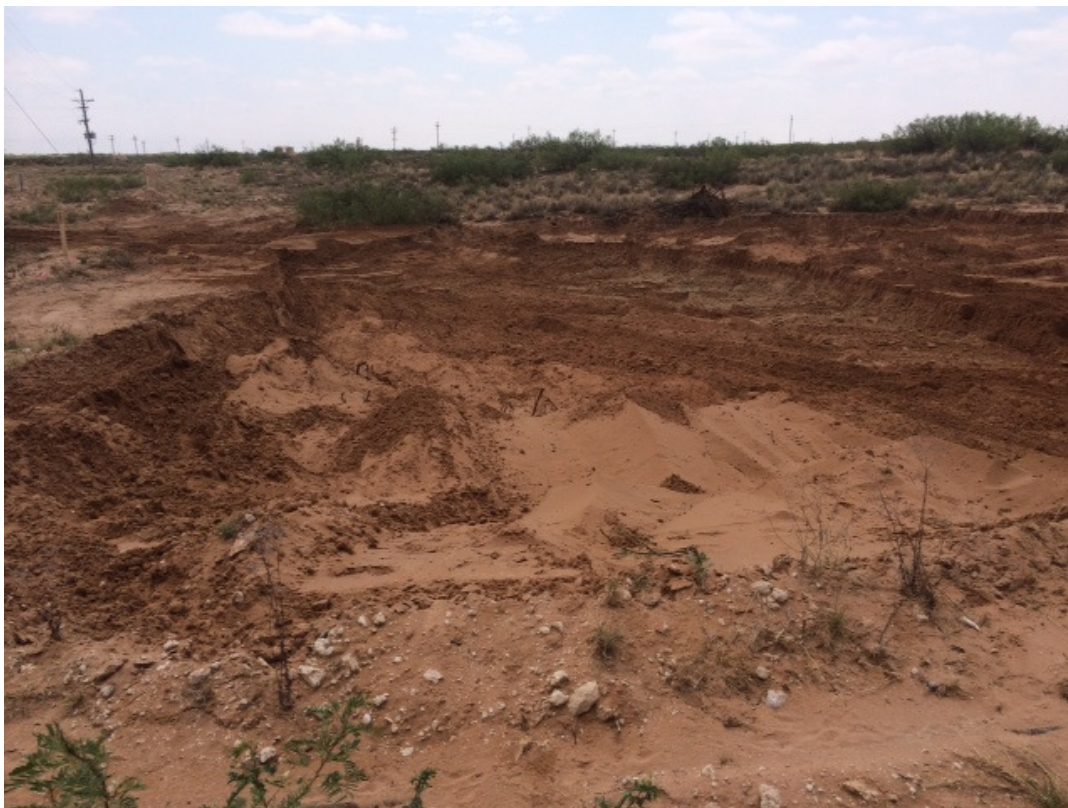
Photograph of the excavated area at the JRU #124H Tank Battery Release Site.

On June 6, 2014, Basin began excavating impacted soil at the release site. The floor and sidewalls of the excavation were advanced until field tests suggested concentrations of BTEX, TPH and chloride were below NMOCD regulatory standards. Excavated soil was stockpiled on-site, pending final disposition.

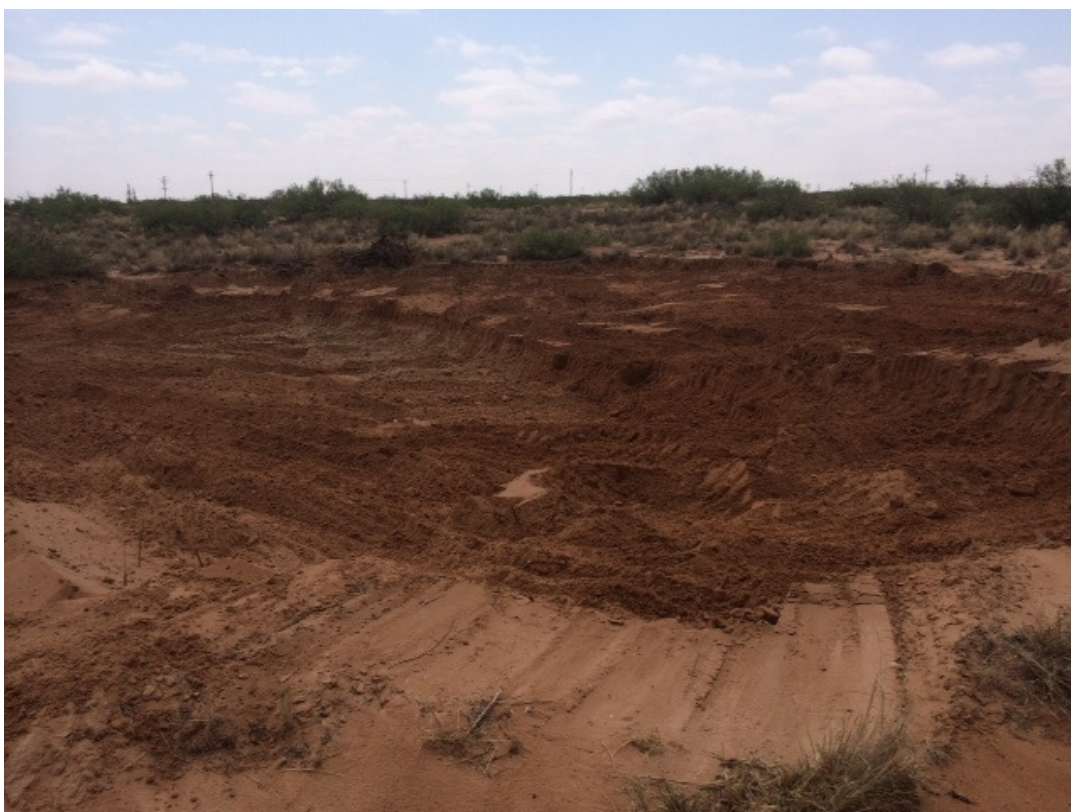
Photograph of the excavated area at the JRU #124H Tank Battery Release Site.

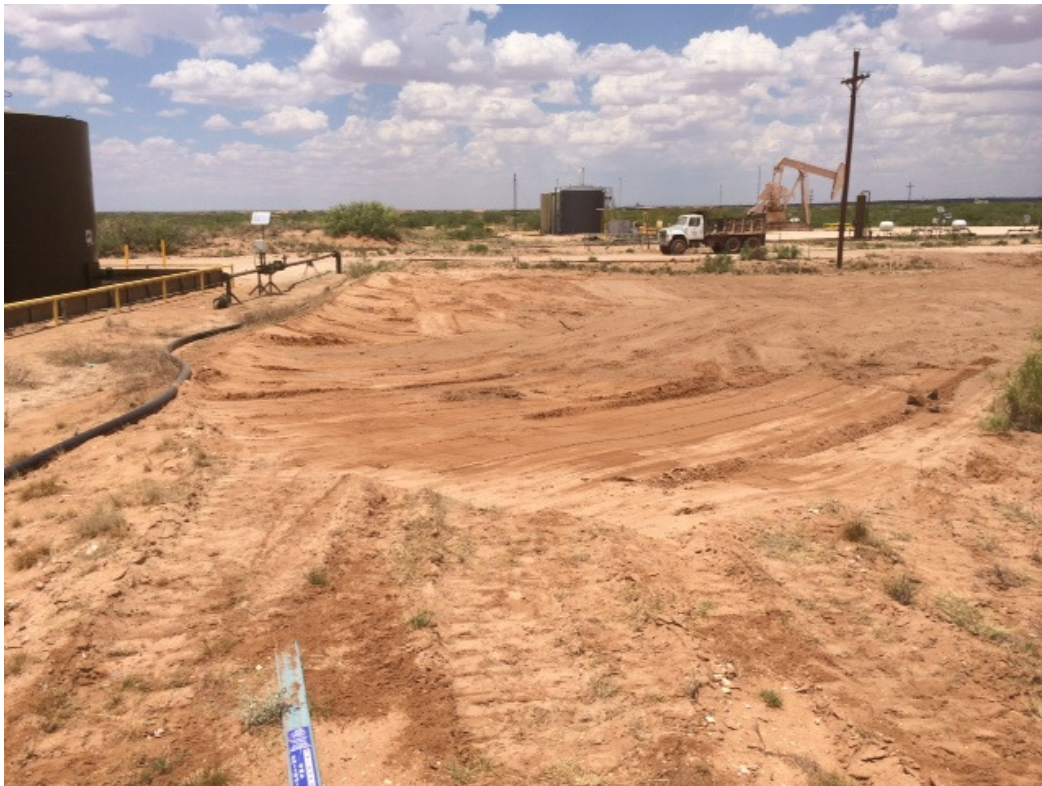
Photograph of backfilling activities at the JRU #124H Tank Battery Release Site.

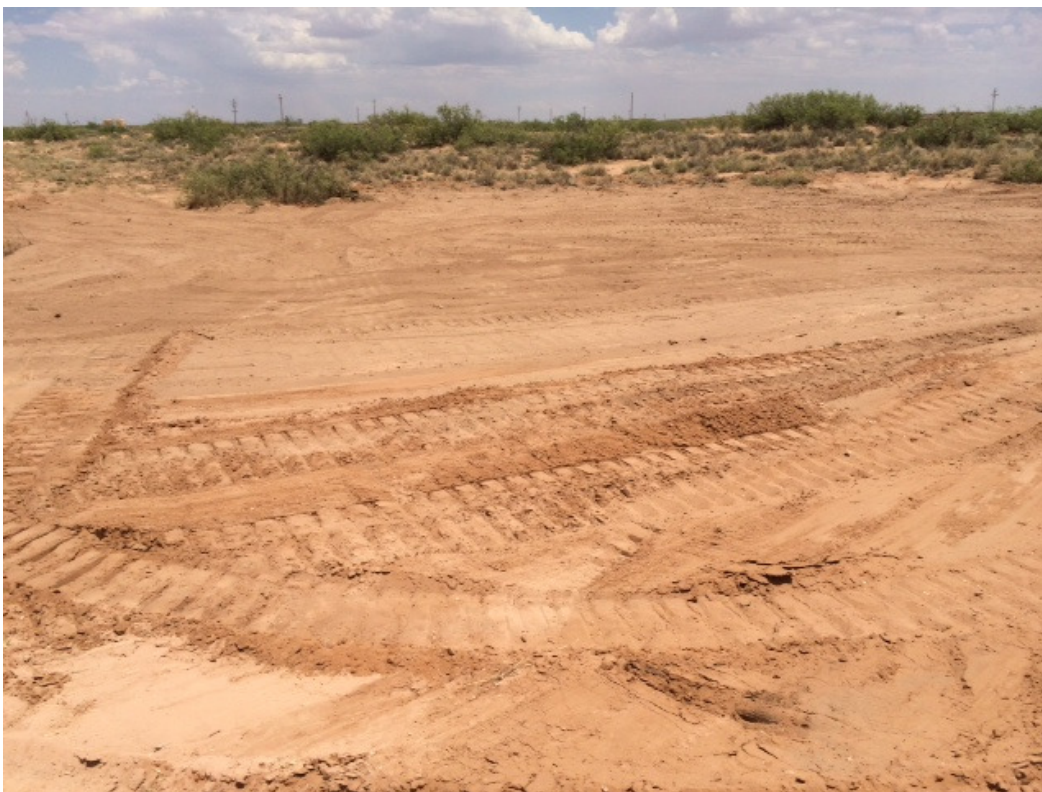
Photograph of backfilling activities at the JRU #124H Tank Battery Release Site.
