REMEDIATION SUMMARY AND SITE CLOSURE REQUEST

**BOPCO, LP
POKER LAKE UNIT #411 TANK BATTERY FLARE RELEASE
Eddy County, New Mexico
Unit Letter "B" (NW/NE), Section 28, Township 24 South, Range 31 East
Latitude 32.193096° North, Longitude 103.780815° West
NMOCD Reference #2RP-2266**

August 2014

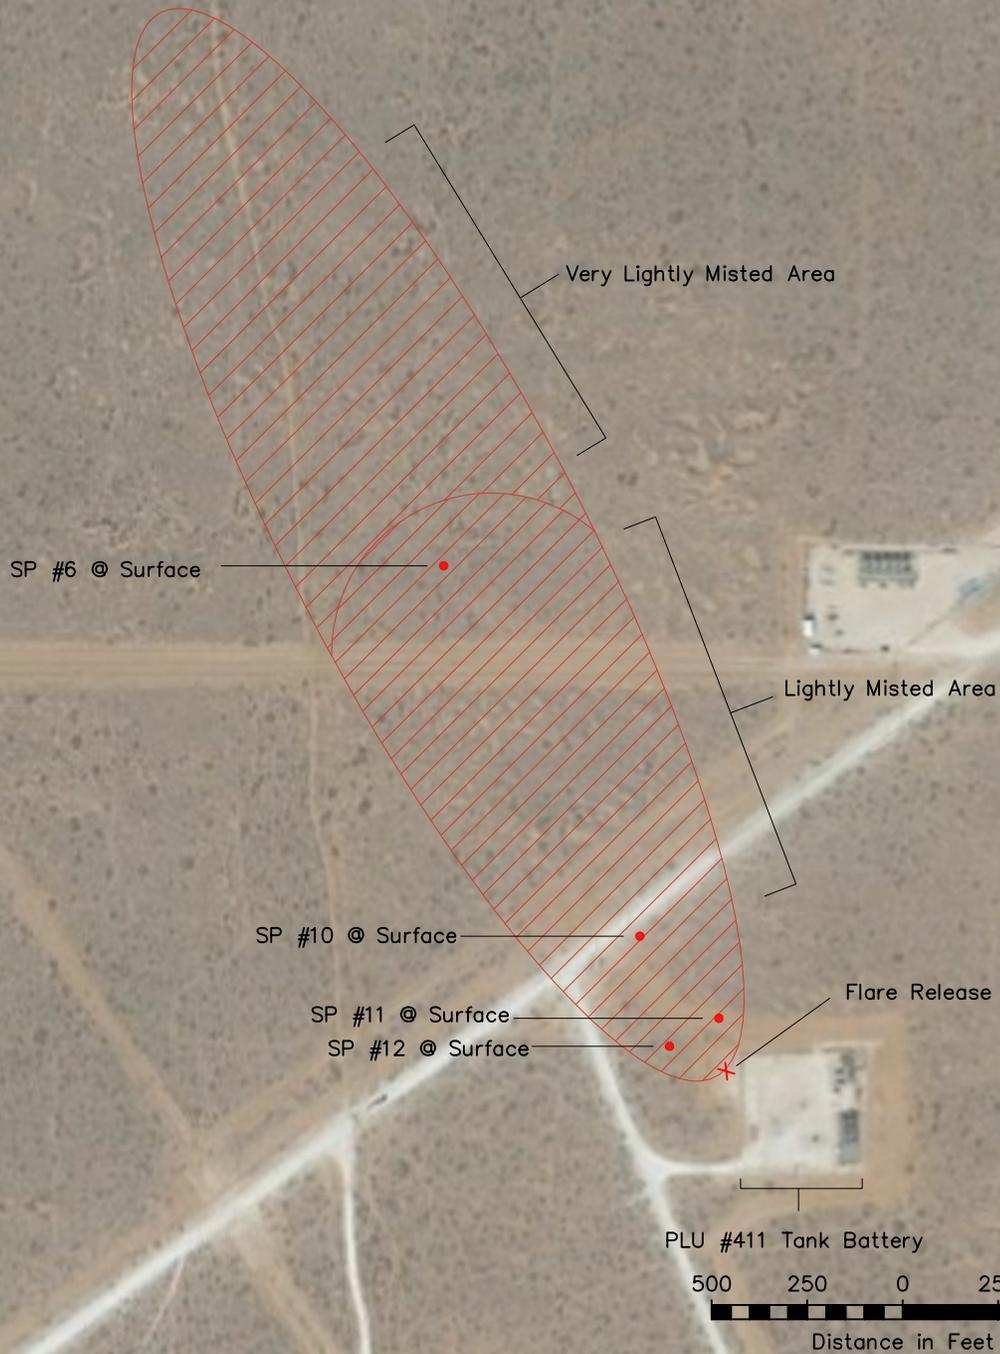
Figure 2
Site & Sample Location Map
BOPCO, L.P
PLU #411 Tank Battery Flare Release
Eddy County, NM

On May 15, 2014, Basin conducted an environmental investigation at the release site in an effort to determine if soils had been affected above NMOCD regulatory standards. During the environmental investigation, a series of soil samples (SP#1 through SP#12) were collected from misted area and field-screened for concentrations of chloride using a field test kit. Field-test results suggested concentrations of chloride were less than the method detection limit (MDL) of 120 ppm in each of the collected soil samples. Four (4) confirmation soil samples (SP #6 @ Surface, SP #10 @ Surface, SP #11 @ Surface and SP #12 @ Surface) were submitted to Cardinal Laboratories of Hobbs, New Mexico, for analysis of TPH concentrations. Laboratory analytical indicated concentrations of TPH were less than the laboratory method detection limit (MDL) in each of the submitted soil samples. In addition, soil sample SP #10 @ Surface was also analyzed for concentrations of BTEX and chloride, which were determined to be less than the appropriate laboratory MDL. A summary of “Concentrations of Benzene, BTEX, TPH & Chloride in Soil” is provided in Table 1. A “Site & Sample Location Map” is provided as Figure 2. Laboratory analytical reports are provided as Appendix C.

Confirmation soil samples collected from the misted area at the PLU #411 Flare Release indicated soil had not been affected above NMOCD regulatory standards. No residue was visible on soils or vegetation within the misted area, suggesting the application of soap and Micro-Blaze® had been effective in mitigating any impacts. Based on these laboratory analytical results and field observations, Basin recommends BOPCO provide the NMOCD-Artesia District Office and the BLM a copy of this *Remediation Summary and Site Closure Request* and request the NMOCD grant site closure to the PLU #411 Flare Release site.

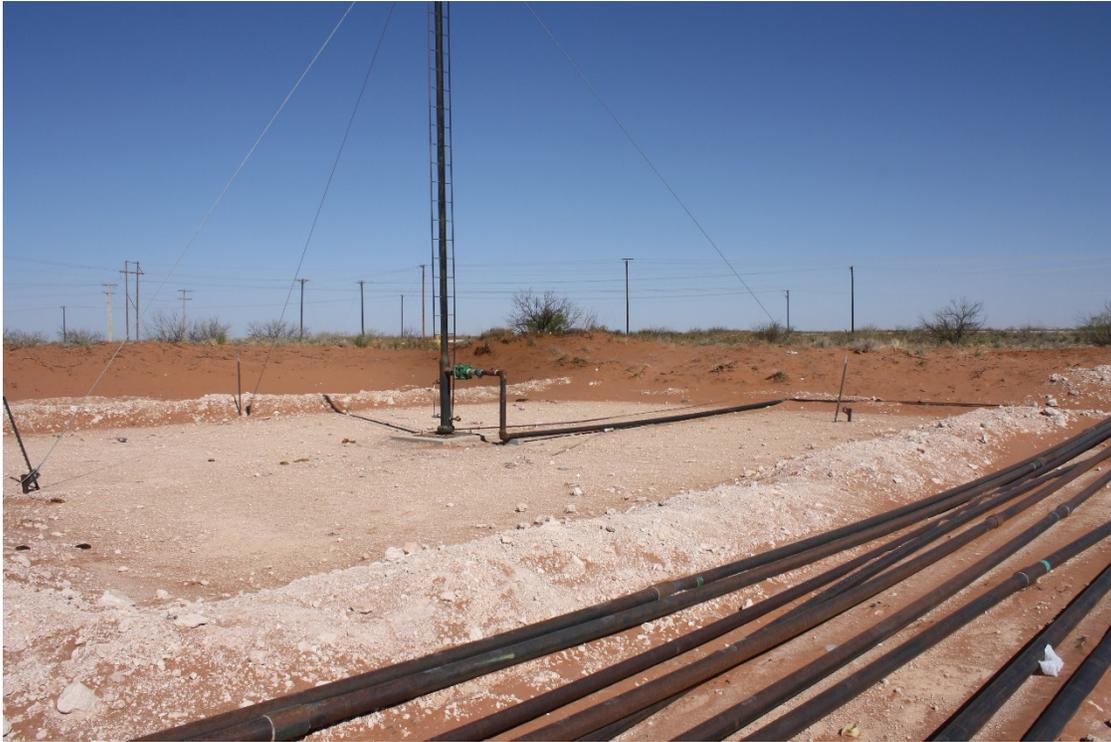
On February 8, 2014, BOPCO discovered a release had occurred on the flare line at the PLU #411 Tank Battery. The release was attributed to the scrubber valve being closed, causing the vessels to pressure up, sending approximately ten barrels (10 bbls) of crude oil out of the flare line. The New Mexico Oil Conservation Division (NMOCD) Artesia District Office and BLM were notified immediately upon discovery. The "Release Notification and Corrective Action" (Form C-141) indicated the release impacted an area measuring approximately three hundred feet (300') by one thousand, three hundred feet (1,300') with a fine mist that covered the vegetation and the surface of the soil with less than one-eighth of an inch (1/8") of saturation. The spill also misted just the vegetation in an area measuring approximately four hundred (400') feet by one thousand, eight hundred feet (1,800').

Photograph of flare and earthen containment at the PLU #411 Tank Battery Flare Release Site.

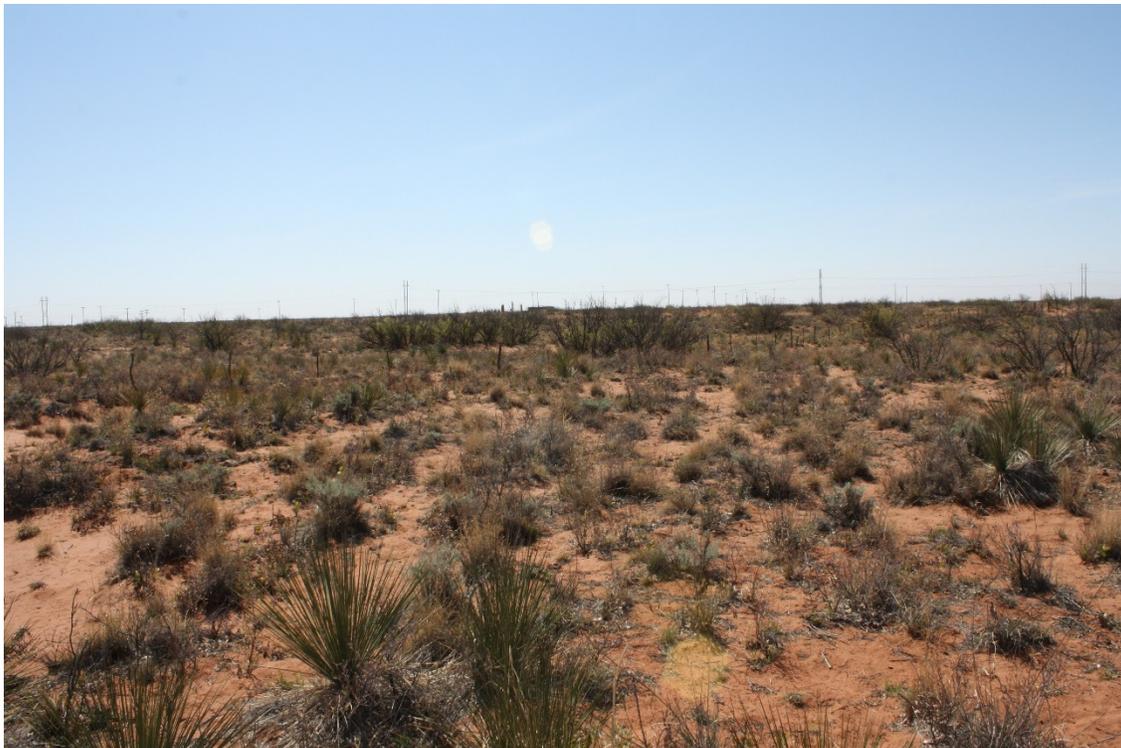
Describe Area Affected and Cleanup Action Taken.*
The spill impacted and area approximately 1300 ft. X 300 ft. with a fine mist that covered the vegetation and the surface of the soil with less than 1/8" of saturation. The spill also misted just the vegetation in an area approximately 1800 ft. X 400 ft. The vegetation in the immediate area around the flare line was washed down with a soap and micro-blaze mixture on 4/9/14. The site was reviewed again on 4/23/14; there was no residue visible on the soil surface and only light to no residue visible on the vegetation, there was no dead vegetation observed. A series of soil samples will be collected from the surface of the impacted area to determine any further remediation required.

Photograph of the misted area at the PLU #411 Tank Battery Flare Release Site.

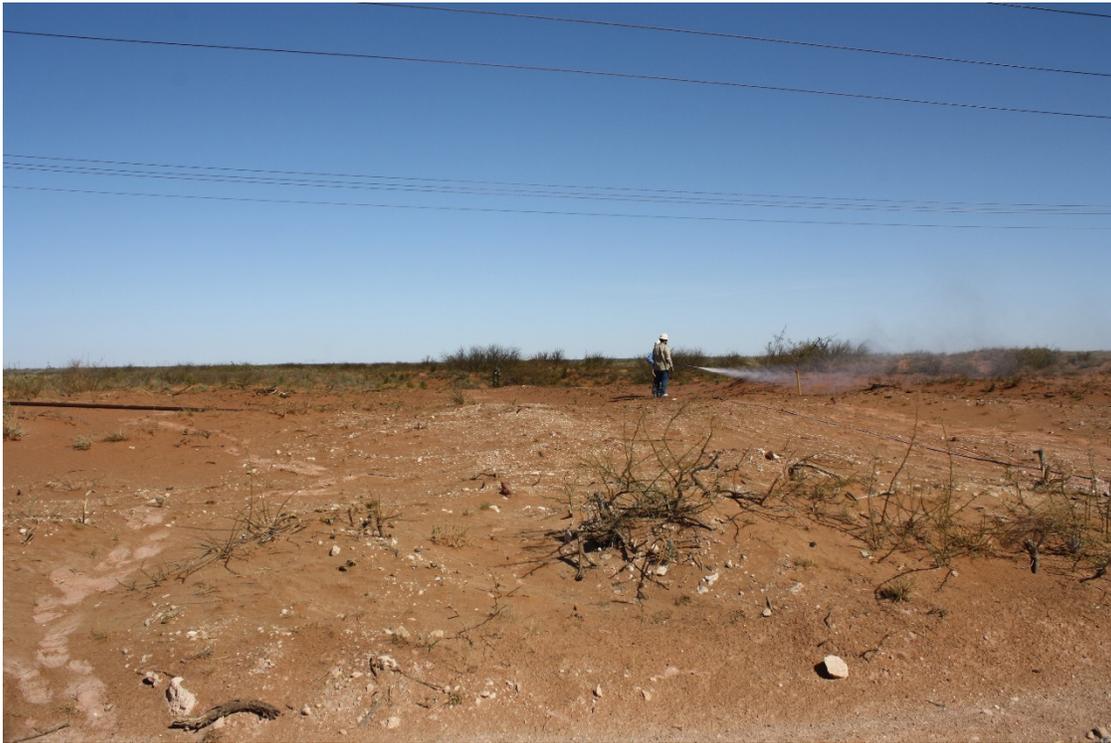
Photograph of the application of soap and Micro-Blaze® to the affected area at the PLU #411 Tank Battery Flare Release Site.

On April 9, 2014, upon receiving BLM approval, BOPCO contractors washed the affected vegetation in the immediate area around the flare line with a soap and Micro-Blaze® solution. The site was assessed again on April 23, 2014, by BOPCO personnel. During the assessment there was no residue visible on the soil surface, only light to no residue visible on the vegetation and no dead vegetation observed.

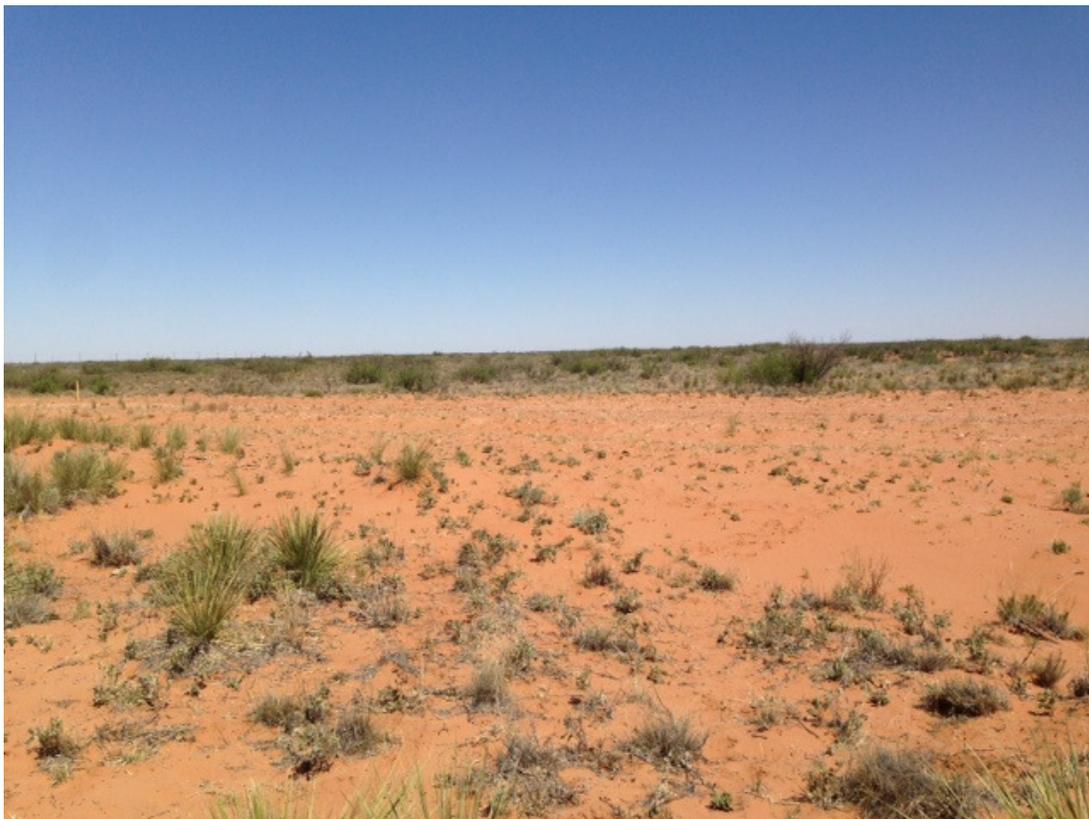
Photograph of the misted area at the PLU #411 Tank Battery Flare Release Site one week after the application of soap and Micro-Blaze®.

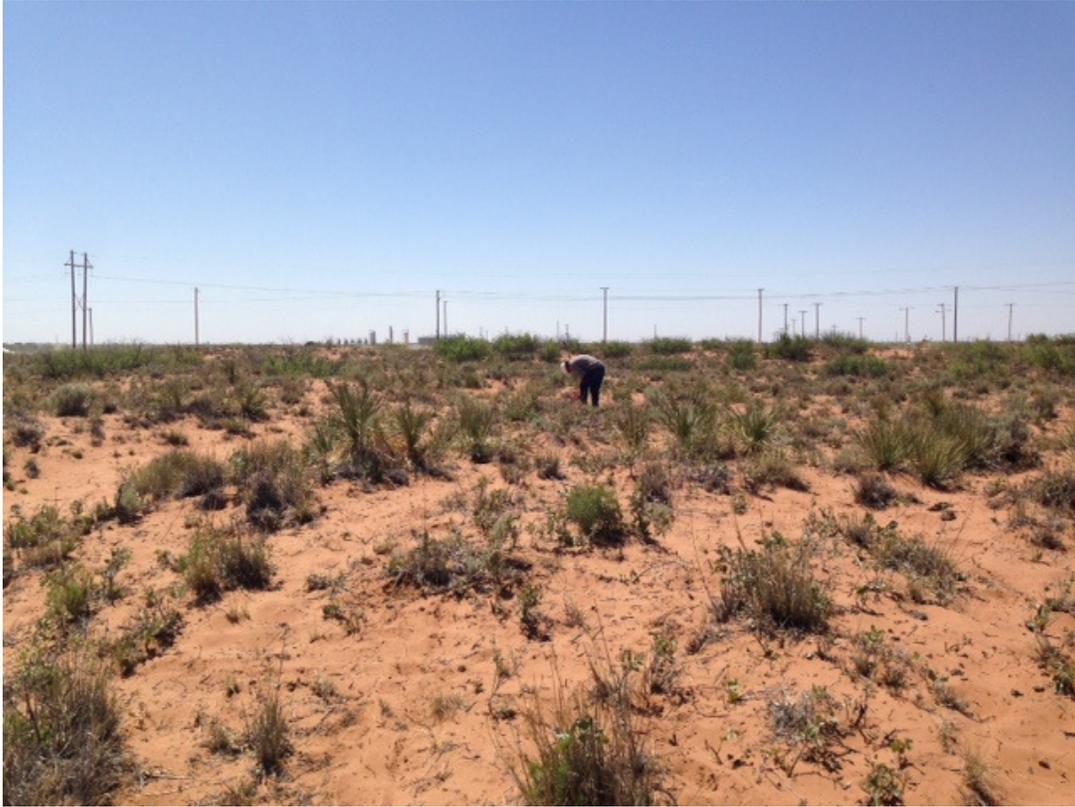
Photograph of the affected area and the collection of confirmation soil samples at the PLU #411 Tank Battery Flare Release Site.

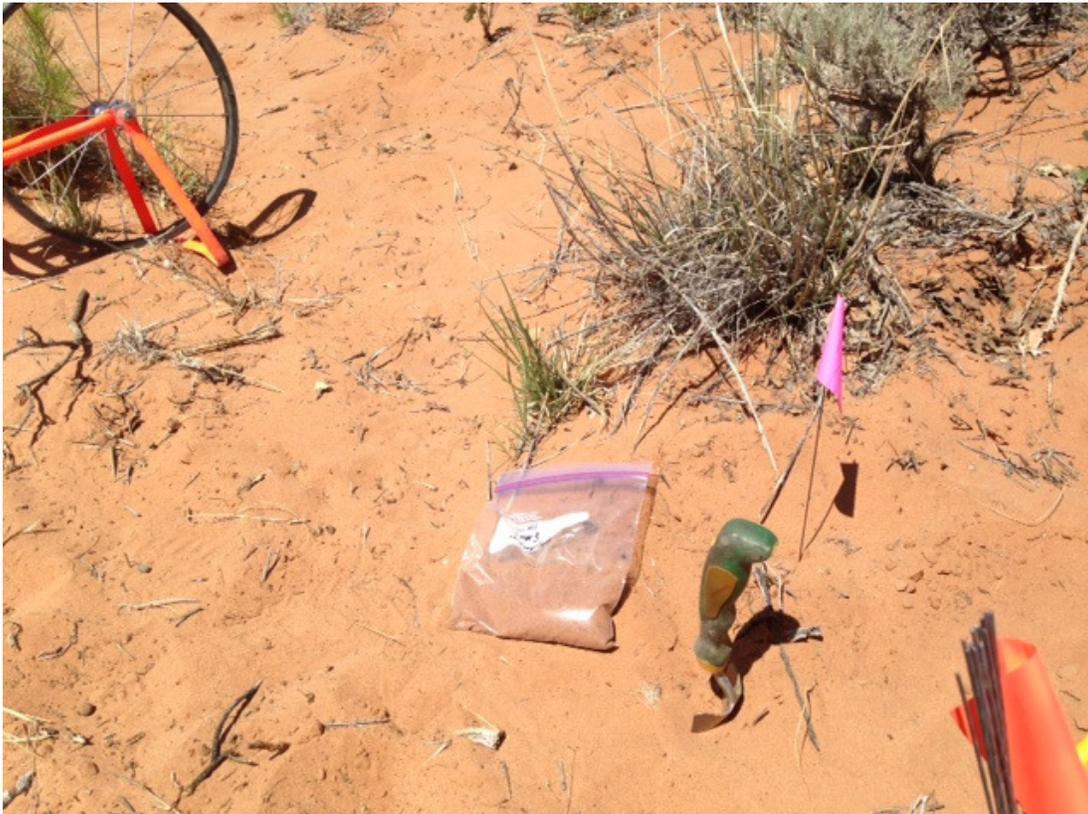
Photograph of the collection of confirmation soil samples at the PLU #411 Tank Battery Flare Release Site.
