## **CLOSURE REPORT**

**BOPCO, LP  
POKER LAKE UNIT #89  
Eddy County, New Mexico  
Unit Letter "G", Section 25, Township 24 South, Range 30 East  
Latitude 32.189772 North, Longitude 103.832101 West  
NMOCD Reference #2RP-2369**

RE: Final Closure Report  
Bopco – Poker Lake Unit #89  
UL-G, Section 25, Township 24 South, Range 30 East  
Eddy County, New Mexico  
NMOCD Reference # 2RP 2369

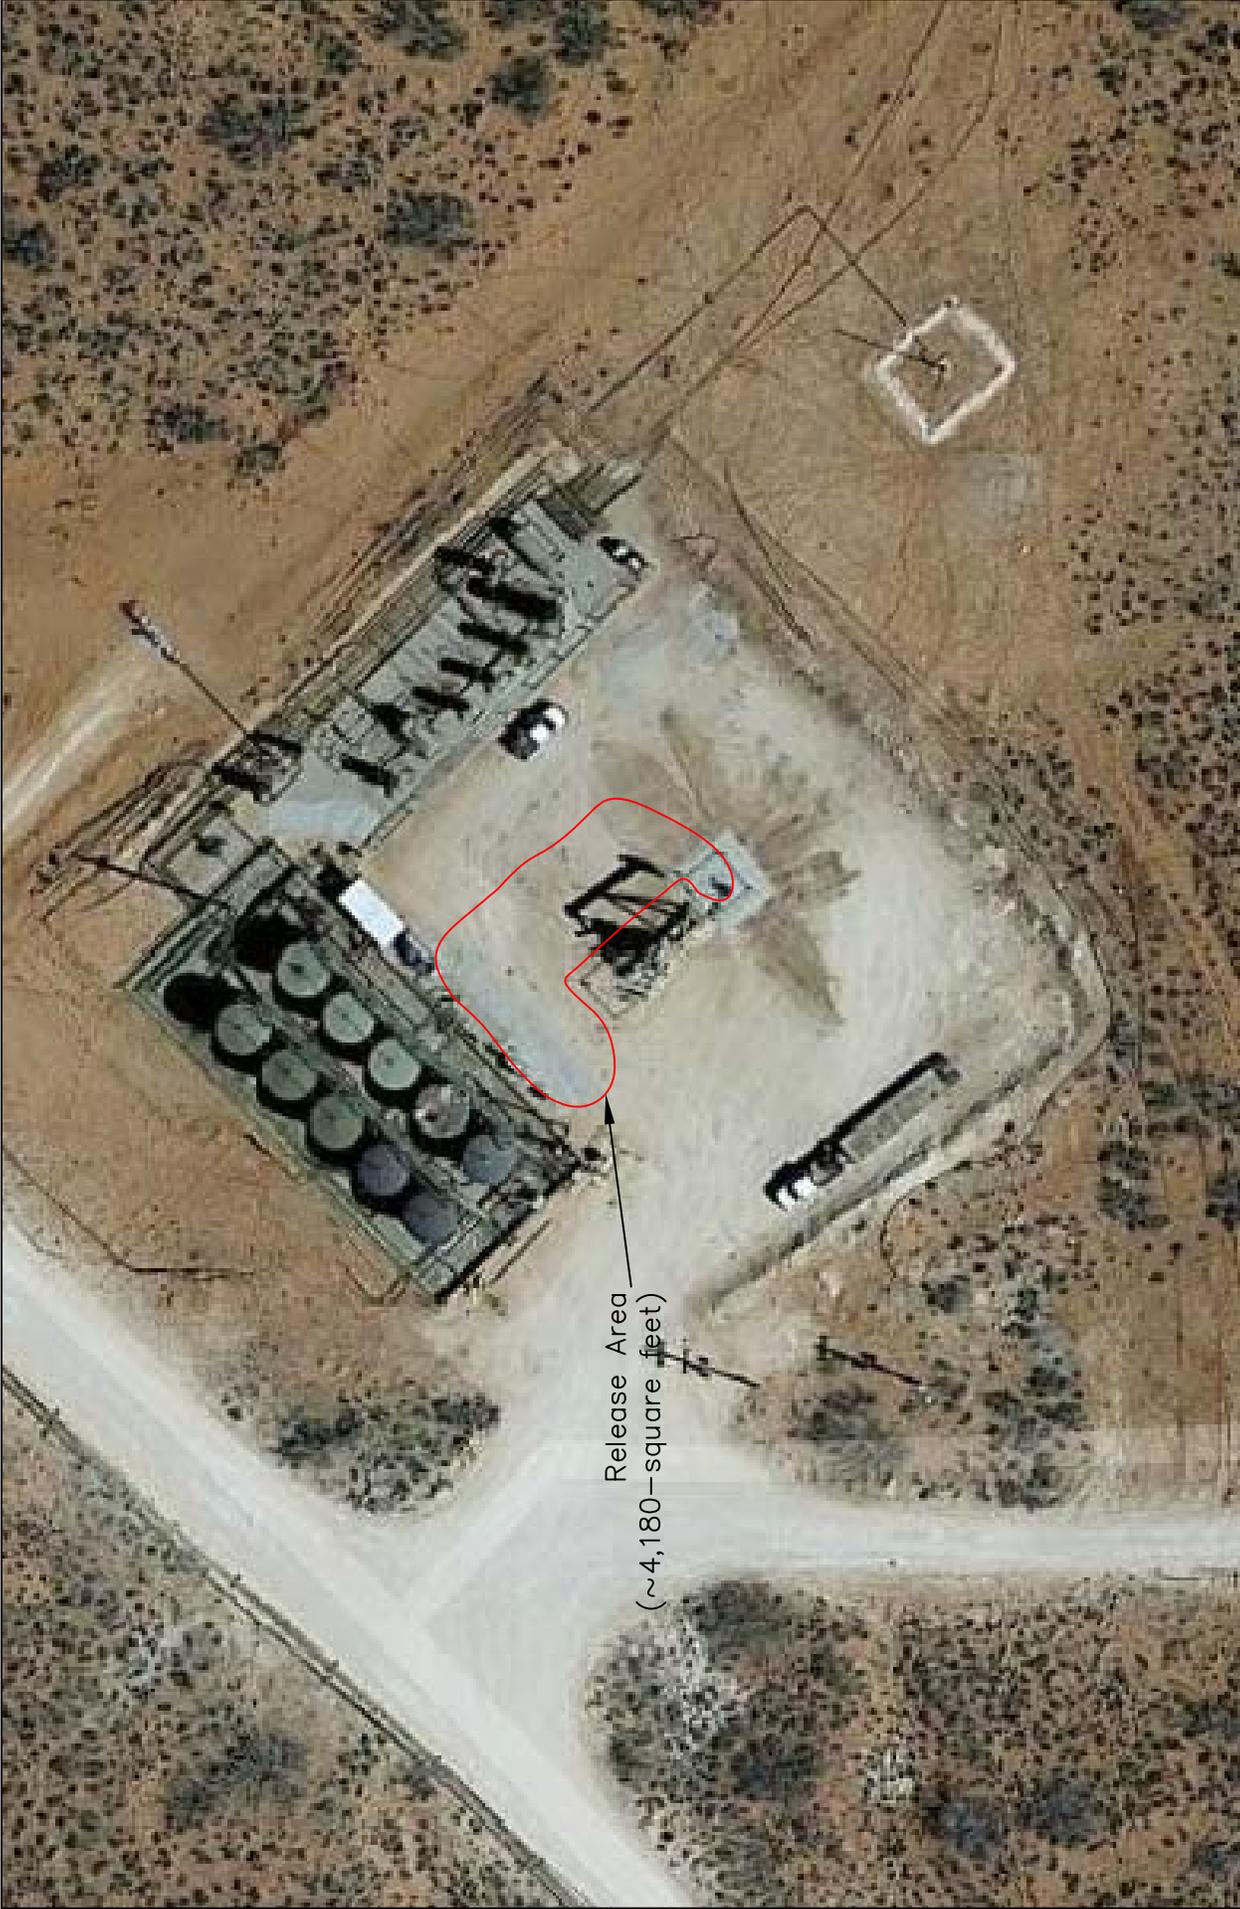
Release Area  
 (~4,180-square feet)

A ¼” hose connecting the wellhead to the high pressure kill switch was damaged by livestock. The hose was replaced with stainless steel tubing. The spill impacted approximately 4,180 sq. ft. of caliche well pad. The free standing fluid was recovered with a vacuum truck.

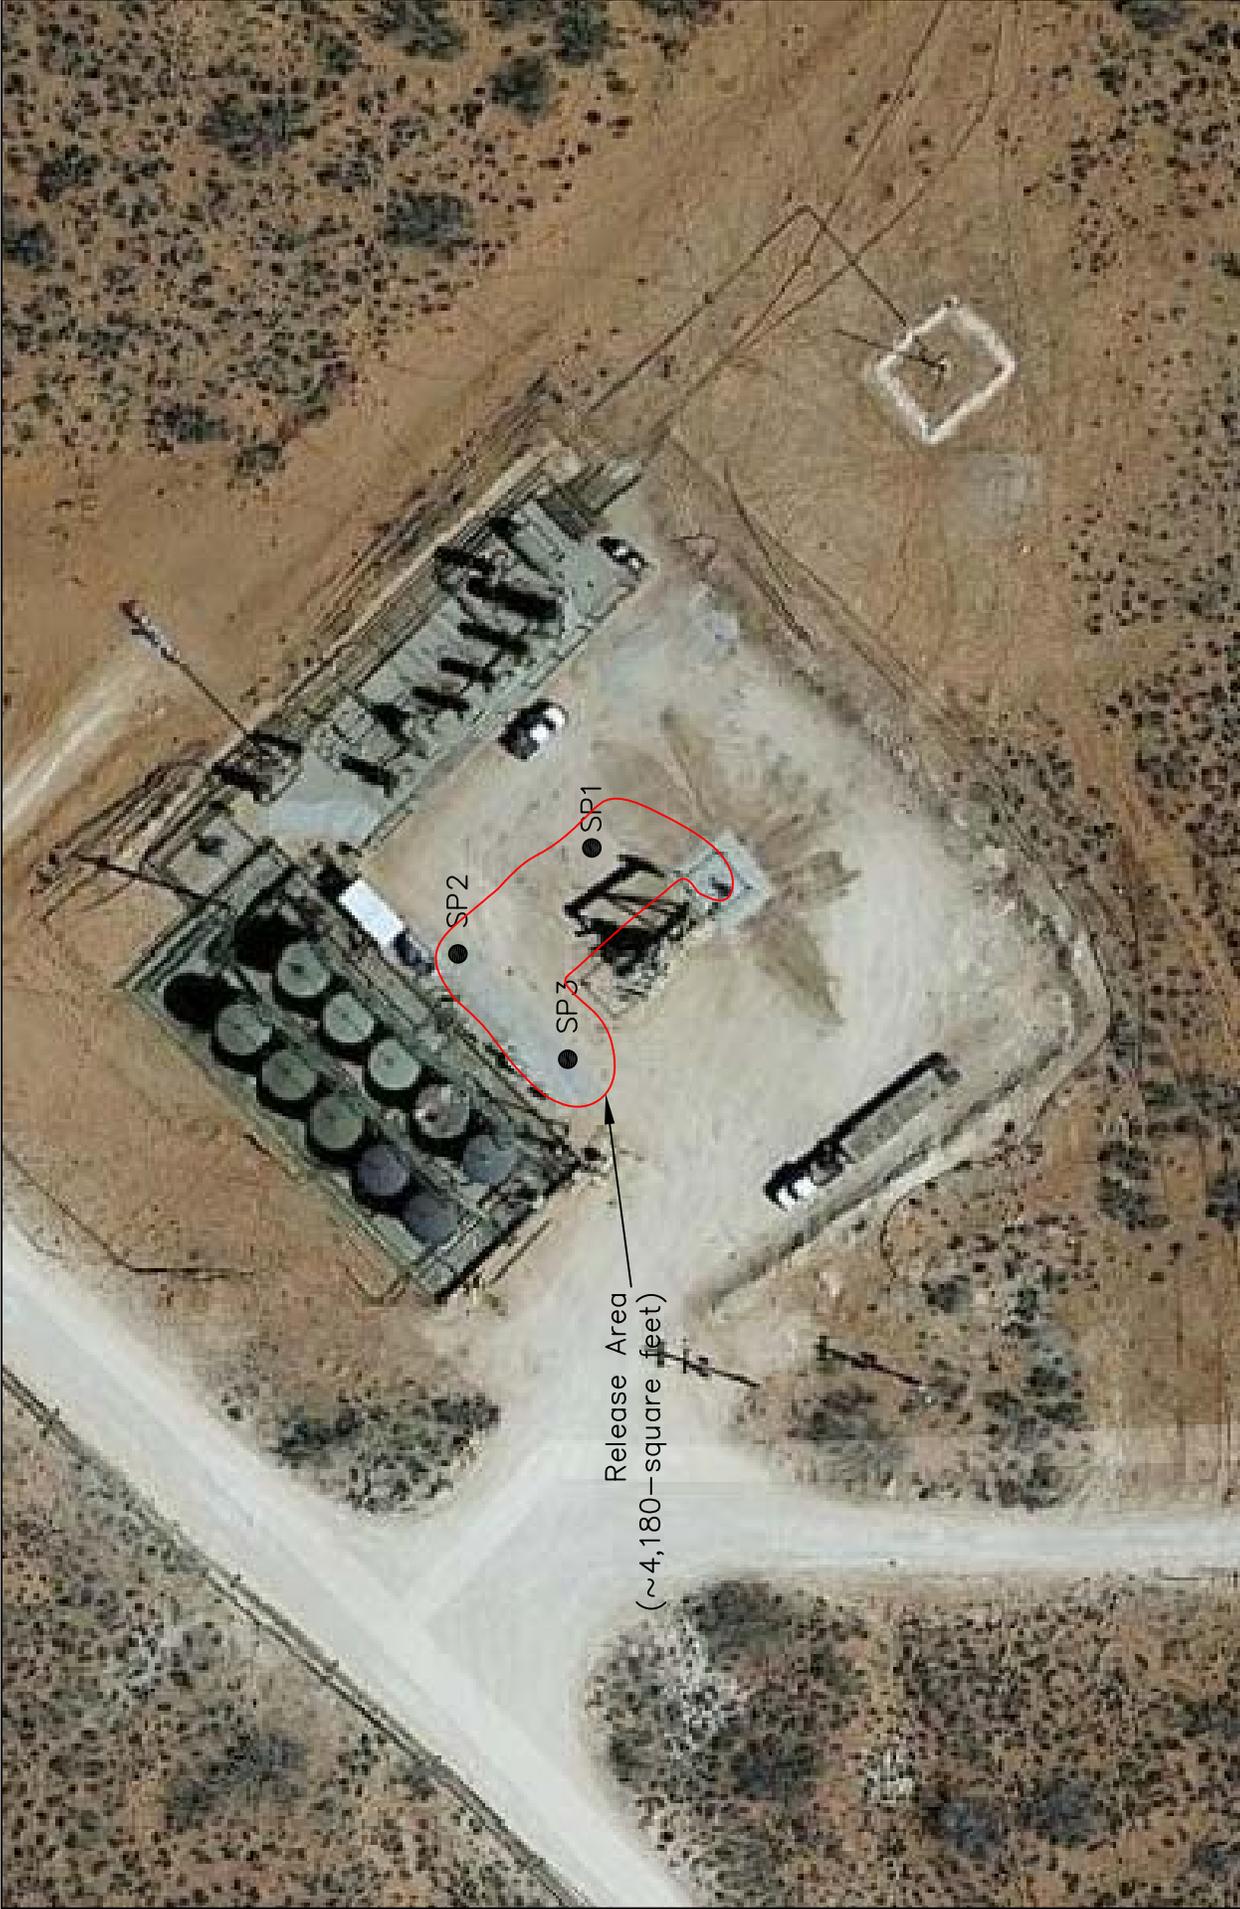
<p>Figure 4 Sample Map Bopco Poker Lake Unit #89</p>	<p>Eddy County, New Mexico SW 1/4 of NE 1/4, Sec. 25, T24S, R30E N 32° 11' 23.18" W 103° 49' 55.56" Elevation: 3,442 feet amsl</p>	<p>DWG By: D Dominguez September 2014</p> <p>REVISIONS: 120 SHEET 1 of 1</p> <p>0 60 120 Feet</p>	
--	--	---	--

EPI personnel mobilized on the site on July 18, 2014 to collect soil samples and determine the vertical extent of contamination. A total of eleven (11) soil samples were collected and sent to Cardinal Labs in Hobbs, New Mexico, for testing. Laboratory analytical results indicate the release area contains concentrations of Benzene, BTEX, TPH and Chlorides in excess of NMOCD Recommended Remedial Action Levels (RRALs) of 10 mg/Kg, 50 mg/Kg, 5,000 mg/Kg, and 1,000 mg/Kg, respectively, no deeper than ground surface (reference *Figure 4* and *Table 2*).

On August 9, 2014 approximately 311 cubic yards of contaminated material were excavated and transported to Lea Land for disposal. The release area was excavated approximately six (6) inches bgs, removing constituent contamination above NMOCD RRALs.

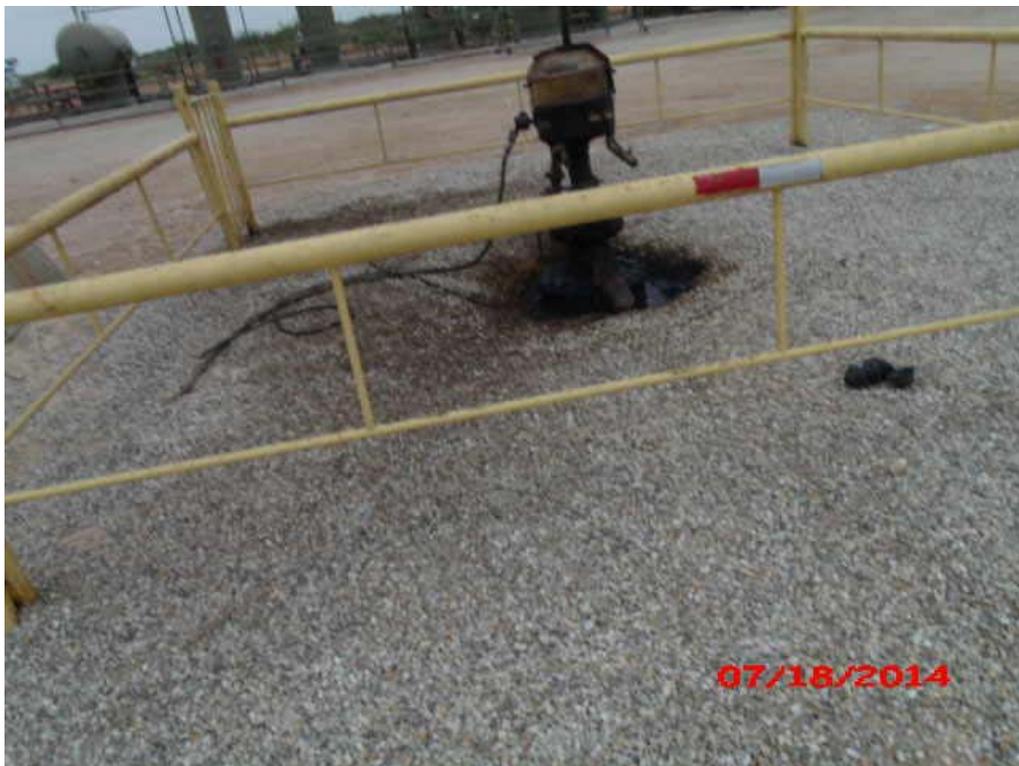
Photograph #2 – Looking northerly across release area

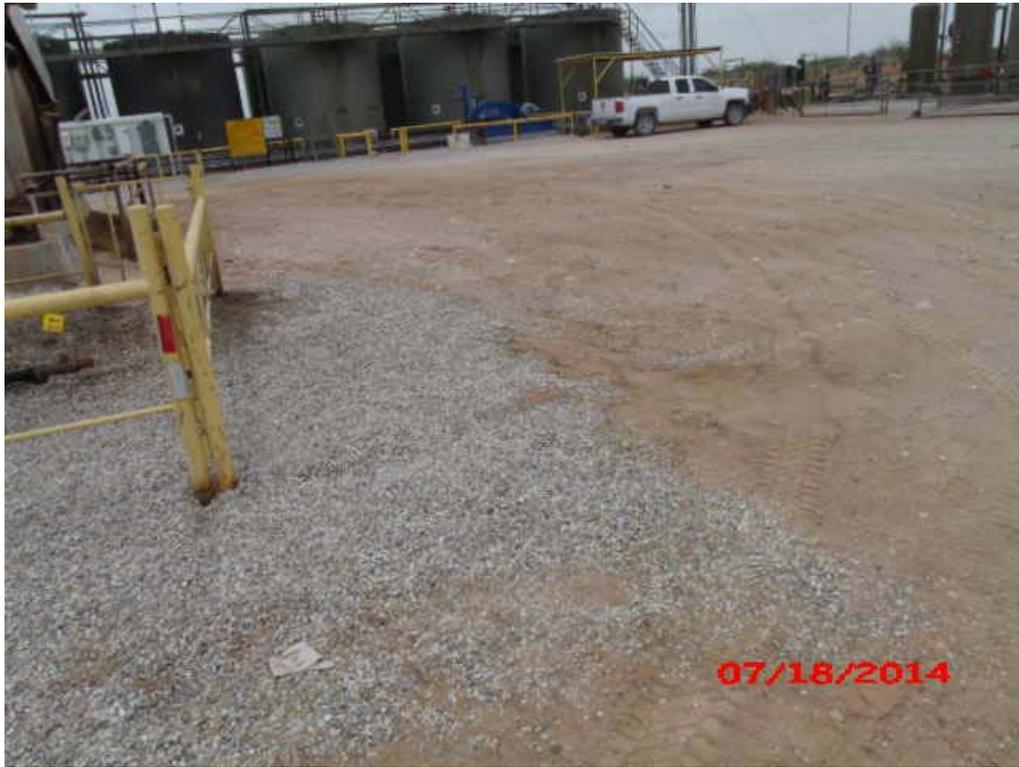
Photograph #3 – Looking westerly across release area

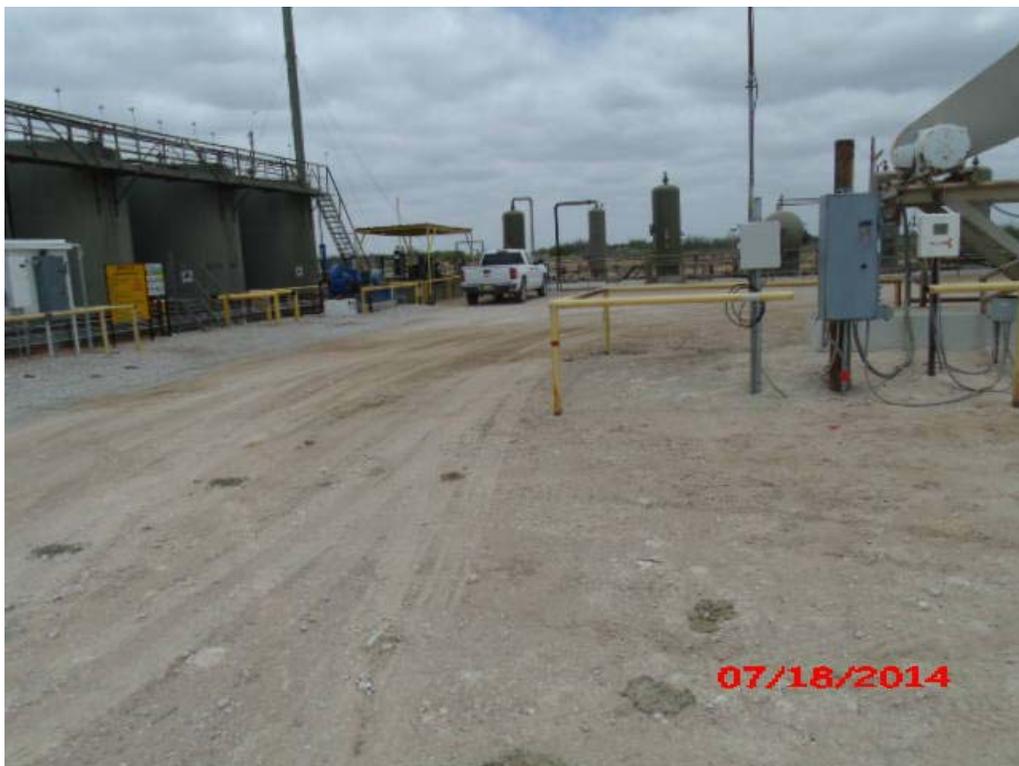
Photograph #4 – Looking northerly across release area

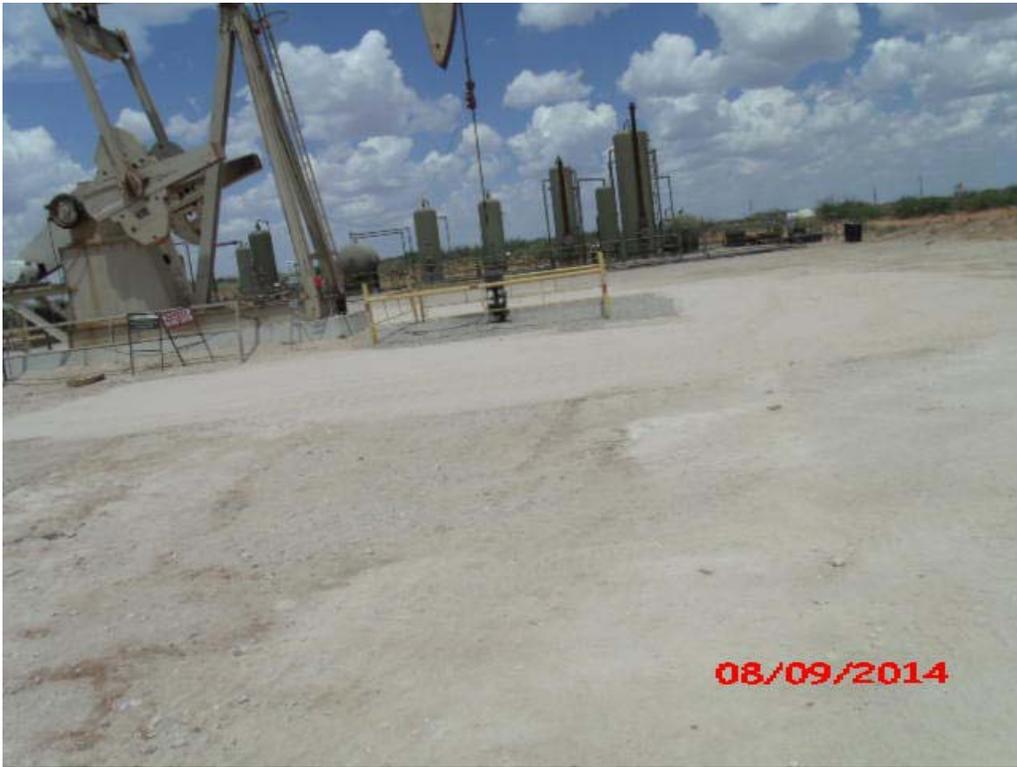
Photograph #5 – Looking across excavated area

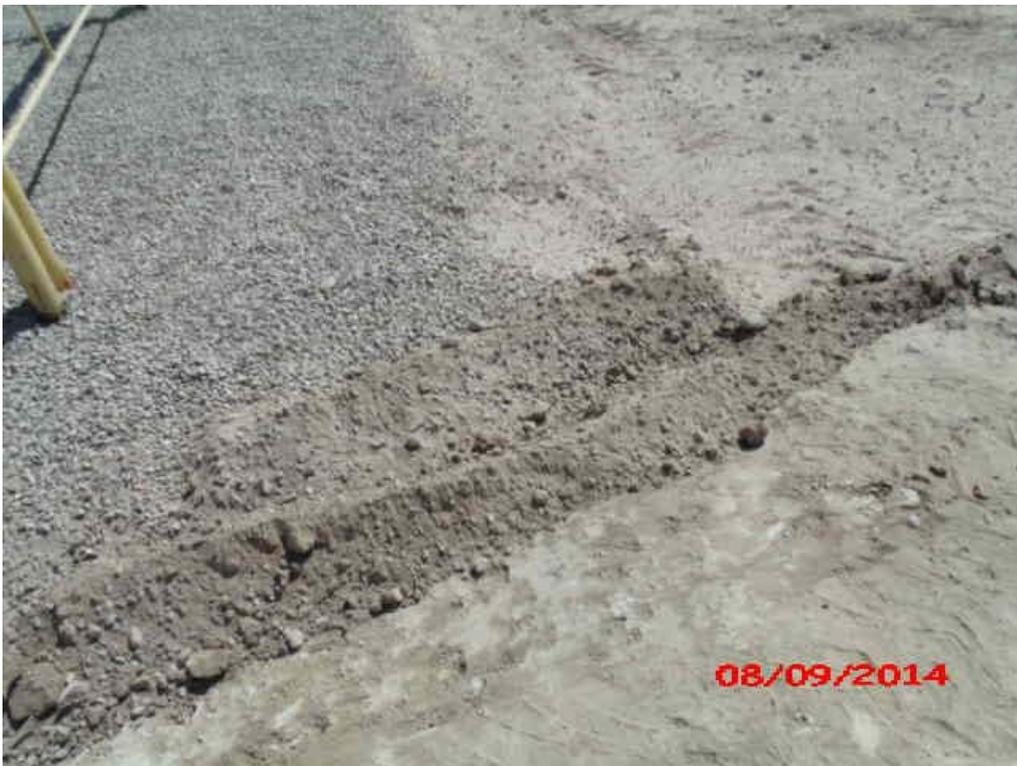
Photograph #6 – Close up view of excavated area around well head

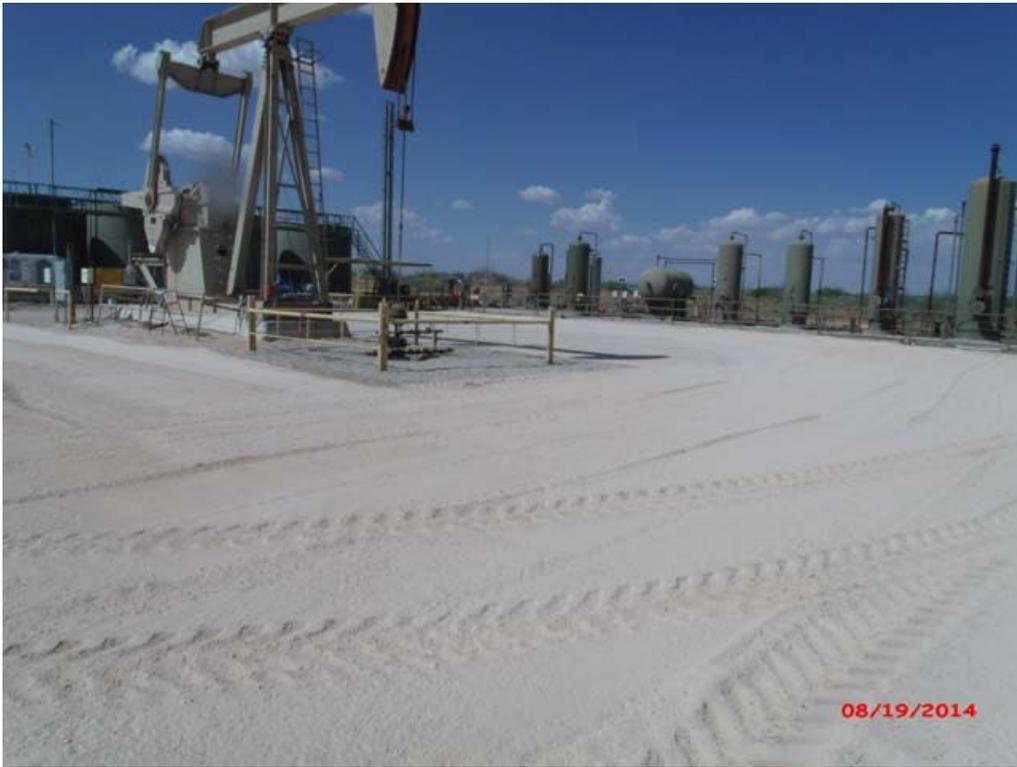
Photograph #7 – Backfilled area

From August 11 - 19, 2014 the excavation was backfilled with approximately 311 cubic yards of caliche and the entire disturbed area was contoured to blend with existing pad to protect against wind/water erosion.

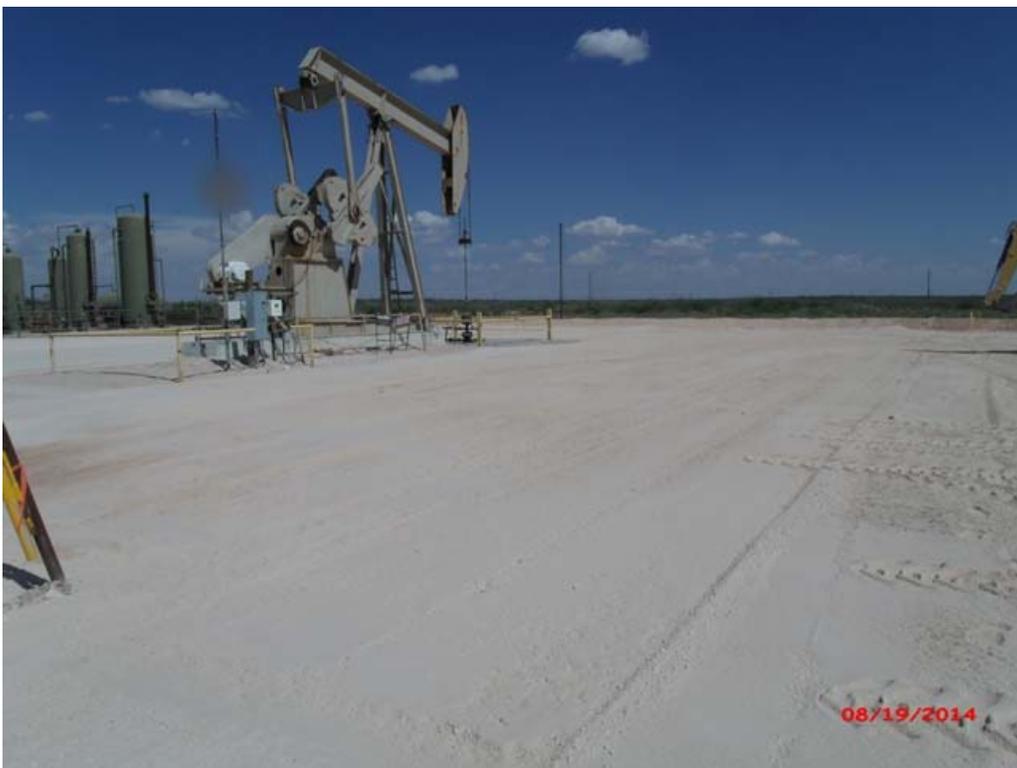
Photograph #8 – Backfilled area
