## **REMEDIATION SUMMARY & RISK-BASED SITE CLOSURE PROPOSAL**

**BOPCO, LP  
BASS 3 FEDERAL #4  
Eddy County, New Mexico  
Unit Letter "I" (NE/SE), Section 3, Township 22 South, Range 28 East  
Latitude 32.420218° North, Longitude 104.067417° West  
NMOCD Reference #: 2RP-2371**

**September 2014**

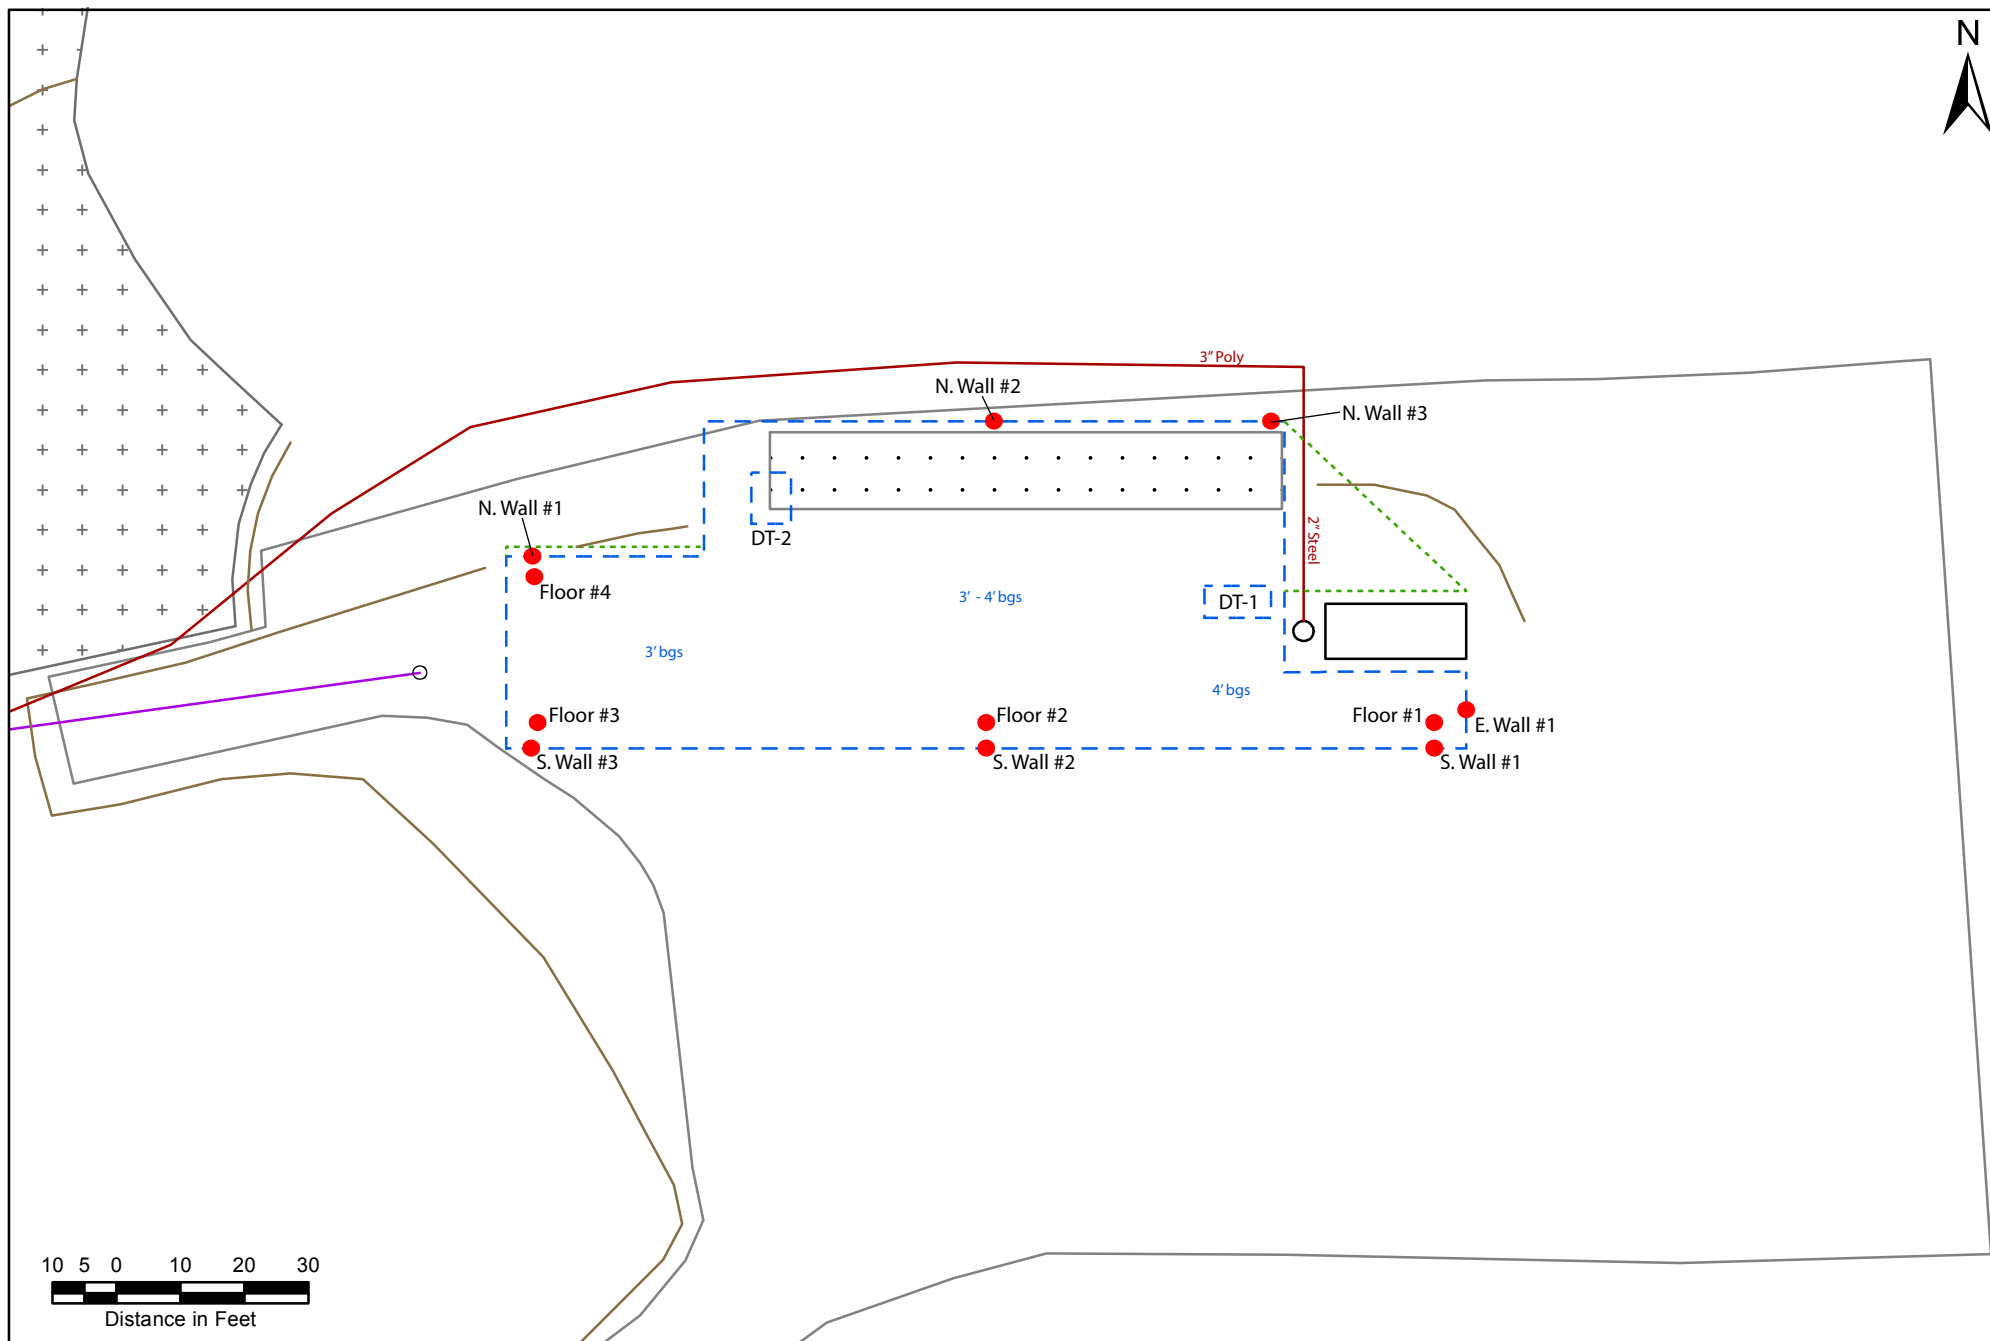
**Figure 2**  
**Site & Sample Location Map**  
**BOPCO, LP**  
**Bass 3 Federal Well #4**  
**Eddy County, New Mexico**  
**NMOCD Reference #: 2RP-2371**

Soil sample locations are depicted in Figure #2, "Site & Sample Location Map". Laboratory analytical results are summarized in Table 1, "Concentrations of Benzene, BTEX, TPH & Chloride in Soil".

- The excavation will be advanced to the west until field-screens and laboratory analytical results indicate chloride concentrations are below the NMOCD recommended remediation action level (RRAL) established for the site.

- The excavation will be advanced to the extent practicable to the north of the on-site pump jack and wellhead and to the east of the two-inch (2") steel flow line to the Bass Federal #1 Tank Battery.

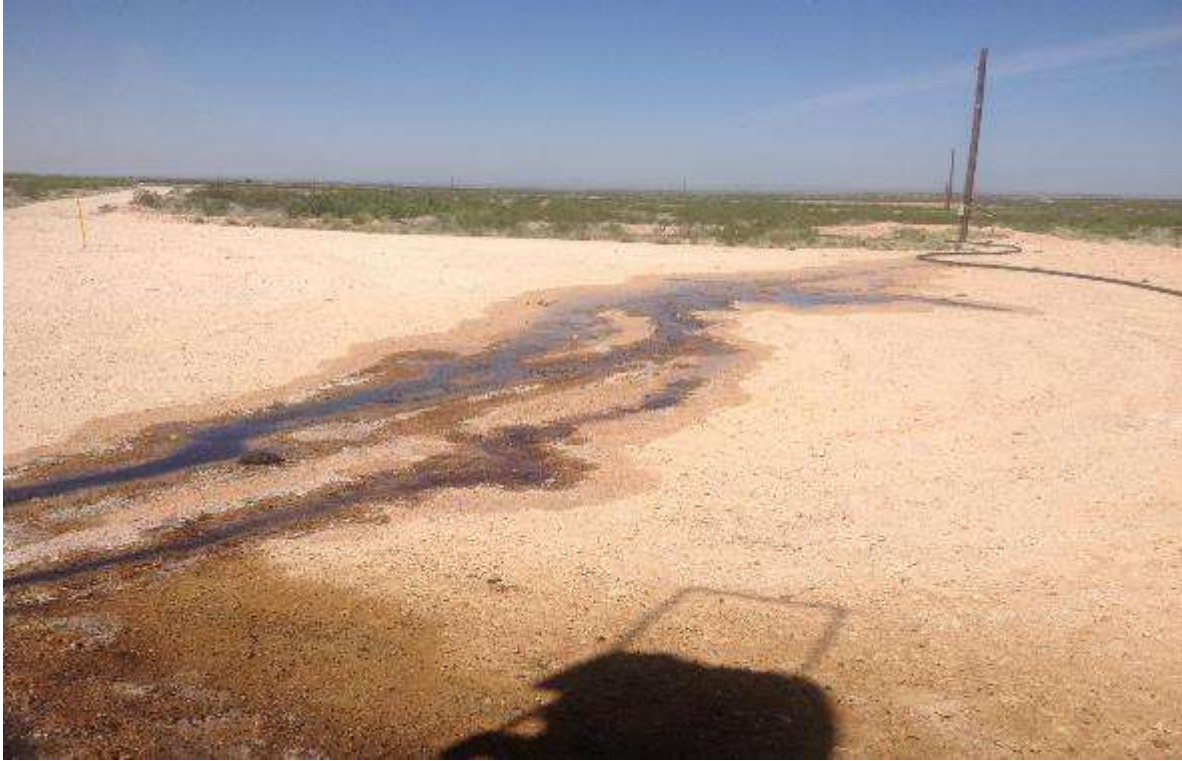
Bass 3 Federal #4 - Release Site (Looking West)

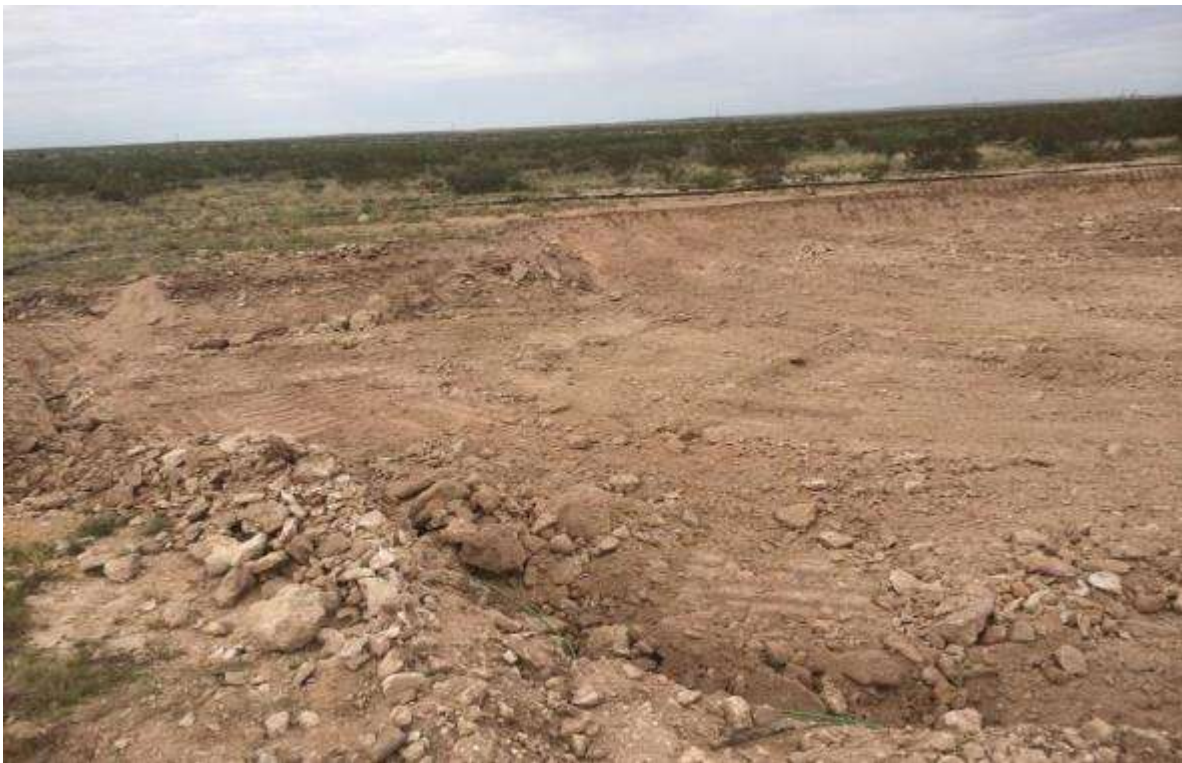
Bass 3 Federal #4 – Excavation (Looking North)

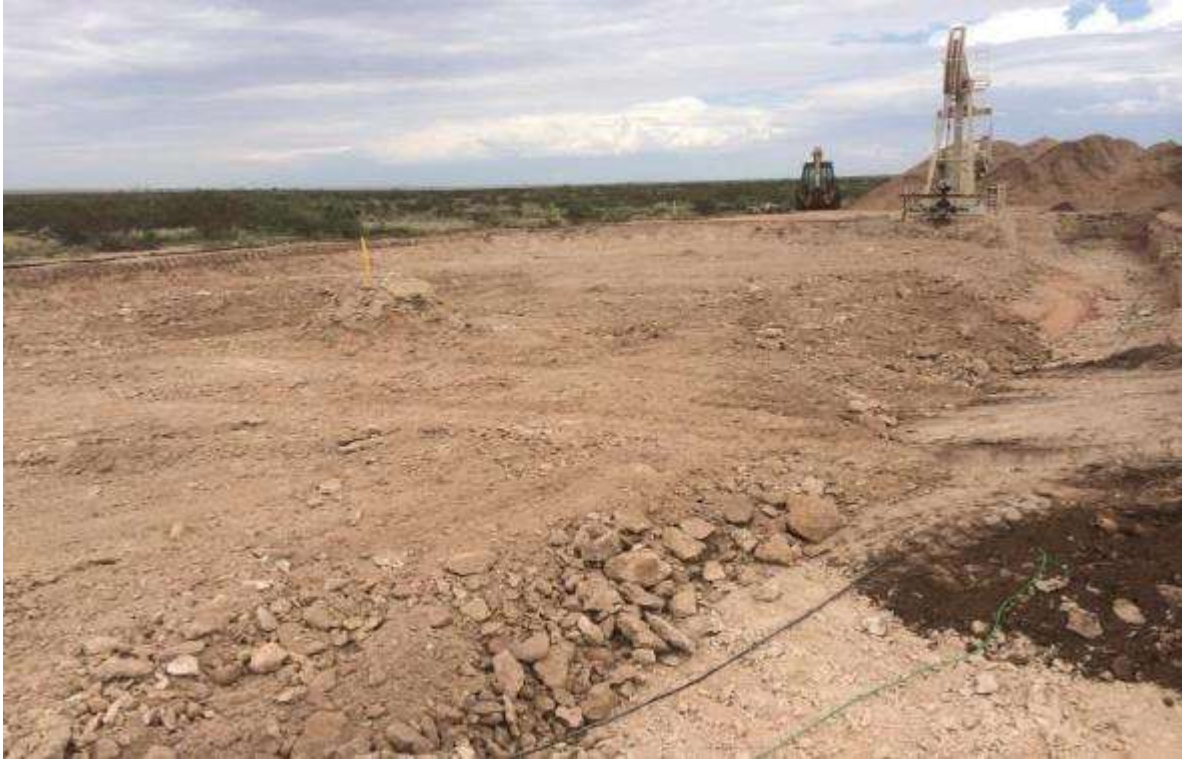
Bass 3 Federal #4 – Excavation (Looking Northeast)

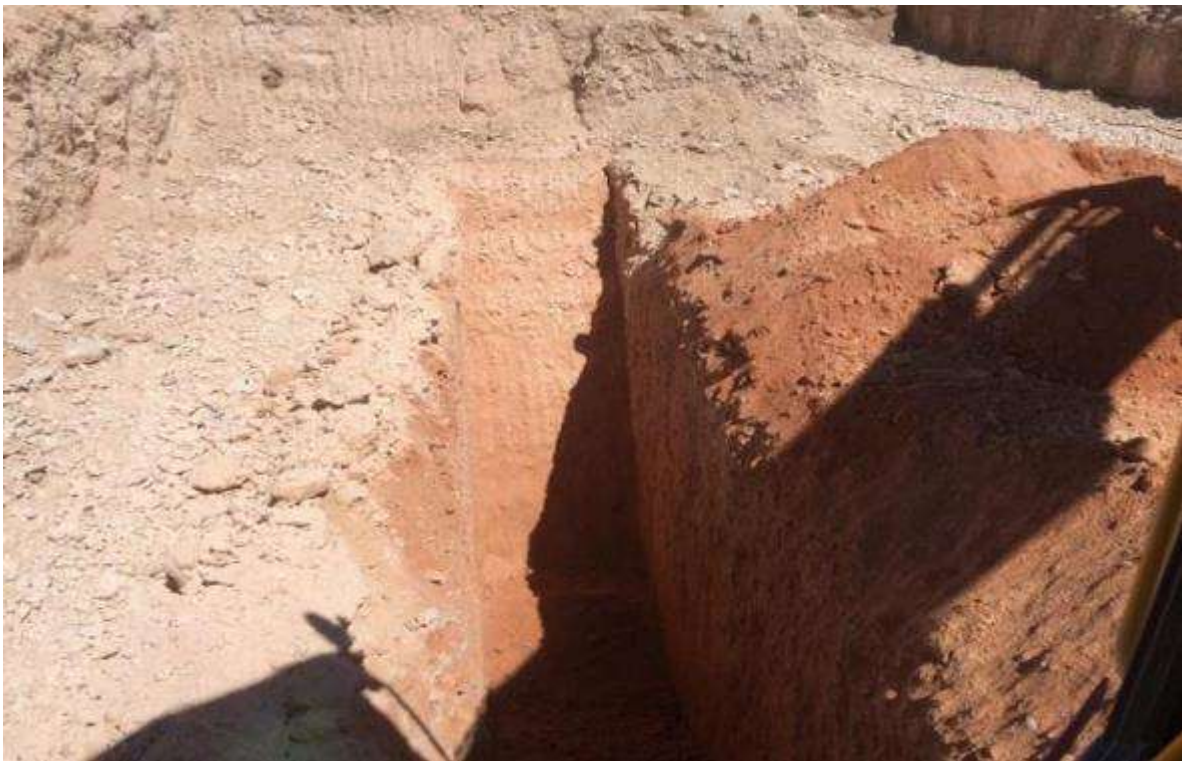
On August 20, 2014, a delineation trench (DT-1) was advanced adjacent to the Bass 3 Federal #4 wellhead to further investigate the vertical extent of impacted soil. Trench DT-1 was advanced to a total depth of approximately twenty feet (20') bgs. Soil samples were collected at two- (2) to three-foot (3') intervals and field-screened with a chloride test kit. Five (5) confirmation soil samples (DT-1 @ 11', DT-1 @ 13', DT-1 @ 15', DT-1 @ 18', and DT-1 @ 20') were submitted to the laboratory for analysis of chloride concentrations. Soil sample DT-1 @ 20' was also submitted for analysis of TPH and BTEX concentrations. Laboratory analytical results indicated chloride concentrations ranged from 320 mg/kg in soil sample DT-1 @ 18' to 1,920 mg/kg in soil sample DT-1 @ 11'. TPH and BTEX constituent concentrations in soil sample DT-1 @ 18' were less than the appropriate laboratory MDL.

Bass 3 Federal #4 – Delineation Trench DT-1

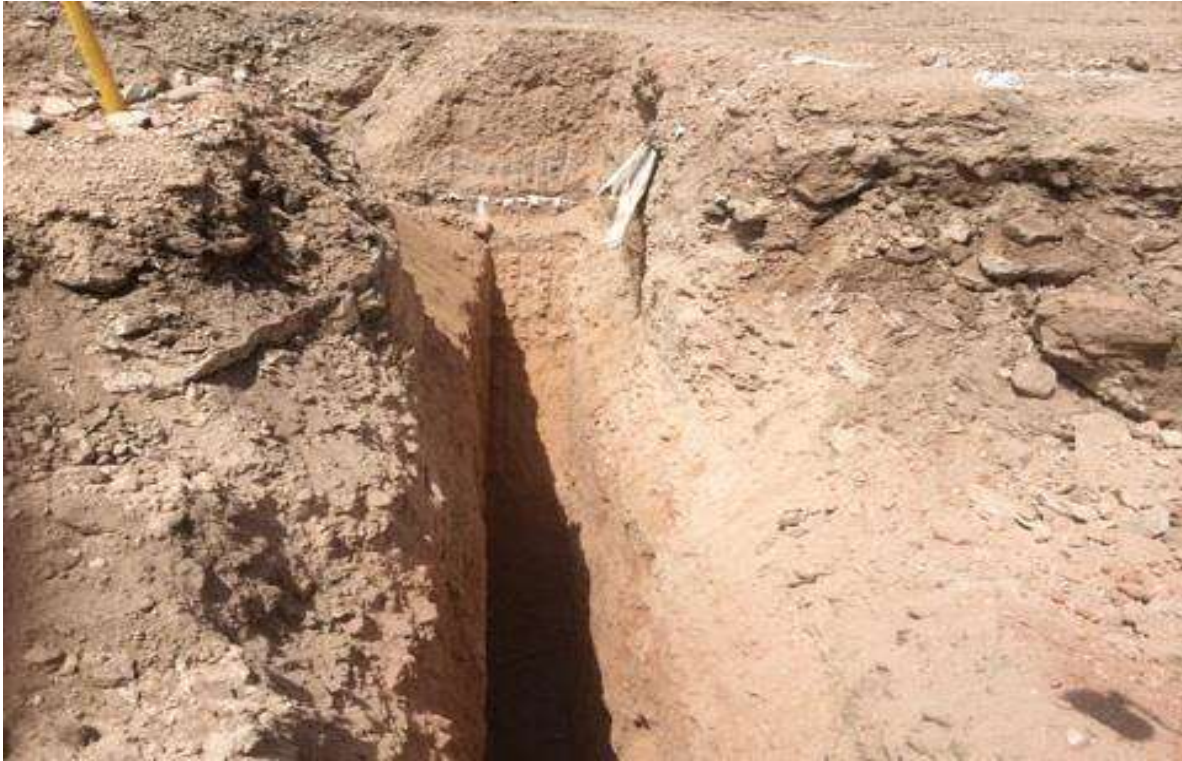
On August 26, 2014, a second delineation trench (DT-2) was advanced in the floor of the excavation in the westernmost corner of the encapsulation trench. Trench DT-2 was advanced to a total depth of approximately twenty-one feet (21') bgs. Soil samples were collected at one- (1) to three-foot (3') intervals and field-screened with a chloride test kit. Seven (7) confirmation soil samples (DT-2 @ 6', DT-2 @ 8', DT-2 @ 13', DT-2 @ 15', DT-2 @ 17', DT-2 @ 20', and DT-2 @ 21') were submitted to the laboratory for analysis of chloride concentrations. Soil sample DT-2 @ 21' was also submitted for analysis of TPH and BTEX concentrations. Laboratory analytical results indicated chloride concentrations ranged from 352 mg/kg in soil sample DT-2 @ 21' to 19,000 mg/kg in soil sample DT-2 @ 8'. TPH and BTEX constituent concentrations in soil sample DT-2 @ 21' were less than the appropriate laboratory MDL.

Bass 3 Federal #4 – Delineation Trench DT-2 (Looking North)
