## Randy Federal Water Station (2RP-2329)

# Termination Request

Unit Letter G, Section 22, Township 17S, Range 30E

**RE: Termination Request  
Apache Randy Federal Water Station (2RP-2329)  
UL/G sec. 22 T17S R30E  
API No. 30-015-36361**

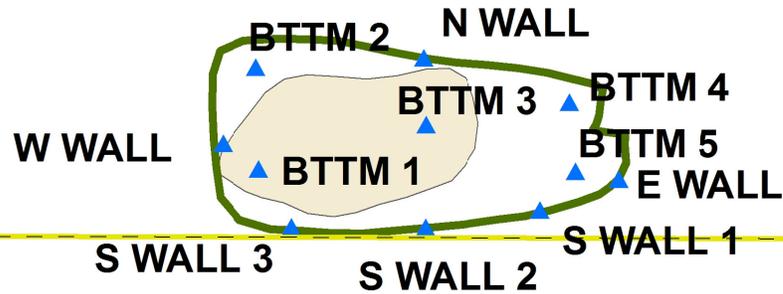
Figure 1

WALL SAMPLES								
	CI-	PID	GRO	DRO	B	T	E	X	BTEX
North Wall	<16	10.8	<10	<10	<0.05	<0.05	<0.05	<0.15	<0.3
East Wall	<16	6.3	<10	<10	<0.05	<0.05	<0.05	<0.15	<0.3
West Wall	128	1.8	<10	<10	<0.05	<0.05	<0.05	<0.15	<0.3
South Wall 1	<16	1.2							
South Wall 2	1460	5.7	<10	<10	<0.05	<0.05	<0.05	<0.15	<0.3
South Wall 3	464	2

- BURIED DCP PIPELINE
- ▲ SAMPLE POINT
- EXCAVATION TO 4 FT
- STAIN 218 SQ FT

CI- FIELD DATA  
CI- LAB DATA

RECS personnel were on site beginning on June 20<sup>th</sup>, 2014. The release was photographed and mapped. Based on a visual inspection of the release, the release area was excavated down to 4 ft bgs. Once the excavation was completed, final wall and bottom grab samples were taken and field tested for chlorides and organic vapors (Figure 1). The wall samples were taken to a commercial laboratory for analysis (Appendix B). All wall samples returned chloride values below 250 mg/kg, except for South Wall 2 and South Wall 3, which abutted the DCP buried line. The bottom samples returned chloride field data above regulatory standards.

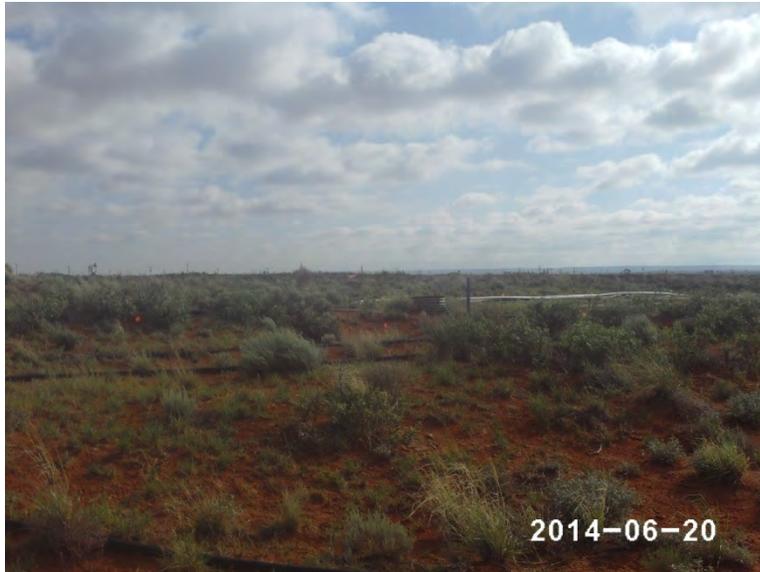
Initial release area, facing northeast 6/20/14

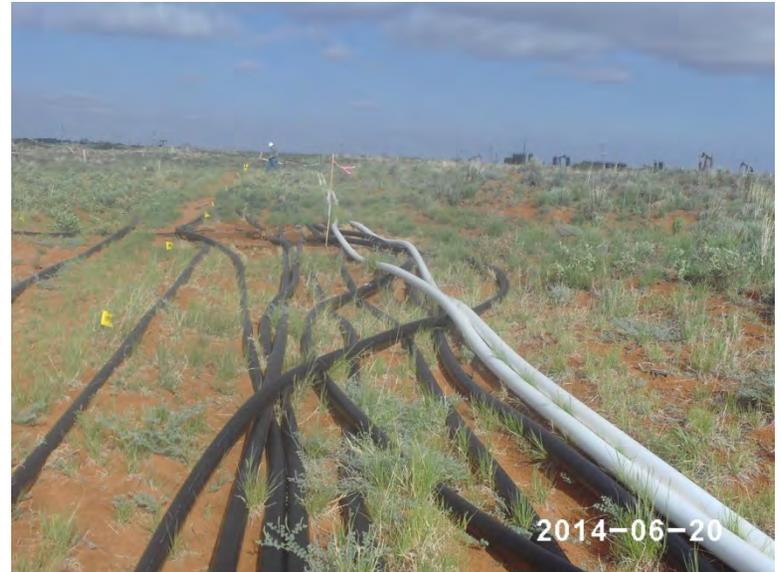
Initial release area, facing west 6/20/14

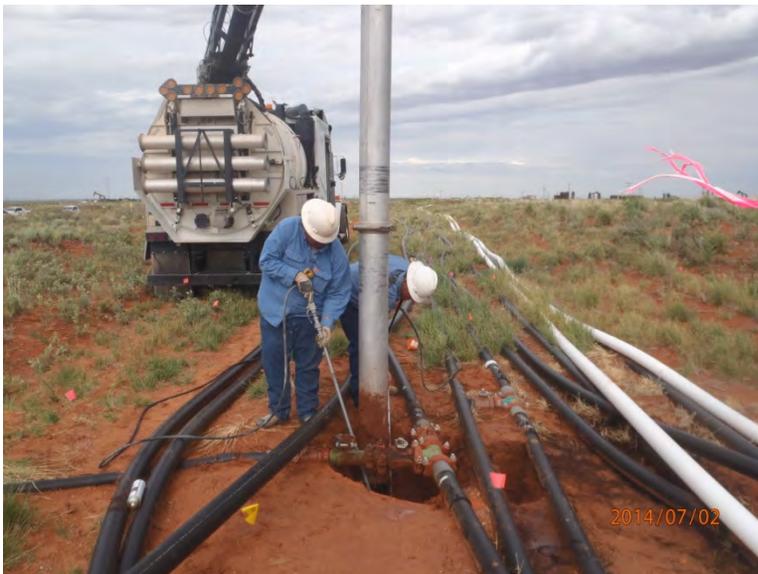
Line spotting with hydrovac, facing west 7/2/14

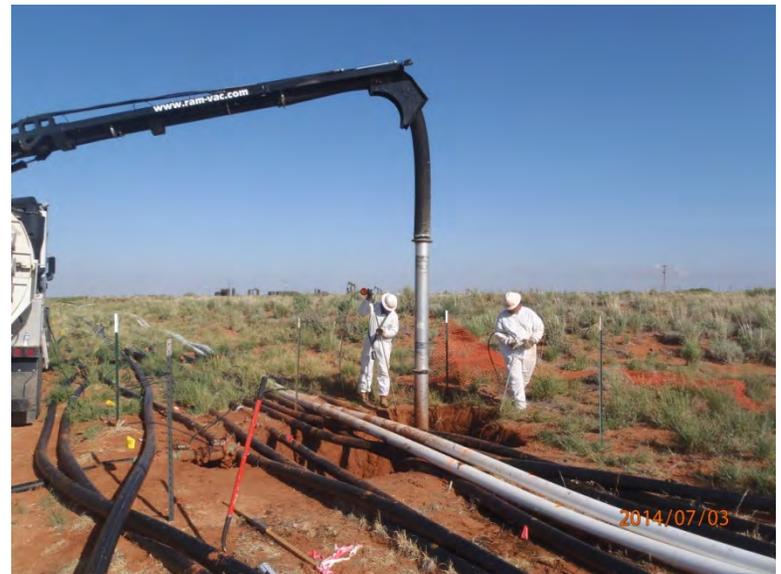
Excavating by hydrovac to 4 ft bgs, facing west 7/3/14

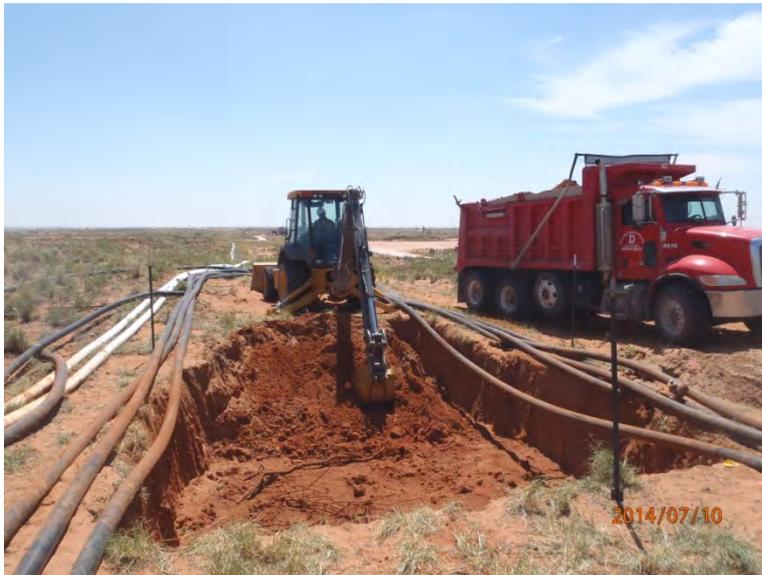
Continue to excavate to 4 ft bgs by backhoe, facing east  
7/10/14

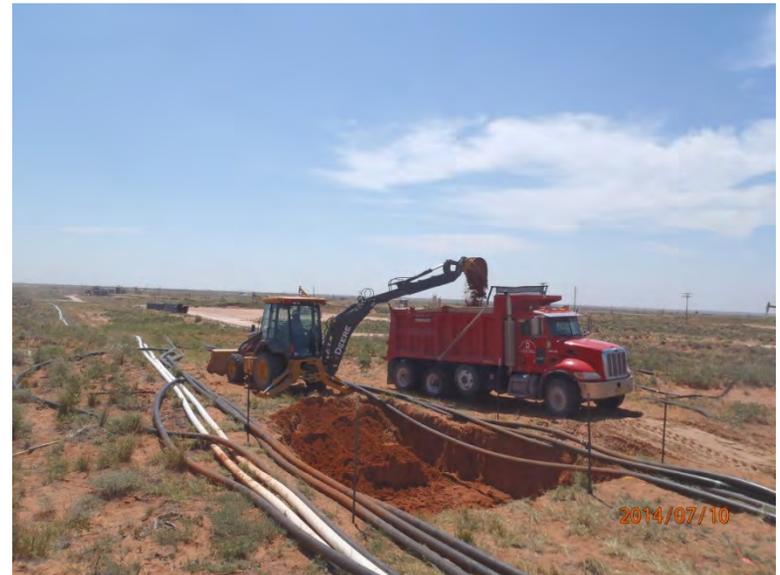
Exporting soil, facing southeast  
7/10/14

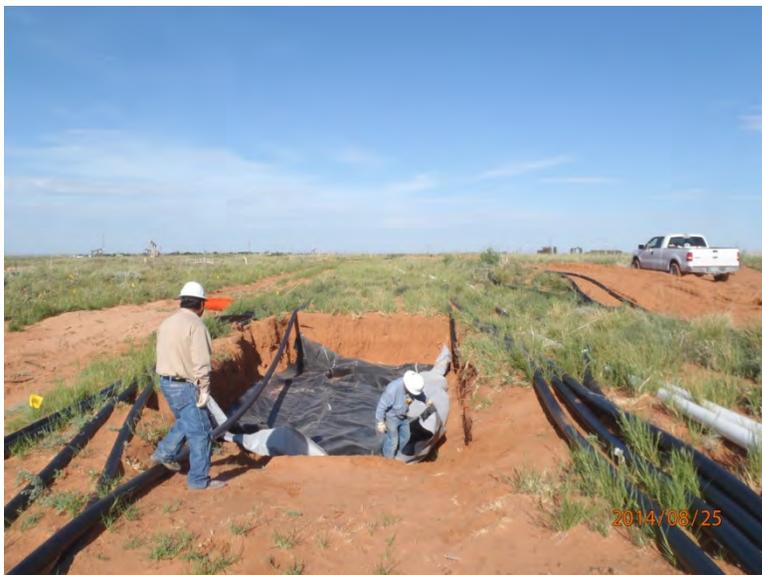
Installing liner, facing west  
8/25/14

On August 25<sup>th</sup>, 2014, a 20-mil reinforced poly liner was installed and properly seated into the base of the excavation. All the excavated soil was taken to a NMOCD approved facility for disposal. Clean top soil was imported to the site to replace all soils taken for disposal. The excavation was backfilled with the clean top soil and contoured to the surrounding location. On September 15<sup>th</sup>, 2014, the site was seeded with LPC mix, and the seed was raked into the site.

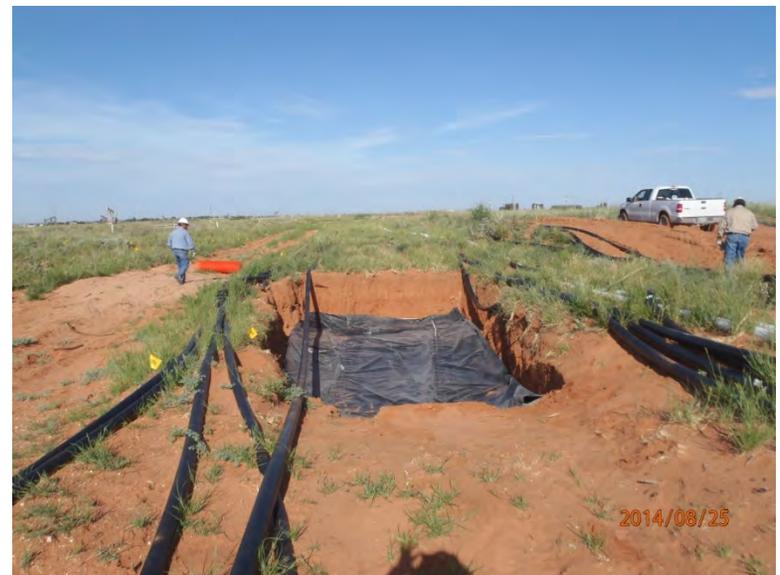
Liner installed, facing west  
8/25/14

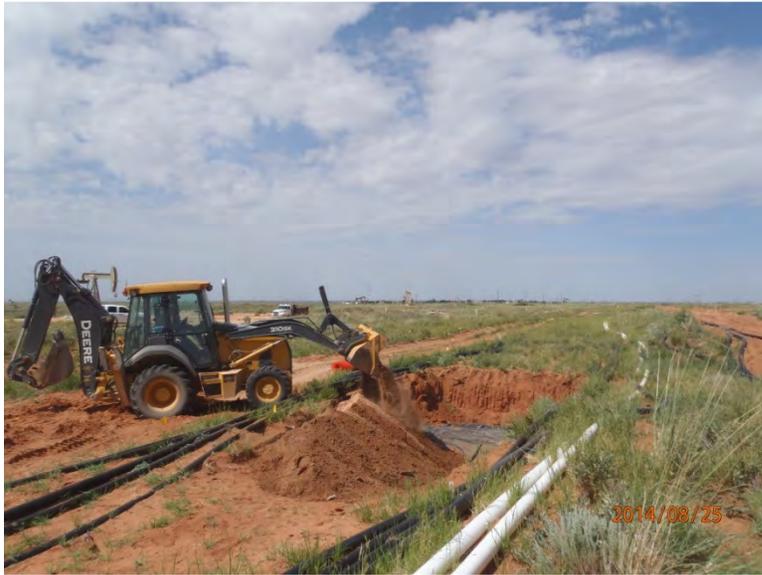
Backfilling site, facing southwest 8/25/14

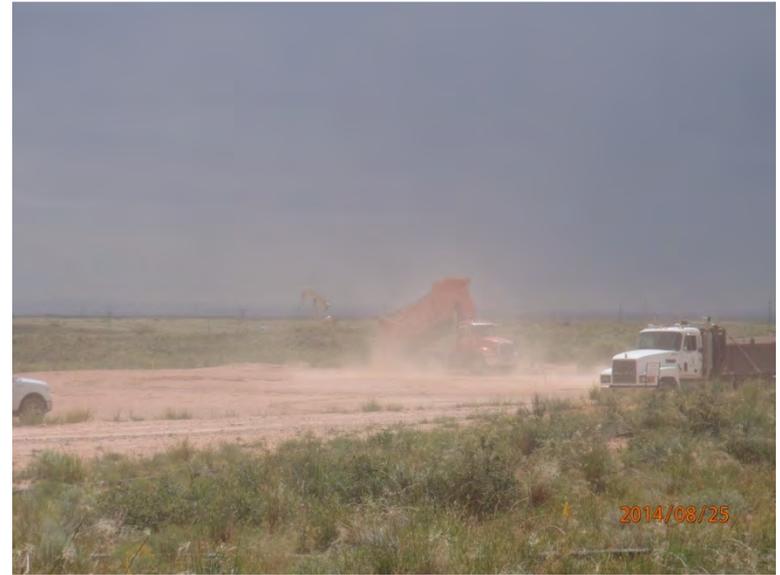
Importing soil, facing southwest 8/25/14

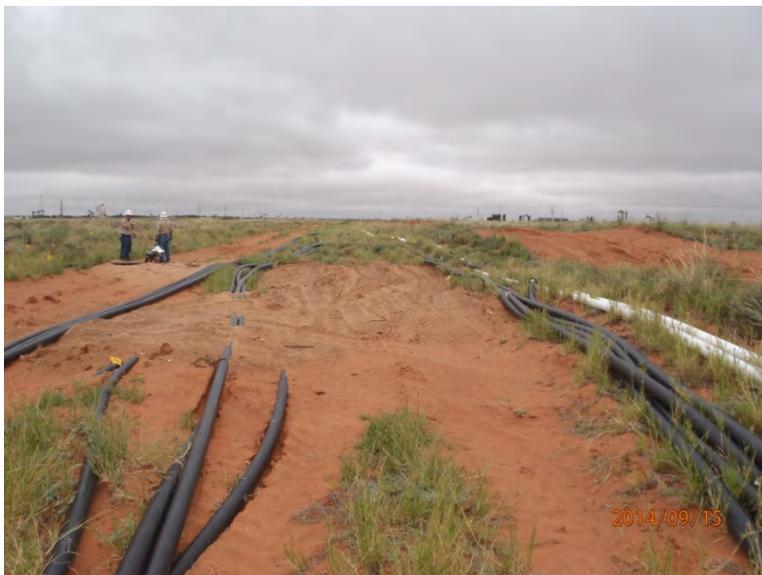
Backfilling completed, facing west 9/15/14

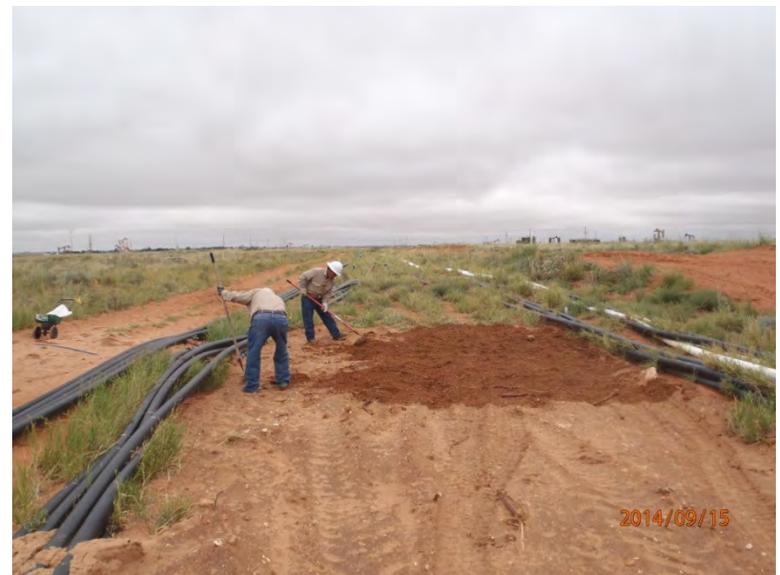
Raking site prior to seeding, facing west 9/15/14

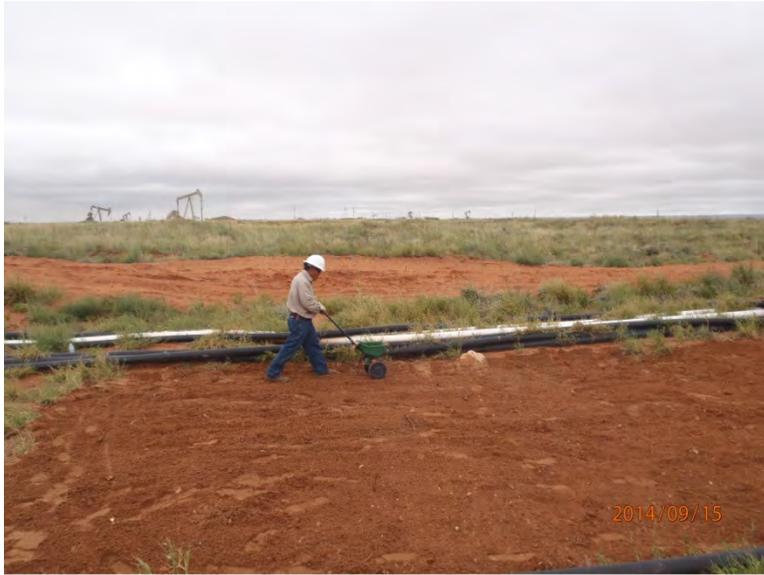
Seeding site, facing north

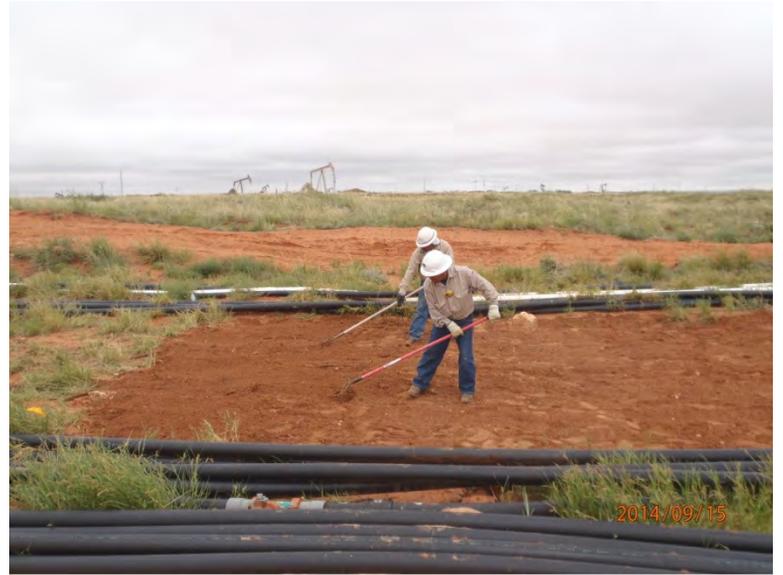
Raking seed into soil, facing north

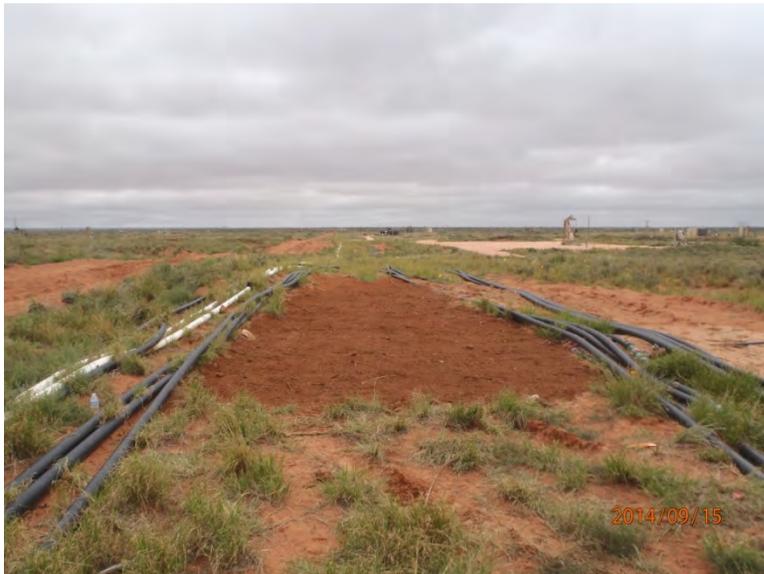
Site completed, facing east

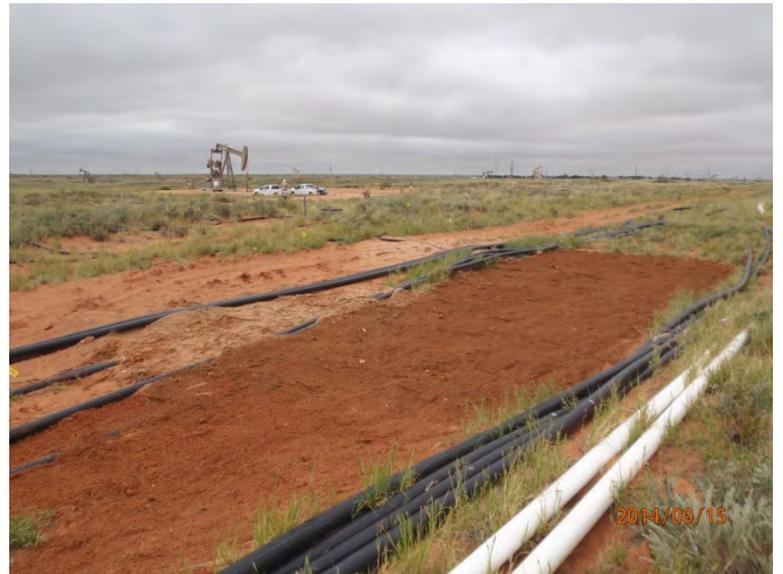
Site completed, facing southwest
