REMEDIATION SUMMARY AND SITE CLOSURE REQUEST

**BOPCO, LP
POKER LAKE UNIT #276 FLOW LINE
Eddy County, New Mexico
Unit Letter "P" (SE/SE), Section 12, Township 24 South, Range 29 East
Latitude 32.224862° North, Longitude 103.929663° West
NMOCD Reference #2RP-2298**

October 2014

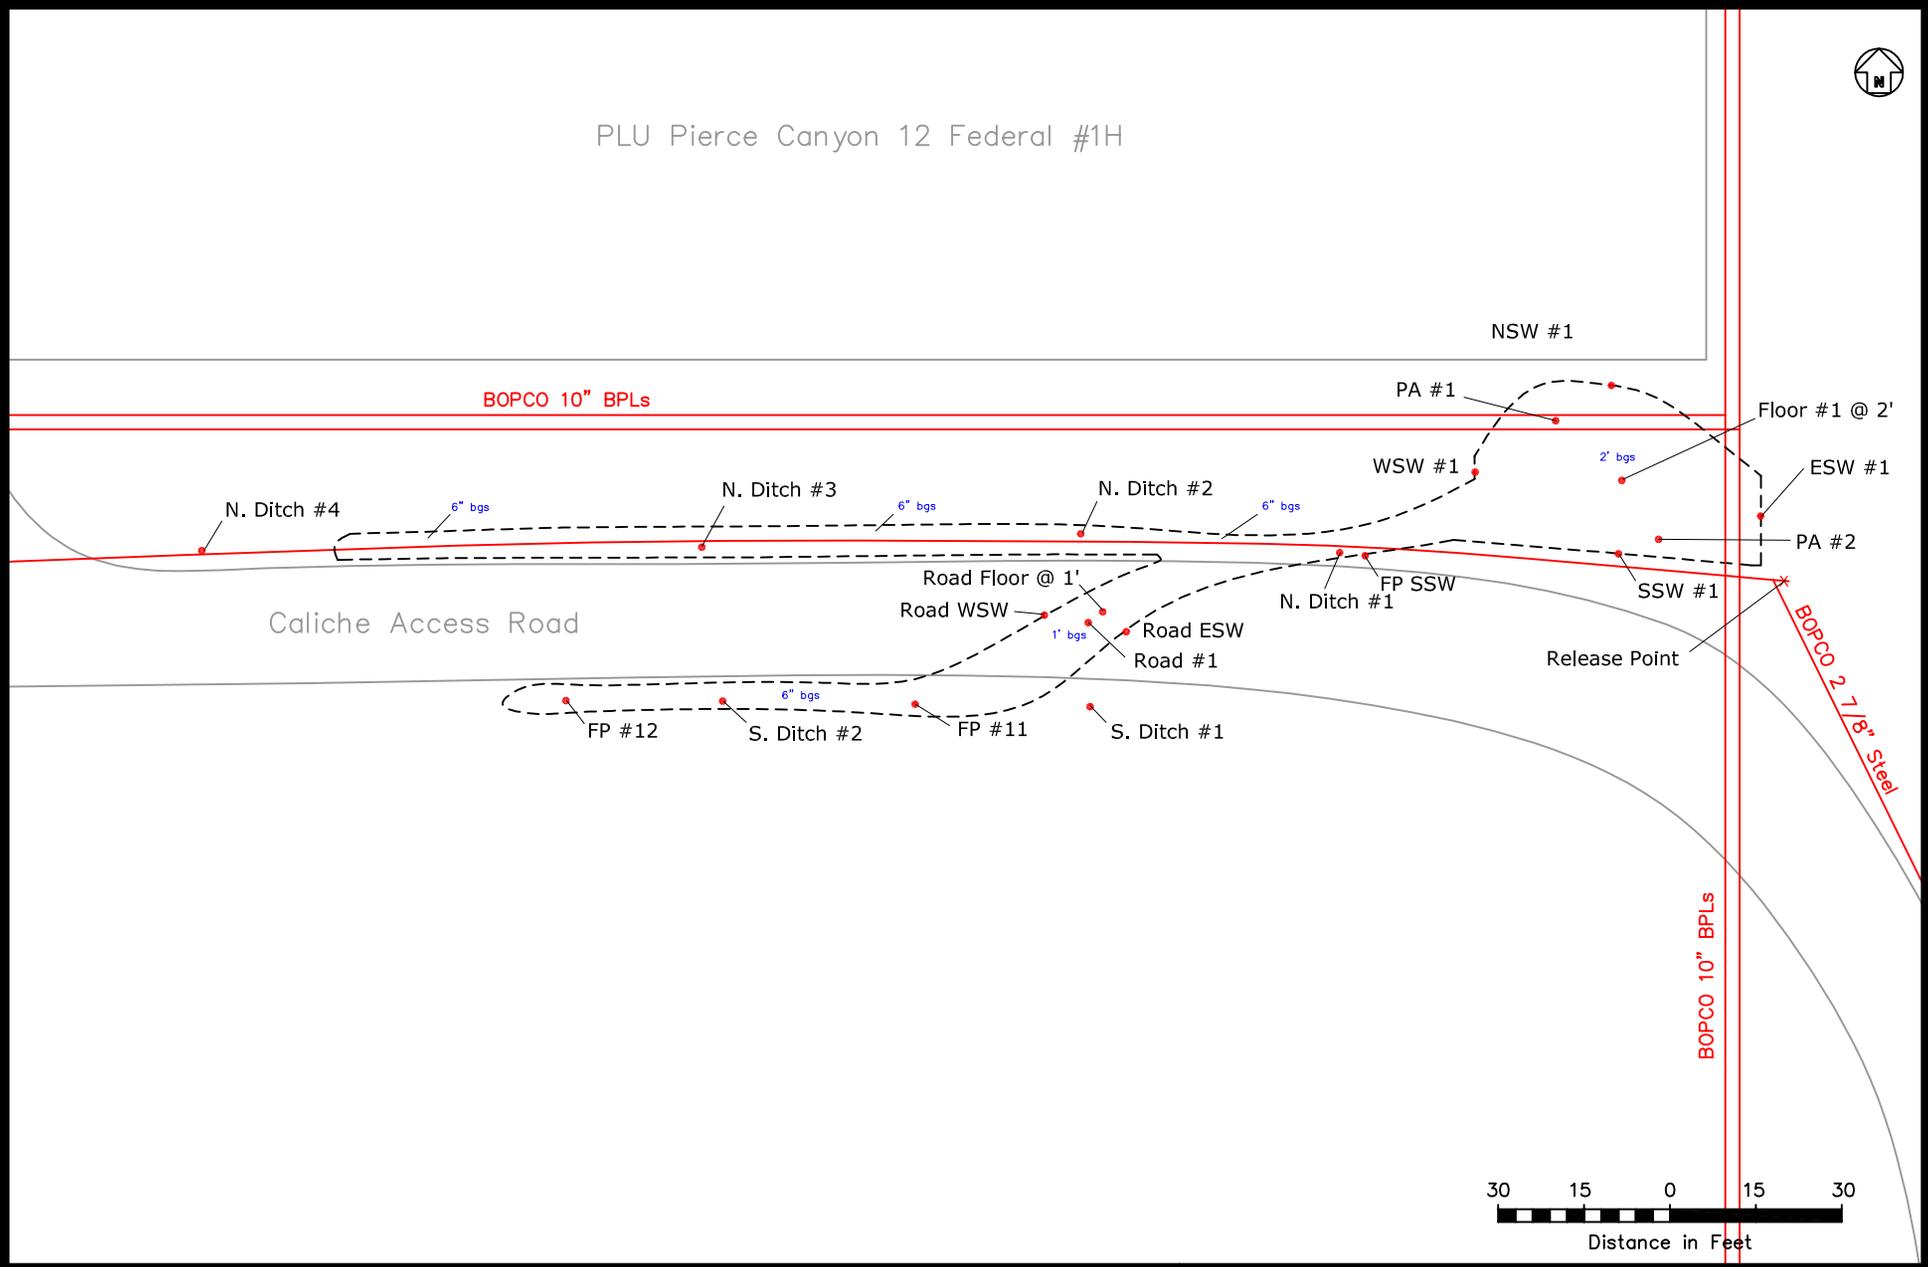
Figure 2
 Site and Sample Location Map
 BOPCO, L.P.
 PLU #276 Flow Line
 NMOCD Ref. # 2RP-2298
 Eddy County, New Mexico

On September 17, 2014, Basin began excavating impacted soil at the release site. The floor and sidewalls of the excavation were advanced until field observations and tests suggested concentrations of BTEX, TPH and chloride were below NMOCD regulatory standards. Excavated soil was stockpiled on-site, pending final disposition.

On September 30, 2014, eleven (11) confirmation soil samples (NSW #1, SSW #1, ESW #1, WSW #1, FP SSW, Road ESW, Road WSW, FP #11, FP #12, Floor #1 @ 2' and Road Floor @ 1') were collected from the excavated area and submitted to the laboratory for analysis of chloride

The final dimensions of the primary excavation were approximately thirty feet (30') in width, forty-five feet (45') in length and two feet (2') in depth. A portion of the affected road measuring approximately fifteen feet (15') in width and thirty feet (30') in length was excavated to approximately one foot (1') bgs. In addition, approximately one hundred and eighty (180) linear feet of bar ditch on the north side of the caliche access road was excavated to approximately six inches (6") bgs, along with seventy-five (75) linear feet to the south. Upon receiving laboratory analytical data from confirmation soil samples, the excavated area was backfilled with locally purchased, non-impacted material. Following backfilling, areas affected by the remediation activities were compacted and contoured to match the surrounding topography.

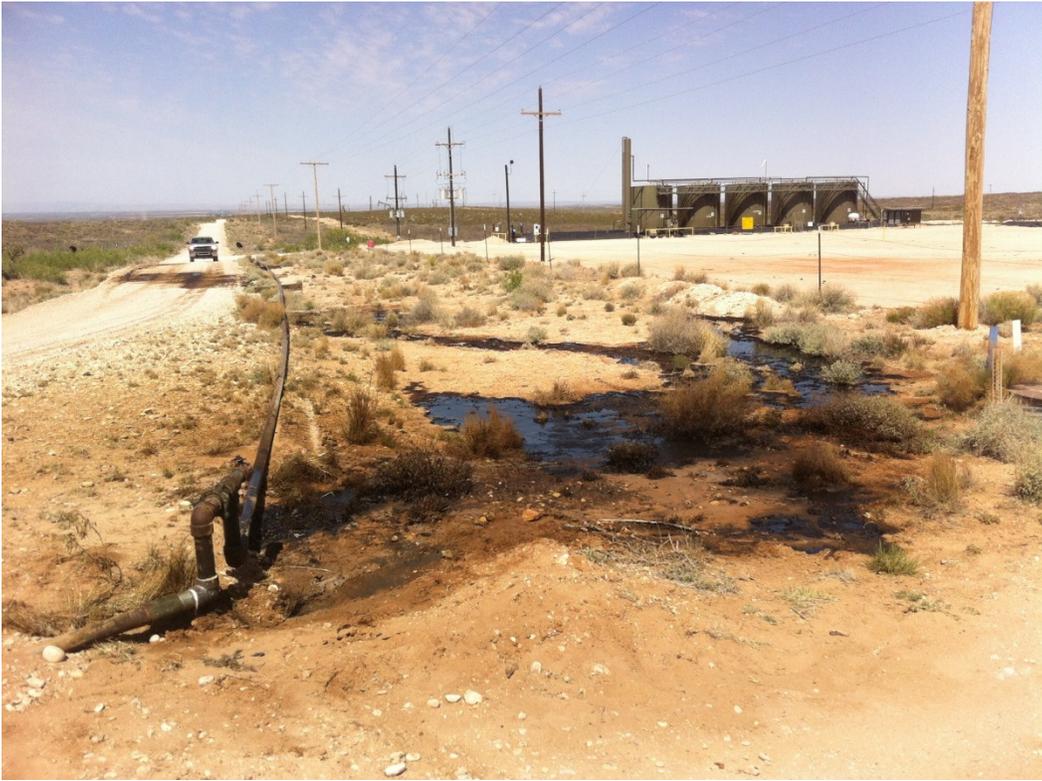
Describe Cause of Problem and Remedial Action Taken.*
An unknown vehicle ran over the flow line "swing" where the line turns west to head to the tank battery. The well was shut in and the broken fitting was replaced.

Describe Area Affected and Cleanup Action Taken.*
The spill impacted approximately 1,740 sq.ft. of pasture alongside the road way in the flow line right of way and approximately 700 sq.ft. of lease road. The saturated soil was scraped up with a backhoe and shovels and stockpiled on-site. The spill area will be cleaned up in accordance to the NMOCD and BLM remediation guidelines.

Photograph of the initial release at the PLU #276 Flow Line release site.

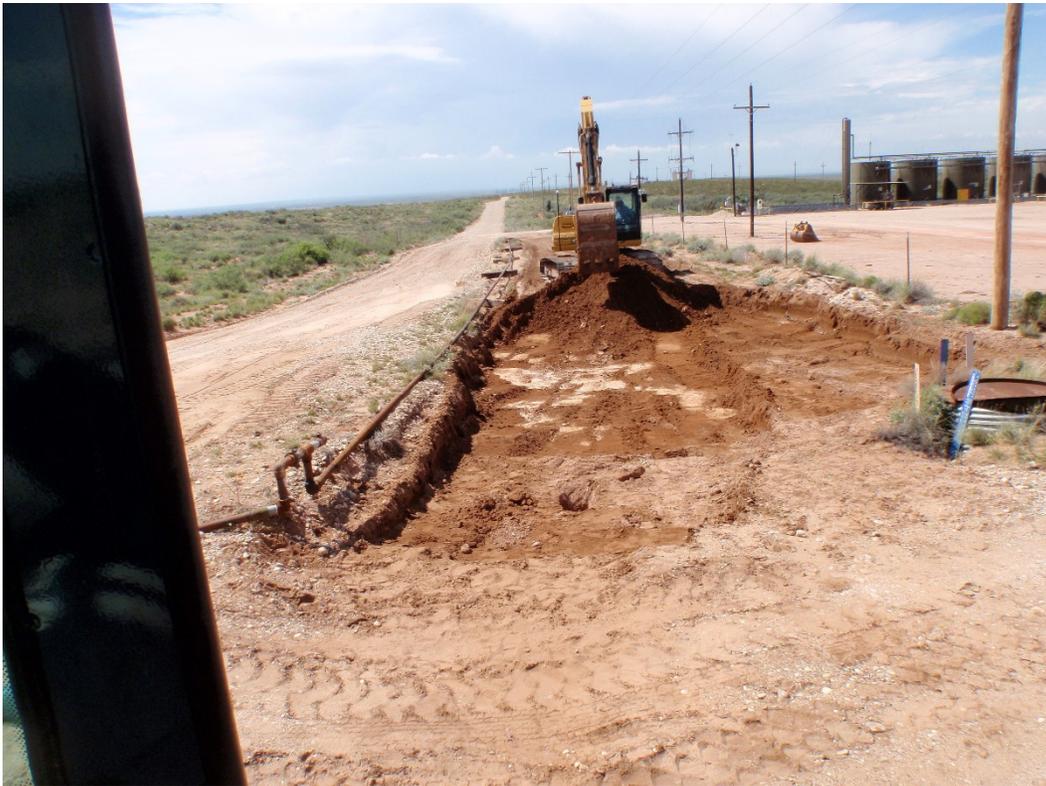
Photograph of excavation activities at the PLU #276 Flow Line release site.

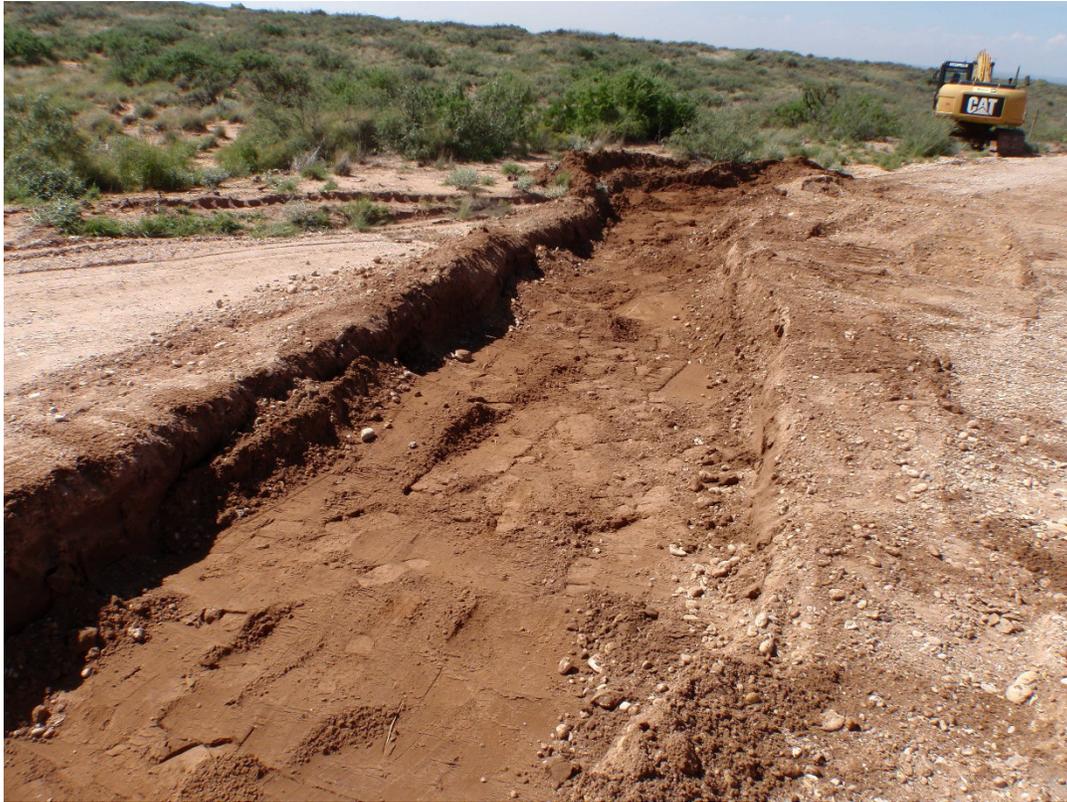
Photograph of excavation activities at the PLU #276 Flow Line release site.

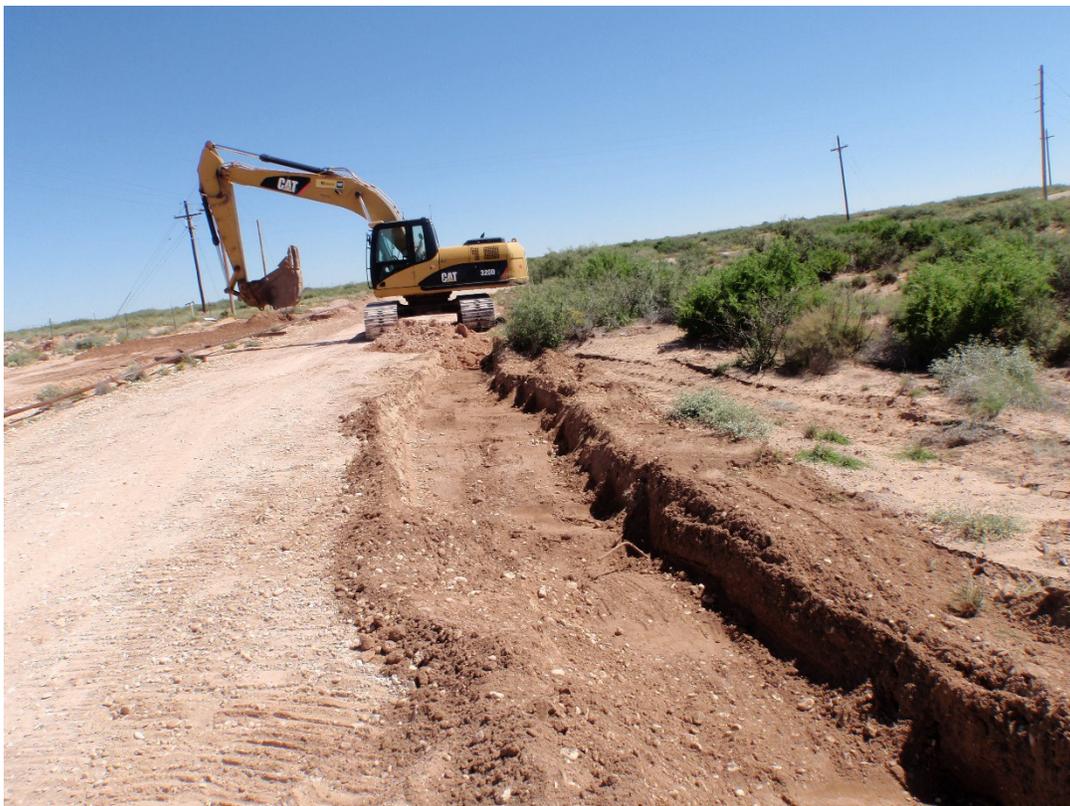
Photograph of excavation activities at the PLU #276 Flow Line release site.

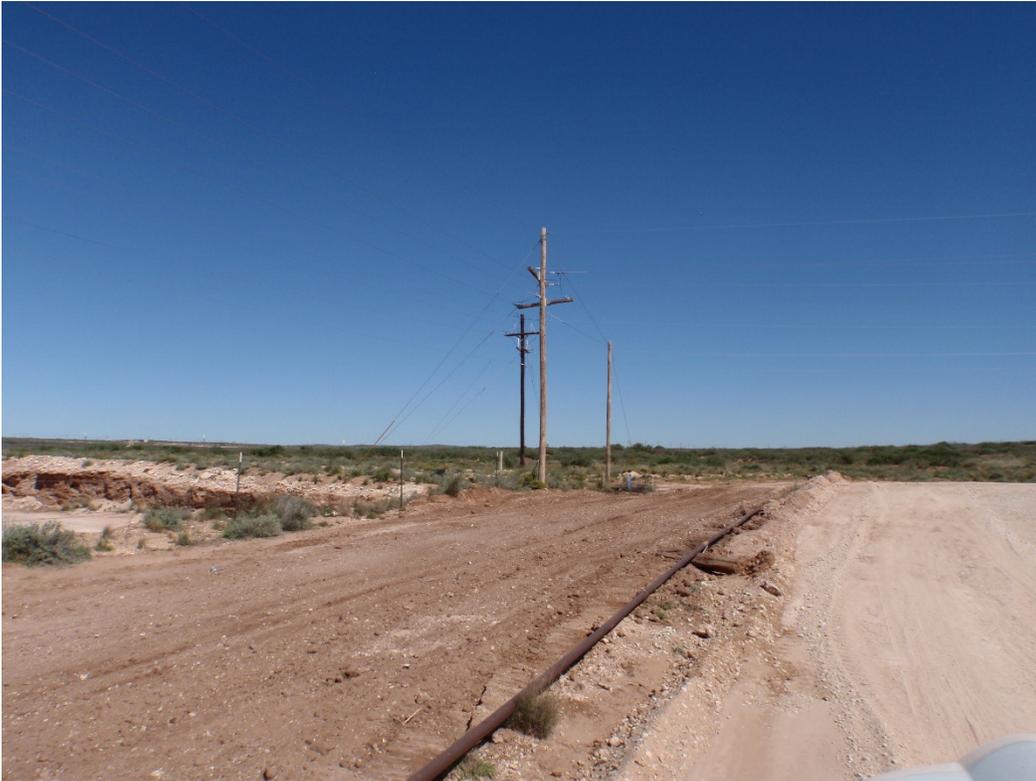
Photograph of the PLU #276 Flow Line release site after remediation activities.

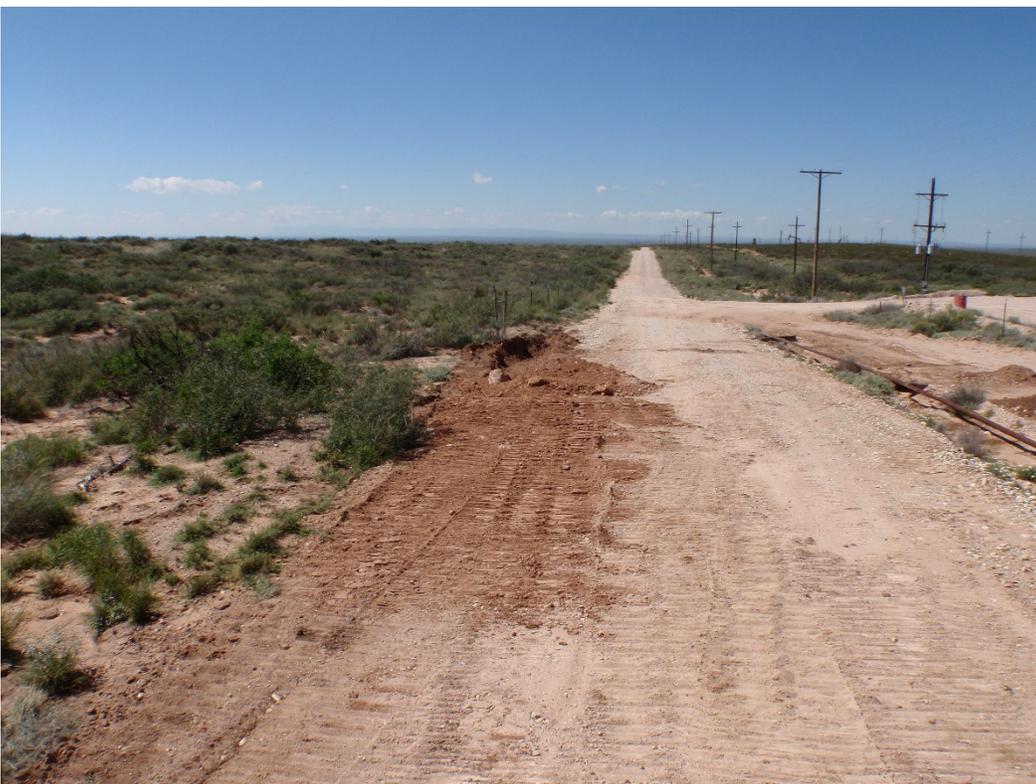
Photograph of the PLU #276 Flow Line release site after remediation activities.
