CLOSURE REPORT

BOPCO, LP
POKER LAKE UNIT #423H
Eddy County, New Mexico
Unit Letter "P", Section 19, Township 25 South, Range 30 East
Latitude 32.113234 North, Longitude 103.915246 West
NMOCD Reference #2RP-2413

RE: Final Closure Report
Bopco – Poker Lake Unit #423H
UL-I, Section 19, Township 25 South, Range 30 East
Eddy County, New Mexico
NMOCD Reference # 2RP 2413

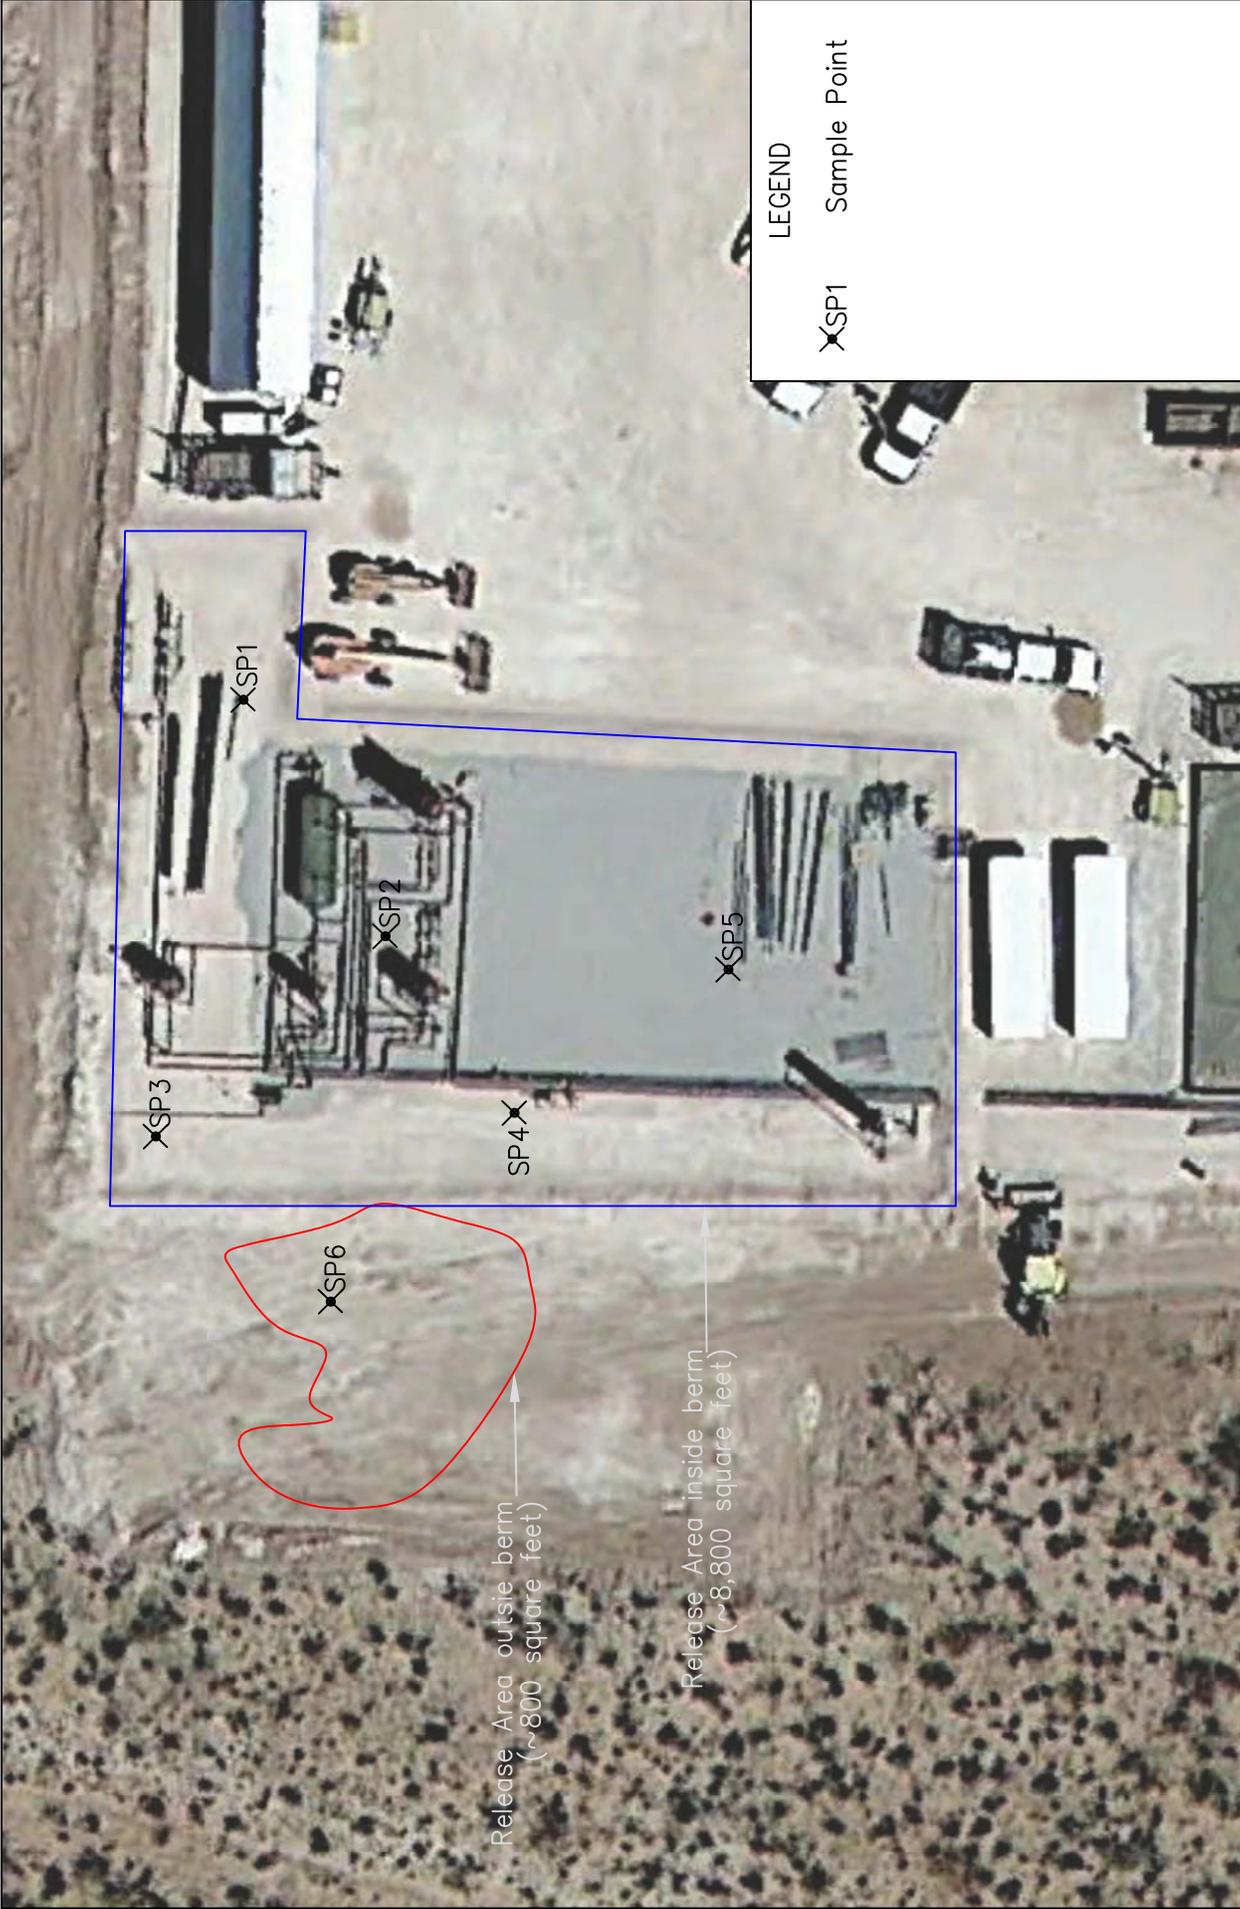
<p>Figure 3 Site/Sample Map Bopco, L.P. Poker Lake Unit #423H</p>	<p>Eddy County, New Mexico NE 1/4 of SE 1/4, Sec. 19, T25S, R30E N 32°6' 47.64" W 103°54' 54.89" Elevation: 3,192 feet amsl</p>		<p>DWG By: D Dominguez October 2014</p>	<p>REVISED:</p>

EPI personnel mobilized on the site on August 1, 2014 to collect soil samples via sample trench to determine the vertical extent of contamination. A total of twenty-three (23) soil samples were collected and sent to Cardinal Labs in Hobbs, New Mexico, for testing. Laboratory analytical results indicate Benzene, BTEX, TPH and Chloride concentrations in excess of NMOCD Recommended Remedial Action Levels (RRALs) of 10 mg/Kg, 50 mg/Kg, 5,000 mg/Kg, and 1,000 mg/Kg, respectively, at surface level in samples SP1 – SP4. Benzene, BTEX, and TPH concentrations exceed NMOCD RRALs at surface level in SP5 and at one (1) foot bgs in sample SP6. Chloride concentrations do not exceed NMOCD RRALs at sample points SP5 or SP6 (reference *Figure 3* and *Table 2*).

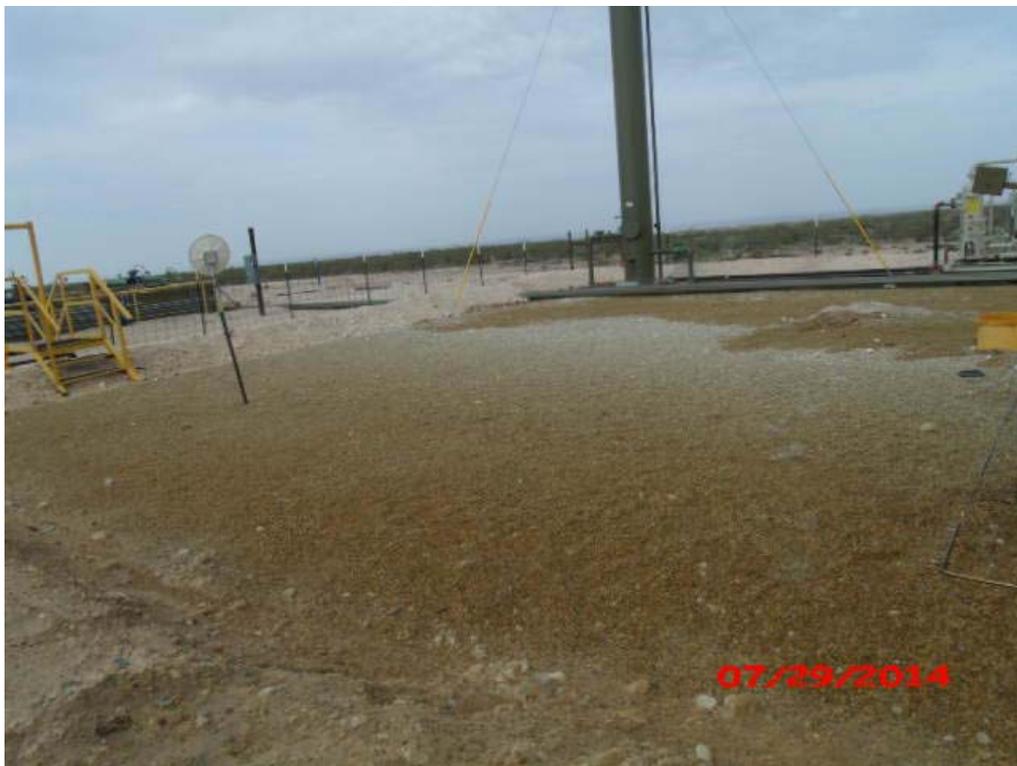
Photograph #2 – Looking across release area

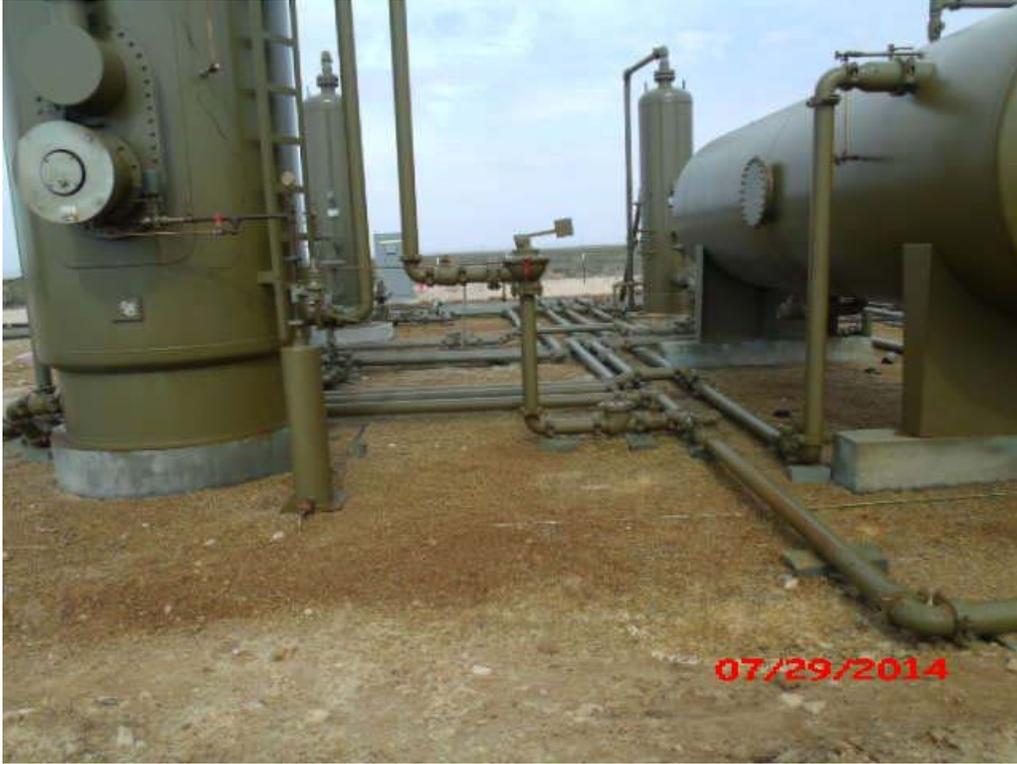
Photograph #3 – Looking across release area

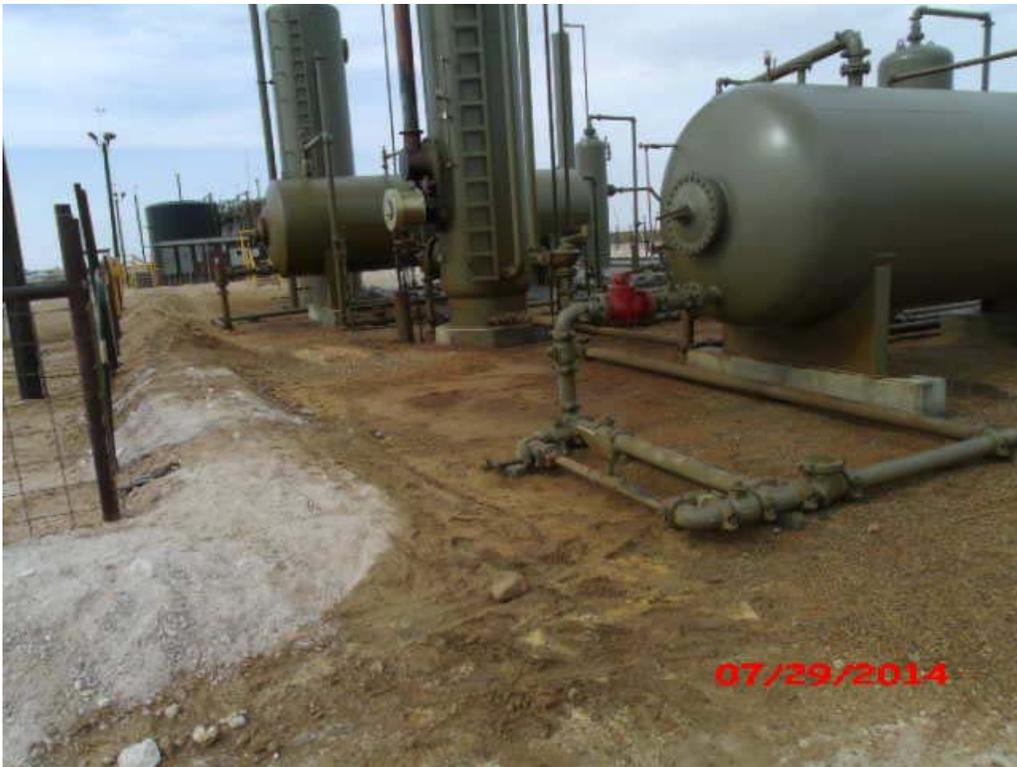
Photograph #4 – Looking across release area

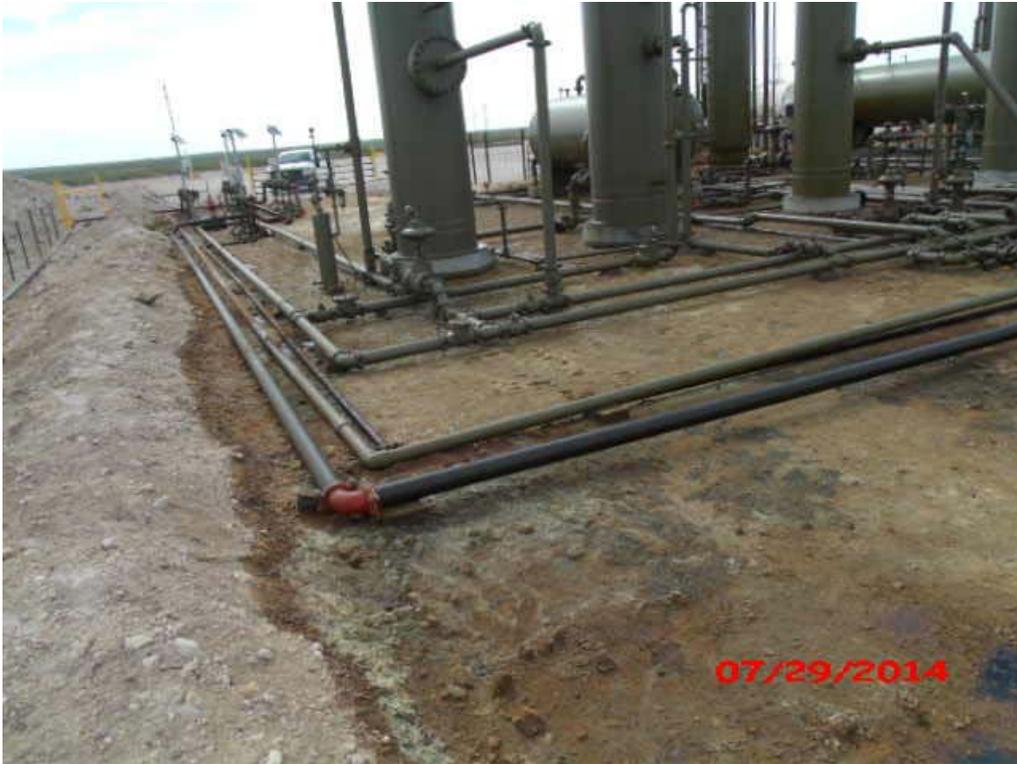
Photograph #5 – Looking across release area

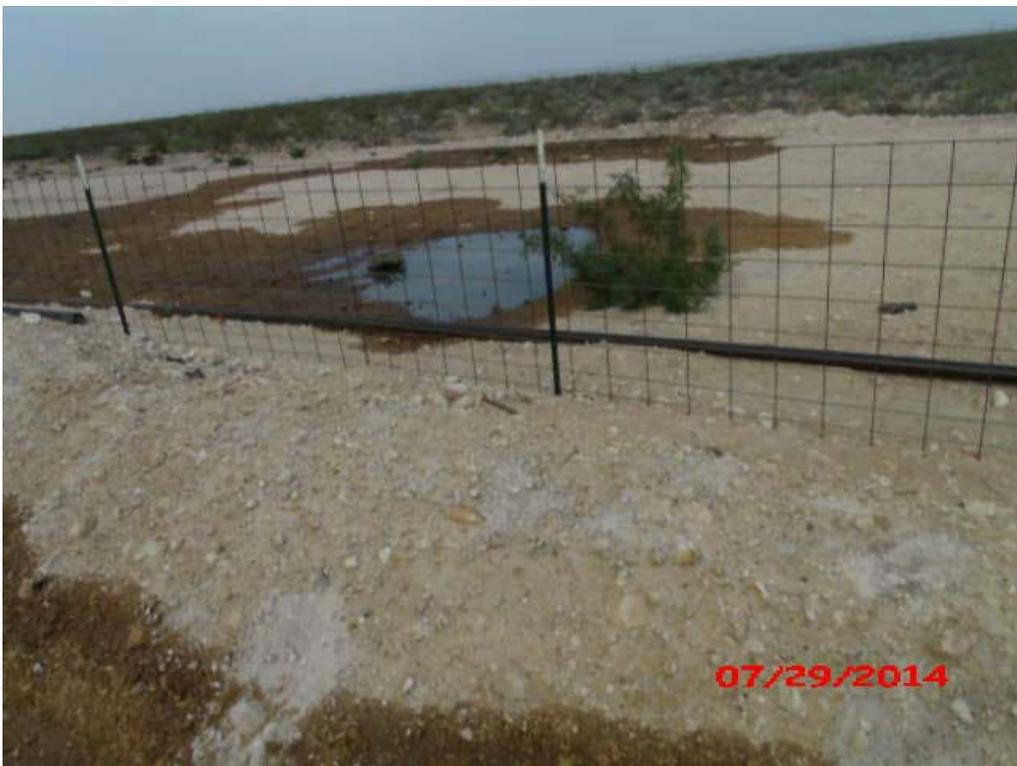
Photograph #6 – Looking across release area

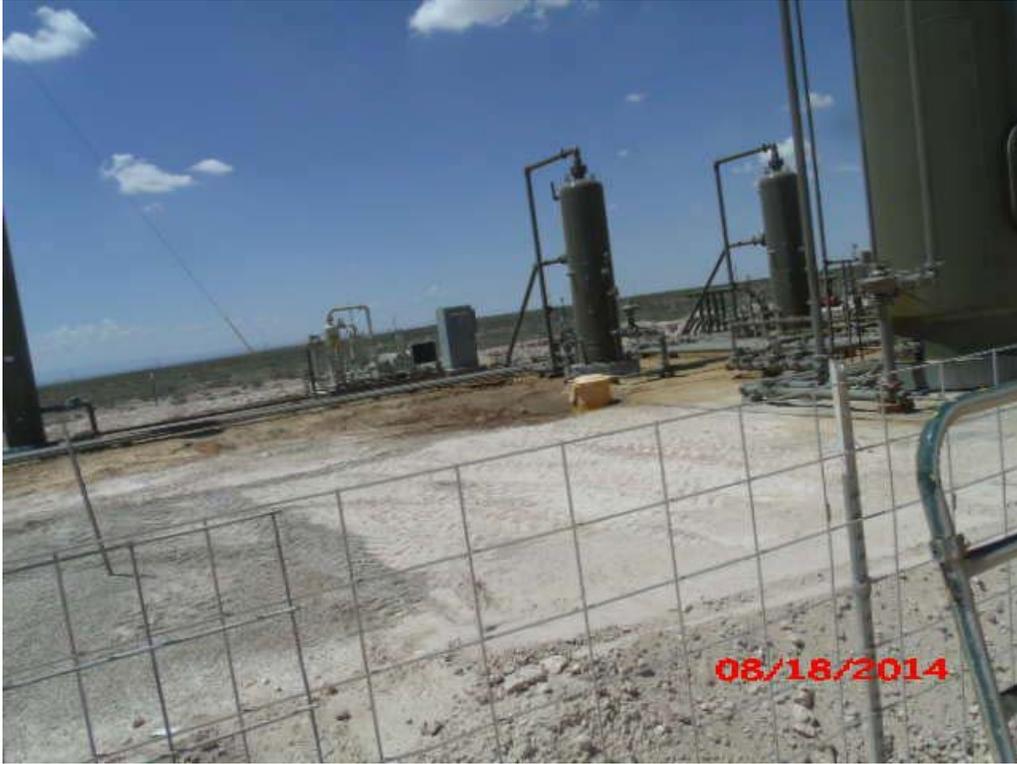
Photograph #7 – Excavated area

From August 8 – 18, 2014 approximately 350 cubic yards of contaminated material were excavated and transported to Lea Land for disposal. The release area off the caliche pad was excavated approximately two (2) feet bgs and the release area inside the berm was excavated by hand to a depth of approximately one (1) foot bgs.

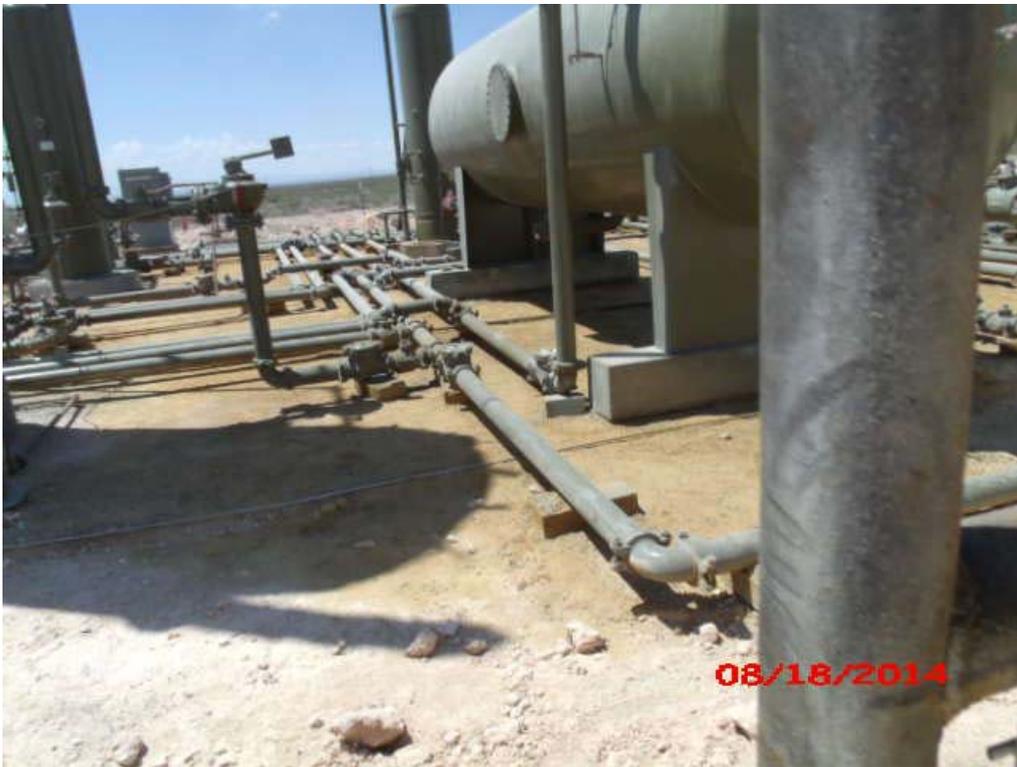
Photograph #8 – Excavated area

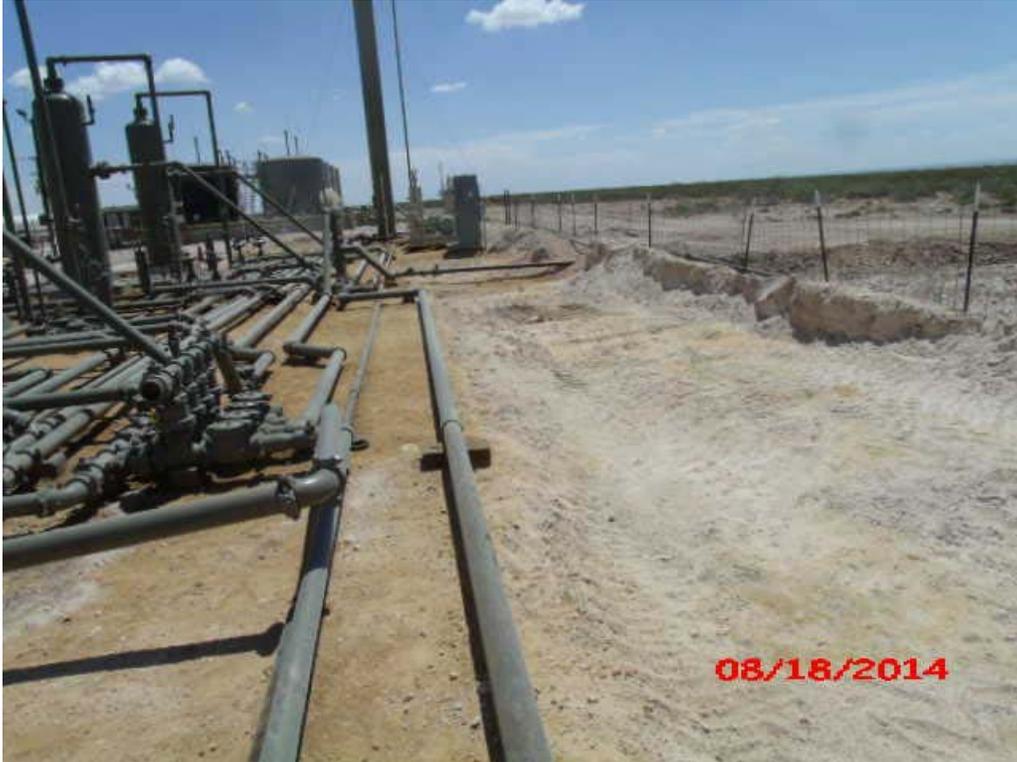
Photograph #9 – Excavated area

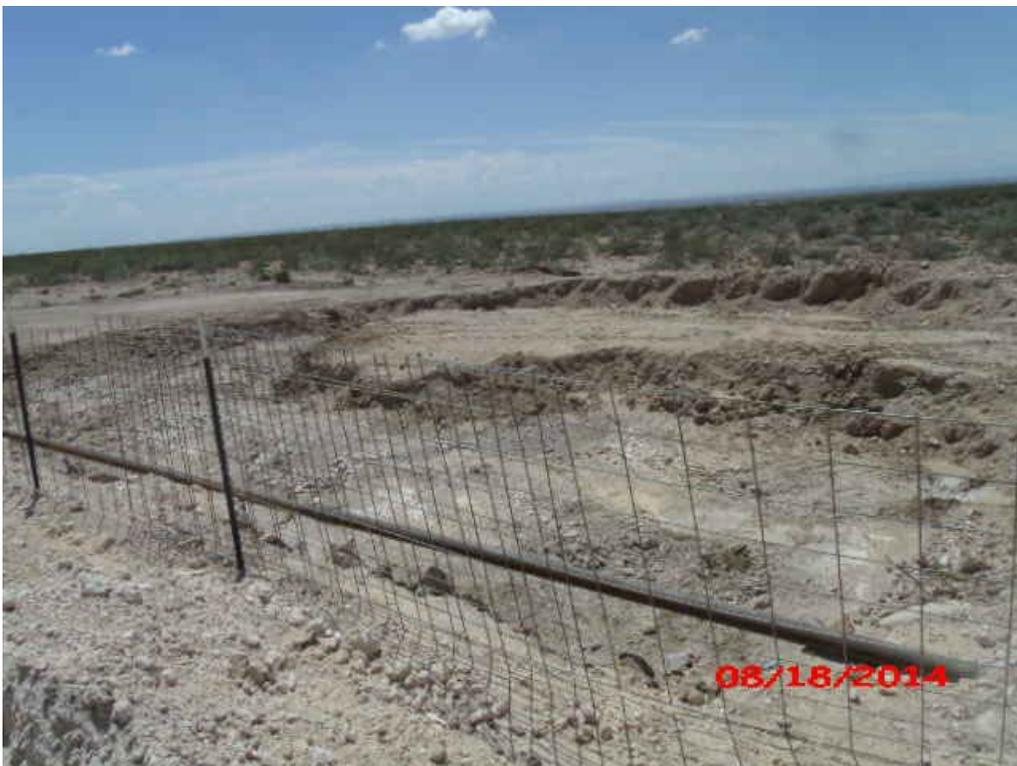
Photograph #10 – Excavated area

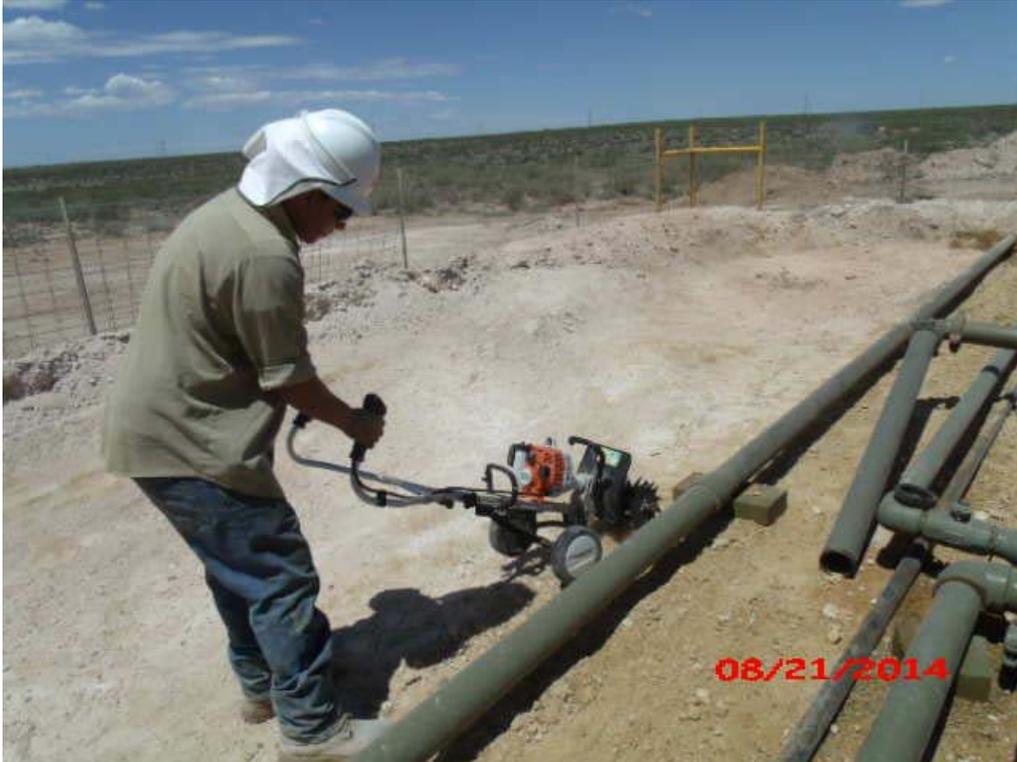
Photograph #11 – Tilling after application of Micro-Blaze

On August 21 and 22, 2014 EPI personnel mobilized on site and thoroughly sprayed the release area within the berm with a six (6) percent solution of Micro-Blaze. After application of Micro-Blaze the area was tilled with a hand tiller to allow deeper penetration of Micro-Blaze. From August 25 – 29 the excavation outside the berm was backfilled with clean soil. The area inside the berm was backfilled with clean caliche and covered with a layer of pea gravel. The area

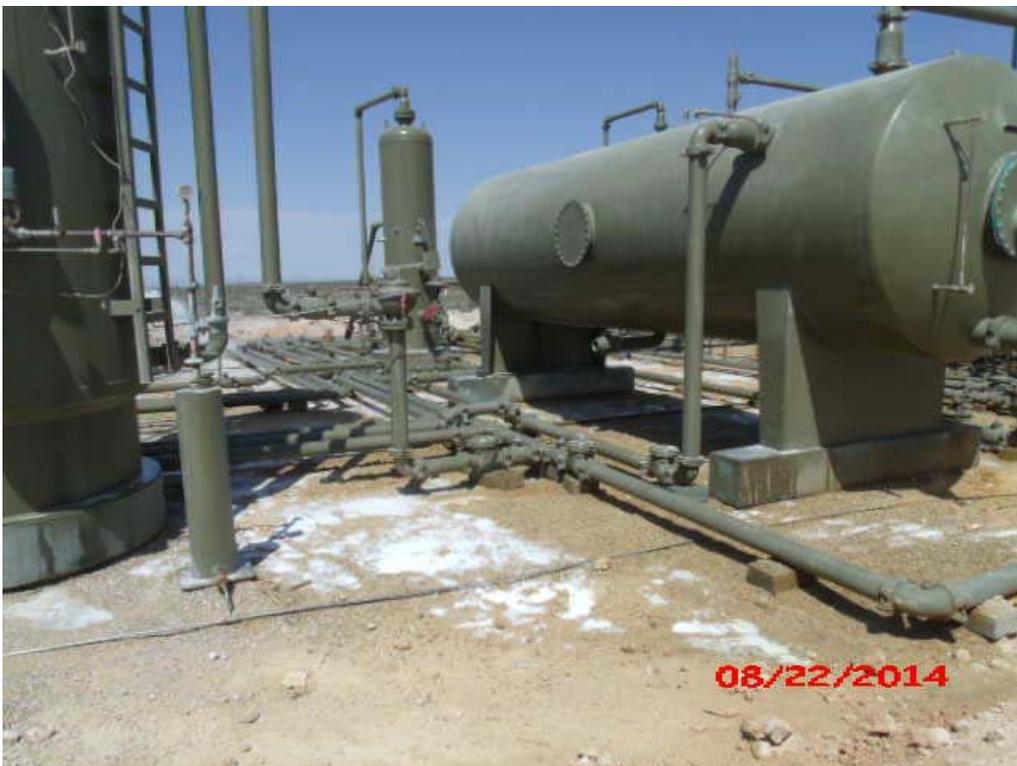
Photograph #12 – Application of Micro-Blaze

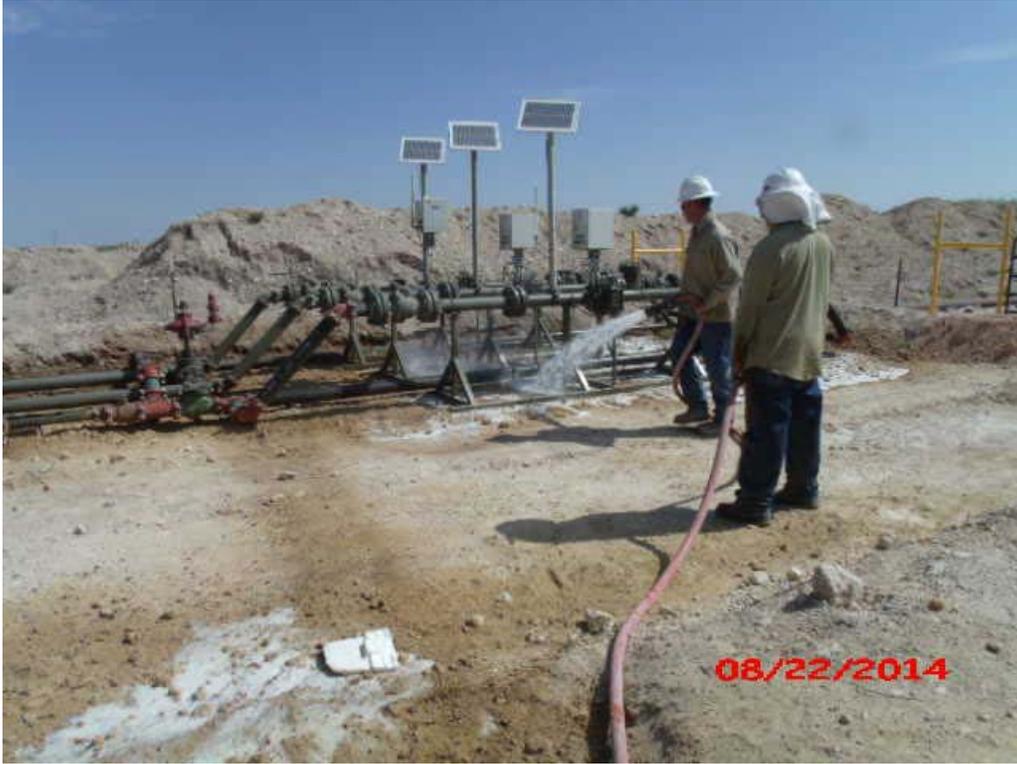
Photograph #13 – Application of Micro-Blaze

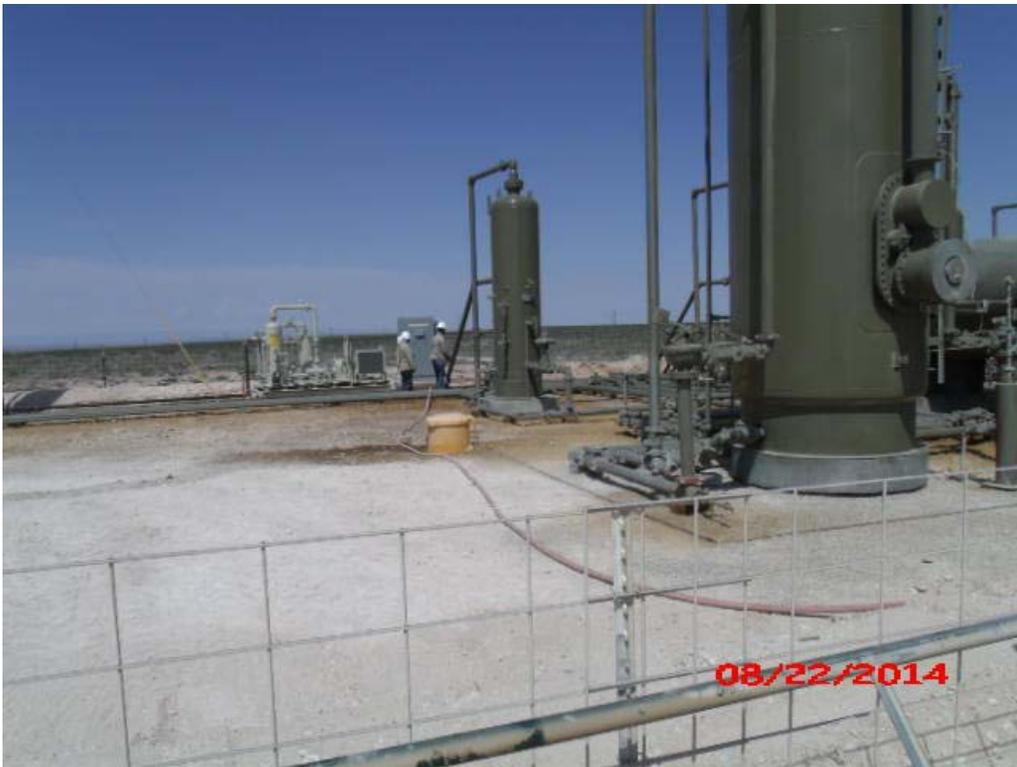
Photograph #14 – Application of Micro-Blaze

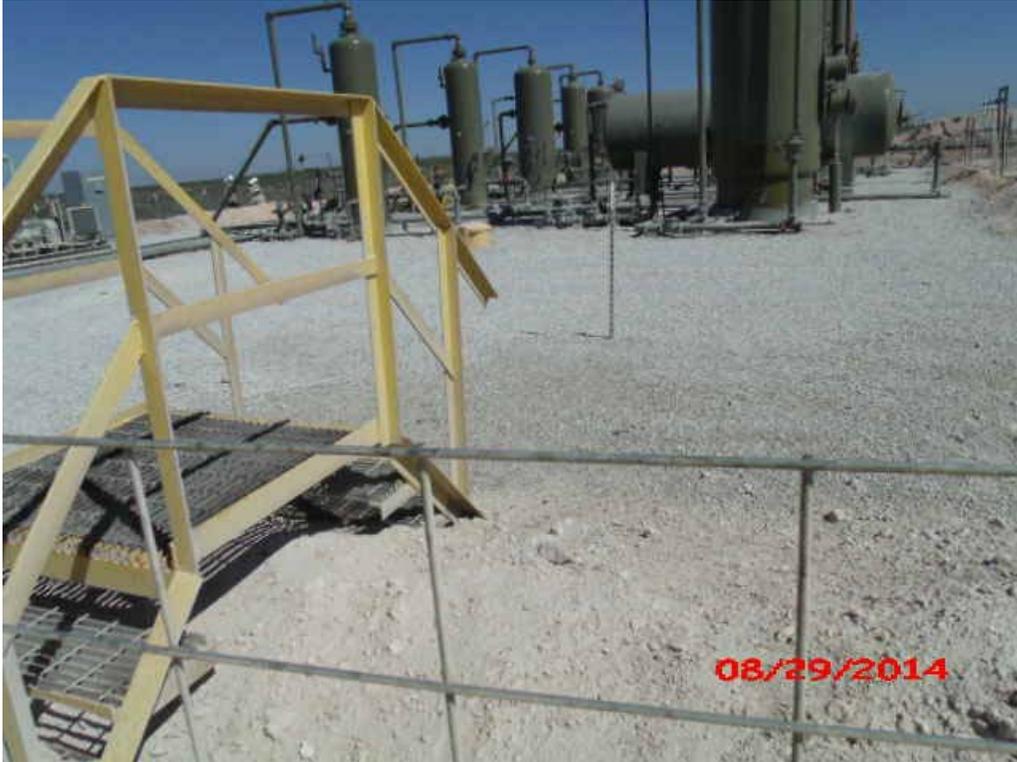
Photograph #15 – Backfilled area

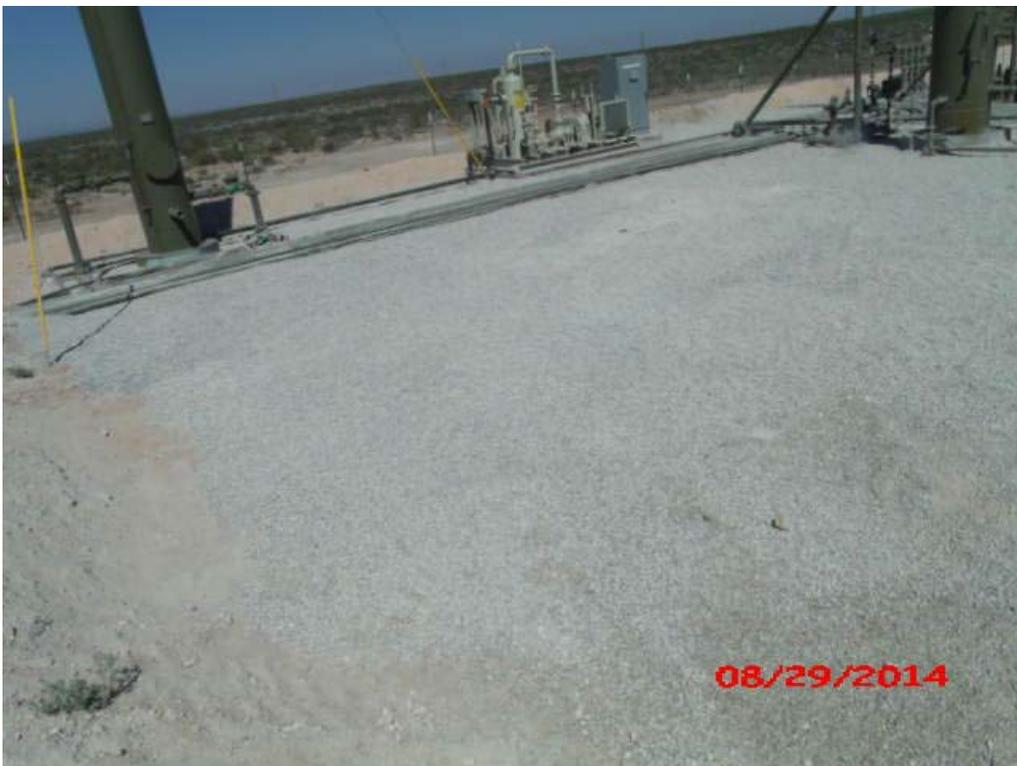
Photograph #16 – Backfilled area

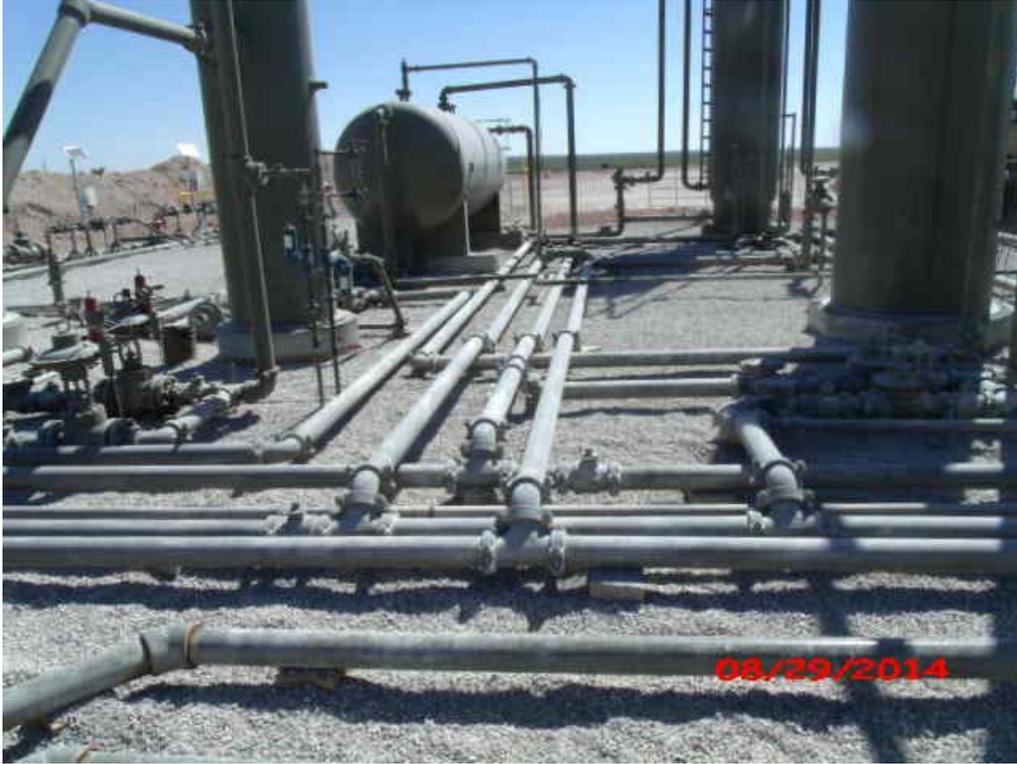
Photograph #17 – Backfilled area

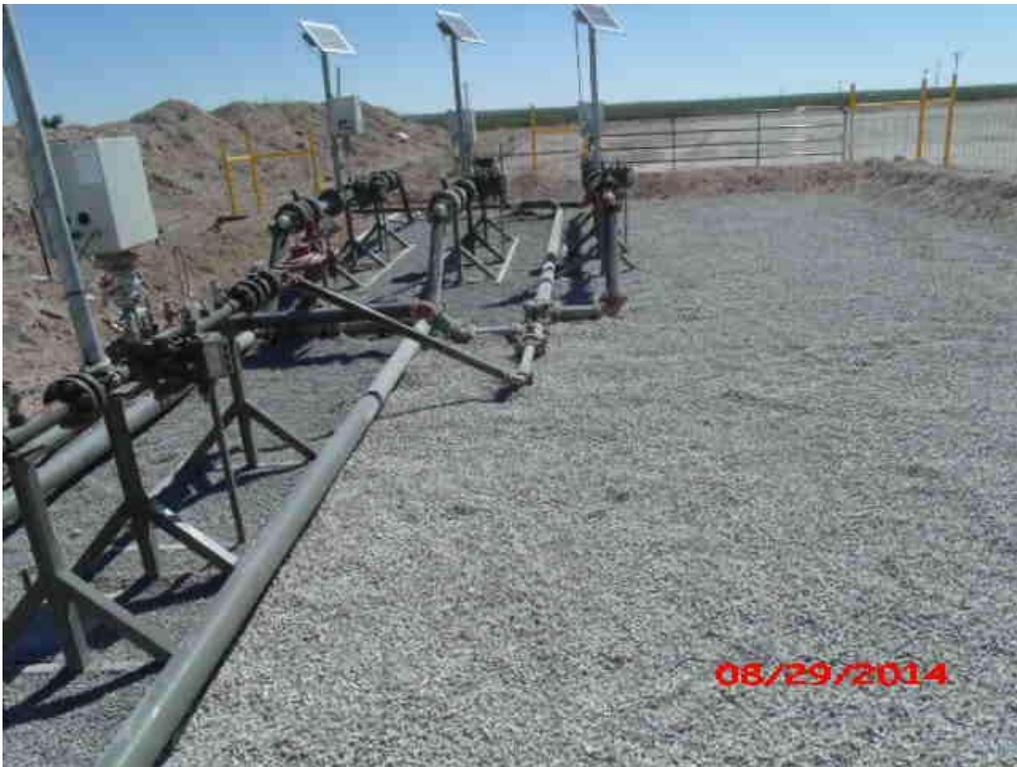
Photograph #18 – Backfilled area

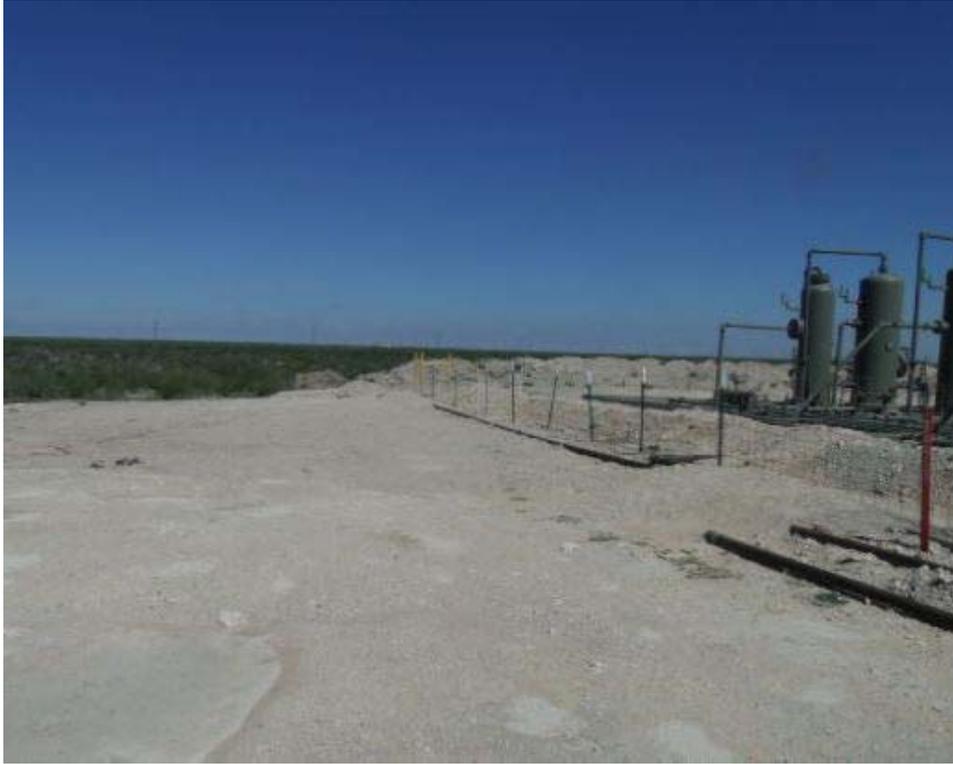
Photograph #19 – Backfilled area

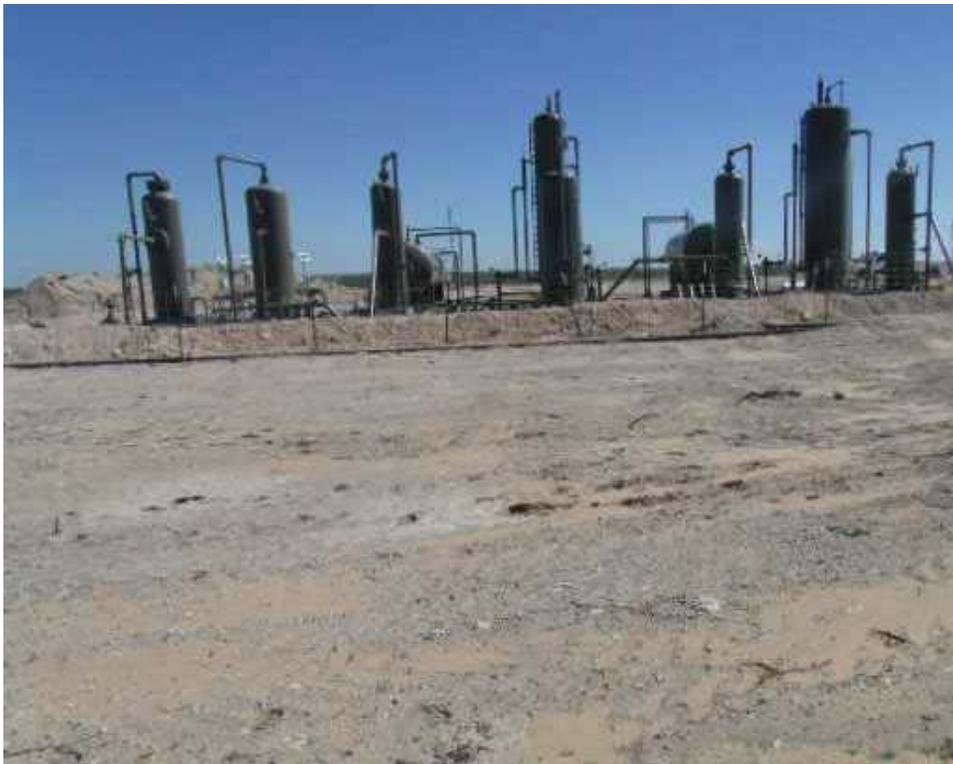
Photograph #20 – Backfilled area
