## **CLOSURE REPORT**

**BOPCO, LP**  
**POKER LAKE UNIT #420H**  
**Eddy County, New Mexico**  
**Unit Letter "P", Section 28, Township 25 South, Range 31 East**  
**Latitude 32.096093 North, Longitude 103.778400 West**  
**NMOCD Reference #2RP-2250**  
**NMOCD Reference #2RP-2487**

RE: Final Closure Report  
Bopco – Poker Lake Unit #420H  
UL-P, Section 28, Township 25 South, Range 31 East  
Eddy County, New Mexico  
NMOCD Reference #'s 2RP 2250 & 2RP 2487

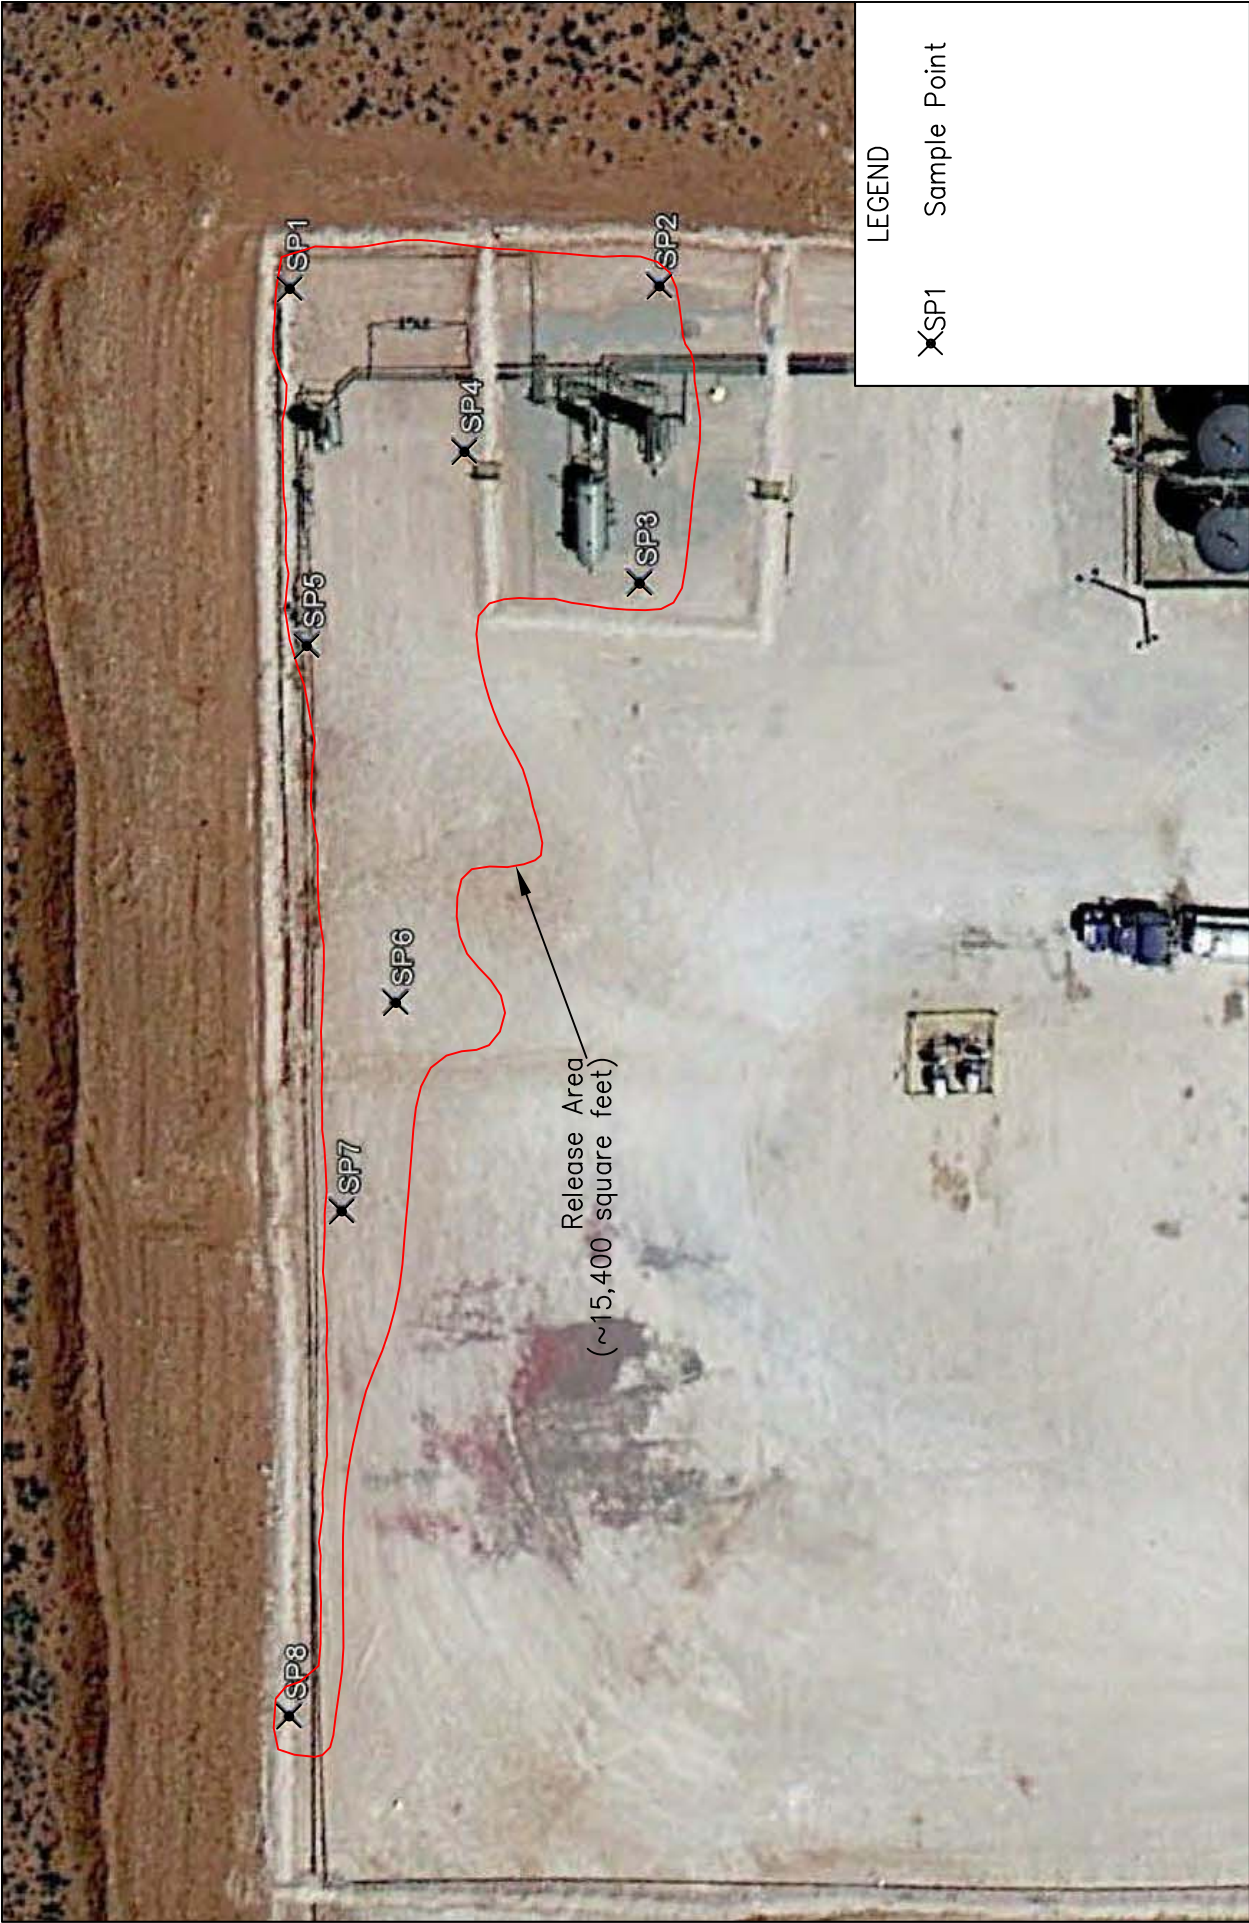
<p>Figure 3 Site/Sample Map Bopco, L.P. Poker Lake Unit #420H</p>		<p>Eddy County, New Mexico SE 1/4 of SE 1/4, Sec. 28, T25S, R31E N 32° 5' 45.94" W 103° 46' 42.24" Elevation: 3,352 feet amsl</p>

EPI personnel mobilized on the site on September 17, 2014 to collect soil samples via sample trenches to determine the vertical extent of contamination. A total of twenty-six (26) soil samples were collected from eight (8) sample locations and sent to Cardinal Labs in Hobbs, New Mexico, for testing. Laboratory analytical results indicate the excavation is void of Benzene, BTEX, and TPH concentrations in excess of NMOCD Recommended Remedial Action Levels (RRALs) of 10 mg/Kg, 50 mg/Kg, and 5,000 mg/Kg, respectively. Laboratory analytical results indicate the excavation contains concentrations of Chlorides in excess of NMOCD RRALs of 1,000 mg/Kg, to a depth of two (2) feet in the areas of SP1, SP4, SP5, SP6 and SP8; to a depth of five (5) feet in the area of SP7, and surface level in the area of SP3. Chloride concentrations did not exceed NMOCD RRALs in the area of SP2 (reference *Figure 3* and *Table 2*).

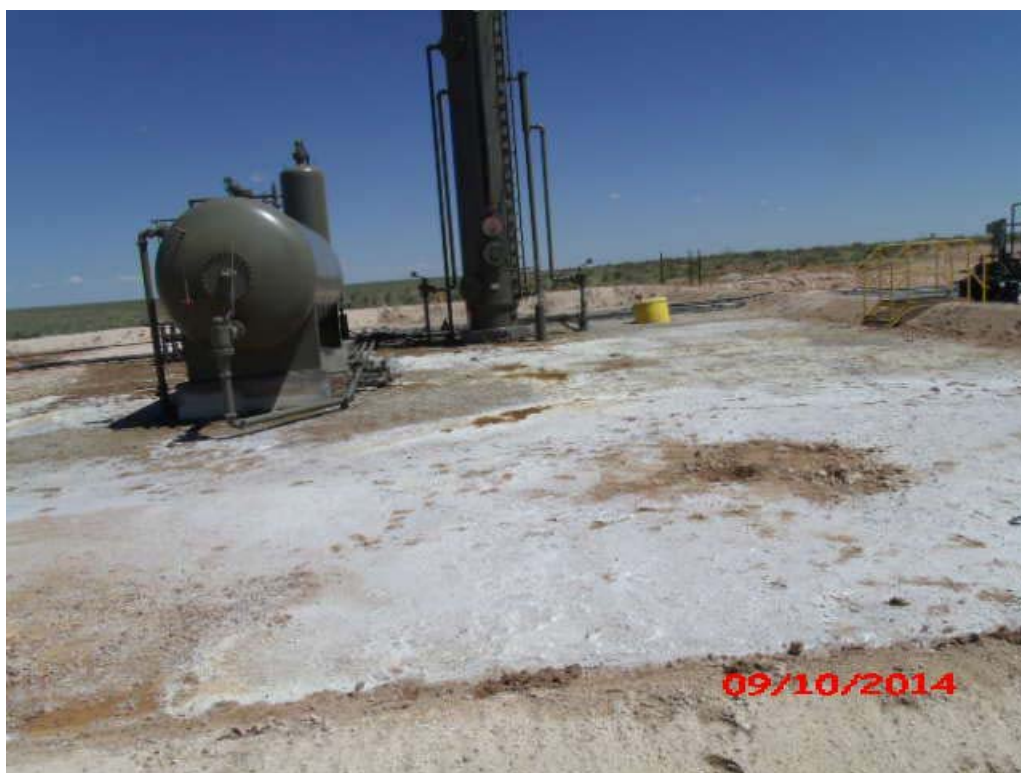
Photograph #2 – Northern view across release area

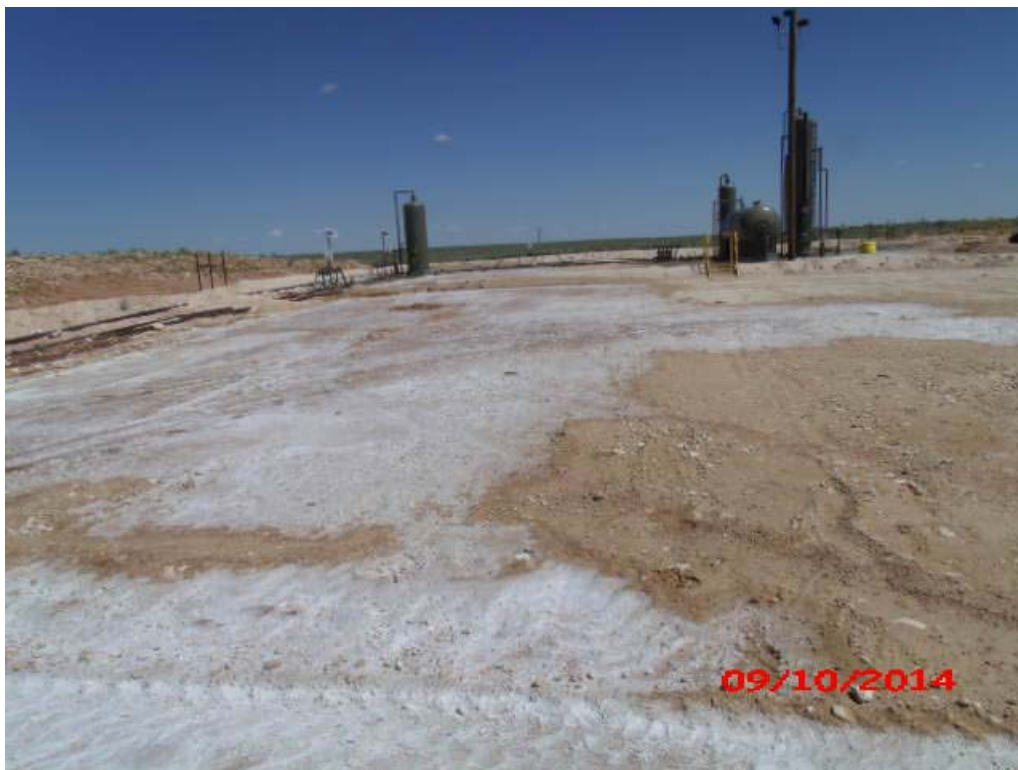
Photograph #3 – Looking easterly across release area

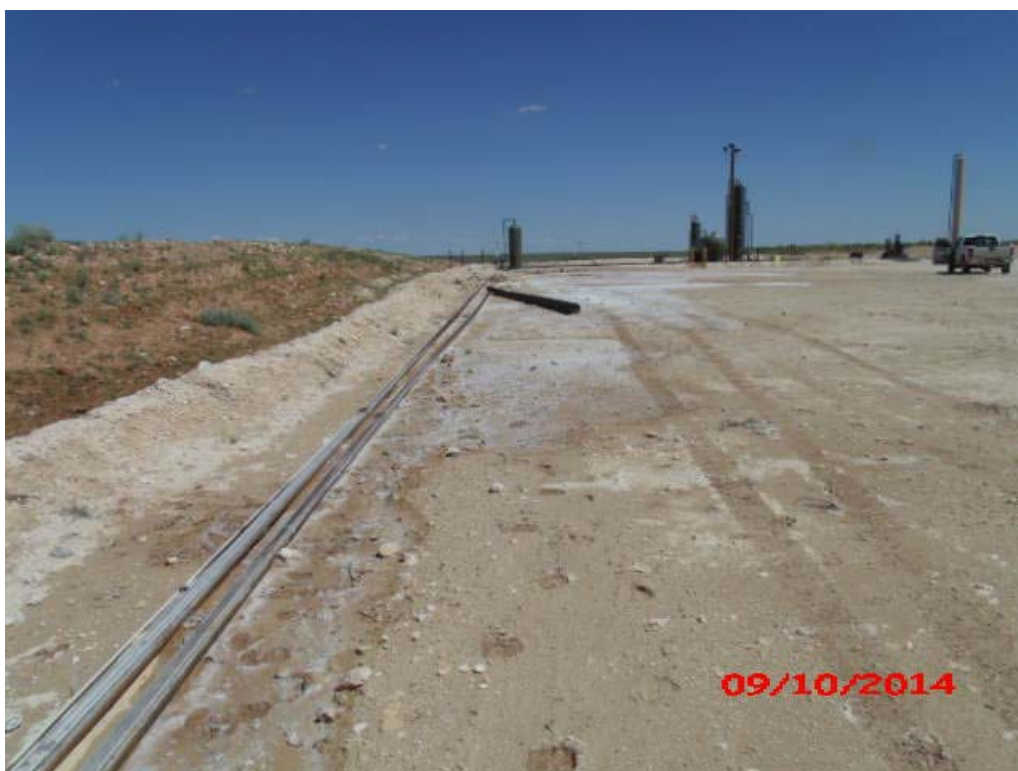
Photograph #4 – Looking easterly across release area

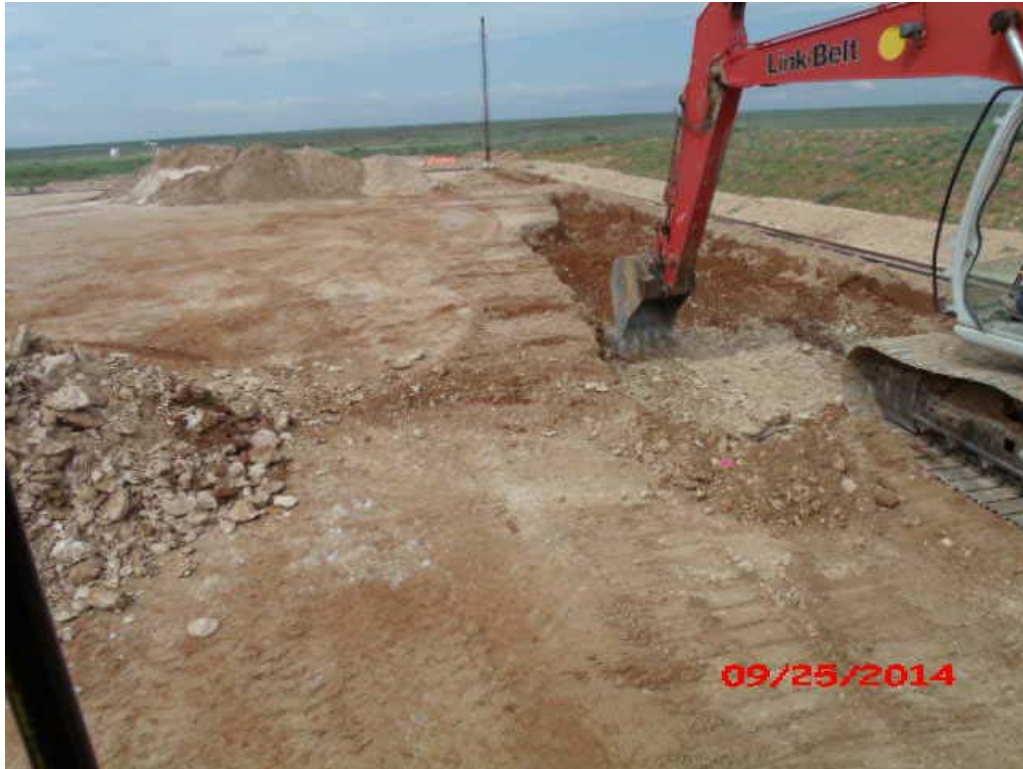
Photograph #5 – North-west view across excavation

From September 23 – October 21, 2014 approximately 1,580 cubic yards of contaminated material were excavated and transported to Lea Land for disposal. The release area was

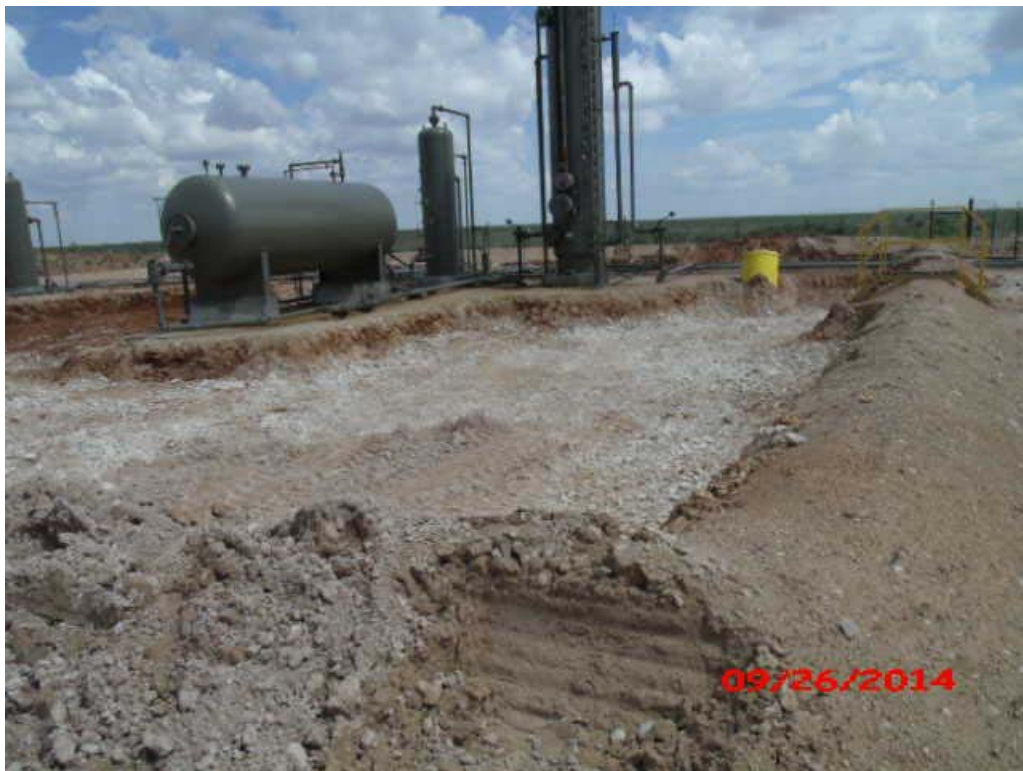
Photograph #6 – Eastern view across excavation

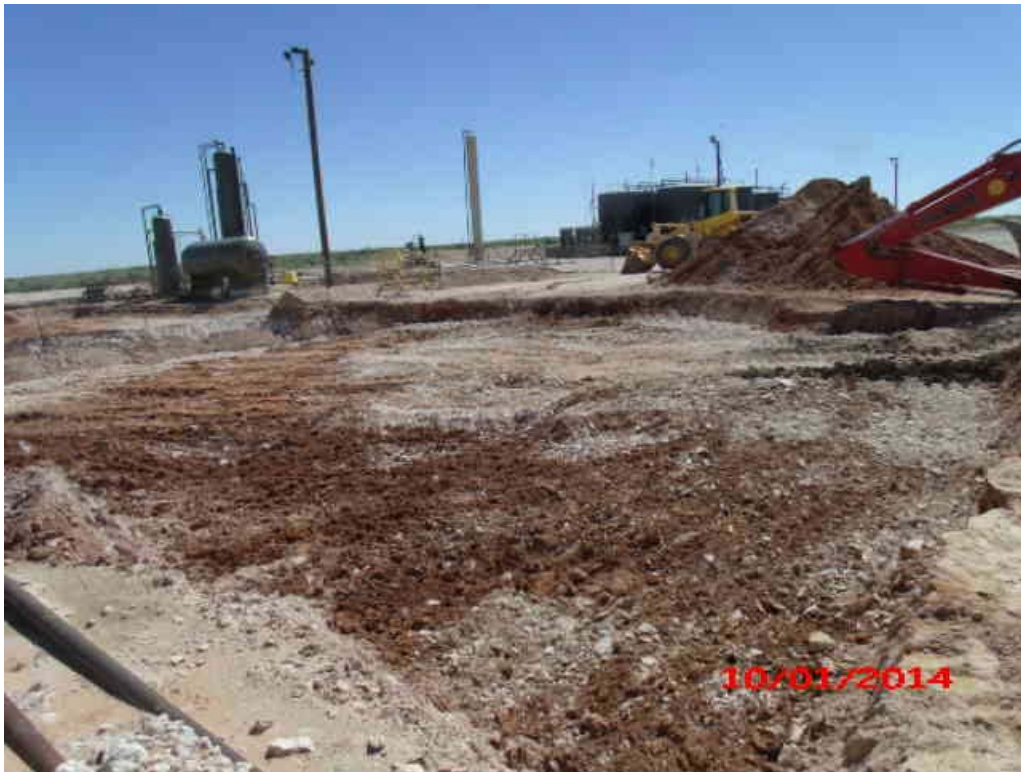
Photograph #7 – South-eastern view across excavation

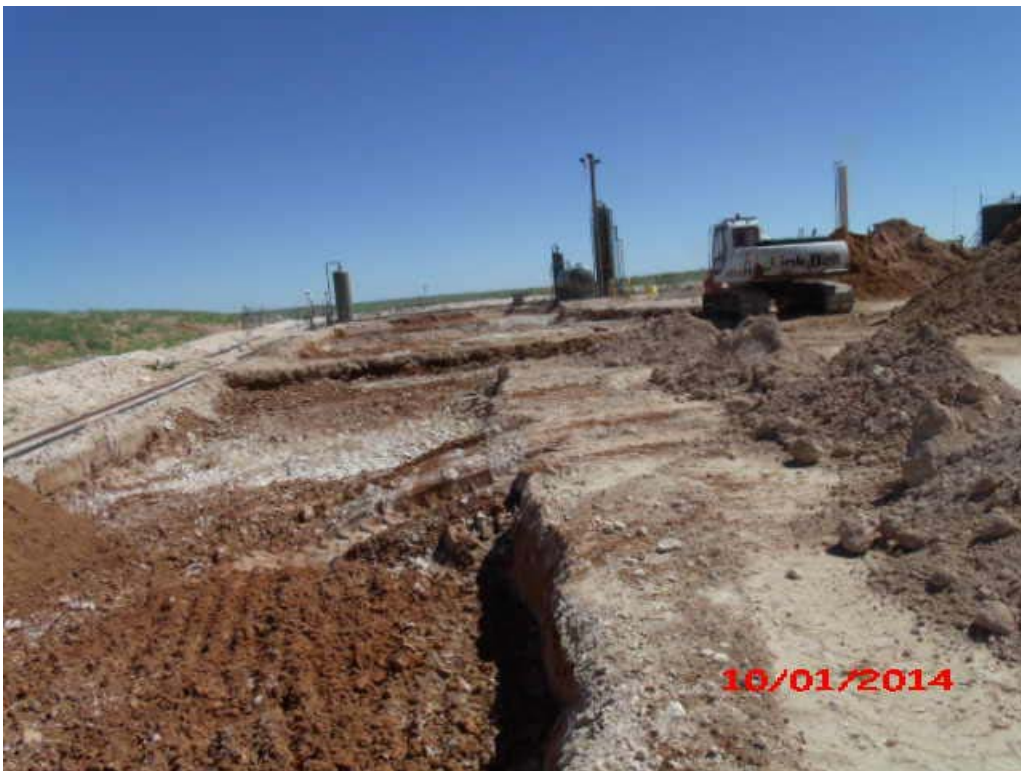
Photograph #8 – Looking east across excavation

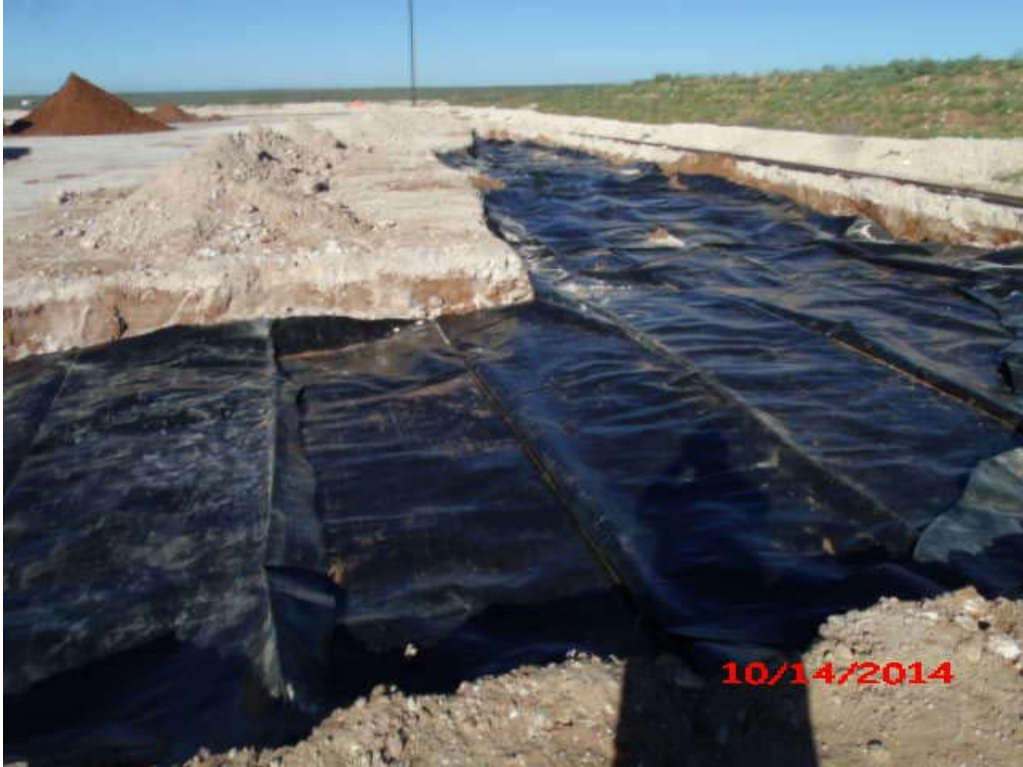
Photograph #9 – Installation of liner

excavated approximately two (2) feet bgs in the areas of SP2, SP3, SP4, SP7, and SP8; approximately three (3) feet bgs in the areas of SP1, SP5, and SP6. On October 14, 2014 a 20 mil polyethylene liner was installed over the area of SP7, mitigating the Chloride concentrations still in excess of NMOCD RRALs. The liner was placed between two (2) one (1) foot cushions of clean soil, free of deleterious material or large clumps.

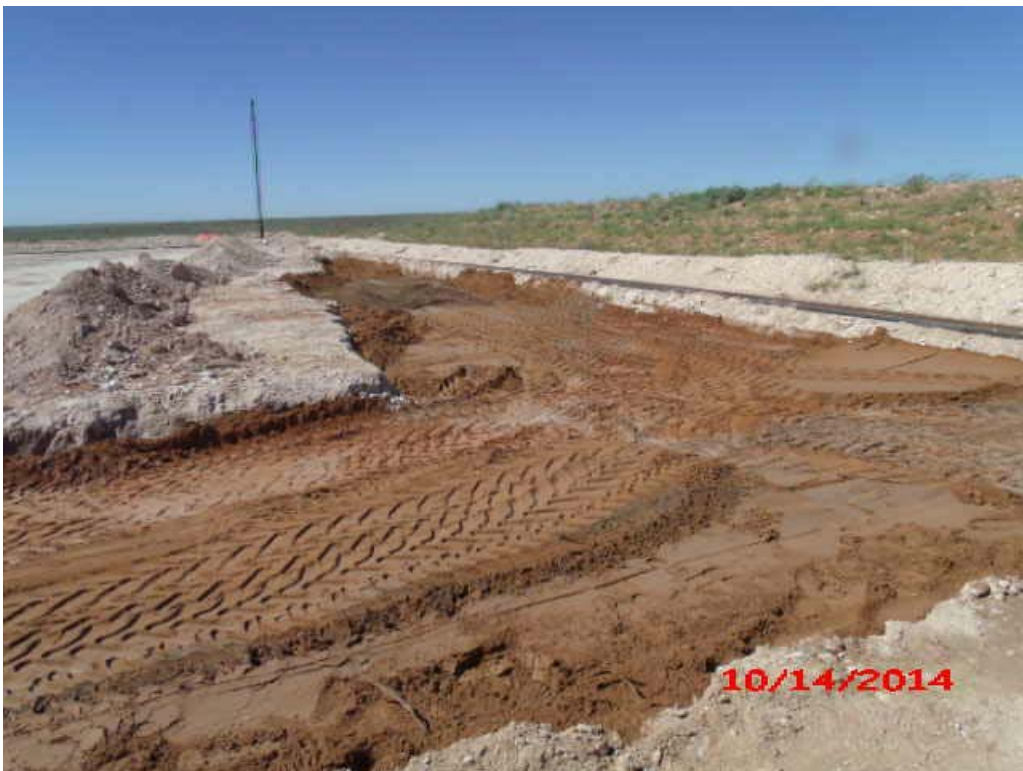
Photograph #10 – Cushion material over liner

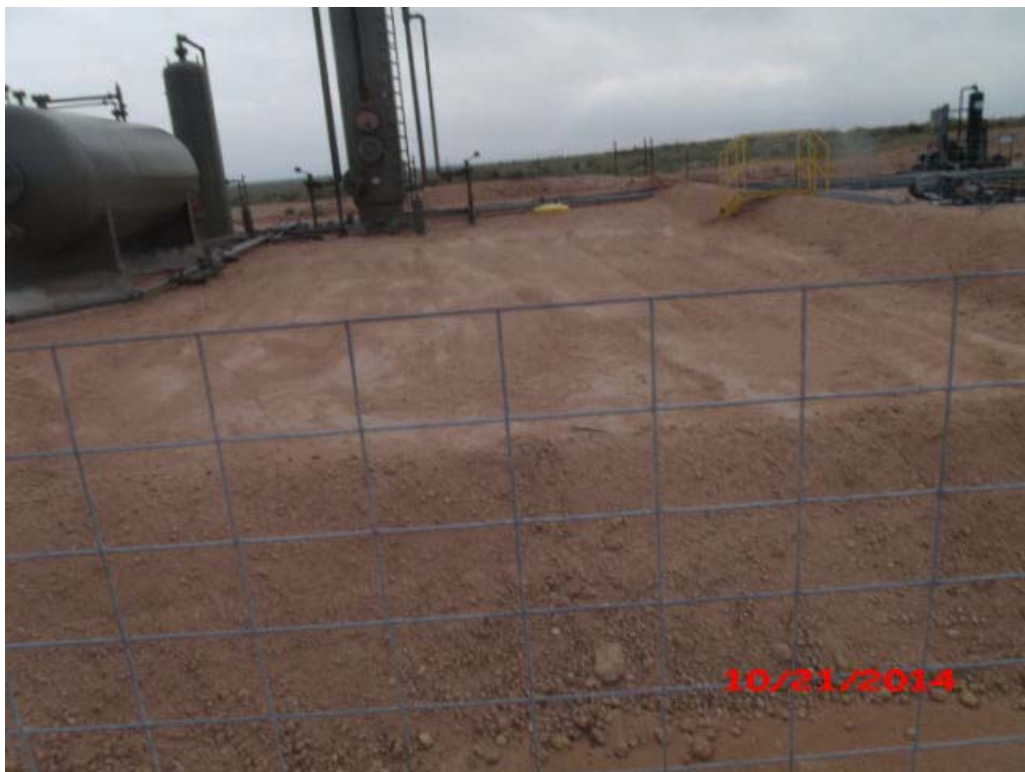
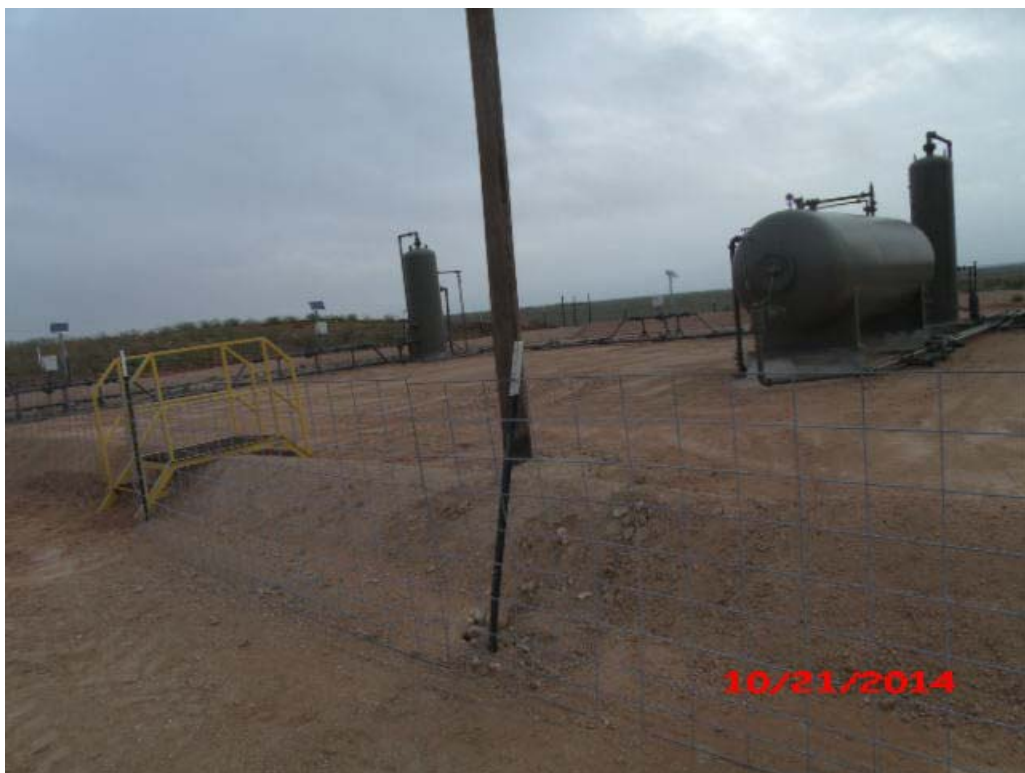
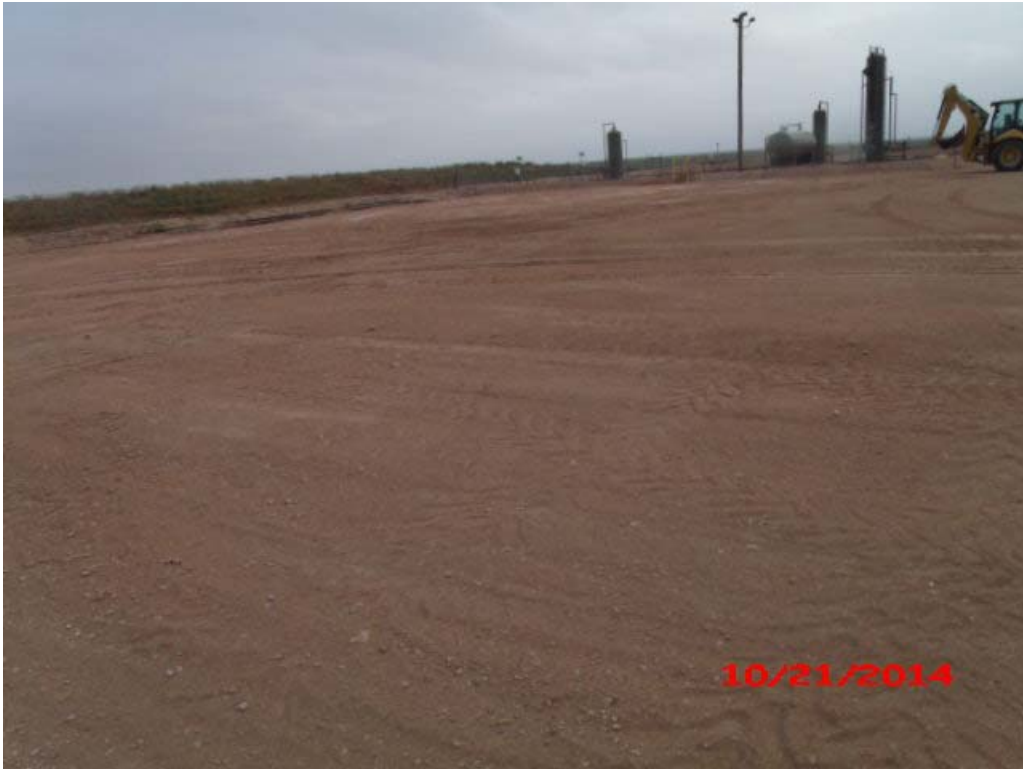
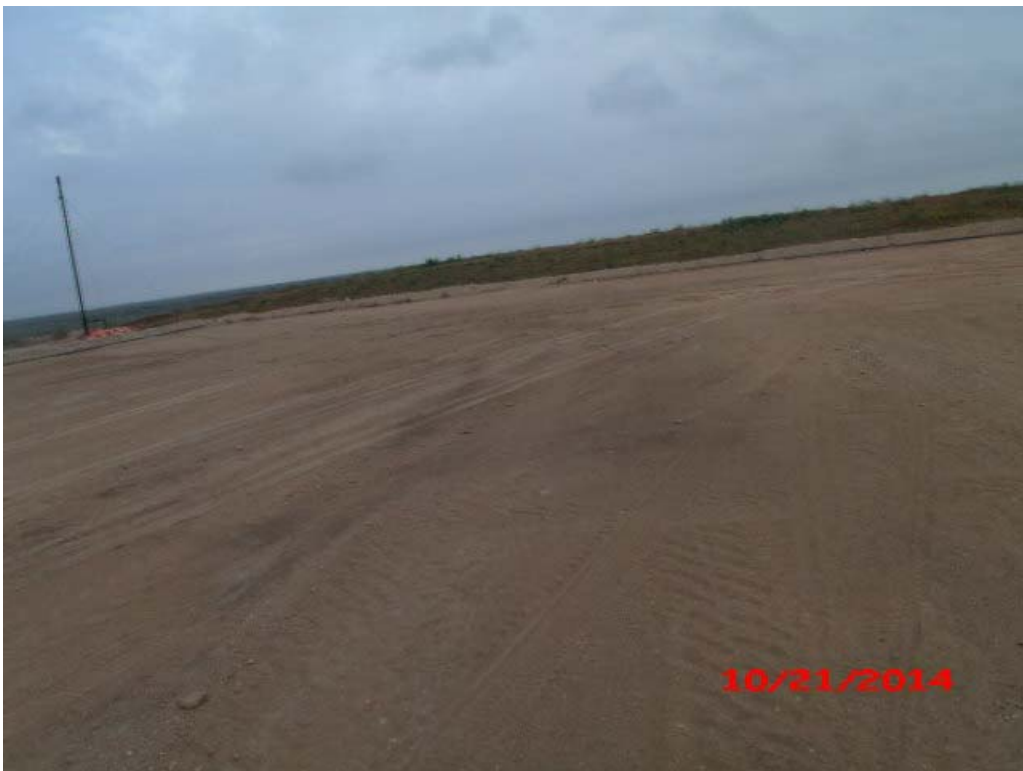
Photograph #11 – Backfilled area

Photograph #12 – Backfilled area

Photograph #13 – Backfilled area

Photograph #14 – Backfilled area

From October 13 – 21, 2014 the excavation was backfilled with approximately 1,024 cubic yards of caliche, 538 cubic yards of topsoil, and 148 cubic yards of chat. The entire disturbed area was then contoured to blend with existing pad to protect against wind/water erosion.
