General Information

Client: LINN Energy

Site Name: Barclay State Battery

Remediation Activity Summary

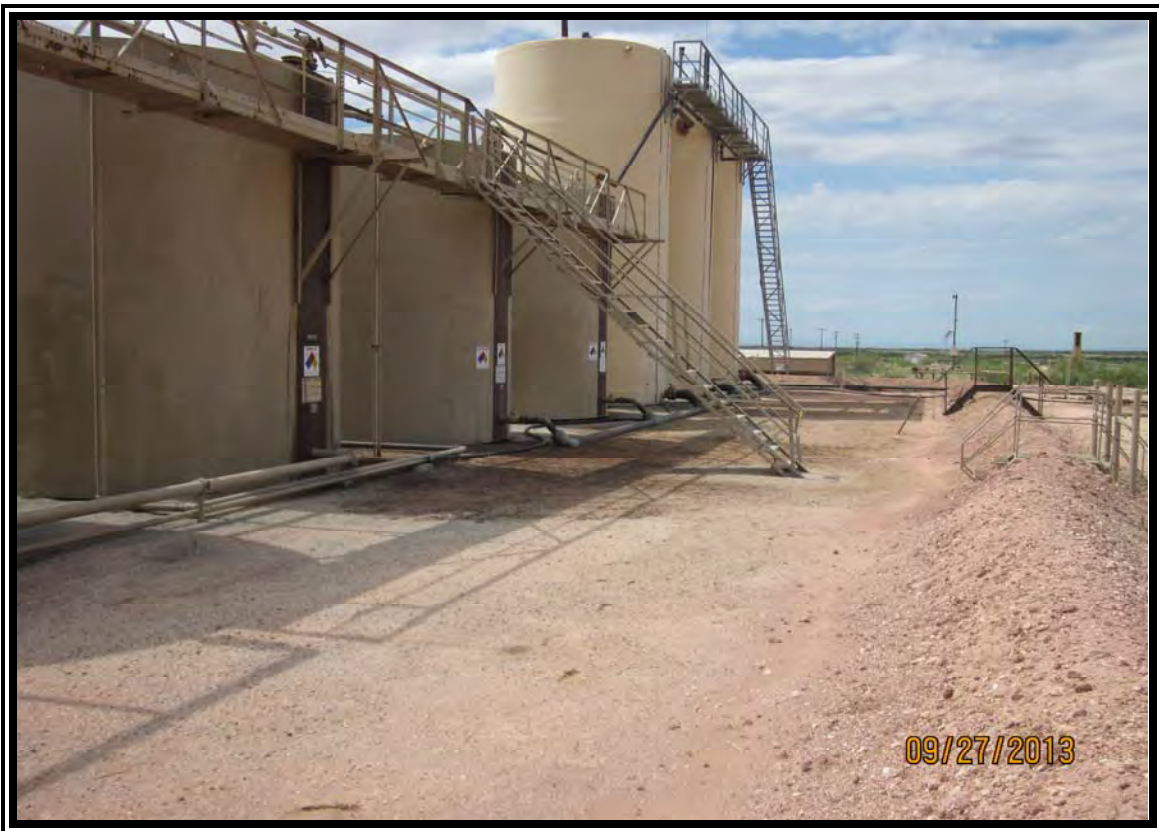
North side of the battery before excavation.

The impacted area on the north side of the tanks, SP1, SP2, SP3 (approximately 146' by 25') has been excavated to a depth of 3 feet vertical. Around the tanks and on the south side of the tanks, SP4, SP5, SP6 (146' by 6') due to safety reasons, the excavation is at a depth of 8". There are numerous lines and an electric pole within the confines of the south side of the excavation. Also, the area between the tanks and the road is approx. 6'. The bottom of the excavation still has elevated levels of chlorides ranging from 5840 to 5640 mg/kg. The proximity of the tanks, lines, and electric pole has restricted further excavation due to safety concerns. Two (2) soils borings via hand auger were advanced within the bottom of the excavation to attempt to delineate the vertical extent of the impact. Refusal was encountered at 4' for SP4 (5840 mg/kg) and 10' for SP5 (112 mg/kg). The chlorides were still above regulatory threshold levels at SP4.

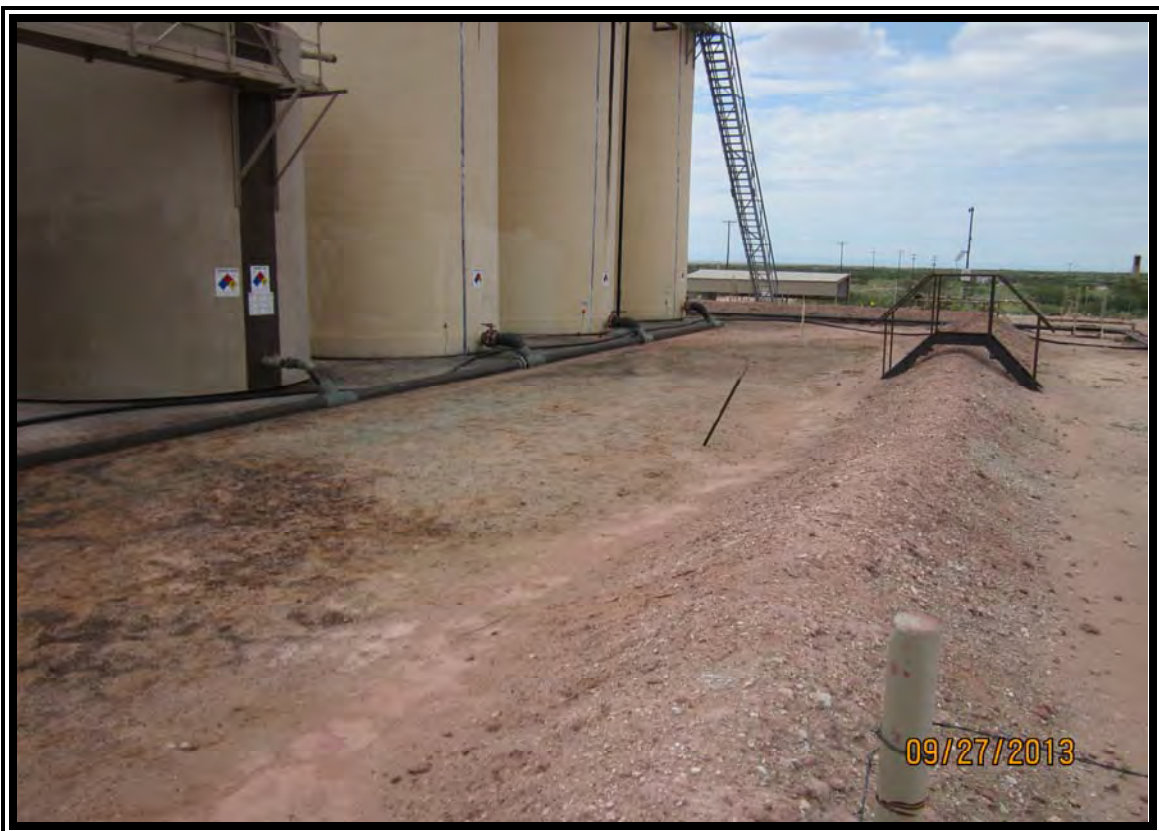
North side of the battery before excavation.

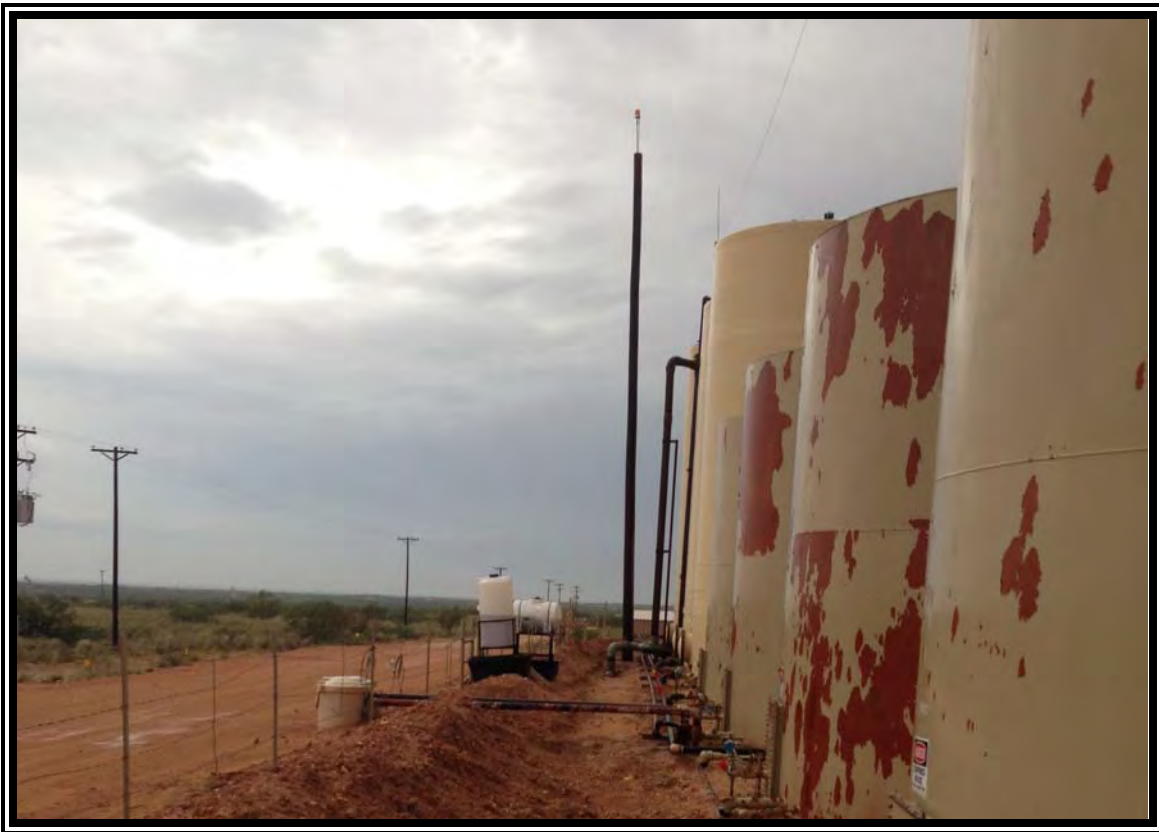
South side of the battery during excavation.

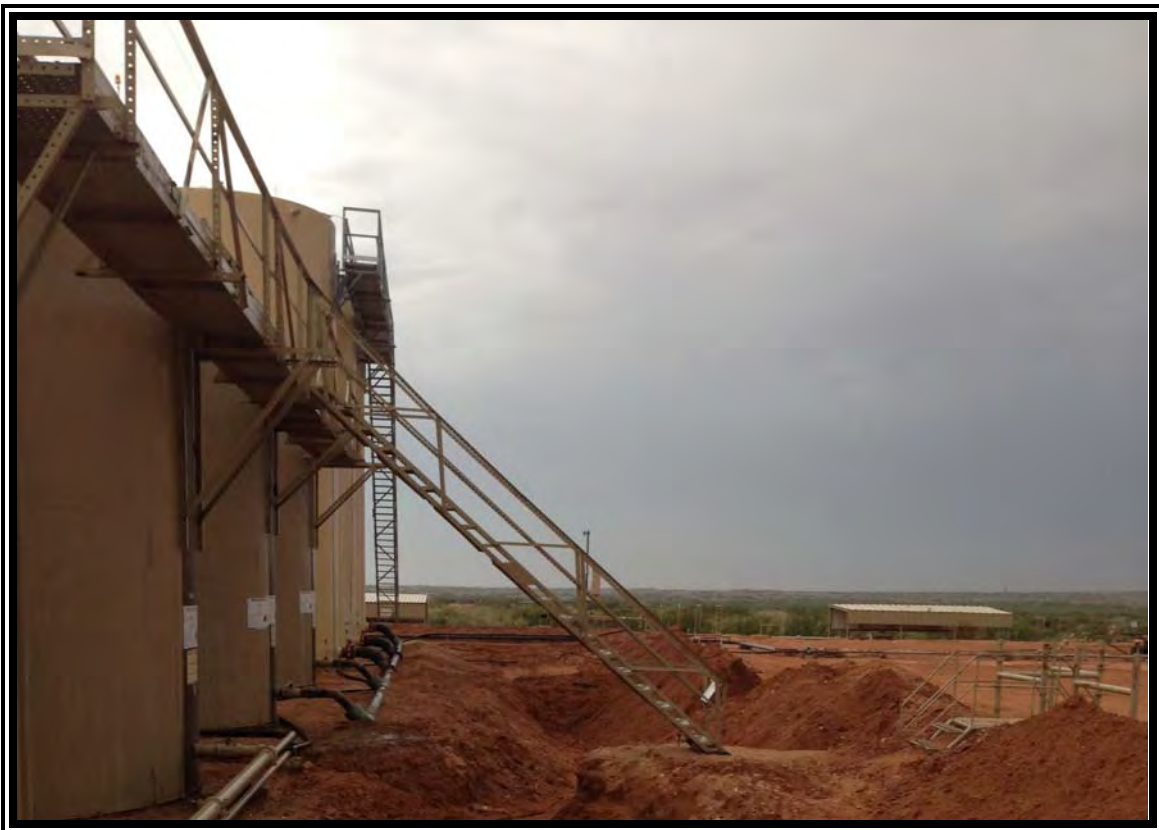
North side of the battery during excavation.

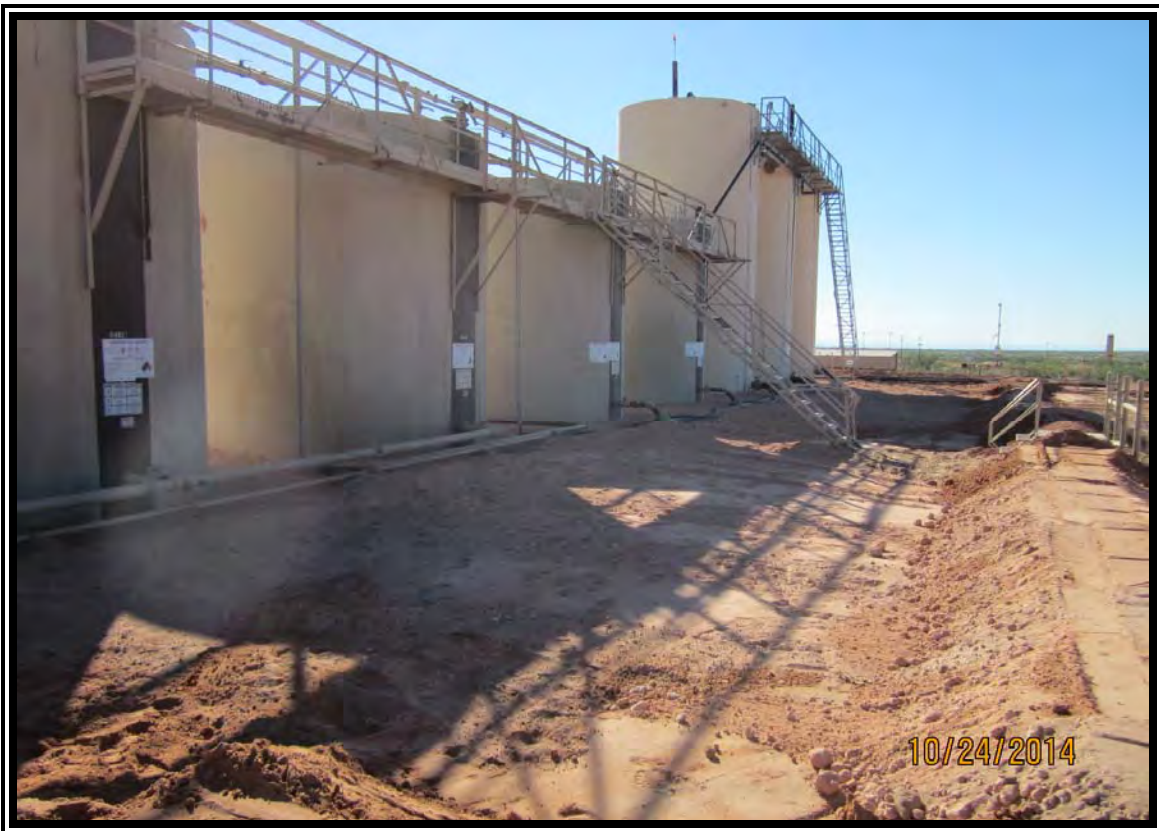
North side of the battery after backfill.

Impacted soils above regulatory threshold levels were manually and mechanically excavated from the spill area. Impacted soils were transported off-site to Lea Land Landfill. Once the impacted soils were removed to acceptable levels, the production pad and pasture areas was backfilled with like materials and smoothed to grade.

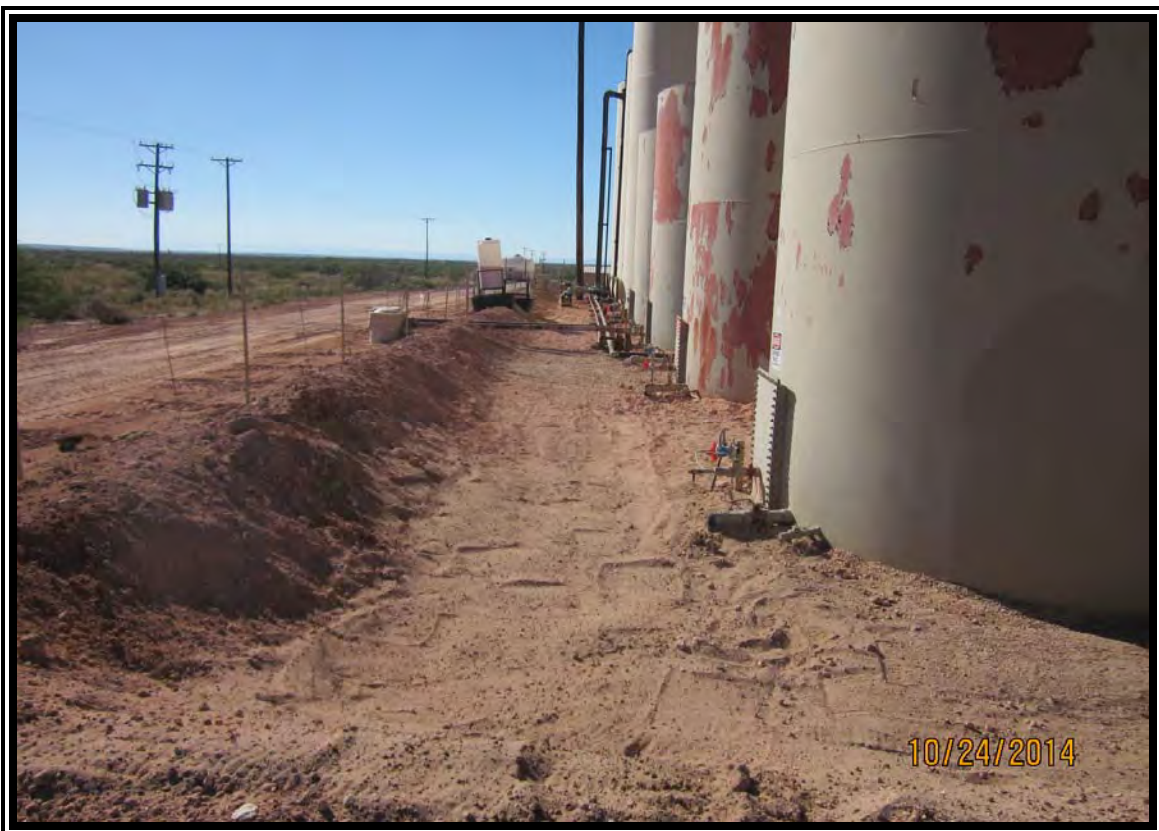
South side of the battery after backfill.

The area that was still high in chlorides is too shallow for a plastic liner or a gypsum liner to be effective, so the area was backfilled and compacted with caliche per OCD.

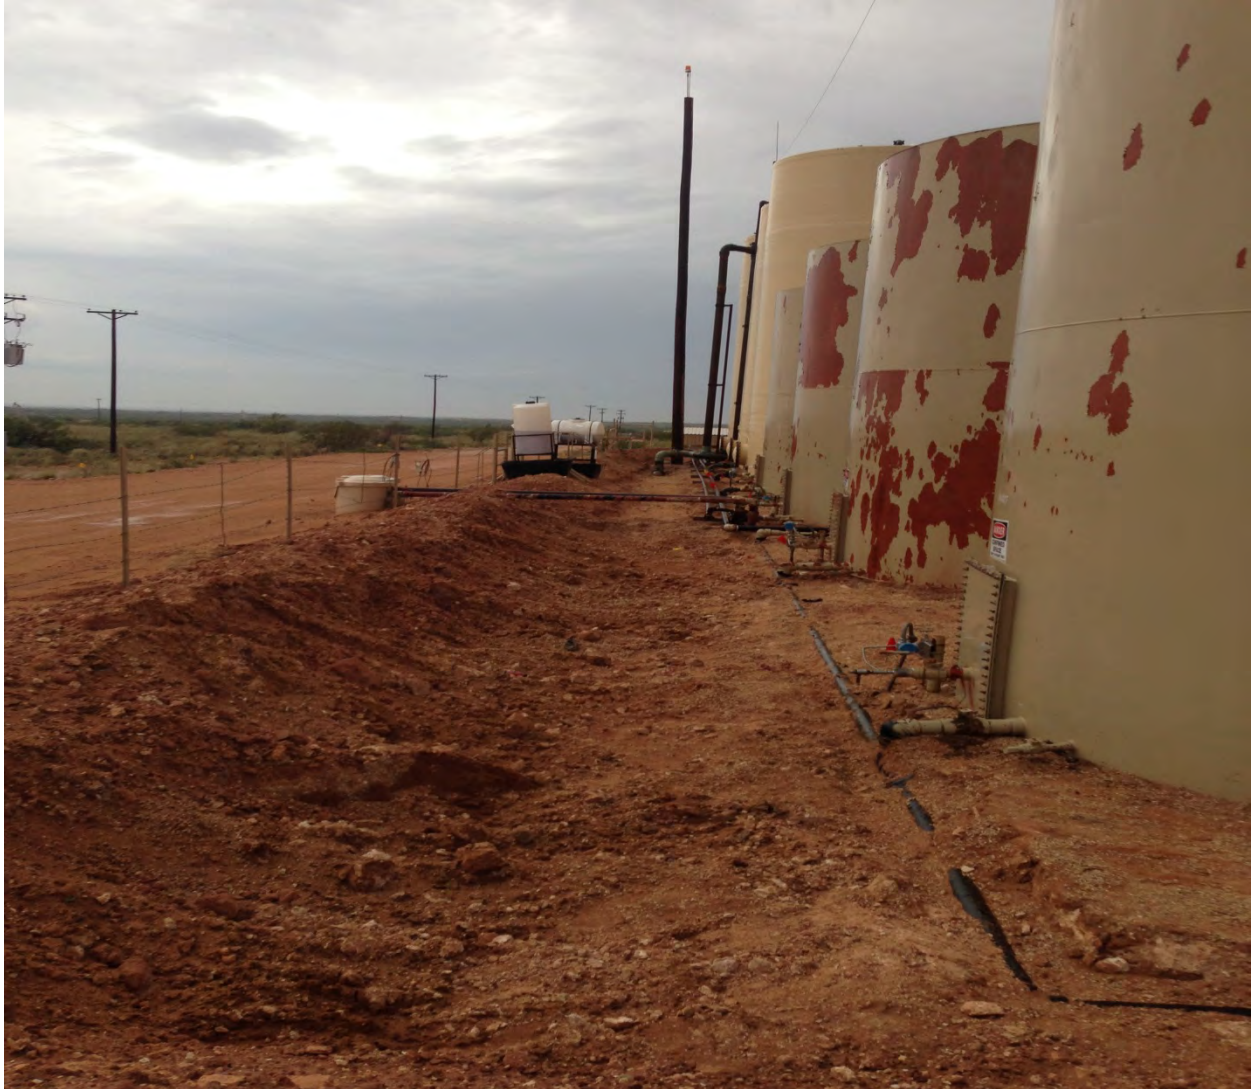
A photograph of the site is provided below:

chlorides were still above regulatory threshold levels. The results of the laboratory analysis of samples collected from the bottom of the soil borings are attached.

LINN is proposing an amendment to the corrective action to this site. The factors used to determine this corrective action include first the safety of all persons related to performing additional excavation within the site. In addition, based upon available data, groundwater in the area is believed to be in excess of 150 feet. The corrective actions evaluated for the site (based upon the above) are presented as follows:
