FINAL REPORT SUMMARIZING CLOSURE FOR INCIDENTS 2RP-2459 & 2RP-2555

MEWBOURNE OIL COMPANY
BLACK LAKE# 5 PA STATE COM #1H
API# 30-015-41124
SECTION 5, T25S R28E, NM
EDDY COUNTY, NM

January 20, 2014
Reference 5B23439 BG2

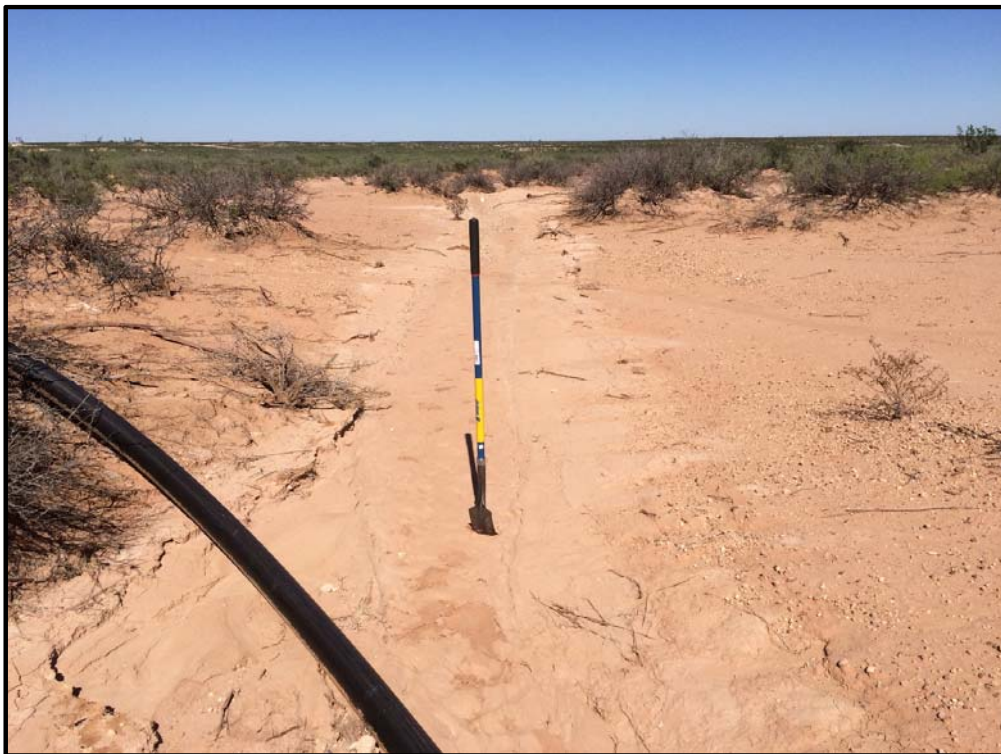
Affected pasture
before excavation
taken on 10/02/14

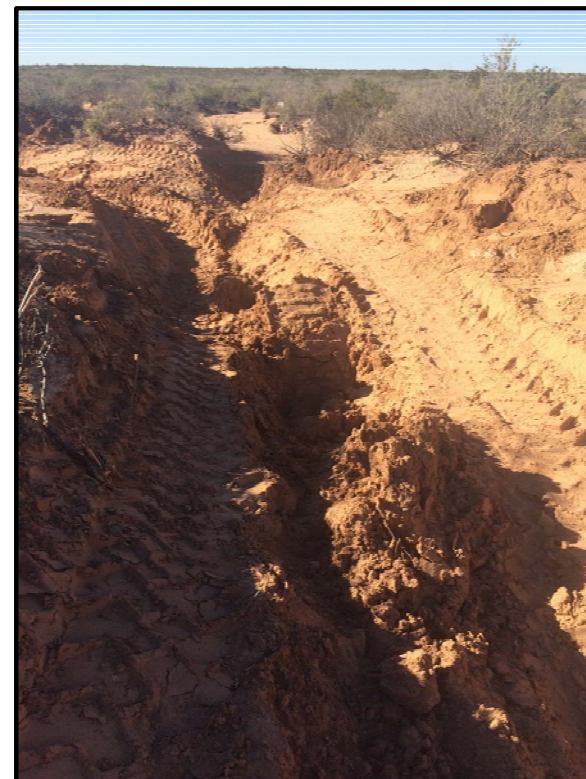
Excavation in pasture
taken on 11/26/14

Initial soil sampling was conducted for the spill on 8/24/14 (Analytical Report- 1409358) included in Appendix A. A second spill occurred on 10/13/14 and sample were taken shown in Table 1. The well pad excavation included removing affected soil from one to three feet between the tank farm and pump jack. For the pasture, delineation was determined in depth of two and a half feet confirmed with samples. See Table 1 for sample results. The pasture excavation removed the affected soils down two and a half feet. After the affected material was removed on the well pad new caliche was back filled to previous grade. In the affected area in the pasture no material was backfilled do to a small arroyo where exaction occurred. This area was contoured as close to the previous condition as possible. Further excavation to three feet in depth was done at sample location 5 seen in Figure 2. Heavy equipment was utilized to remove and transport all affected soil and wastes of location to NMOCD approved disposal facilities. The contaminated soil was removed and hauled off. See Appendix C for waste manifest tickets. Then the excavated area was raked smooth.

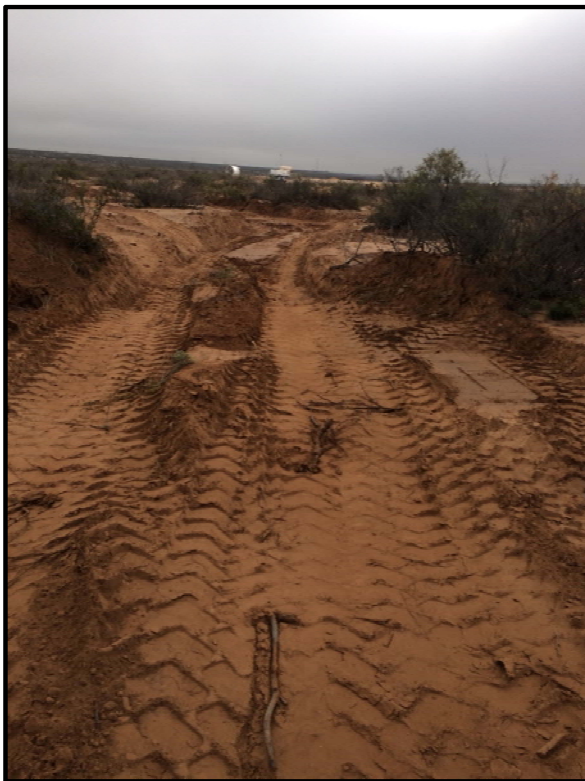
Pasture after
excavation taken on
12/12/14

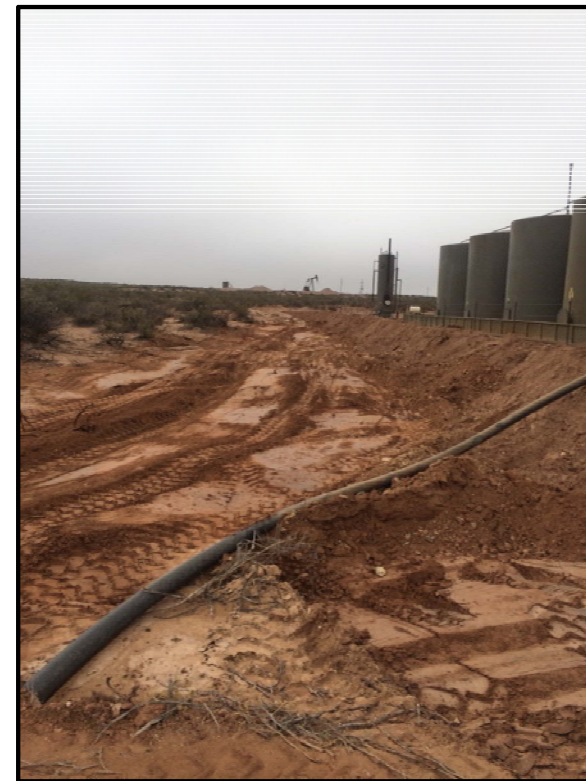
Pasture behind tank
battery taken on
12/12/14
