**RE: Termination Request
Burnett Oil Co. – Jackson B-5 Gas Line (2RP-2243)
UL/L sec. 13 T17S R30E
API No. 30-015-32793**

- Figure 1 – Initial Sampling Data
- Figure 2 – Proposed Corrective Actions
- Figure 3 – Excavation Map
- Appendix A – Initial C-141
- Appendix B – Initial Sampling Labs
- Appendix C – Imported Top Soil Lab
- Appendix D – Photo Documentation
- Appendix E – Final C-141

**BURNETT
JACKSON B-5
GAS LINE**
UL L SECTION 13
T-17-S R-30-E
EDDY COUNTY, NM

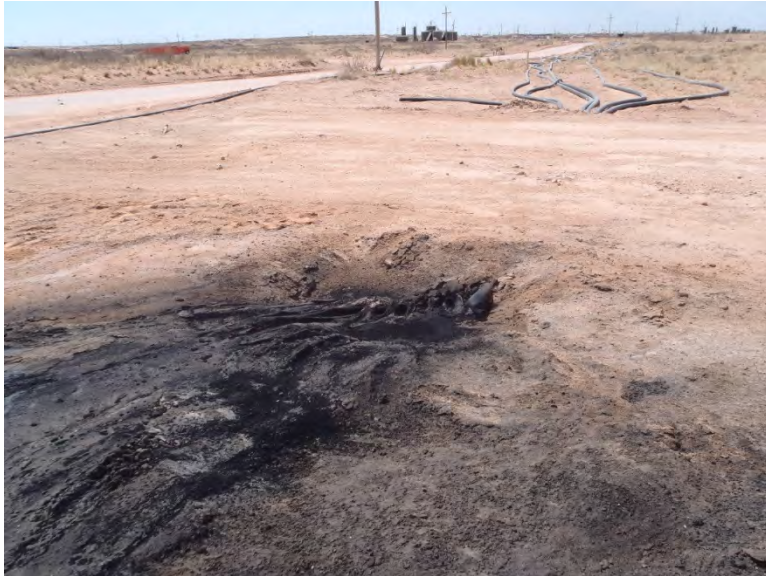
Source of release, facing southwest

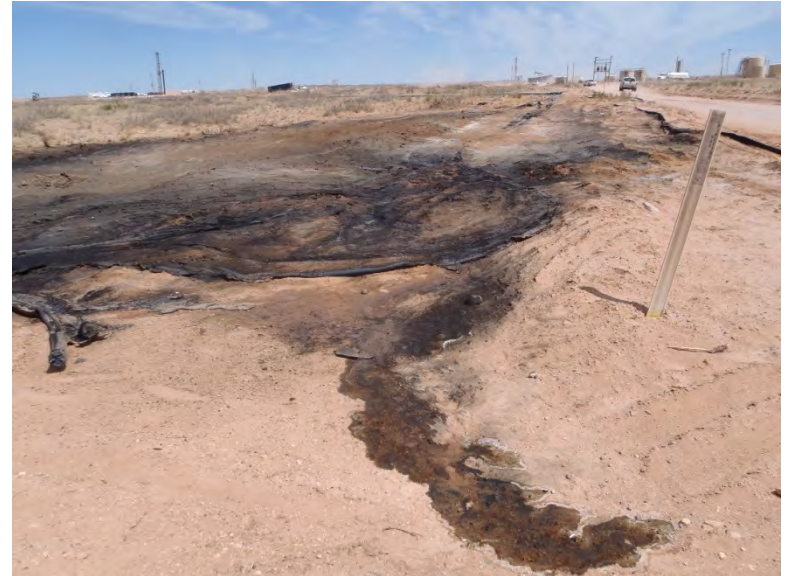
Initial release area, facing northeast

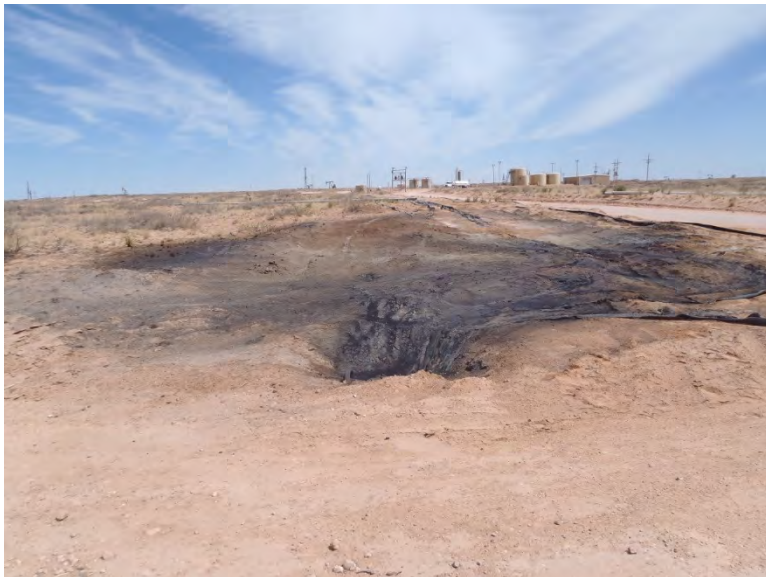
Initial release area, facing east

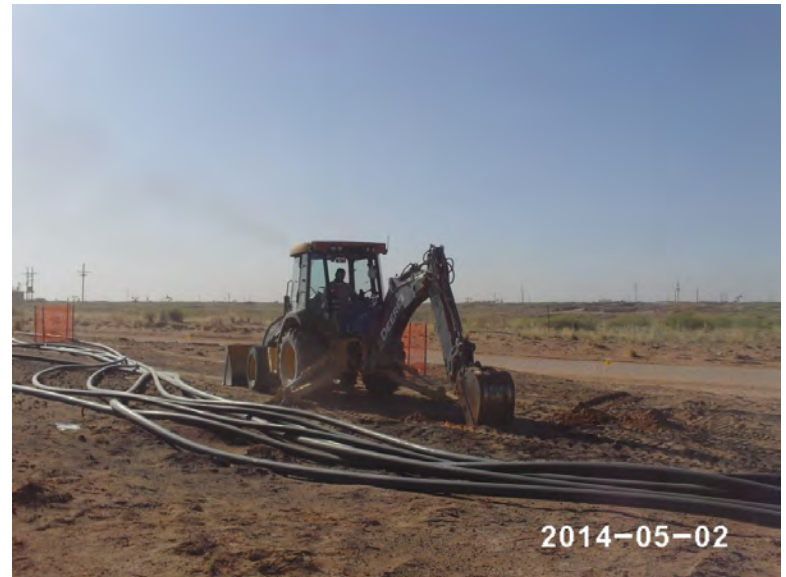
Installing the vertical, facing southeast

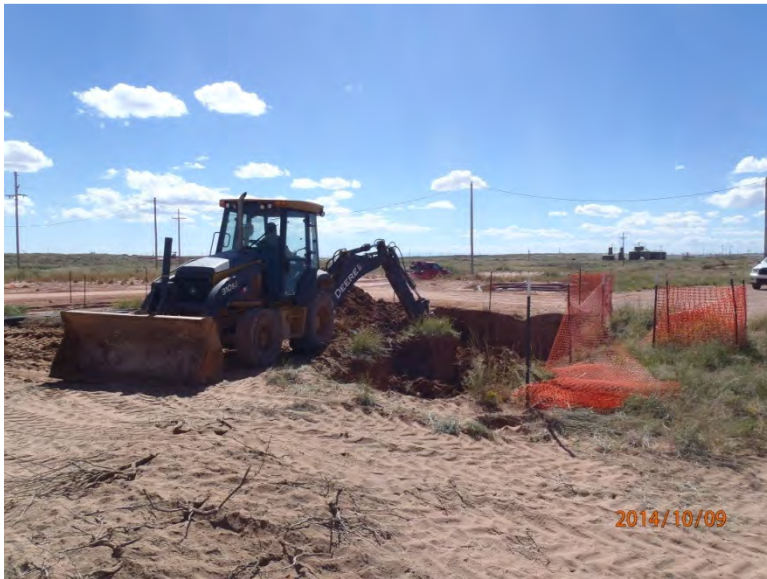
Excavating, facing southwest

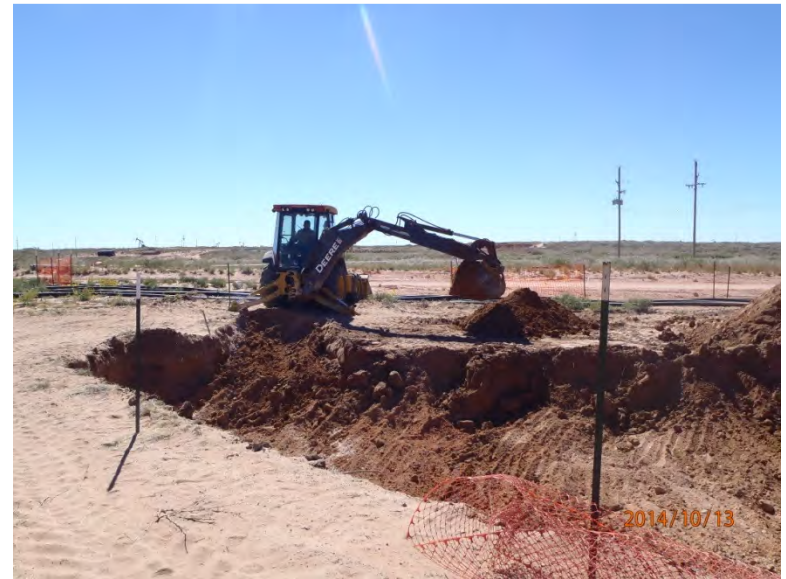
Continue excavating, facing southeast

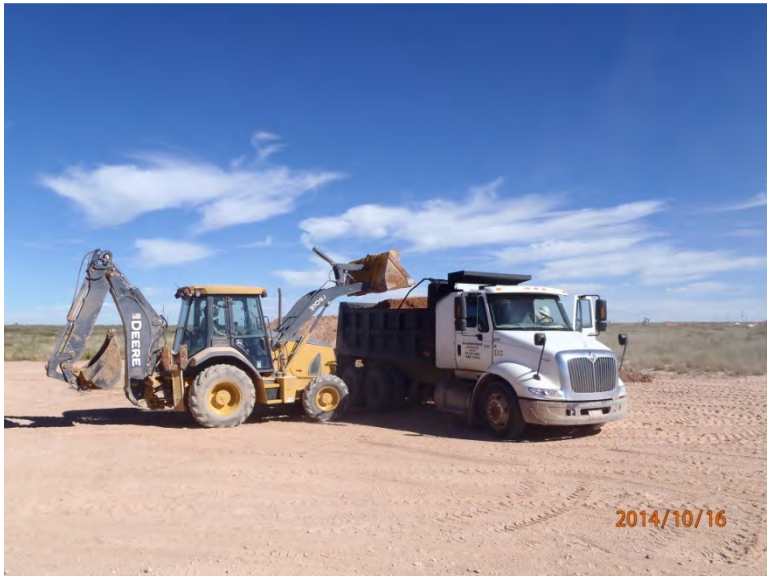
Exporting soil, facing northeast

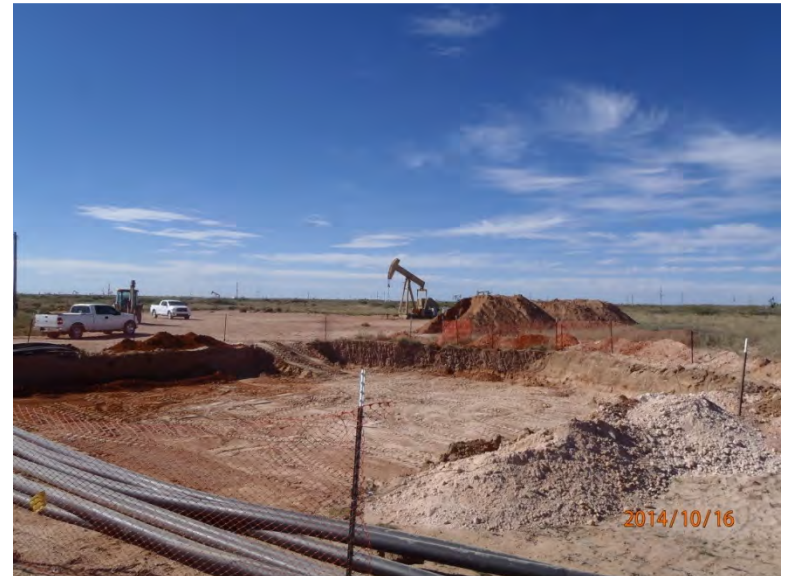
Excavation completed, facing northwest

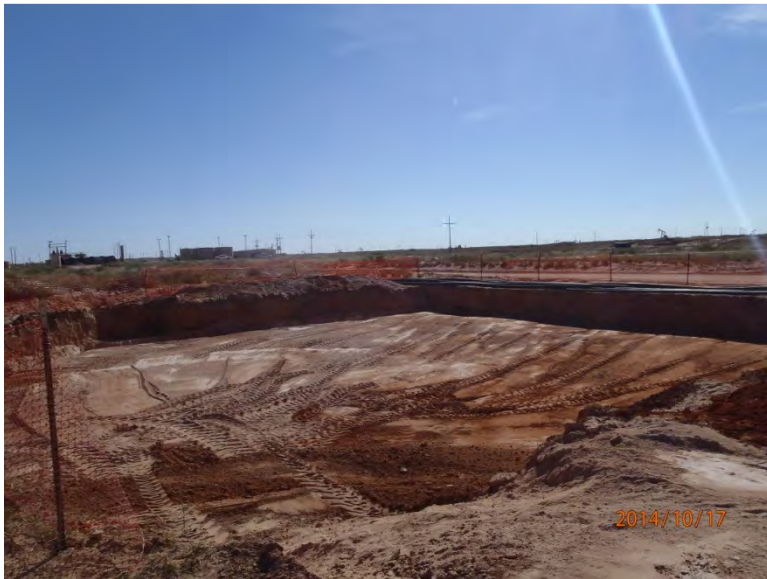
Excavation completed, facing southeast 10/17/14

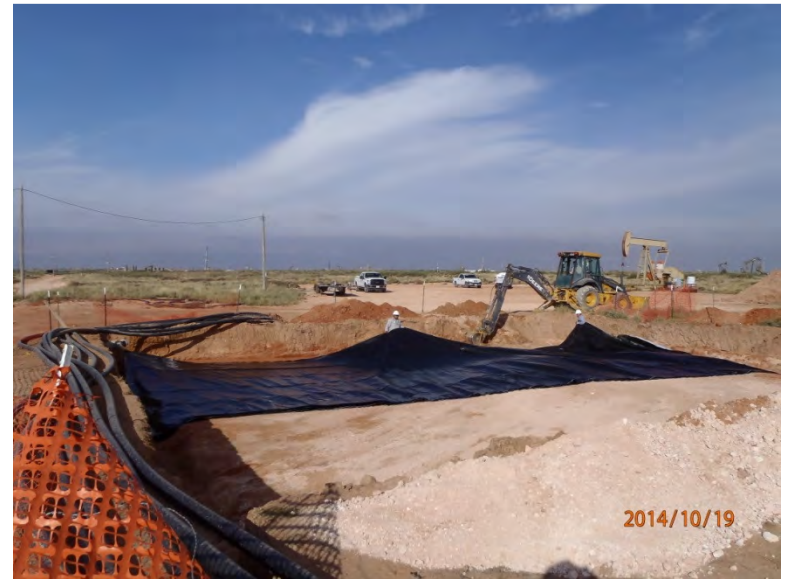
Installing liner, facing west 10/19/14

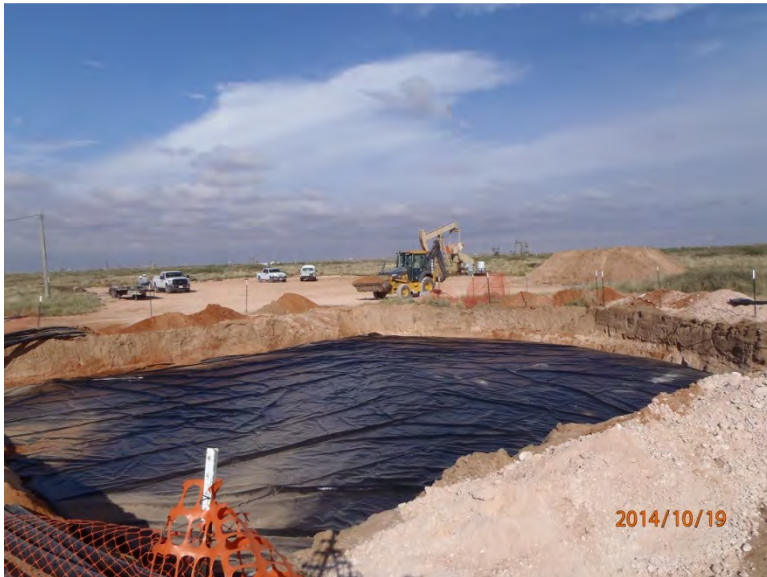
Key set of liner completed, facing northwest 10/19/14

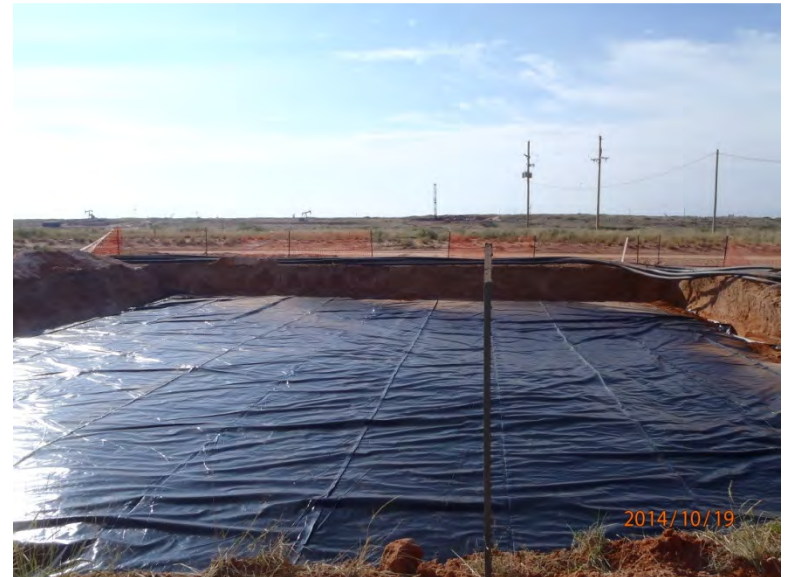
Key set of liner completed, facing south 10/19/14

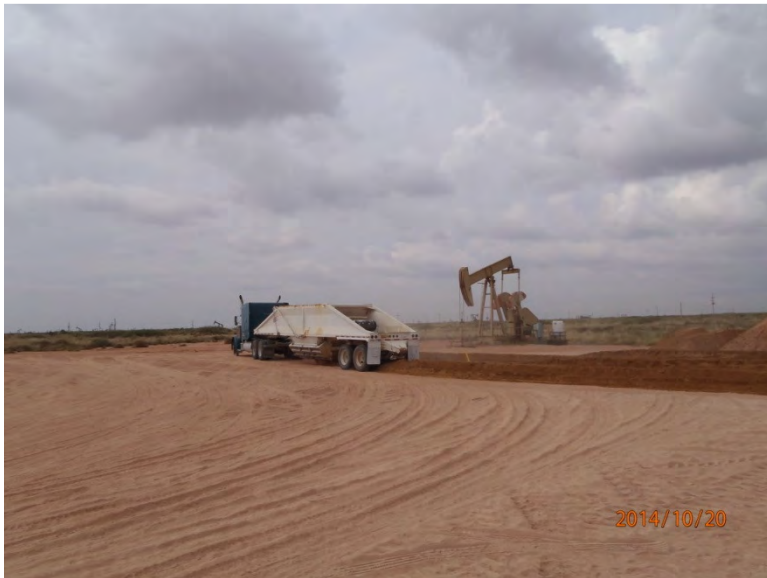
Importing top soil, facing northwest 10/20/14

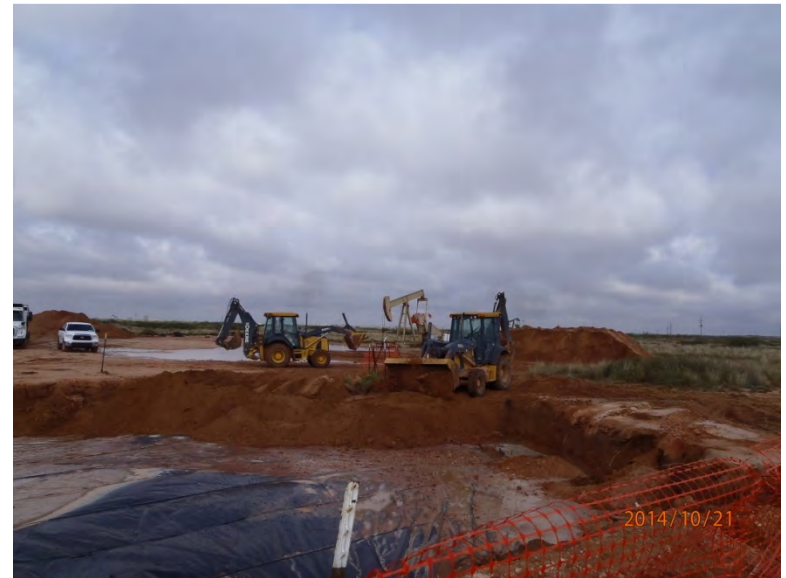
Backfilling excavation, facing northwest 10/21/14

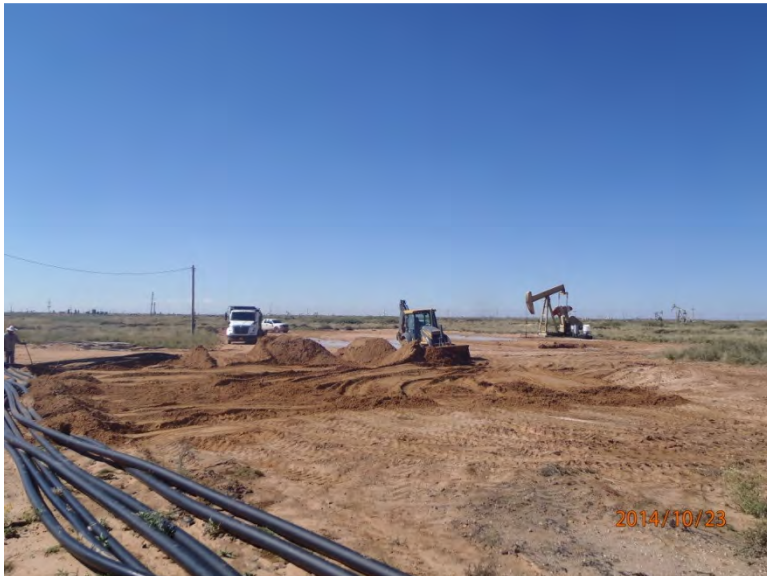
Backfilling excavation, facing west 10/23/14

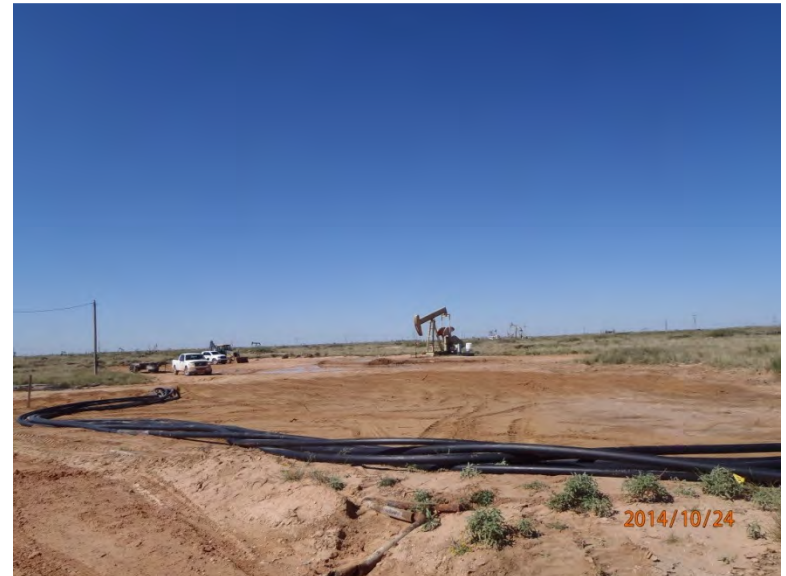
Excavation backfilled, facing northwest 10/24/14

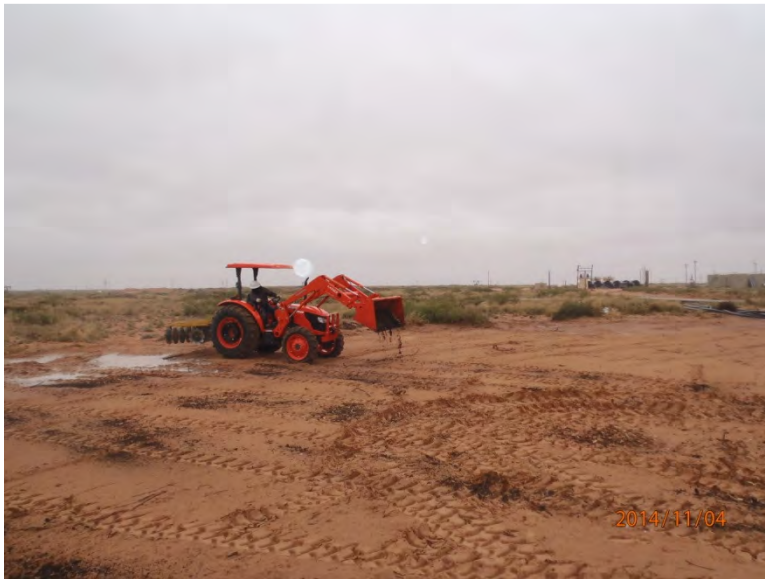
Spreading soil amendments, facing northeast 11/4/14

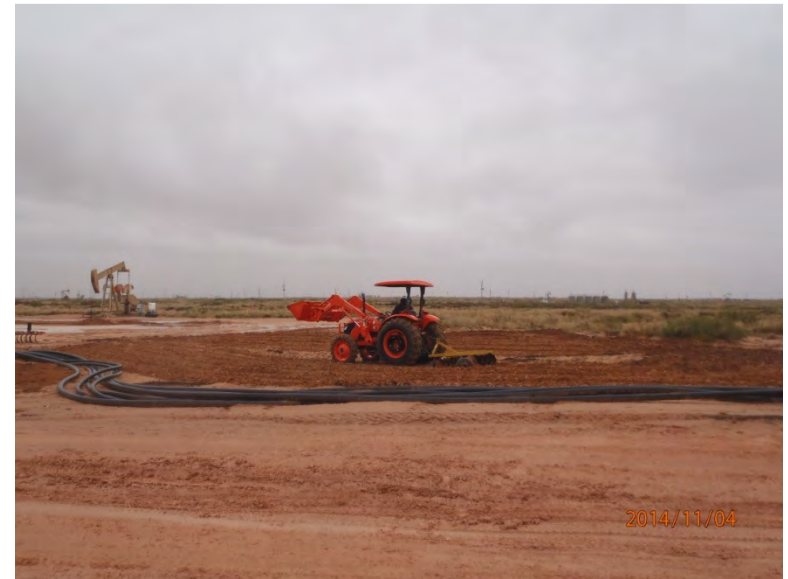
Tilling in soil amendments, facing north 11/4/14

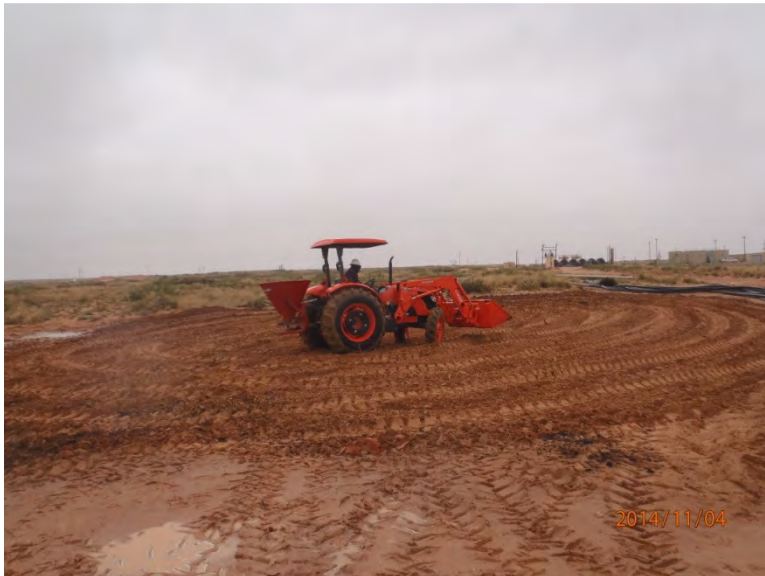
Seeding site, facing east 11/4/14

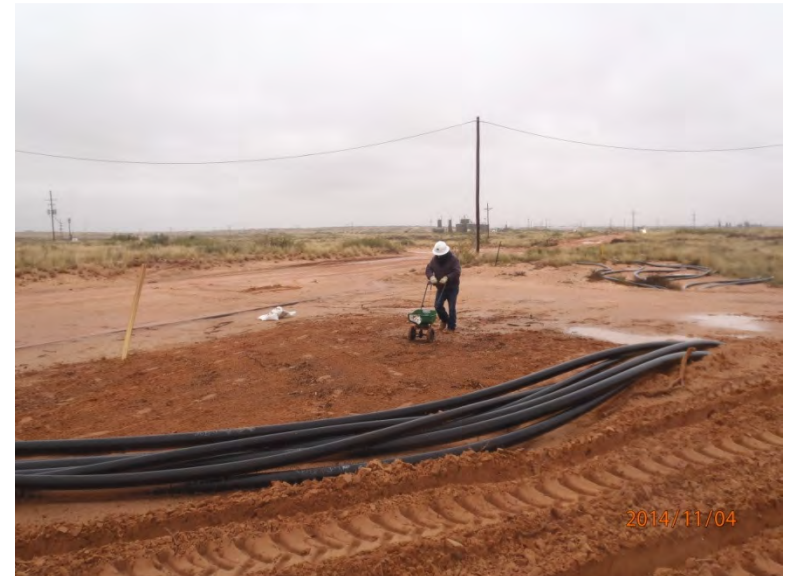
Seeding site, facing southwest 11/4/14

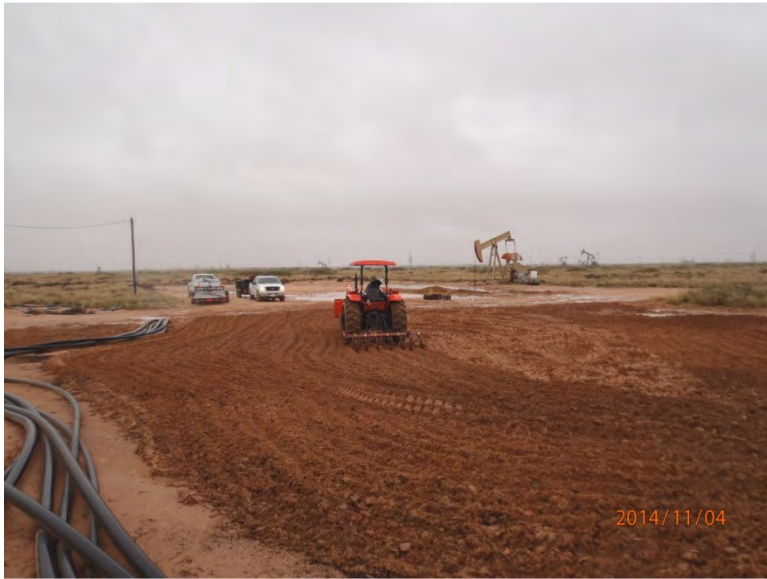
Tilling in the seed, facing west

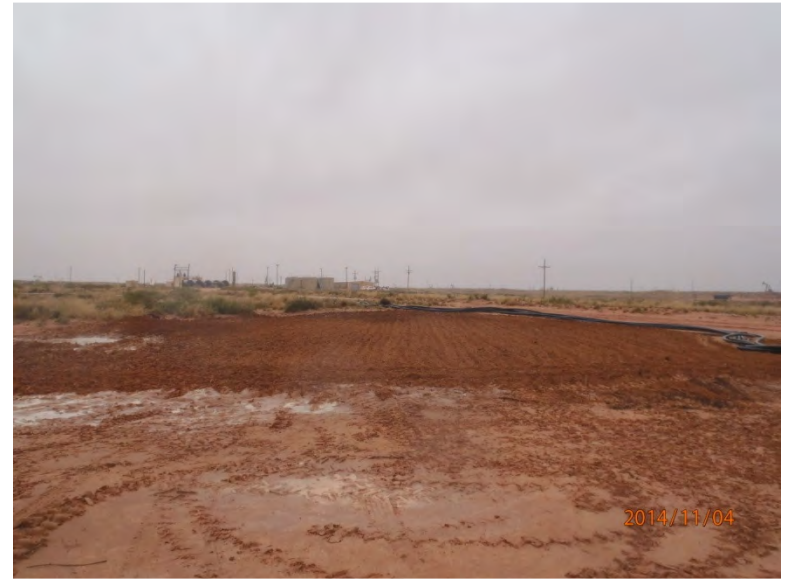
Site completed, facing east

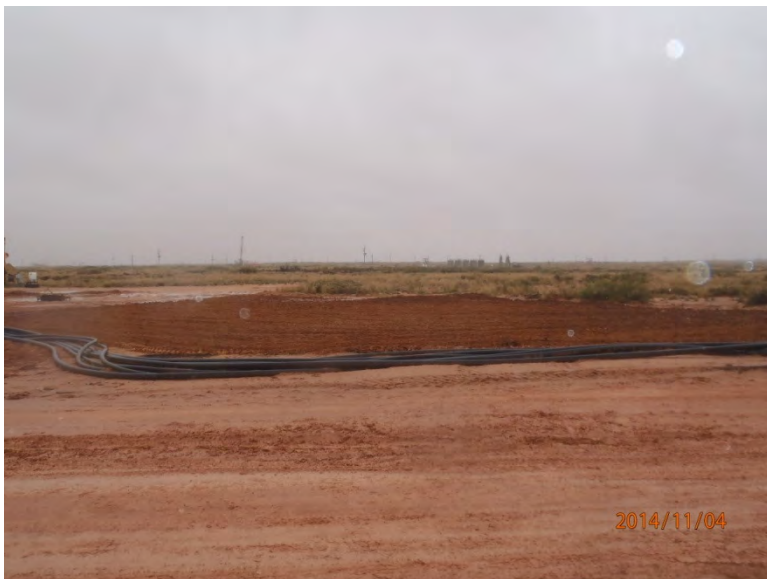
Site completed, facing north

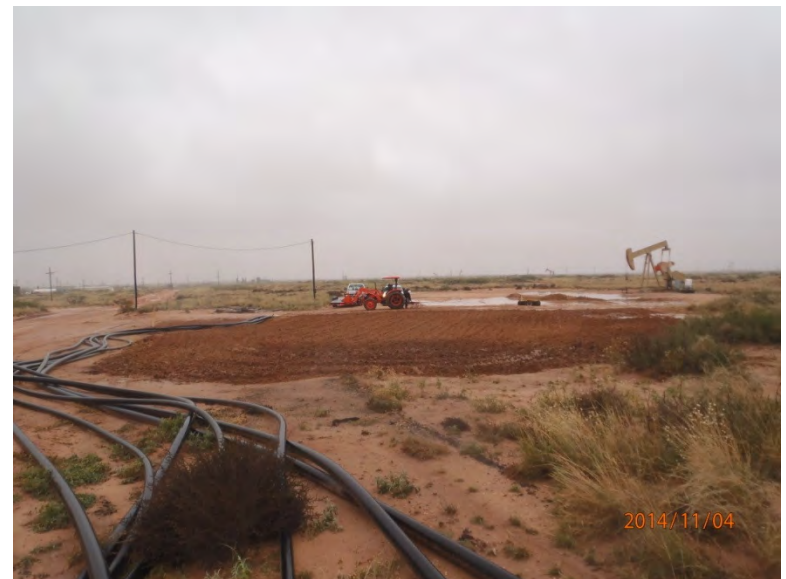
Site completed, facing west
