REMEDIATION SUMMARY & RISK-BASED SITE CLOSURE REQUEST

**BOPCO, LP
INDIAN FLATS BASS FEDERAL SWD TANK BATTERY
Eddy County, New Mexico
Unit Letter "J" (NW/SE), Section 35, Township 21 South, Range 28 East
Latitude 32.433935° North, Longitude 104.055036° West
NMOCD Reference #: 2RP-2198**

September 2014

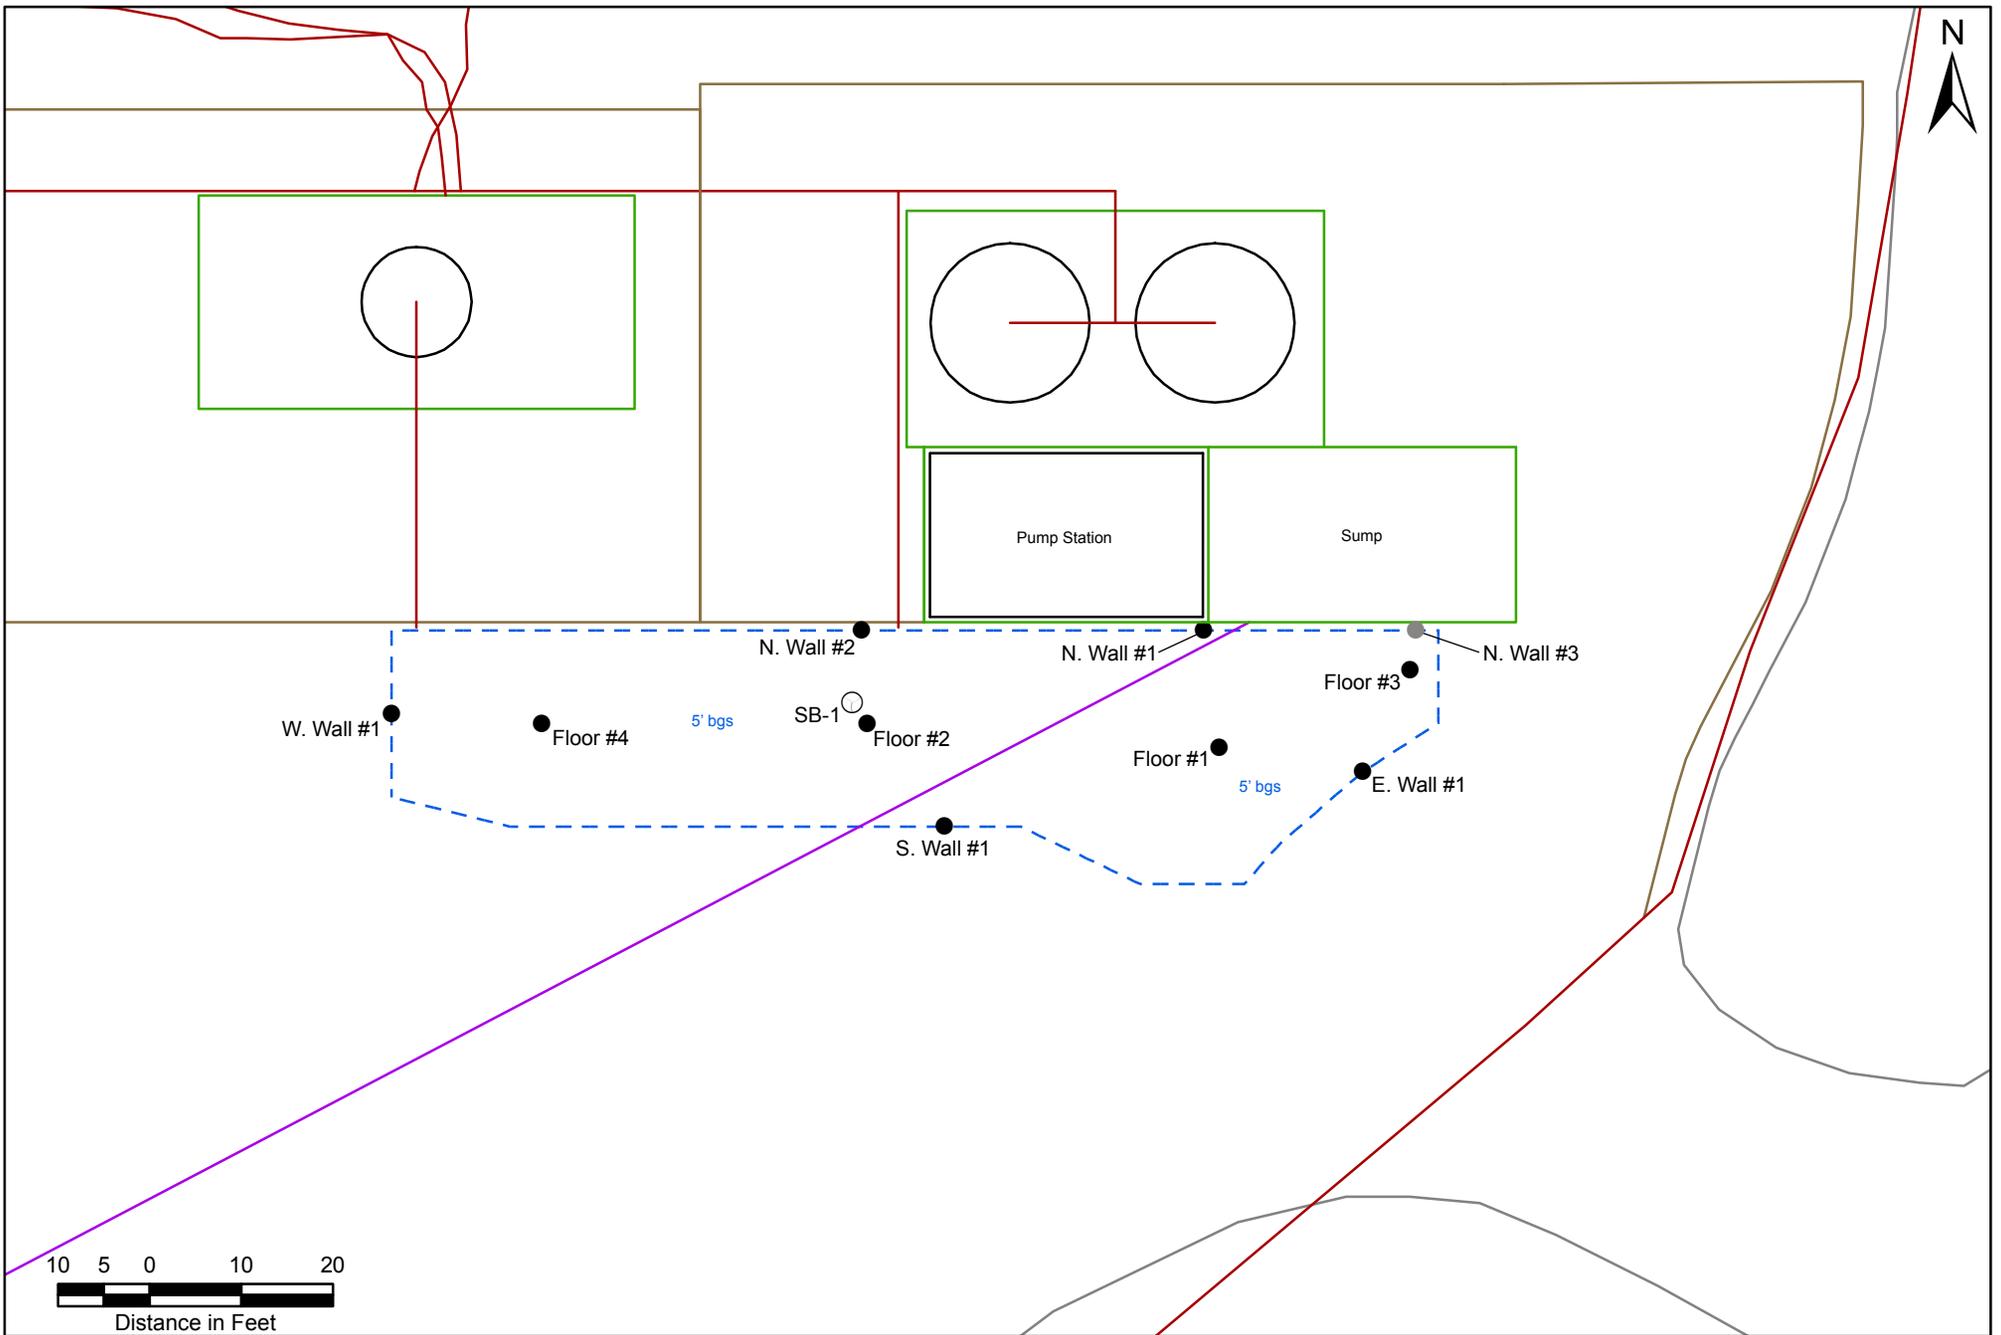
Figure 2
Site & Sample Location Map
BOPCO, LP
Indian Flats Bass Federal SWD
Eddy County, New Mexico
NMOCD Reference #: 2RP-2198

On July 15, 2014, six (6) soil samples (Floor #1, Floor #2, Floor #3, N. Wall #1, N. Wall #2, and E. Wall #1) were collected from the floor and sidewalls of the excavation and submitted to Cardinal Laboratories in Hobbs, New Mexico, for analysis of chloride concentrations in accordance with Environmental Protection Agency (EPA) Method 4500 Cl-B. Laboratory analytical results indicated chloride concentrations ranged from 2,320 mg/kg in soil sample Floor #3 to 6,960 mg/kg in soil sample N. Wall #1. Table 1 summarizes the “Concentrations of Benzene, BTEX, TPH & Chloride in Soil”. A “Site & Sample Location Map” is provided as Figure 2. Laboratory analytical reports are provided as Appendix D.

Further excavation to the north was precluded by the presence of the active SWD and associated sump, booster pumps, electrical utilities, pipes, and appurtenances. Further excavation to the east was precluded by an active pipeline adjacent to the excavation.

On July 17, 2014, three (3) soil samples (Floor #4, S. Wall #1, and W. Wall #1) were collected from the floor and sidewalls of the excavation and submitted to the laboratory for analysis of chloride concentrations. Soil sample S. Wall #1 was also analyzed for concentrations of TPH and BTEX in accordance with EPA Methods SW-846 80 and SW-846 8021b, respectively. Laboratory analytical results indicated chloride concentrations ranged from 192 mg/kg in soil sample S. Wall #1 to 4,720 mg/kg in soil sample W. Wall #1. TPH and BTEX constituent concentrations in soil sample S. Wall #1 were less than the appropriate laboratory method detection limit (MDL).

On July 28, 2014, one (1) soil boring (SB-1) was advanced in the area represented by soil sample Floor #2 to further investigate the vertical extent of impacted soil. Soil samples were collected at five-foot (5') drilling intervals and field-screened using a chloride test kit. Soil samples collected at drilling depths of five feet (5'), ten feet (10'), twenty feet (20'), thirty feet (30'), thirty-five feet (35'), and forty feet (40') bgs were submitted to the laboratory for analysis of TPH, BTEX, and/or chloride concentrations. Laboratory analytical results indicated TPH concentrations were less than the laboratory MDL in all submitted soil samples, with the exception of soil sample SB-1 @ 5', which exhibited a TPH concentration of 79.6 mg/kg. BTEX constituent concentrations were less than the appropriate laboratory MDL in all submitted soil samples. Chloride concentrations ranged from 80.0 mg/kg in soil sample SB-1 @ 5' to 3,280 mg/kg in soil sample SB-1 @ 10'. A soil boring log is provided as Appendix C.

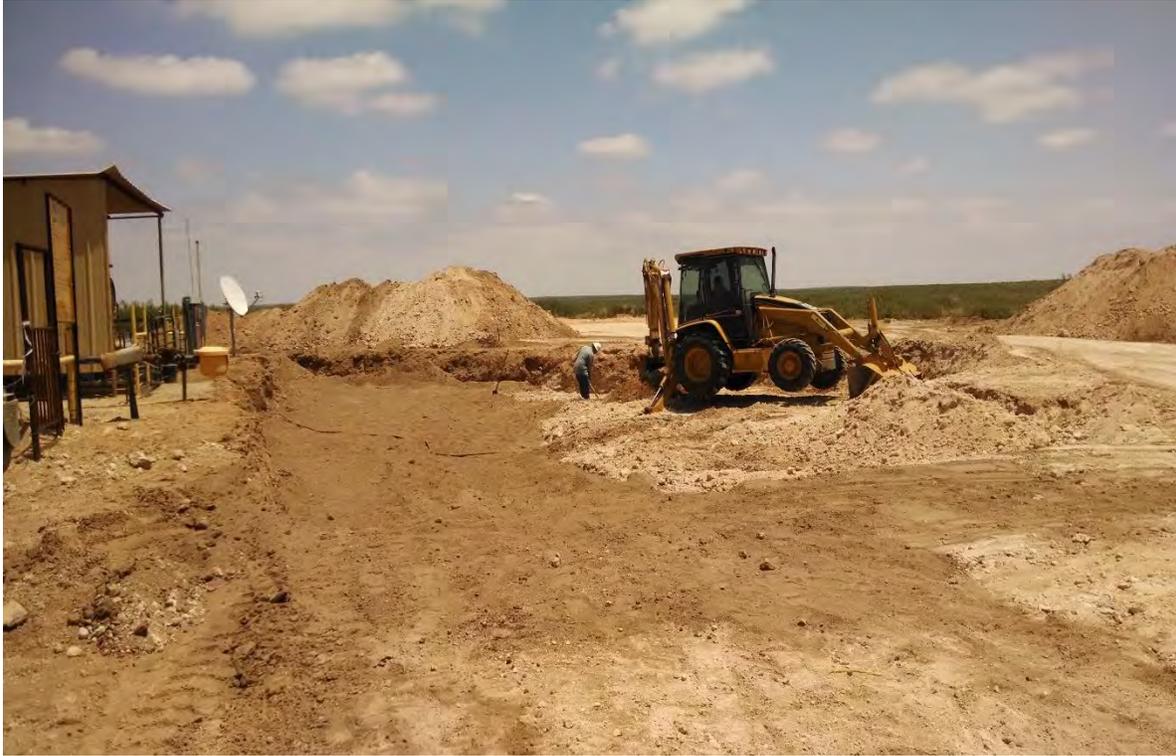
Indian Flats Bass Federal SWD – Excavation (Looking East)

On July 14, 2014, excavation of impacted soil commenced at the site. A chloride test kit was used to field-screen the horizontal extent of impacted soil and to guide the excavation. From July 15 through July 23, 2014, approximately seven hundred and eighty cubic yards (780 yd³) of impacted soil was excavated and transported to Lea Land, Inc. (NMOCD Permit # WM-01-035), for disposal.

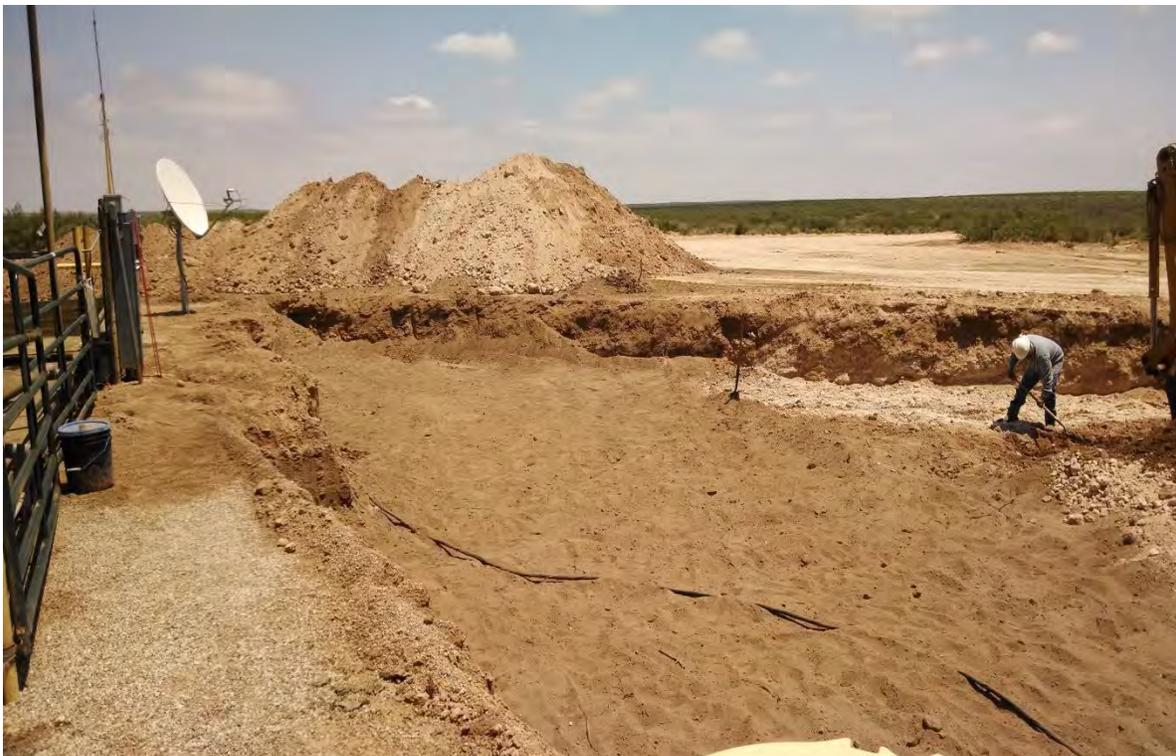
Indian Flats Bass Federal SWD – Excavation & Exposure of Existing Liner
(Looking East-Southeast)

The release impacted an area which had been affected by several releases in the past (see NMOCD reference #'s 2RP-1037, 1207, 1208, 1209, 1457, and 1656). The previous releases were remediated concurrently, to the extent practicable, and remediation activities are summarized in the "Remediation Summary & Risk-Based Site Closure Request" dated August 2013. A portion of the February 10, 2014, release comingled with a zone of contaminated soil, which had been left in-situ with NMOCD approval. A portion of the release also impacted an area which had been previously remediated and lined with an impermeable, twenty-millimeter (20mm) polyurethane plastic liner prior to backfilling.

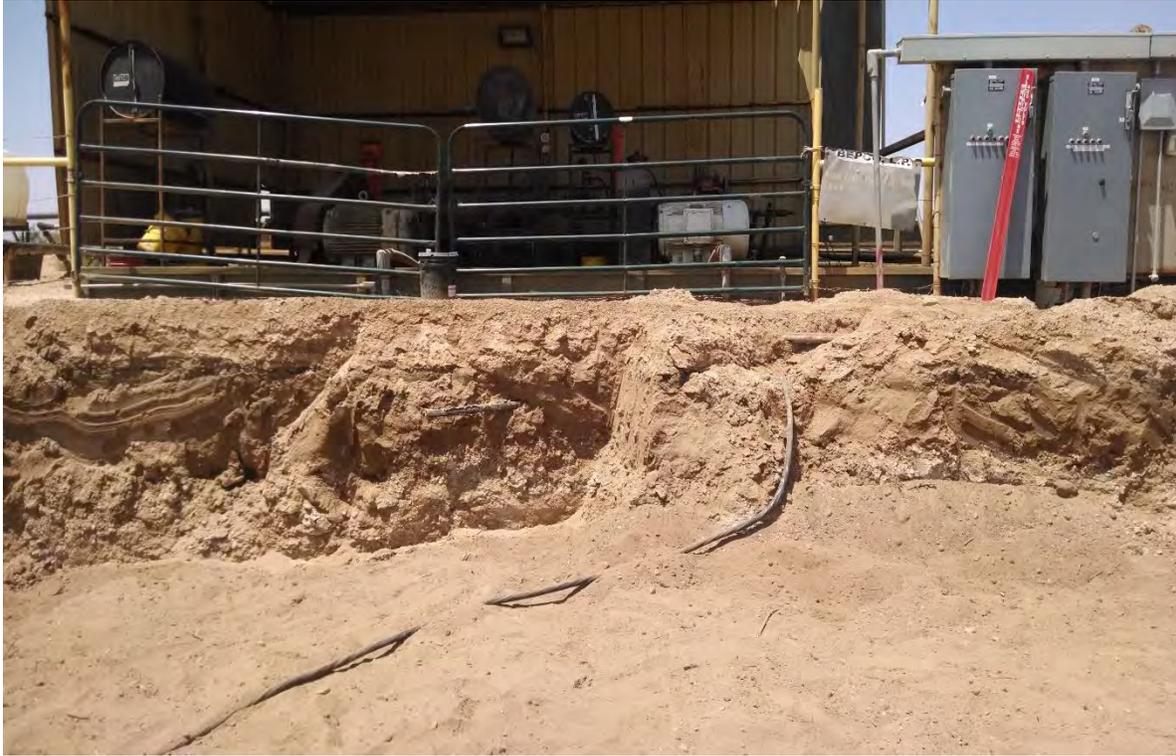
Indian Flats Bass Federal SWD – Excavation (Looking North)

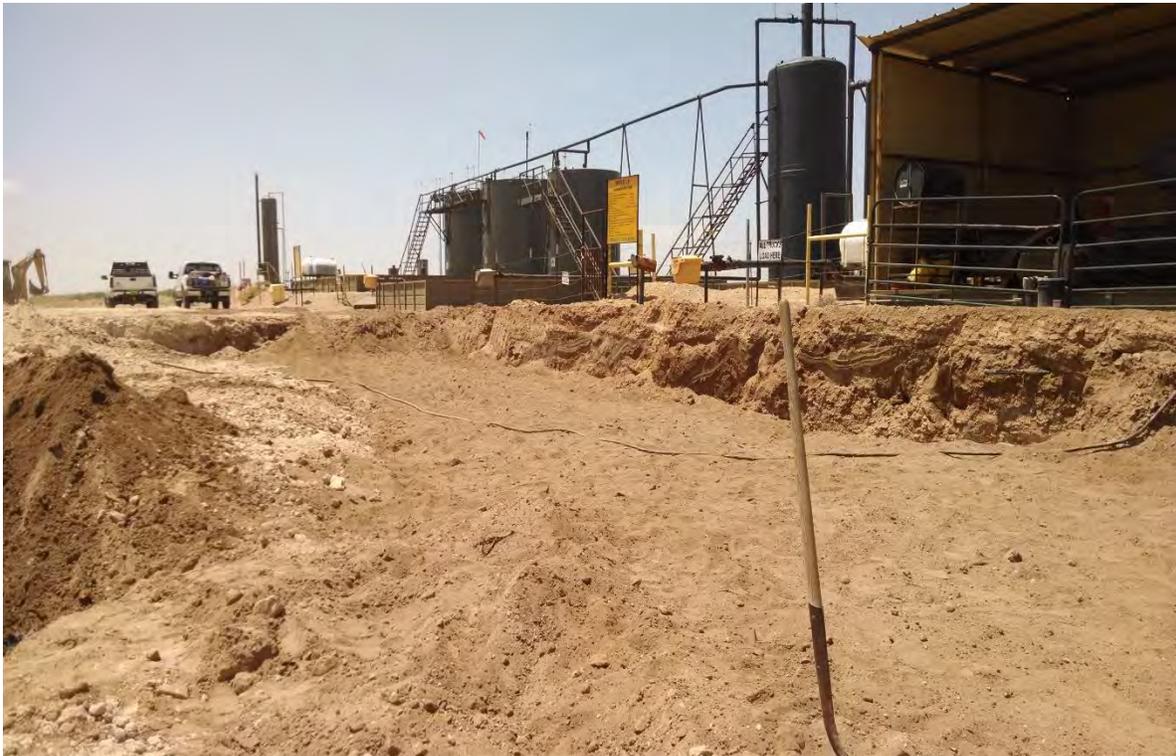
Indian Flats Bass Federal SWD – Excavation (Looking West-Northwest)

Soil sample W. Wall #1 represents an area of comingled contamination from the February 10, 2014, release and the six (6) prior releases referenced in Section 1.0, “Introduction & Background Information”. Further excavation in that area was deemed impracticable due to the presence of an

active truck lane and load lines adjacent to the excavation. The truck lane represents the only thoroughfare to two (2) active production wells to the west of the Indian Flats SWD. Limiting access to both the production wells and the Indian Flats SWD would have placed an undue financial burden on BOPCO and introduced an environmental hazard due to the increased risk for subsequent releases.

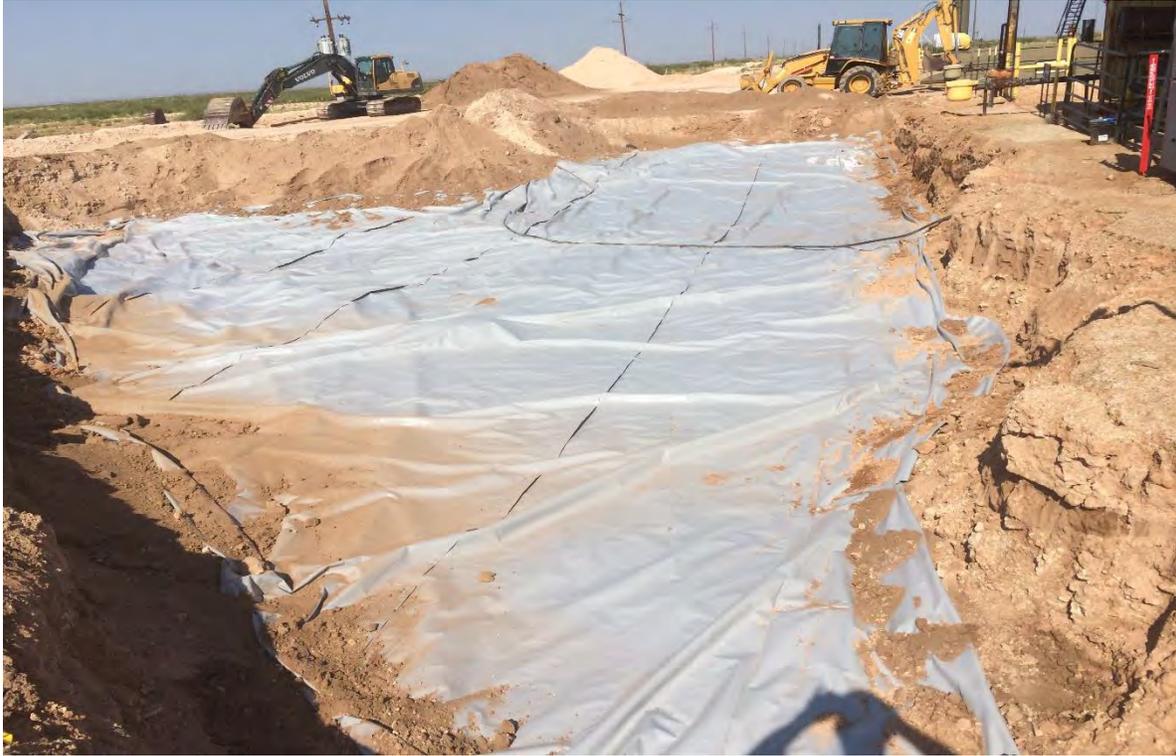
Indian Flats Bass Federal SWD – Liner Installation (Looking West)

July 1, 2014, a twenty (20) mil polyurethane liner was installed on the floor excavation at approximately four feet (4') bgs. A cushion of sand was installed approximately one foot (1') both above and below the liner to protect the liner from damage during installation and backfilling activities.

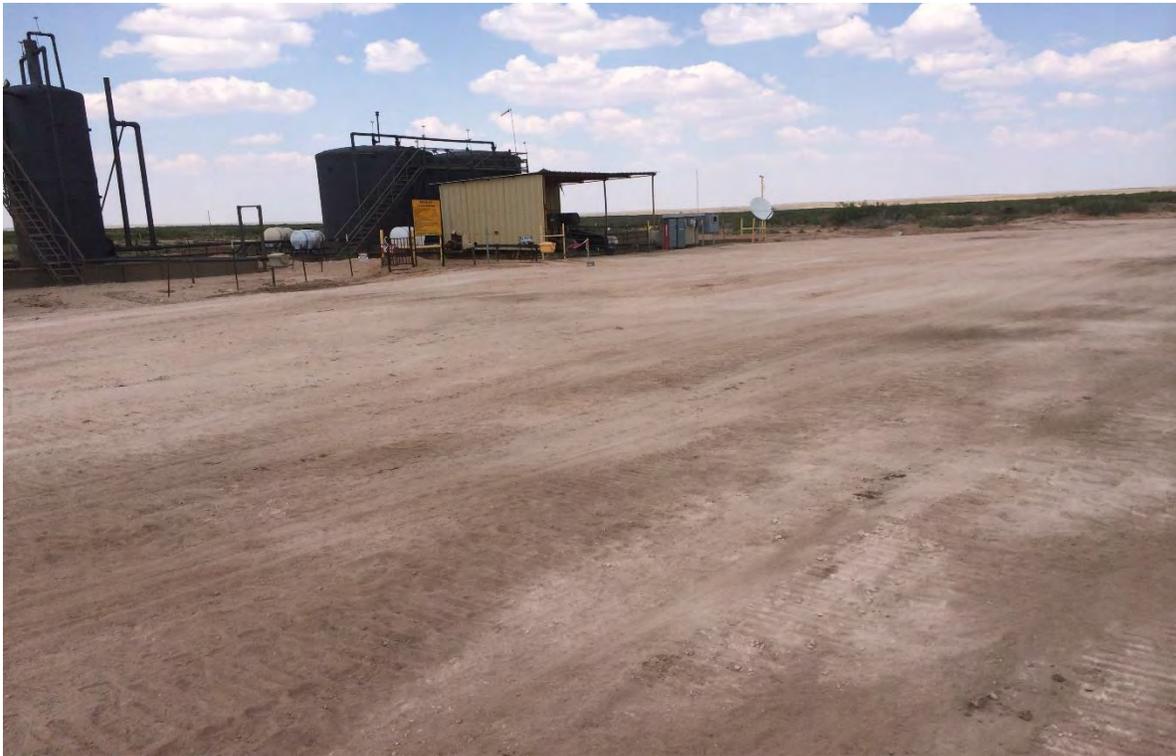
Indian Flats Bass Federal SWD – Backfilled Excavation (Looking Northwest)

Based on laboratory analytical results, and with NMOCD approval, from July 19 through July 24, 2014, the excavation was backfilled with non-impacted material, compacted, and contoured to fit the surrounding topography. Prior to backfilling, the final dimensions of the excavation were approximately two hundred and sixty feet (260') in length, varying in width from approximately forty feet (40') to approximately eighty feet (80'), and approximately five feet (5') in depth.

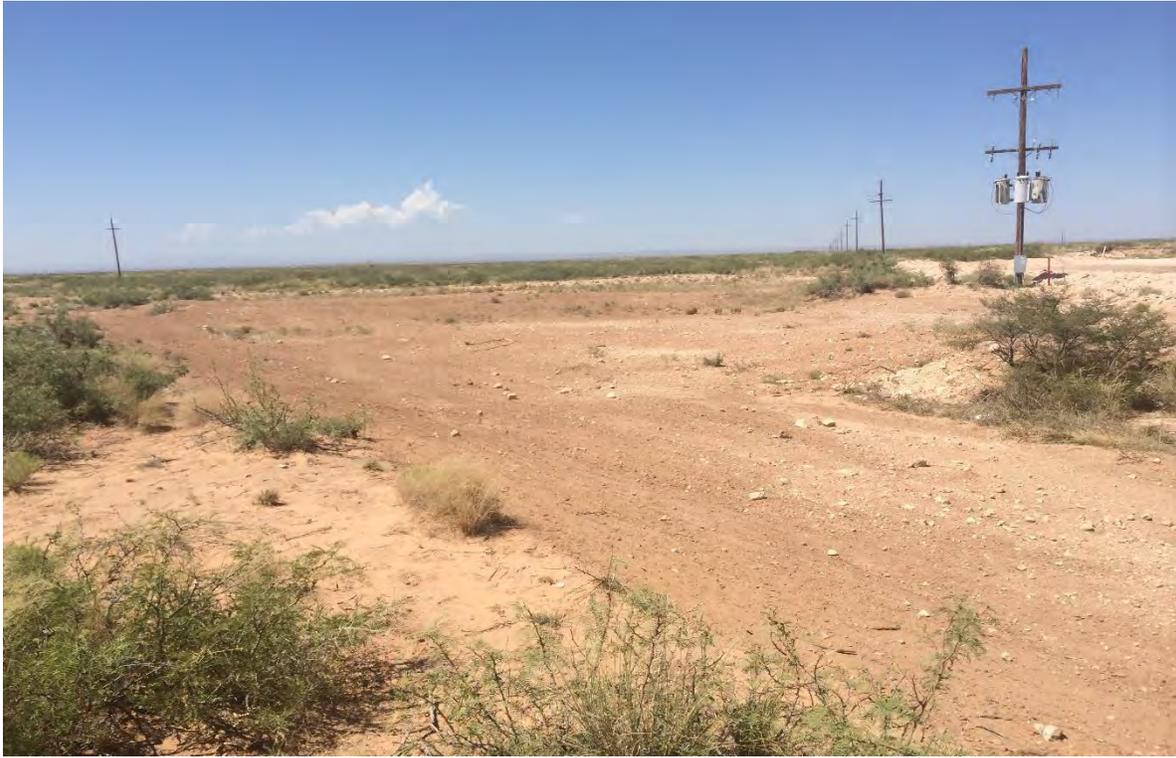
Indian Flats Bass Federal SWD – Staging Area Adjacent to Release Site
(Following Seeding; Looking West)

On August 28, 2014, a disturbed area of pastureland adjacent to the release site, which had been used as a staging area during remediation activities, was seeded with a BLM-approved seed mixture. Post-seeding photographs of the site are included in Appendix B.

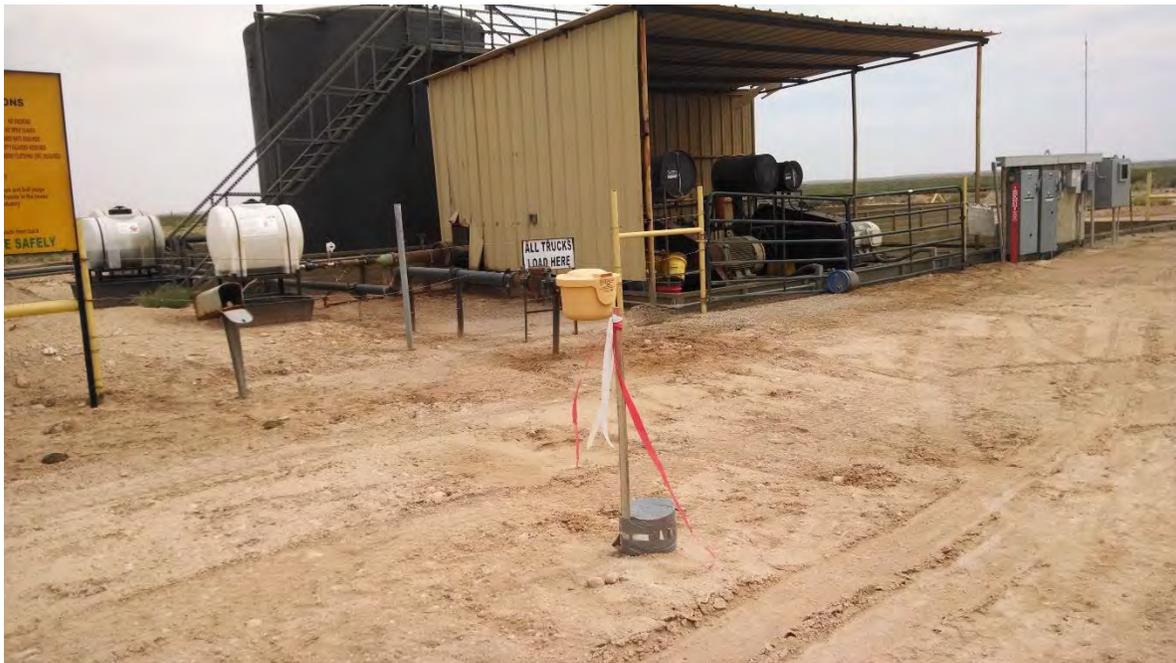
Indian Flats Bass Federal SWD – PVC Conduit for Advancement of Soil Boring SB-1

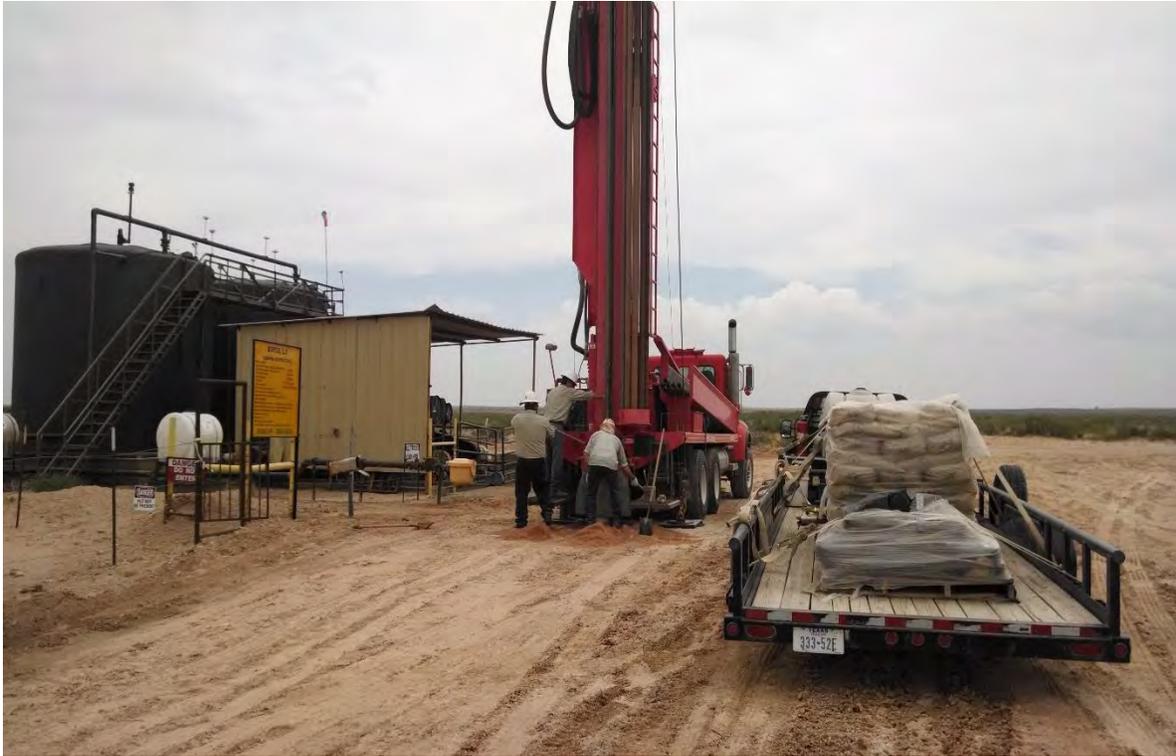
Indian Flats Bass Federal SWD – Advancement of Soil Boring SB-1
