APACHE CORPORATION

MJ SWD Line
(2RP-2827)

Termination Request

**RE: Termination Request
Apache MJ SWD Line (2RP-2827)
UL/A sec. 2 T18S R27E
API No. 30-015-00724**

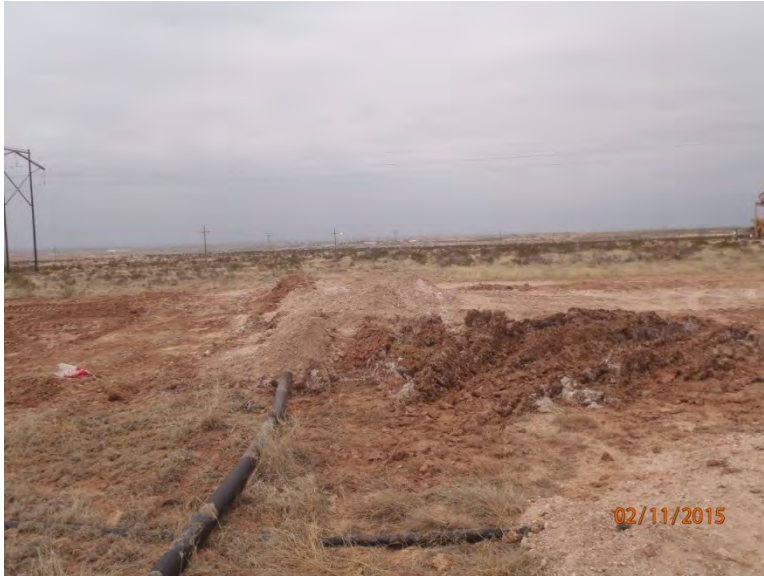
Initial release area, facing west

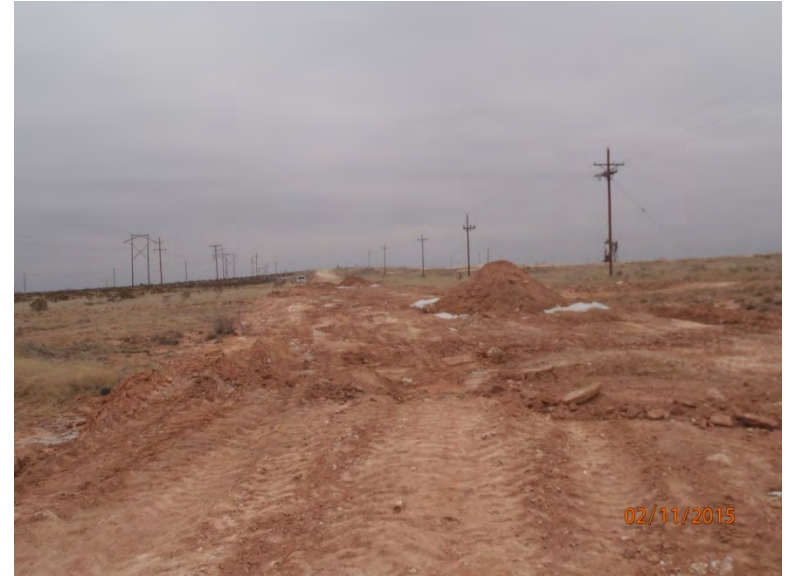
Initial release area, facing north

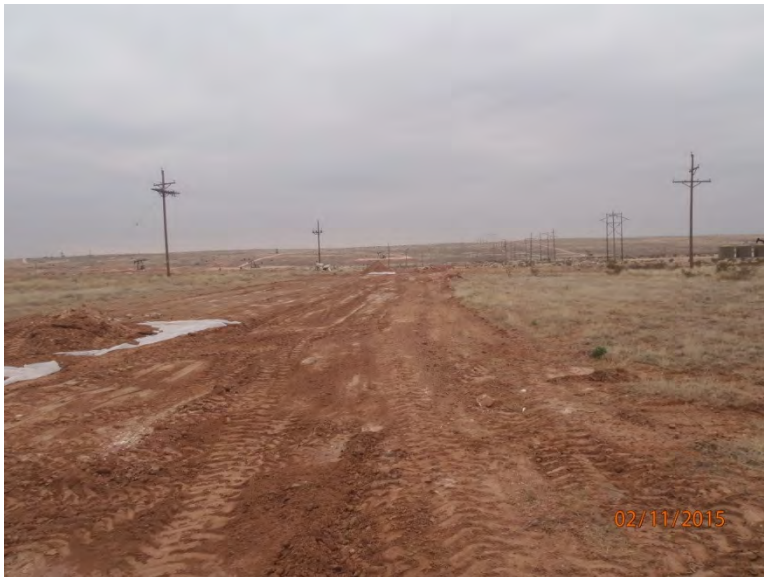
Initial release area, facing south

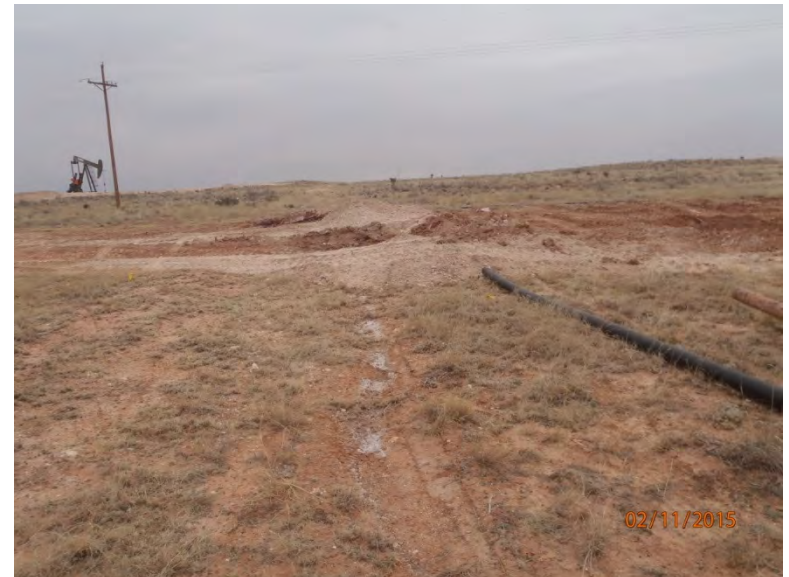
Initial release area, facing east

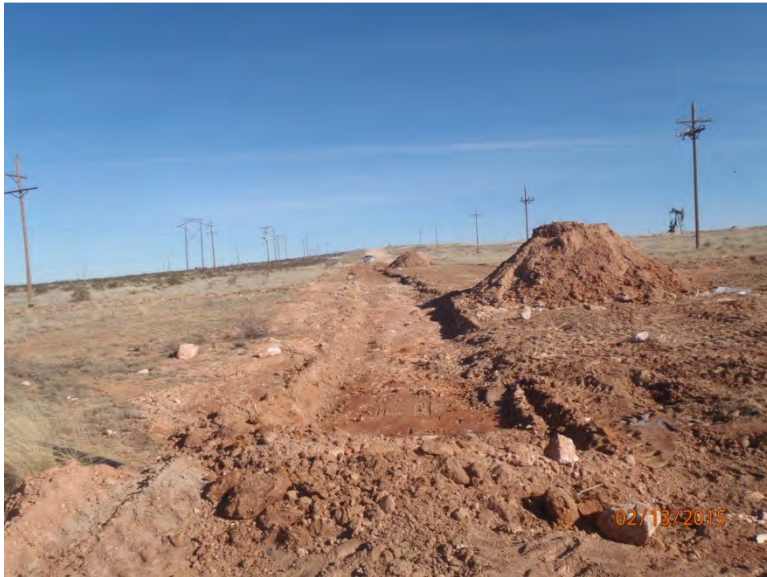
Scraping site, facing north

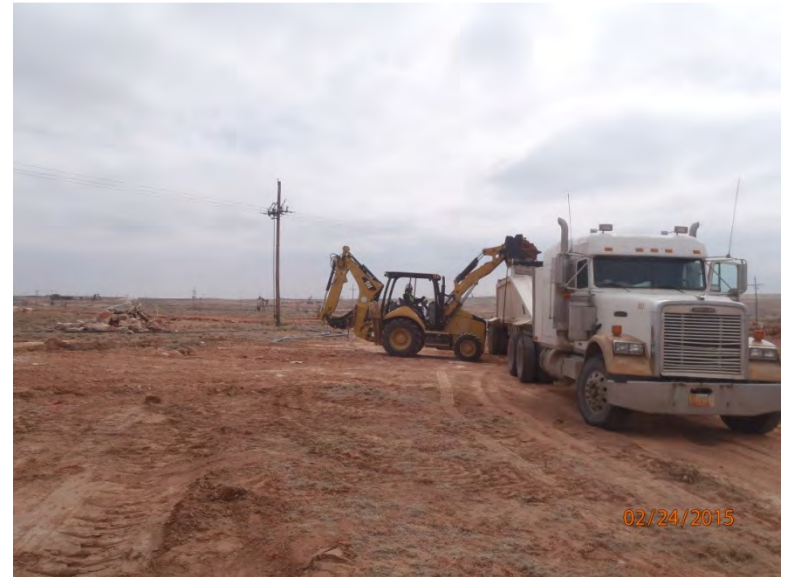
Exporting soil, facing east

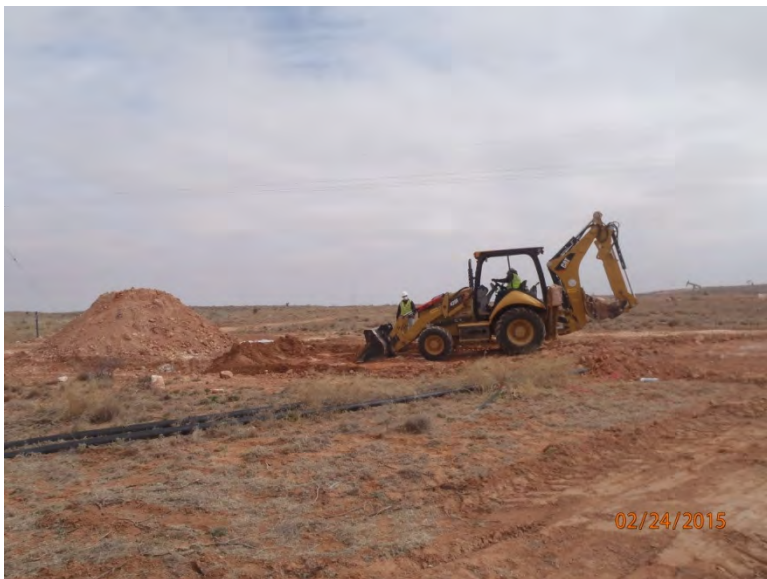
Continue scraping site, facing northeast

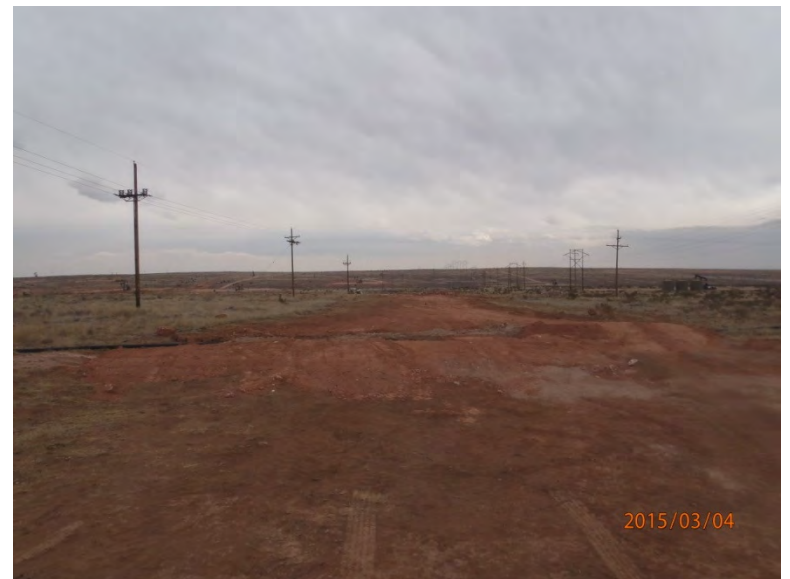
Site completed, facing south

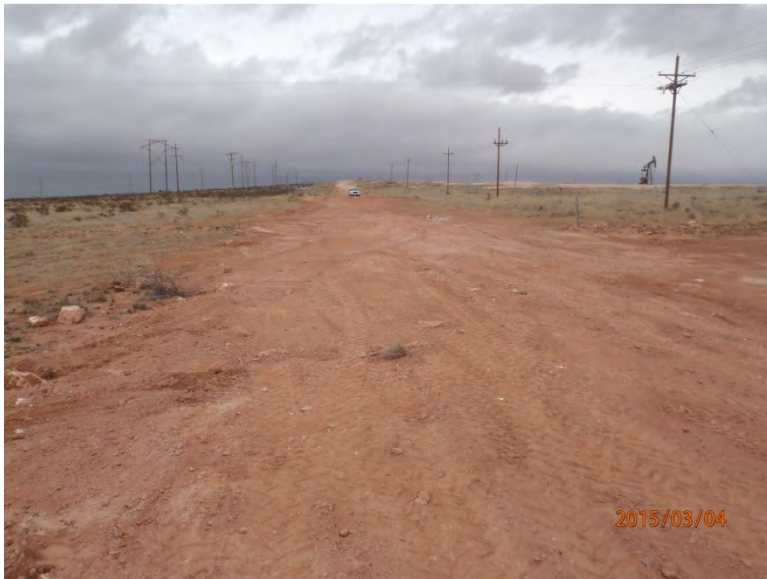
Site completed, facing north

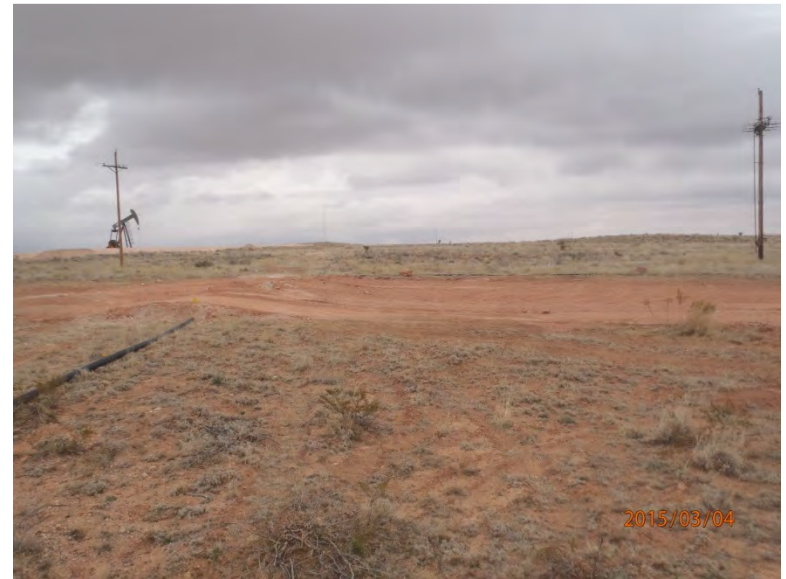
Site completed, facing east
