# HE West B 85

## Termination Request

API No. 30-015-28387

**RE: Termination Request  
Linn HE West B 85  
UL/K sec. 3 T17S R31E  
API No. 30-015-28387**

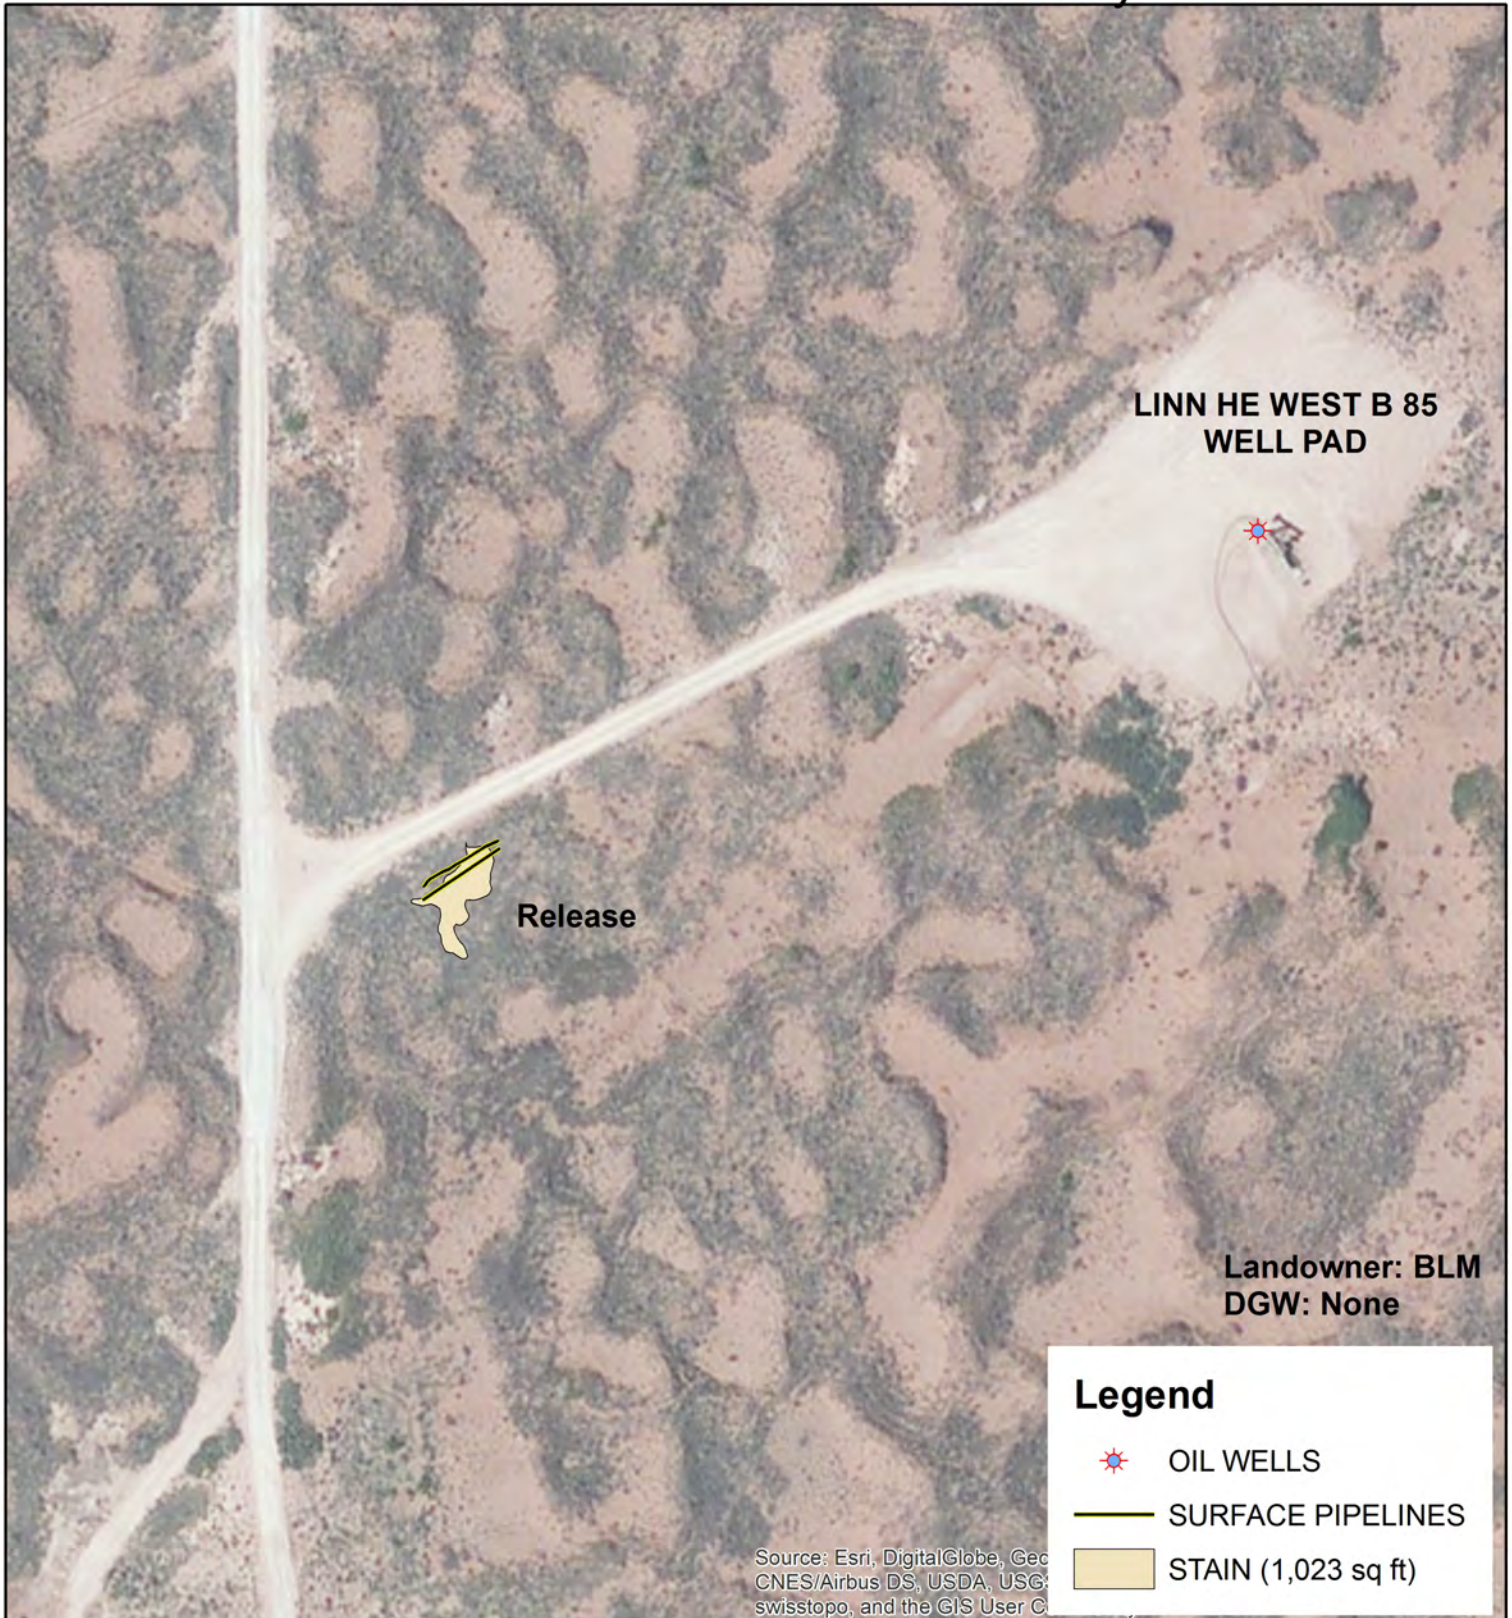
# Location to Site for Direct Bury

The excavated soil would be taken to the HE West B 85 lease pad and direct buried (Figure 2). Caliche would be scraped from the pad and piled off to the side. A repository would be excavated to a volume which would encompass the excavated soil from the release, including an additional 4 ft cap of clean top soil (Figure 3). The repository would be lined in entirety with a 20-mil reinforced poly liner. The excavated soil from the release would then be placed in the lined repository, and the top of the repository would be capped with a 20-mil reinforced poly liner. Four feet of clean top soil would be placed over the capped repository, and the scraped caliche would be backfilled over the top soil.

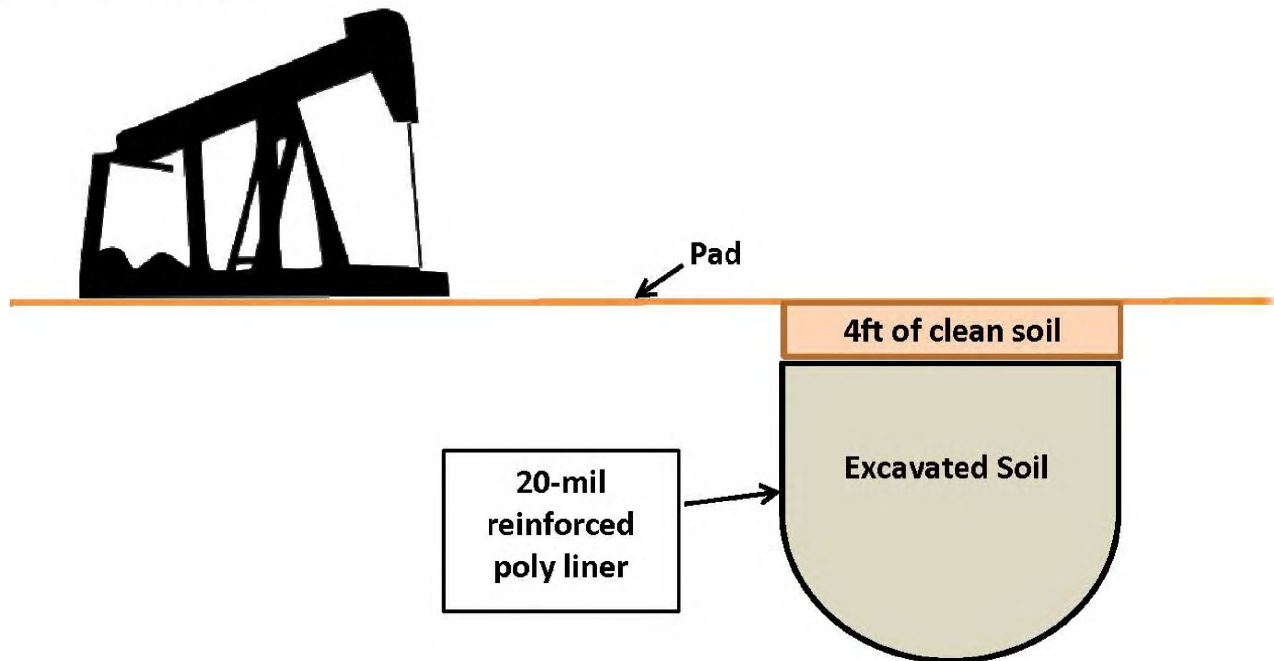
# Direct Bury Under Lease Pad

At the base of the 3 ft excavation, a 20-mil reinforced poly liner was installed and key set (Figure 4). A total of 84 cubic yards of contaminated soil was taken to the HE West B 85 lease pad to be direct buried. At the HE West B 85 lease pad, the caliche over the proposed repository was scraped and piled off to the side. The repository was excavated to 1,742 square feet to a depth of 9 ft bgs.

Once the repository excavation was completed, it was lined with a 20-mil reinforced poly liner. The contaminated soil from the release was backfilled into the lined repository and then seamed closed. Repository soil was backfilled over the liner to a depth of 4 ft, and the removed caliche was backfilled over the soil. To bring the repository excavation back up to surface level and to repair the lease pad, 48 cubic yards of clean caliche were imported to the site.

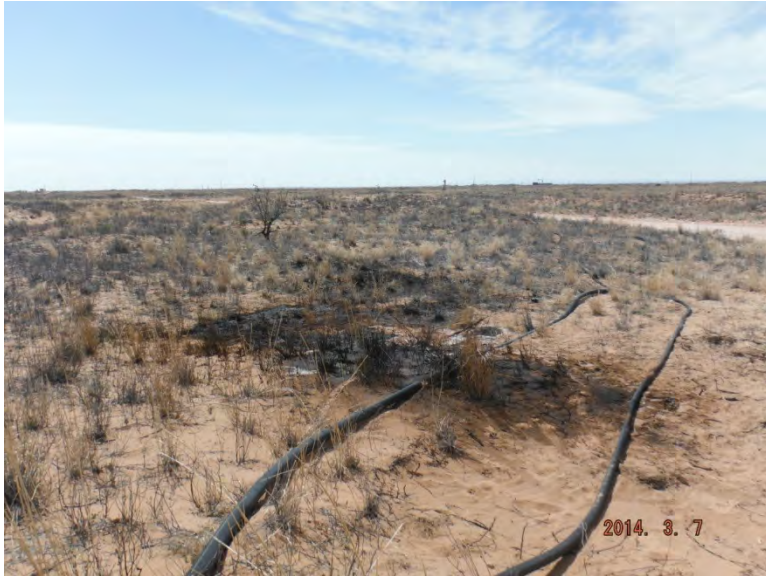
Initial release area, facing southwest 3/7/14

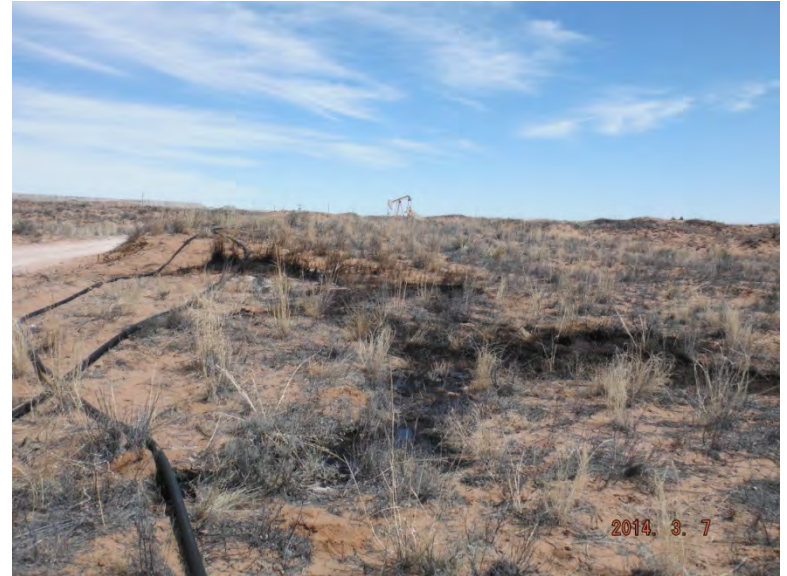
Initial release area, facing east 3/7/14

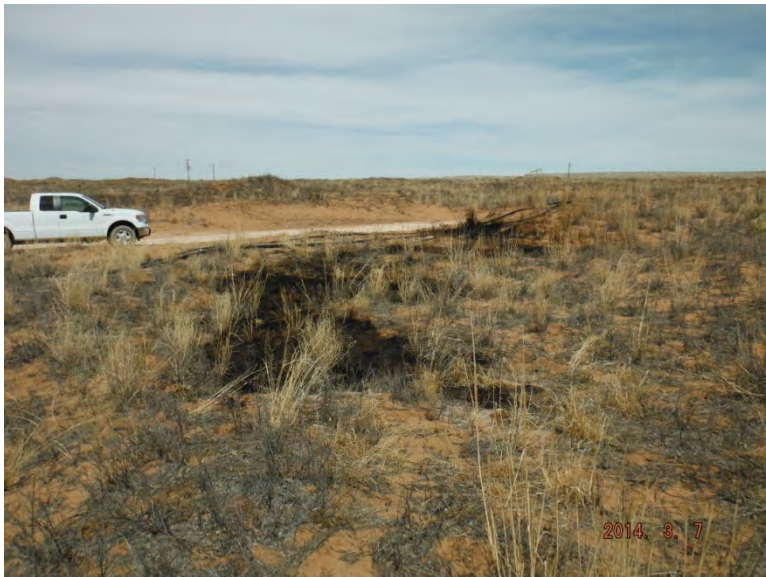
Initial release area, facing northeast 3/7/14

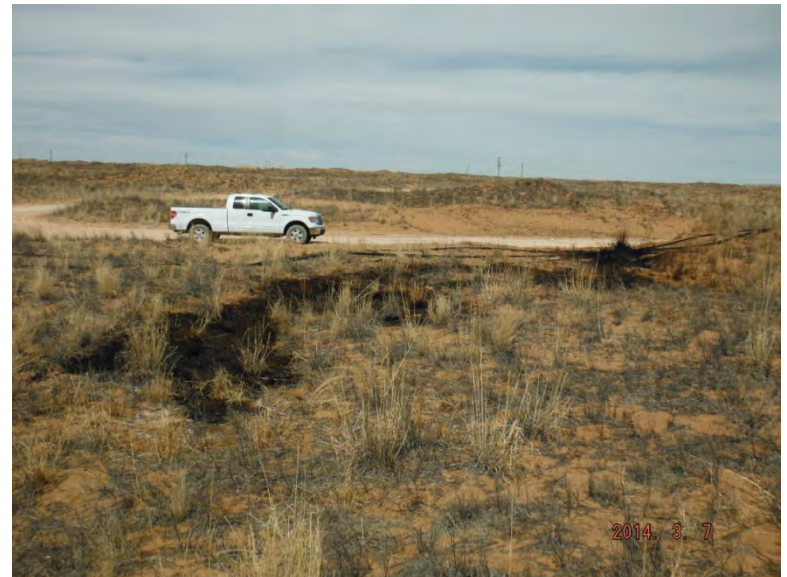
Initial release area, facing north 3/7/14

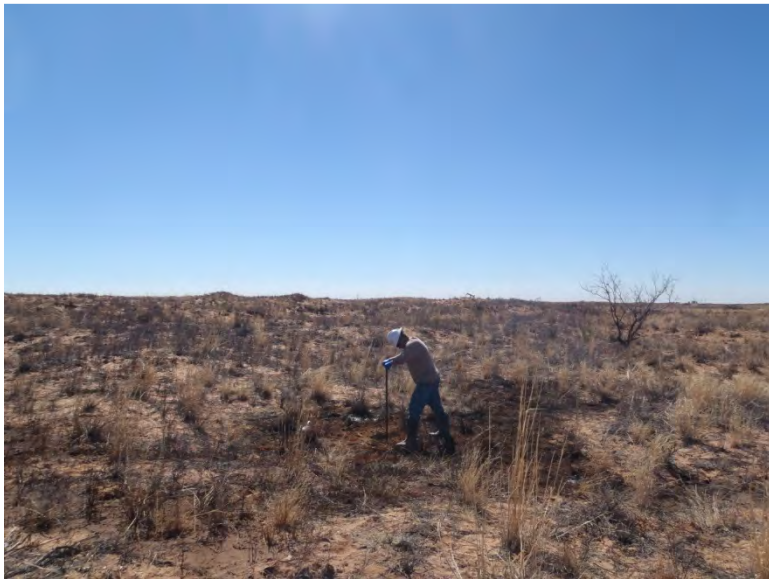
Sampling for depth, facing south

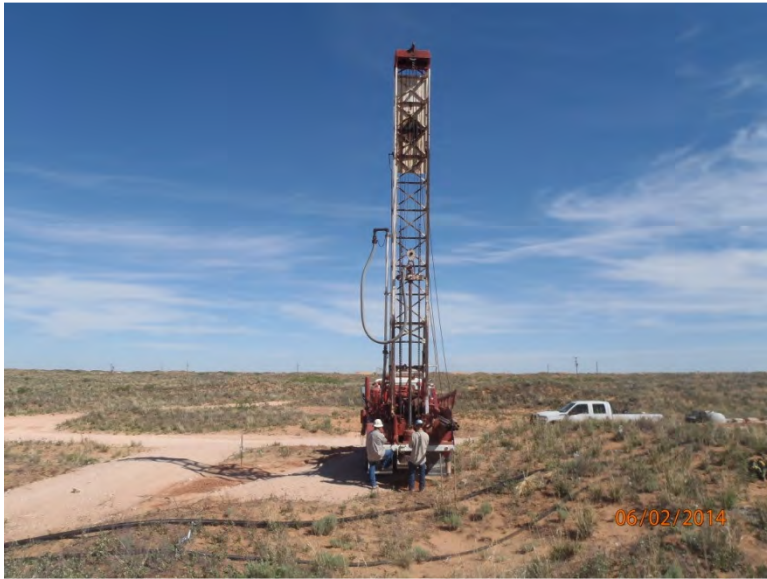
Drilling SB-1, facing northwest

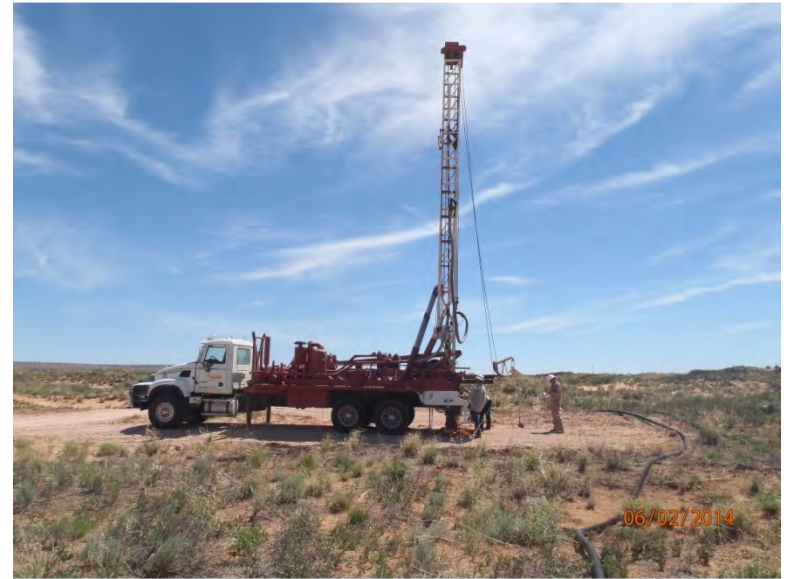
Drilling SB-2, facing east

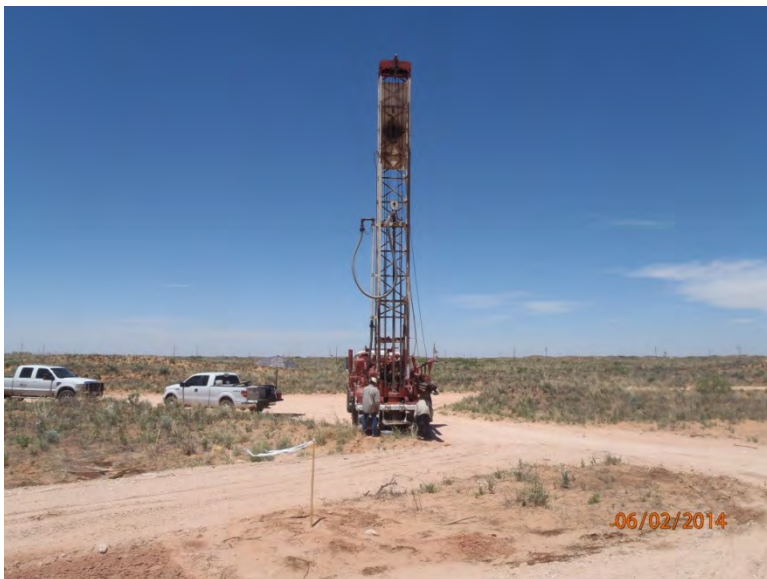
Drilling SB-3, facing west

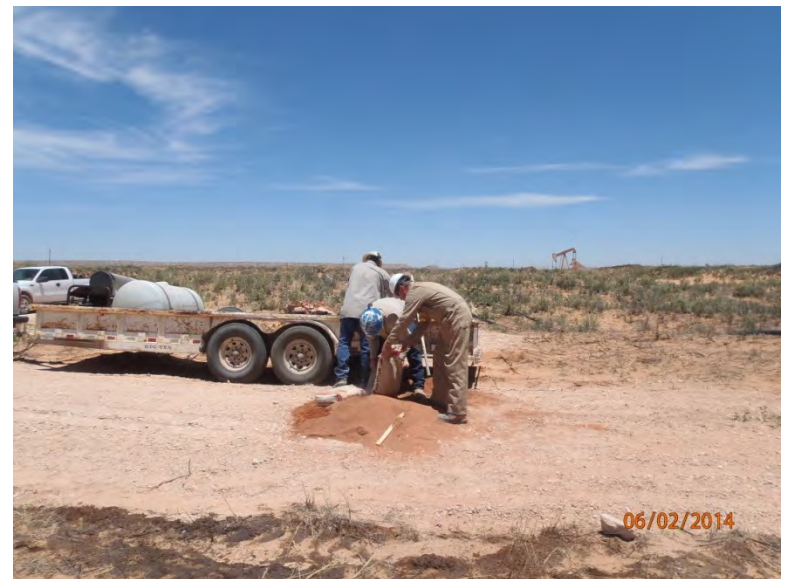
Plugging SBs in total with bentonite, facing east

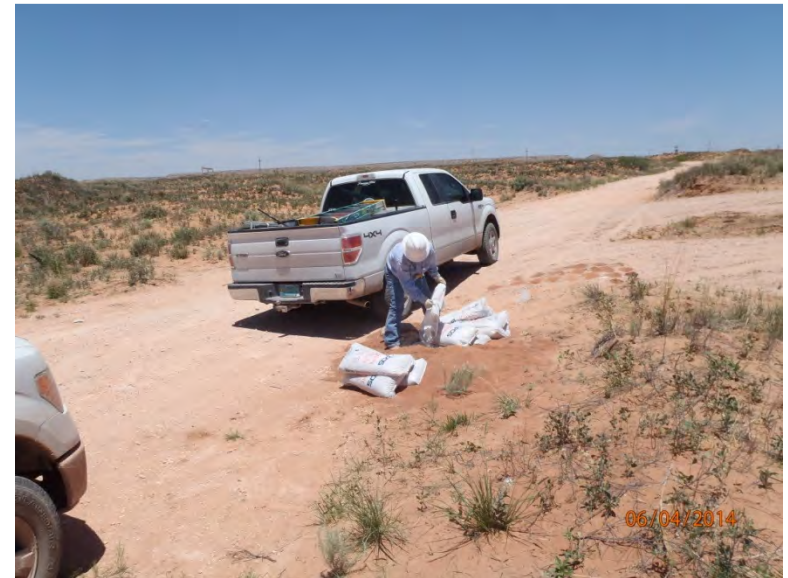
Plugging SB-3 in total with bentonite, facing northeast  
6/4/14

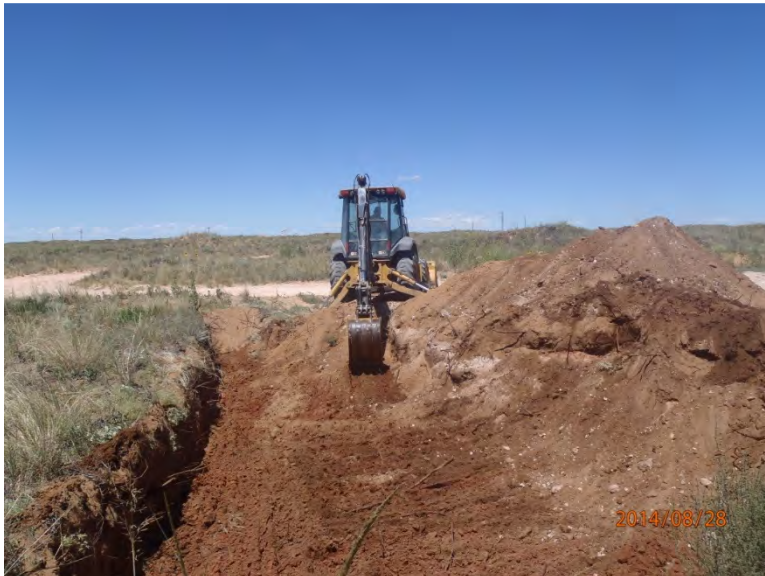
Beginning the excavation to 3 ft, facing north 8/28/14

Corrective actions began at the site on August 28<sup>th</sup>, 2014. The release area was excavated to a depth of 3 ft. Once the excavation was completed, grab samples from the walls of the excavation were taken and field tested for chlorides and organic vapors. The samples were then sent to a commercial laboratory for analyses (Appendix C). All four walls from the excavation returned chloride values at or near non-detectable levels. GRO, DRO and BTEX readings returned values of non-detect.

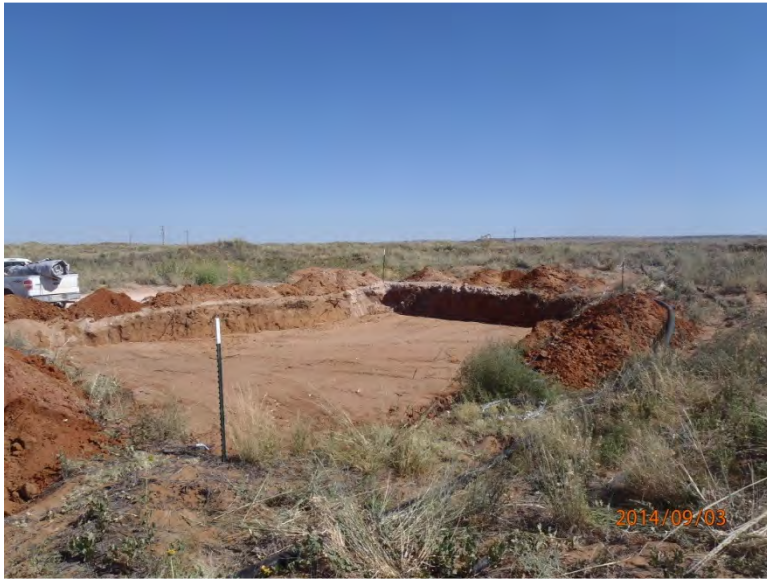
Excavation completed, facing northeast 9/3/14

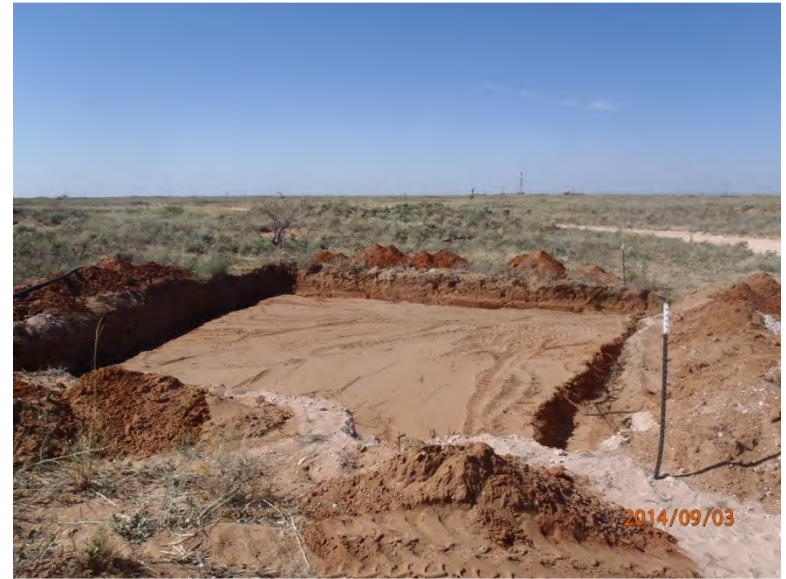
Excavation completed, facing southwest 9/3/14

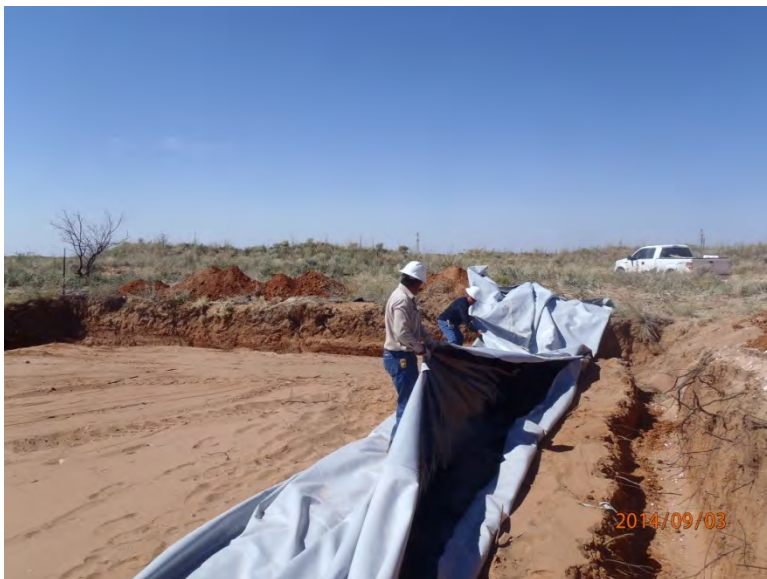
Installing 20-mil poly liner, facing west 9/3/14

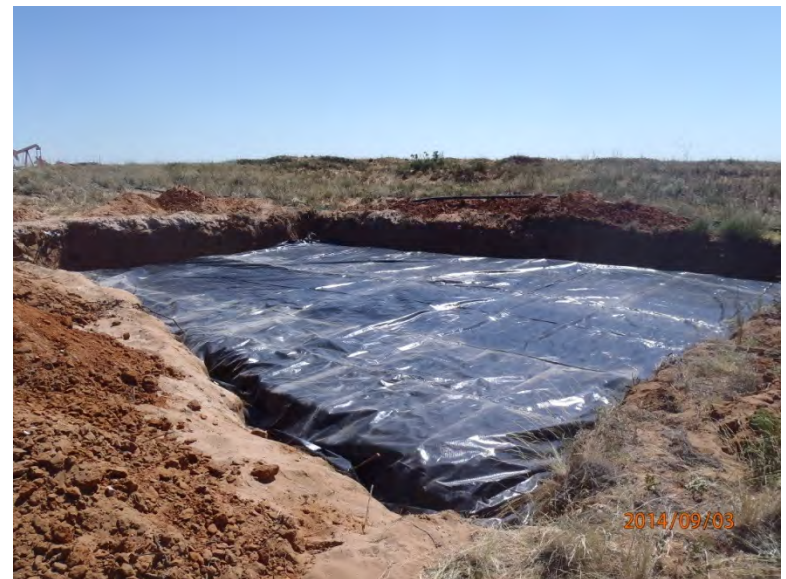
Liner installed and key set into excavation, facing southeast 9/3/14

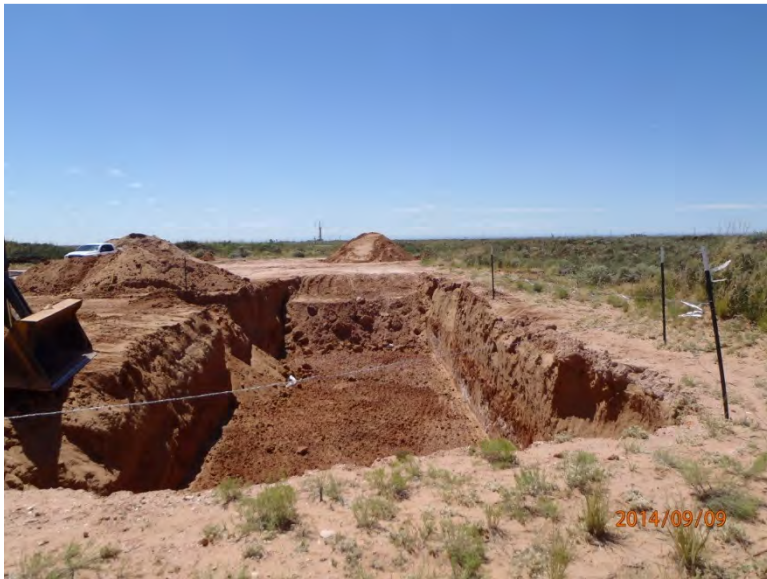
Deep bury repository completed, facing south 9/9/14

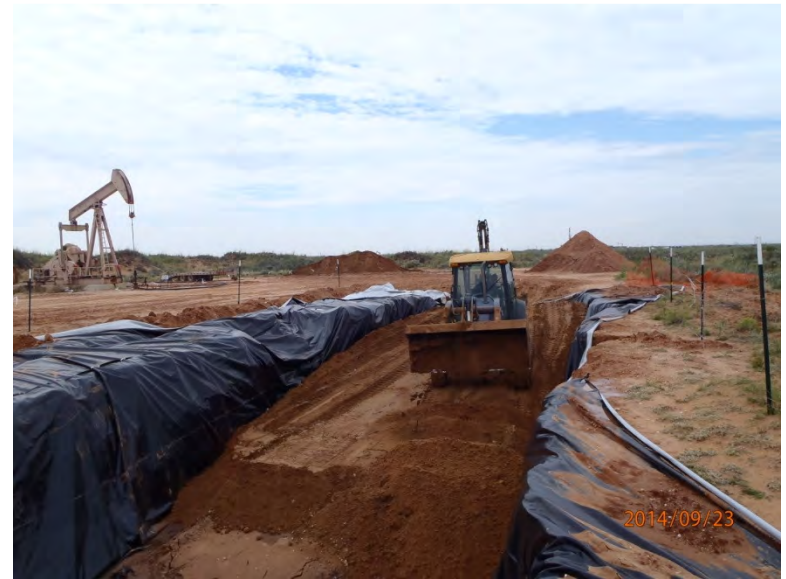
Deep burying contaminated soil, facing south 9/22/14

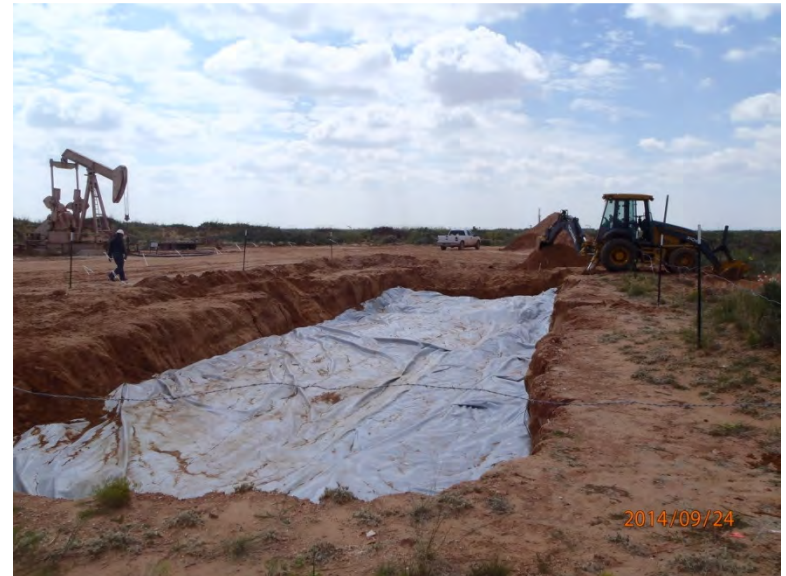
Liner installation over deep buried soil completed facing south 9/24/14

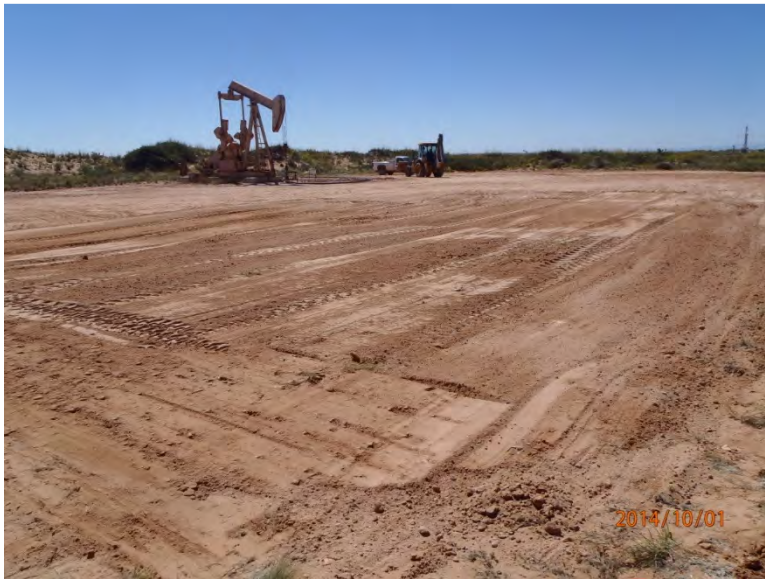
Backfilling of repository completed, facing south  
10/1/14

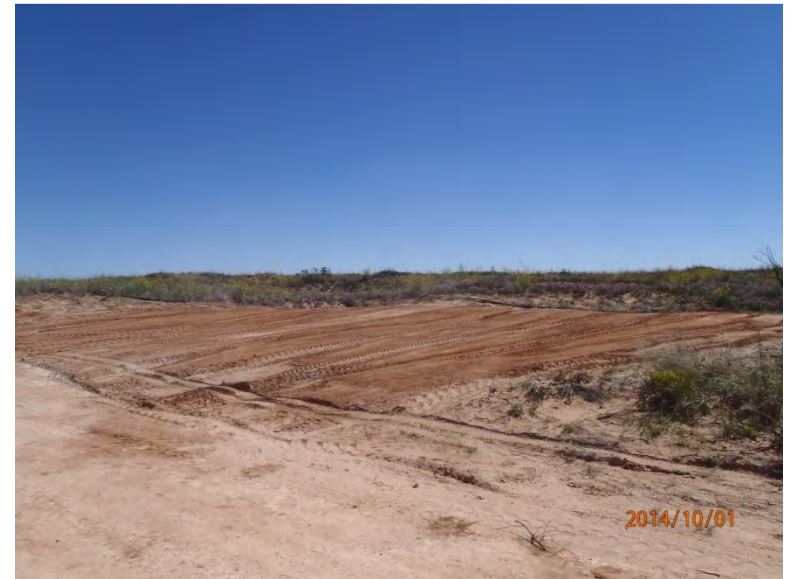
Backfilling of release area completed, facing southeast  
10/1/14

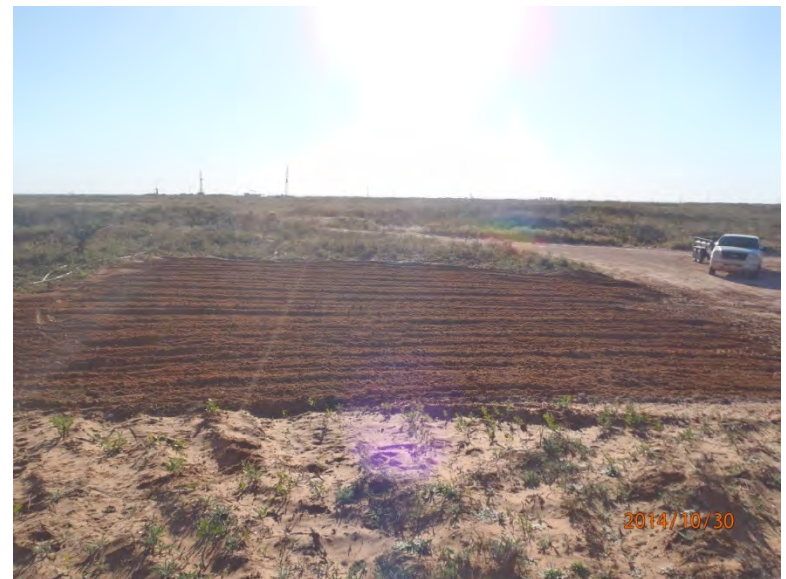
Site completed, facing west 10/30/14

On October 30<sup>th</sup>, 2014, soil amendments were added to the disturbed area around the release excavation, and the site was seeded with LPC mix. Photo documentation of the field activities can be found in Appendix D.
