Mirage 30 PM St. com #1H battery

### API# 30-015-40753

# **Corrective Action Plan**

### RE: Mewbourne Mirage 30 PM St. Com 1H – Remediation Work Plan UL/P, Section 30, T19S, R29E API No. 30-015-40753

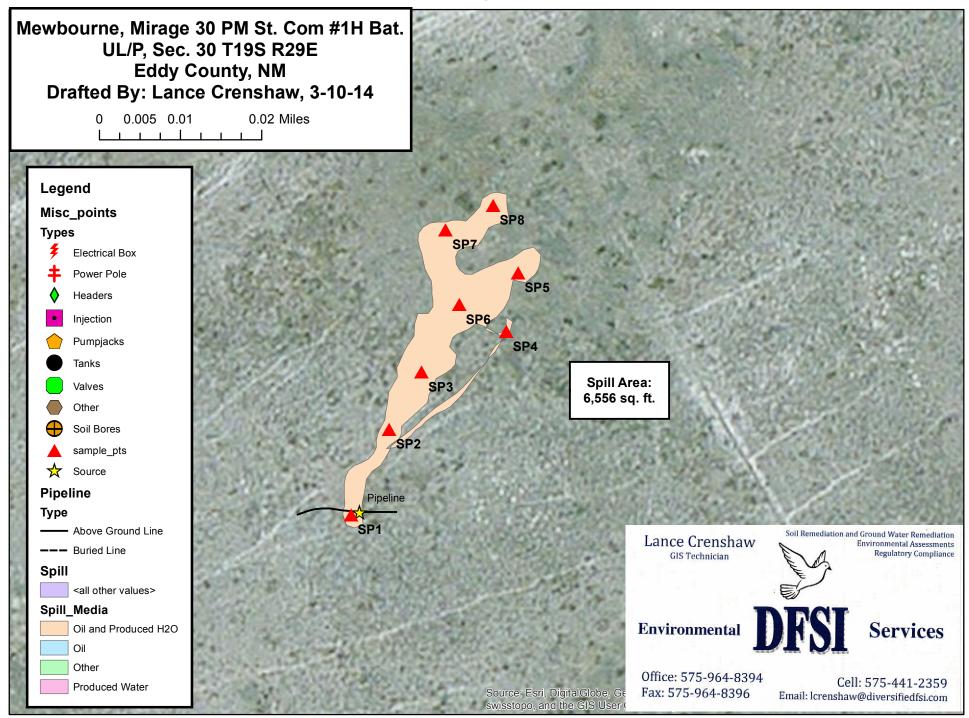
### Site Diagram

On March 10th, 2015 DFSI personnel obtained surface and below ground surface (BGS) samples of the leak area. Field samples were taken on eight sample points, each sample was tested for chlorides levels as well as BTEX. The BTEX samples were performed using a Mini Rae Photoionization Detector (PID). All clean field samples found under the BLM/NMOCD standards, were taken to Cardinal Lab of Hobbs to obtain confirmation samples. The results will be provided once obtained from the lab. The field data is attached.

DFSI proposes to remove the contaminated soil in the areas of Sp #1, #2, #3, #7 to 4' bgs. We will remove the contaminated soil in the areas of SP #6 and #8 to 3' bgs, We will remove contaminated soil in the areas of SP #4 and #5 to 2' bgs. All contaminated soil will be hauled to a NM approved disposal facility. We will backfill with clean native soil and reseed to NMOCD/BLM standards
