RE: Remediation Progress Report and Closure Proposal XTO Energy – ADU #816 UL-D, Section 4, Township 21 South, Range 27 East Eddy County, New Mexico NMOCD Reference # 2RP-2674

The following *Remediation Progress Report and Closure Proposal* serves as a condensed update on remedial activities undertaken and closure proposal for the above referenced Site.

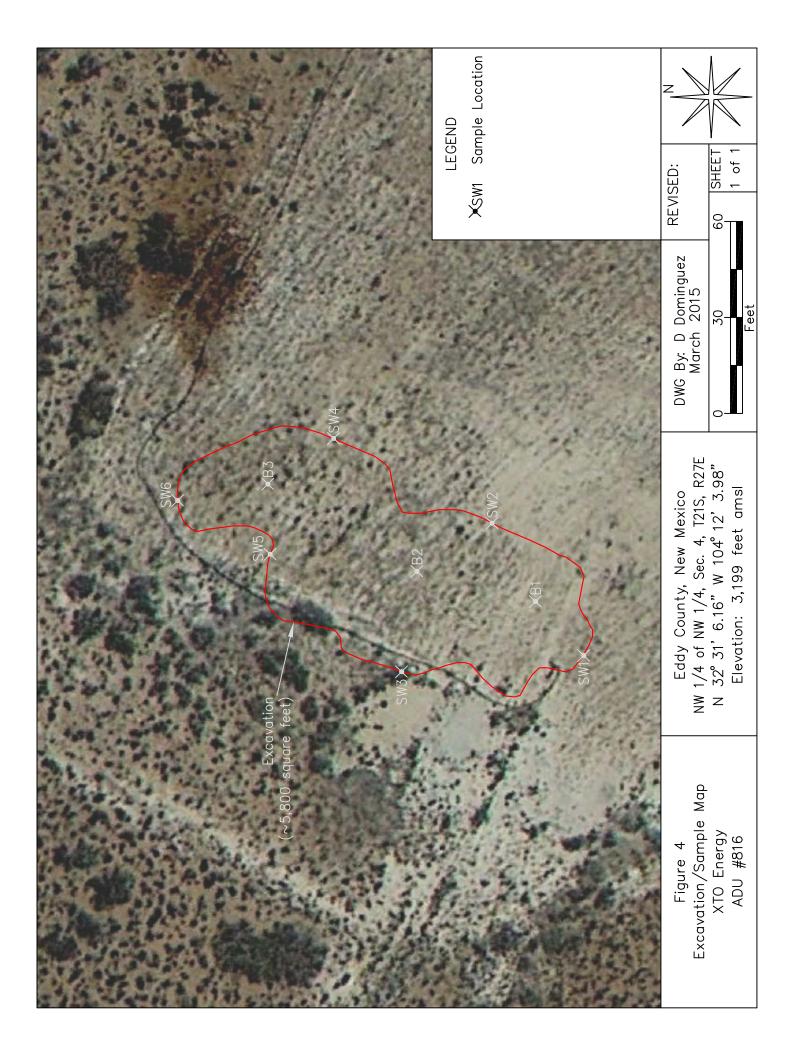
Laboratory analytical results indicate the excavation sidewalls and floor are void of Benzene, BTEX, and TPH concentrations in excess of NMOCD RRALs of 10 mg/Kg, 50 mg/Kg, and 100 mg/Kg respectively. However, Chloride concentrations exceed NMOCD RRALs of 250 mg/Kg in all samples other than SW3 and SW5 (reference *Figure 4* and *Table 2*).

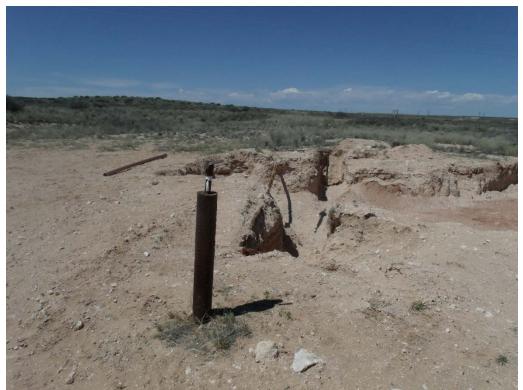
Photograph #1 – Looking north-westerly across excavation

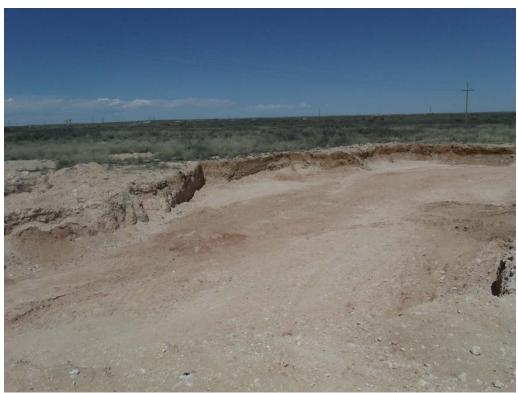
Photograph #2 – Looking north-westerly across excavation

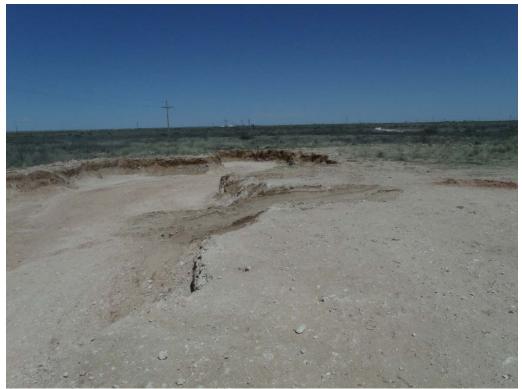
Photograph #3 – Looking northerly across excavation

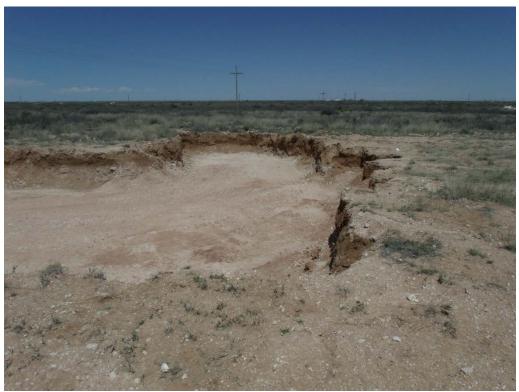
Photograph #4 – Looking northerly across excavation
