SITE CLOSURE REPORT

Henshaw Station 533 Crude Oil Release
Eddy County, New Mexico

NMOCD - 2RP #2820

Conestoga-Rovers & Associates

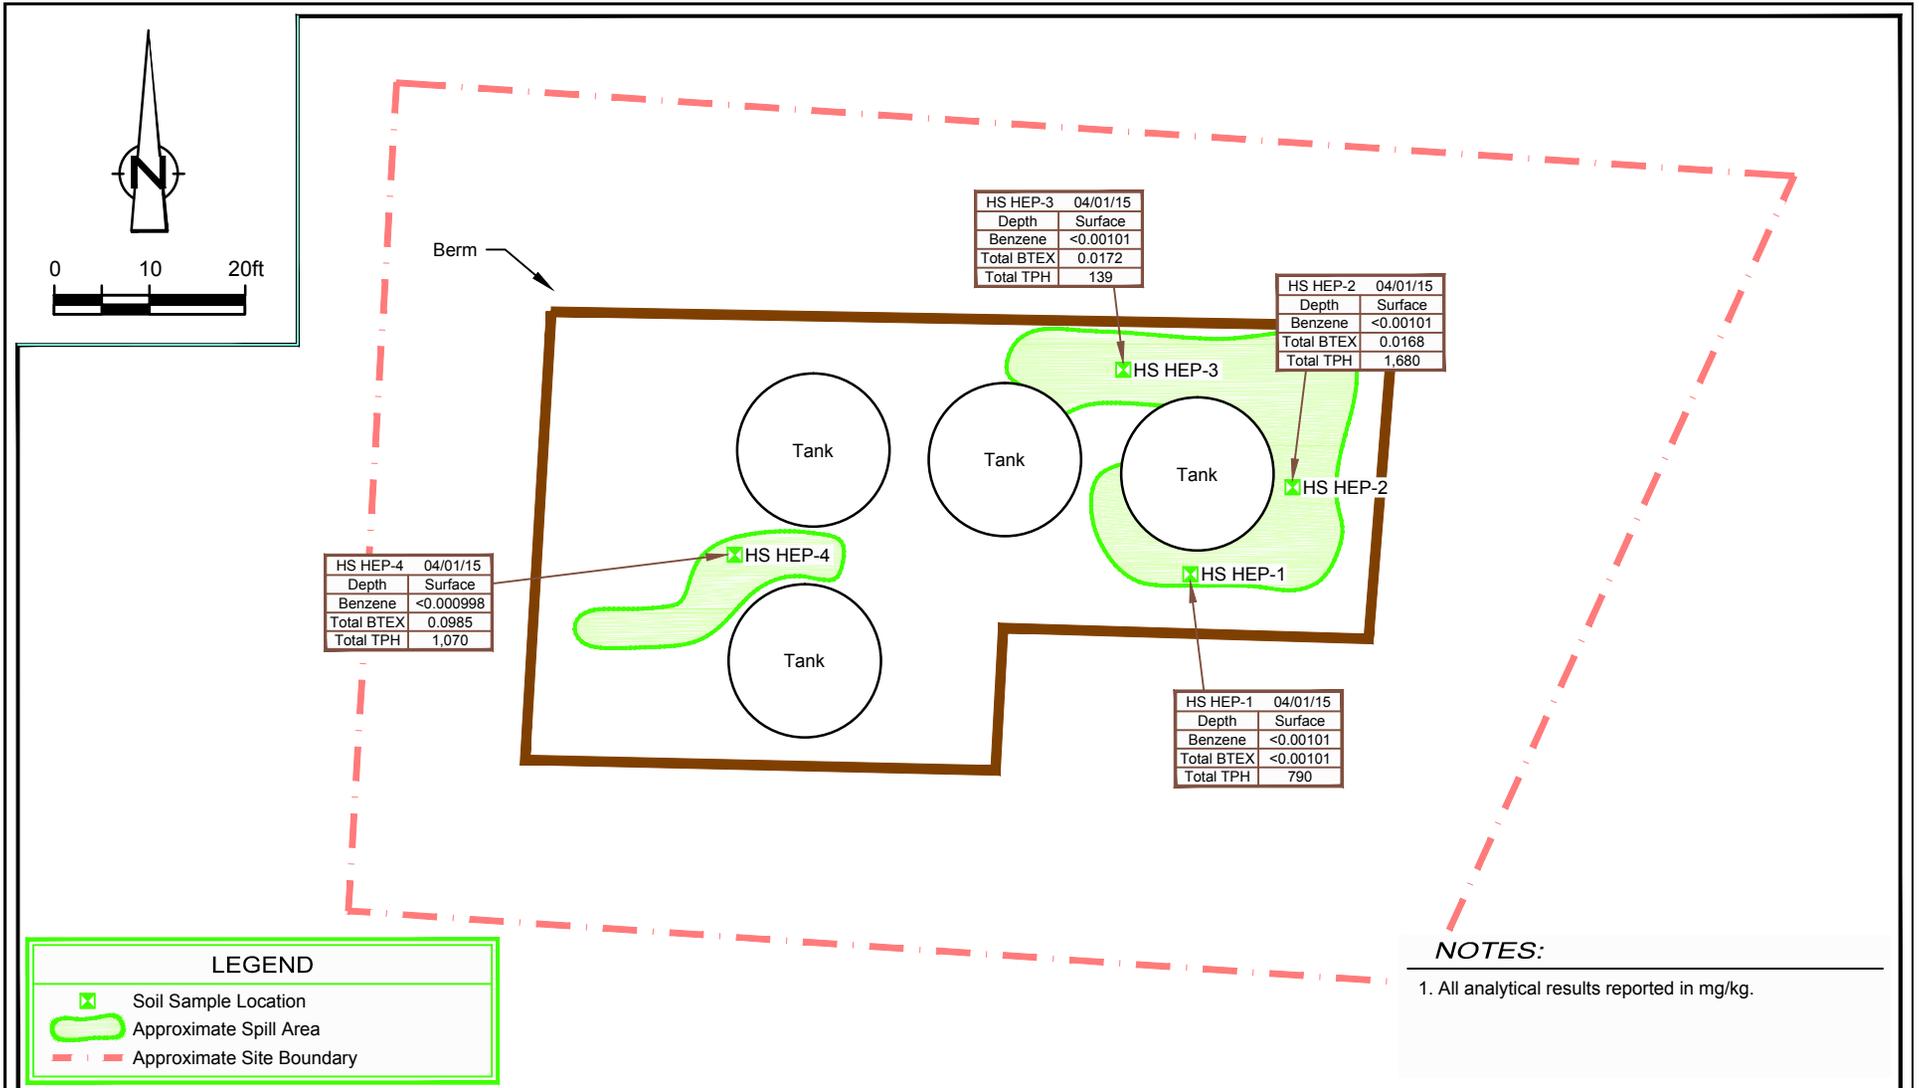
figure 3
 SITE DETAILS MAP AND ANALYTICAL RESULTS MAP
 HENSHAW STATION 5H
 EDDY COUNTY, NEW MEXICO
 Holly Energy

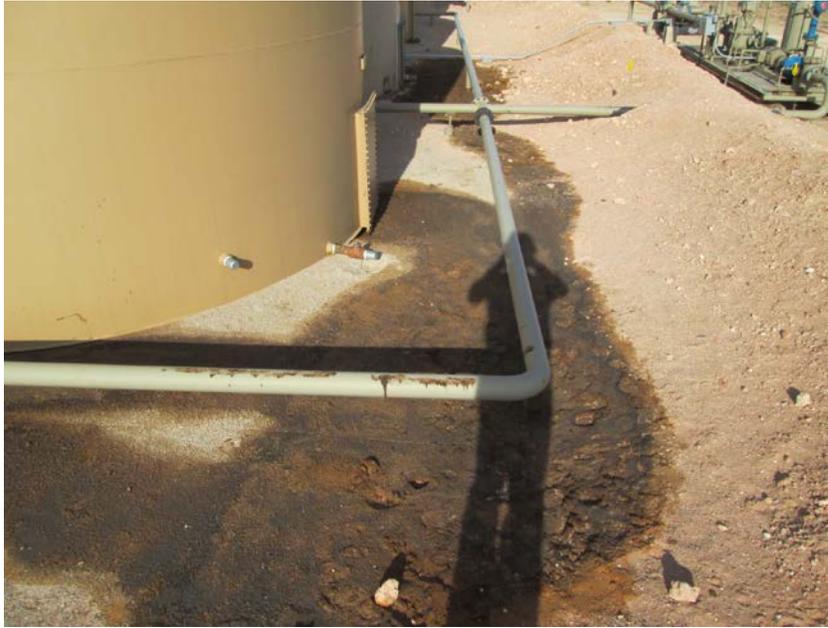
PHOTO 1: VIEW FACING WEST OF THE TANK BATTERY SHOWING PRODUCT SATURATED SOIL ALONG THREE CRUDE OIL TANKS

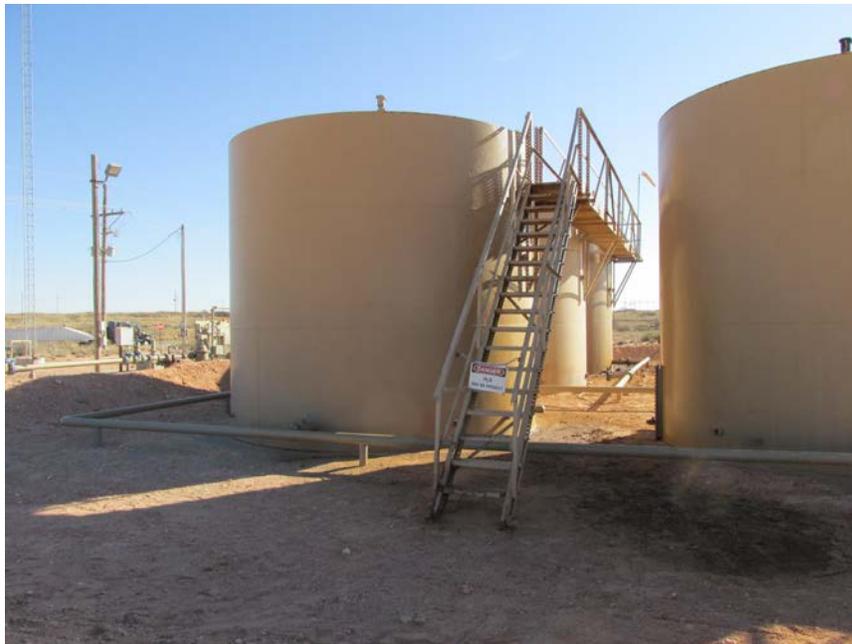
PHOTO 2: VIEW FACING NORTH EAST OF THE TANK BATTERY SHOWING PRODUCT SATURATED SOIL AROUND TWO CRUDE OIL TANKS

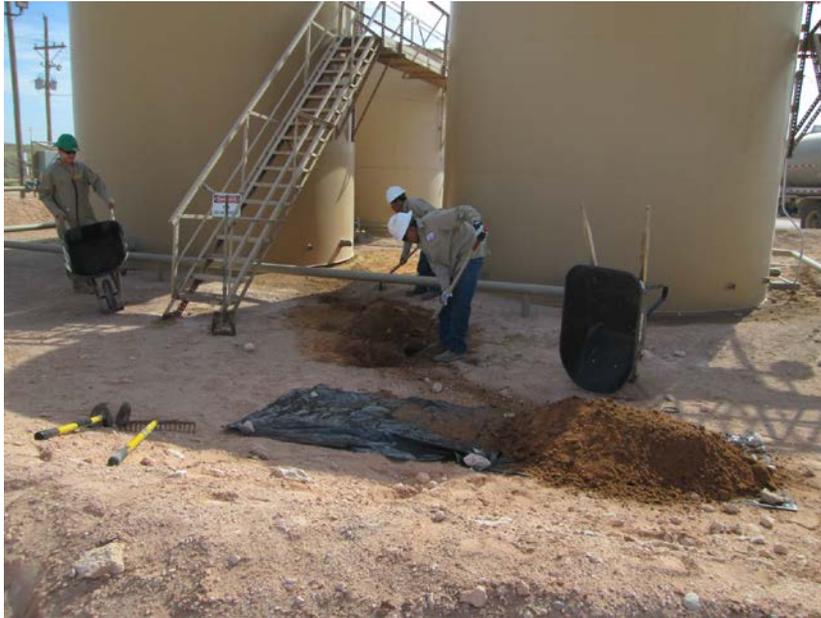
PHOTO 3: VIEW FACING NORTH EAST OF THE TANK BATTERY SHOWING SEVERAL LOBO'S CREW MEMBERS REMOVING PRODUCT SATURATED SOIL

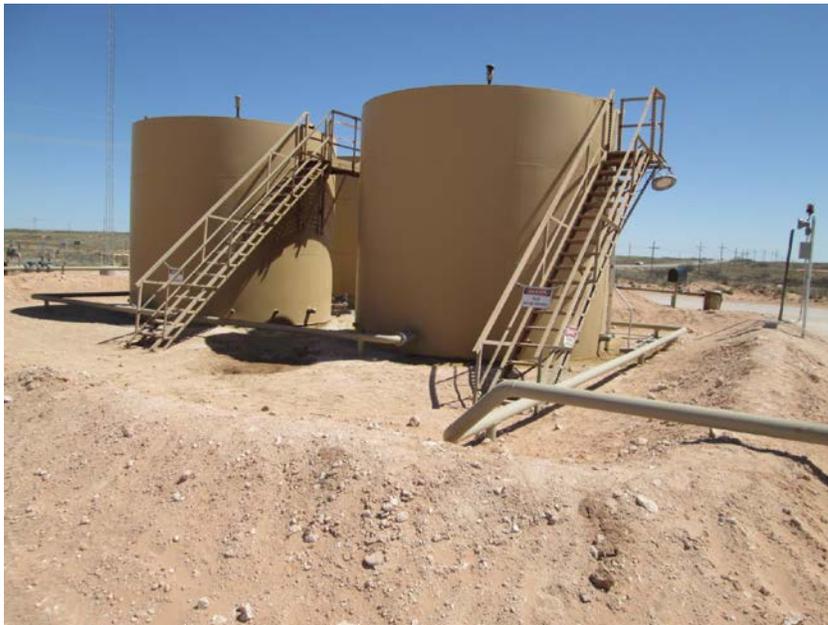
PHOTO 4: VIEW FACING NORTH EAST OF THE TANK BATTERY SHOWING REMEDIATED SOIL

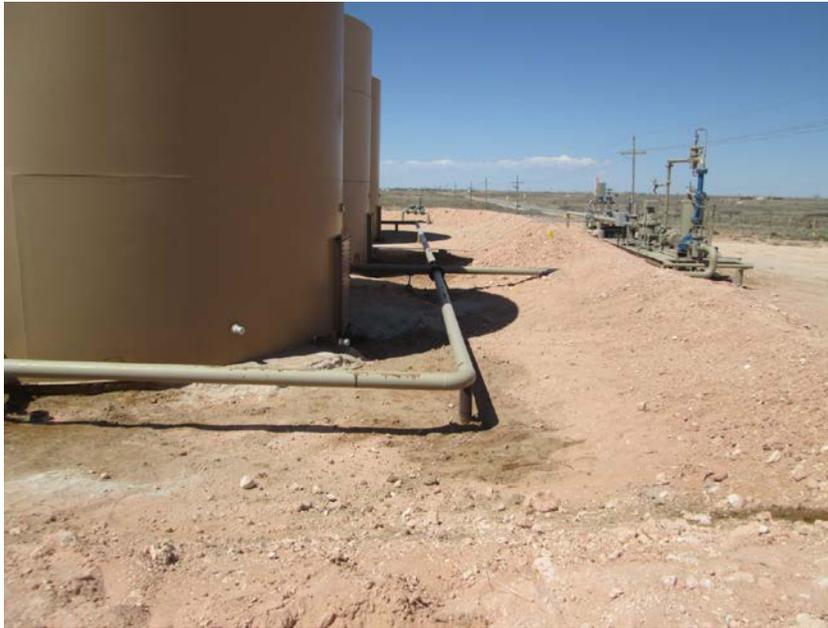
PHOTO 5: VIEW FACING WEST OF THE TANK BATTERY SHOWING REMEDIATED SOIL ALONG THREE CRUDE OIL TANKS
