REMEDIATION SUMMARY & SITE CLOSURE REQUEST

**BOPCO, LP
BIG EDDY UNIT DI-9 #35H FRAC TANK
API 30-015-42007
Eddy County, New Mexico
Unit Letter "P" (SE/SE), Section 21, Township 21 South, Range 30
East Latitude 32.45780° North, Longitude 103.88015° West
NMOCD Reference #2RP-2417**

April 2015

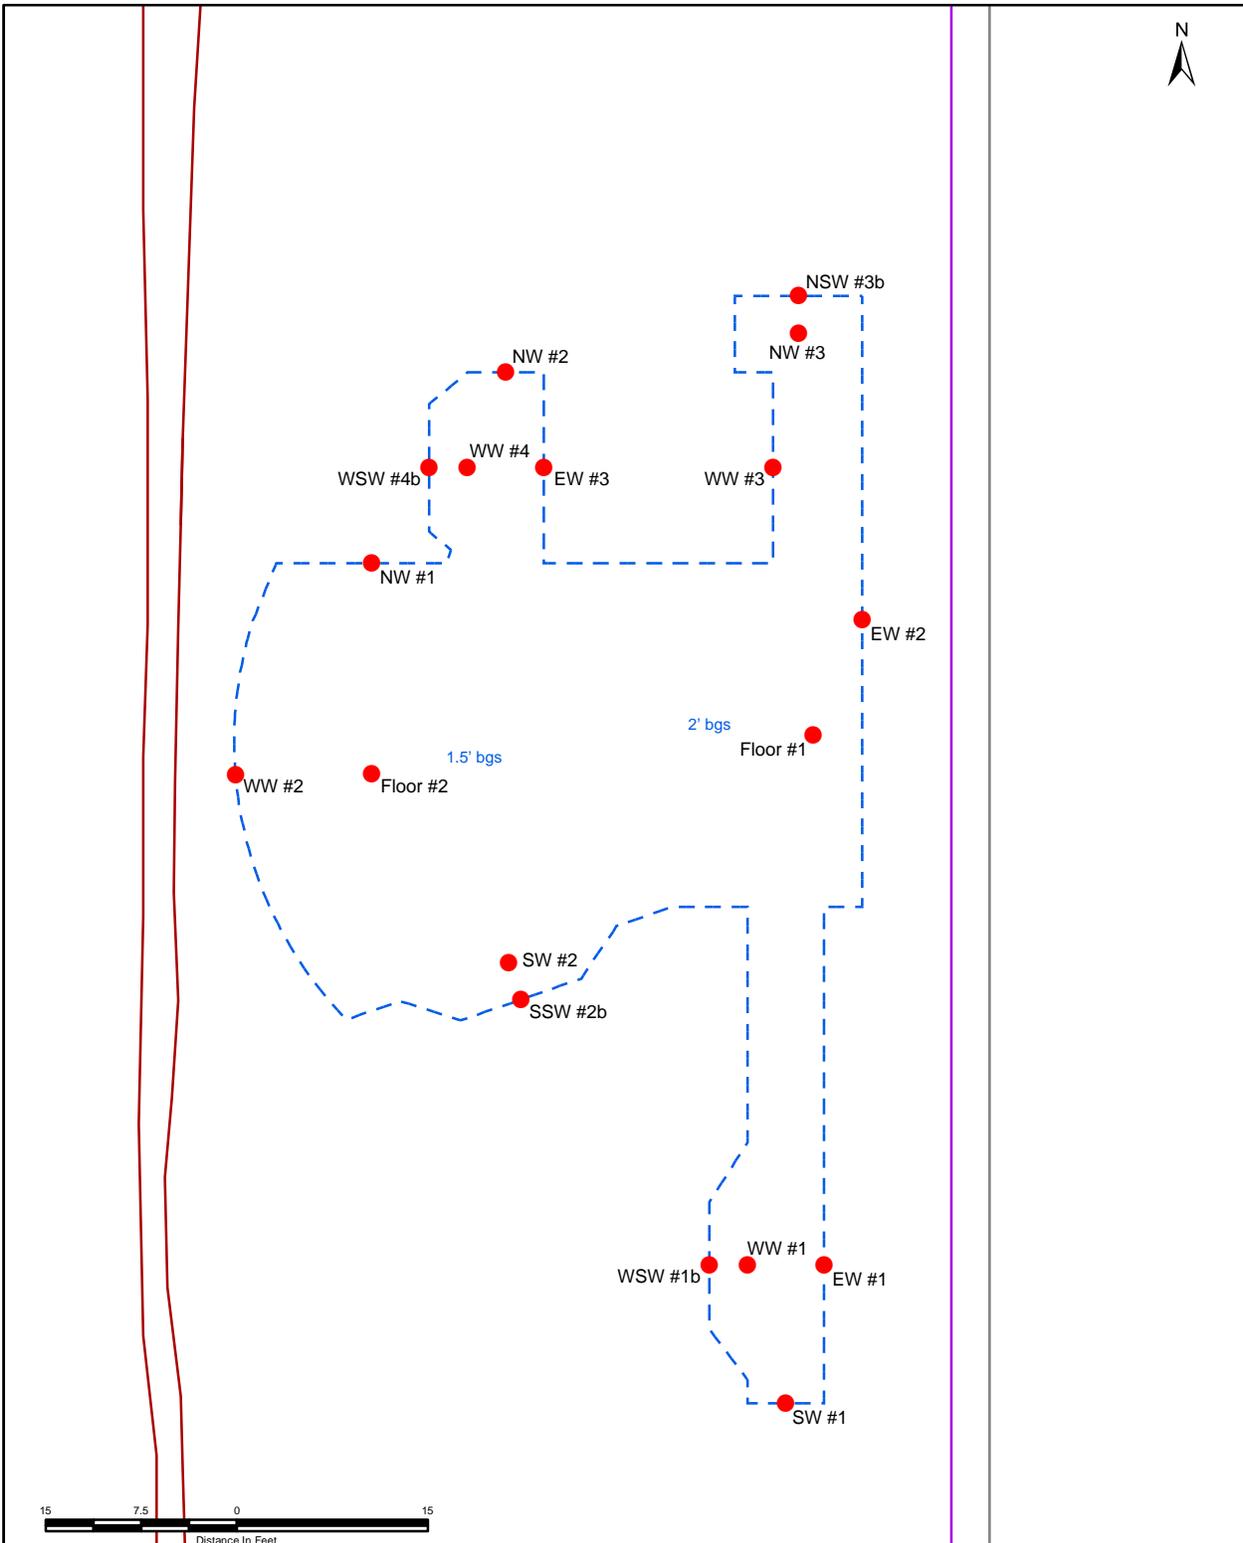
Figure 2
Site & Sample Location Map
BOPCO, LP
Big Eddy Unit DI-9 #35H
Eddy County, New Mexico
NMOC Ref. #: 2RP-2417

A summary of "Concentrations of Benzene, BTEX, TPH & Chloride in Soil" is provided in Table 1. A "Site & Sample Location Map" is provided as Figure 2. Laboratory analytical reports are provided in Appendix C.

On January 30, 2015, fourteen (14) soil samples (NW #1, NW #2, NW #3, SW #1, SW #2, EW #1, EW #2, EW #3, WW #1, WW #2, WW #3, WW #4, Floor #1, and Floor #2) were collected from the floor and sidewalls of the excavation and submitted to Cardinal Laboratories, Inc., in Hobbs, New Mexico, for analysis of chloride concentrations using the Environmental Protection Agency (EPA) analytical method listed in Section 4.1, "Soil Sampling", below. Samples Floor #1 and Floor #2 were also analyzed for concentrations of TPH and BTEX. Laboratory analytical results indicated chloride concentrations ranged from less than the laboratory method detection limit (MDL) in samples SW #1, EW #1, and Floor #2 to 1,640 mg/kg in sample WW #4. TPH and BTEX constituent concentrations in samples Floor #1 and Floor #2 were less than the appropriate laboratory MDL. Based on these laboratory analytical results, additional excavation was required in the areas represented by samples NW #3, SW #2, WW#1, and WW #4.

On February 12, 2015, the excavation was advanced in the areas represented by samples NW #3, SW #2, WW#1, and WW #4. Samples collected from the excavation sidewalls were field-screened with a chloride test kit, and four (4) confirmation samples (NSW #3b, SSW #2b, WSW #1b, and WSW #4b) were submitted to the laboratory for analysis of chloride concentrations. Laboratory analytical results indicated chloride concentrations ranged from 64.0 mg/kg in sample NSW #3b to 432 mg/kg in sample WSW #1b.

Based on laboratory analytical results, the excavation was backfilled with the blended material, compacted, and contoured to fit the surrounding topography. Prior to backfilling, the final dimensions of the excavation were approximately eighty-four feet (84') in length, fifty feet (50') in width, and one (1) to two feet (2') in depth.

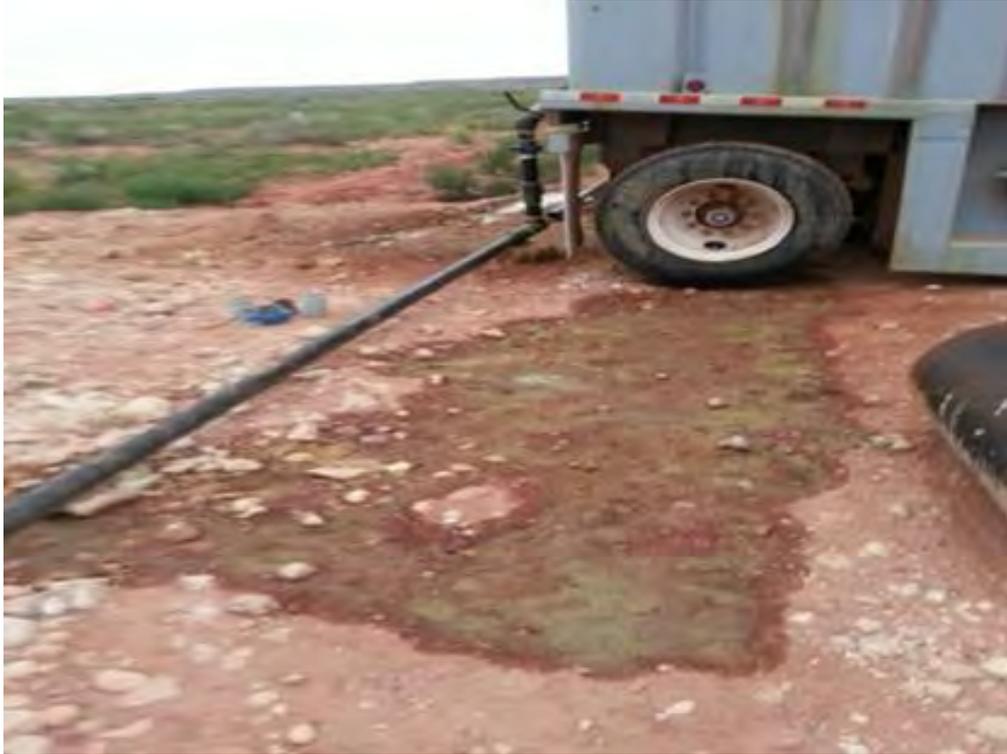
Big Eddy Unit DI-9 #35H – Point of Release

On July 18, 2014, BOPCO discovered a release had occurred at the Big Eddy Unit Drilling Island (DI) 9 #35H well pad. A leak in a hammer union and a subsequent gas kick caused a frac tank to overflow, resulting in the release of approximately two barrels (2 bbls) of crude oil and seven barrels (7 bbls) of produced water. During initial response activities, the hammer union was retightened.

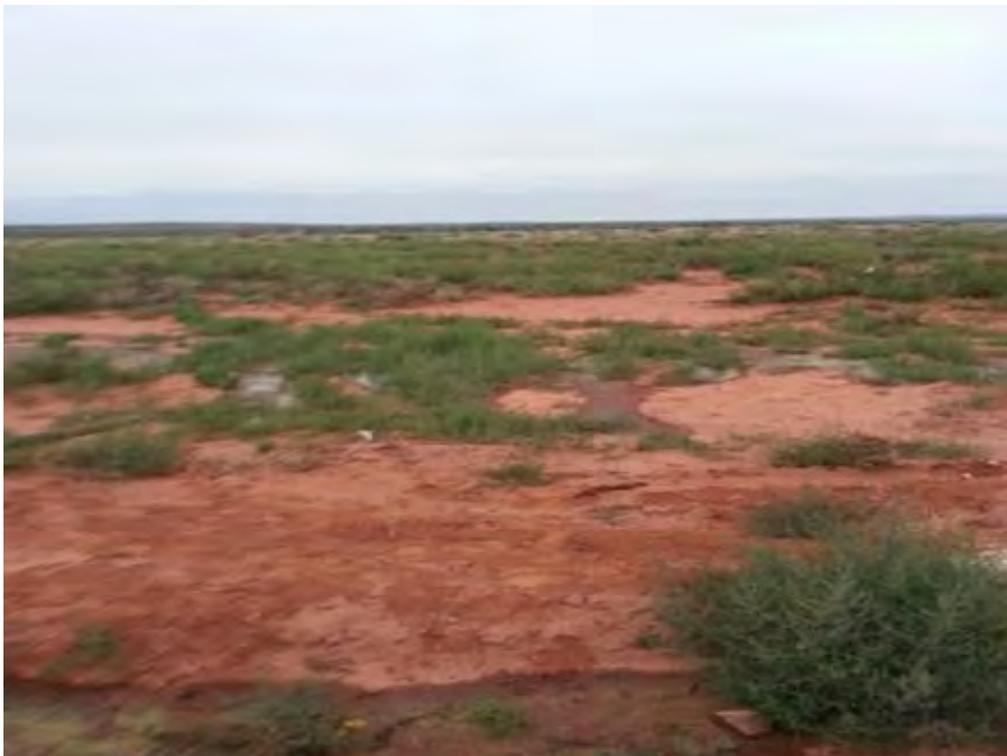
Big Eddy Unit DI-9 #35H – Release Site

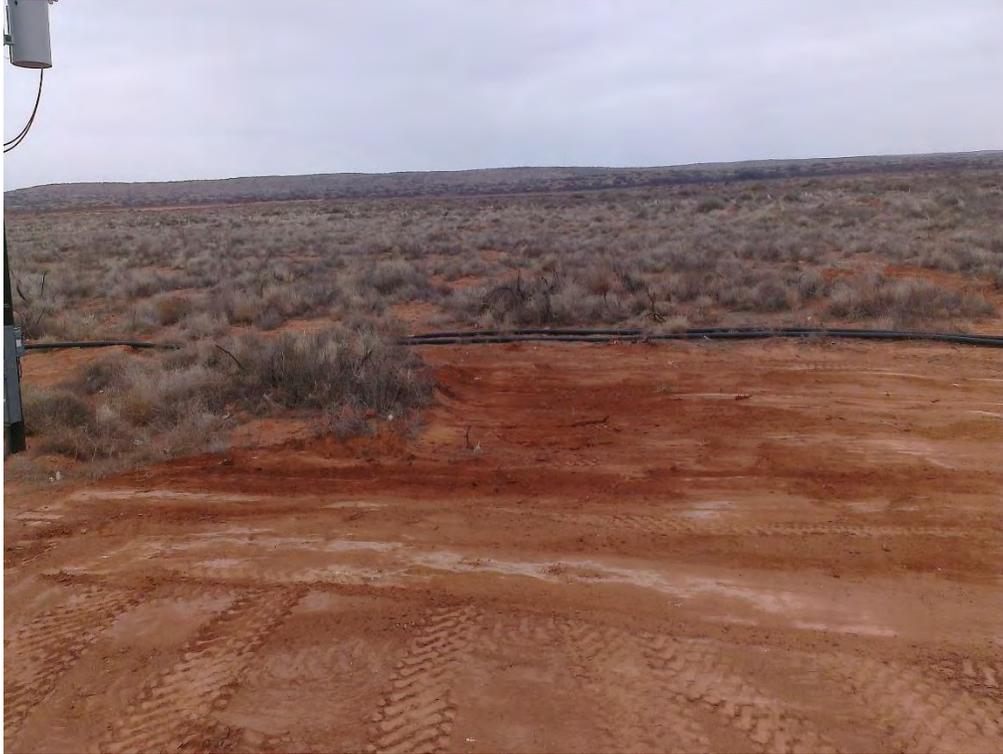
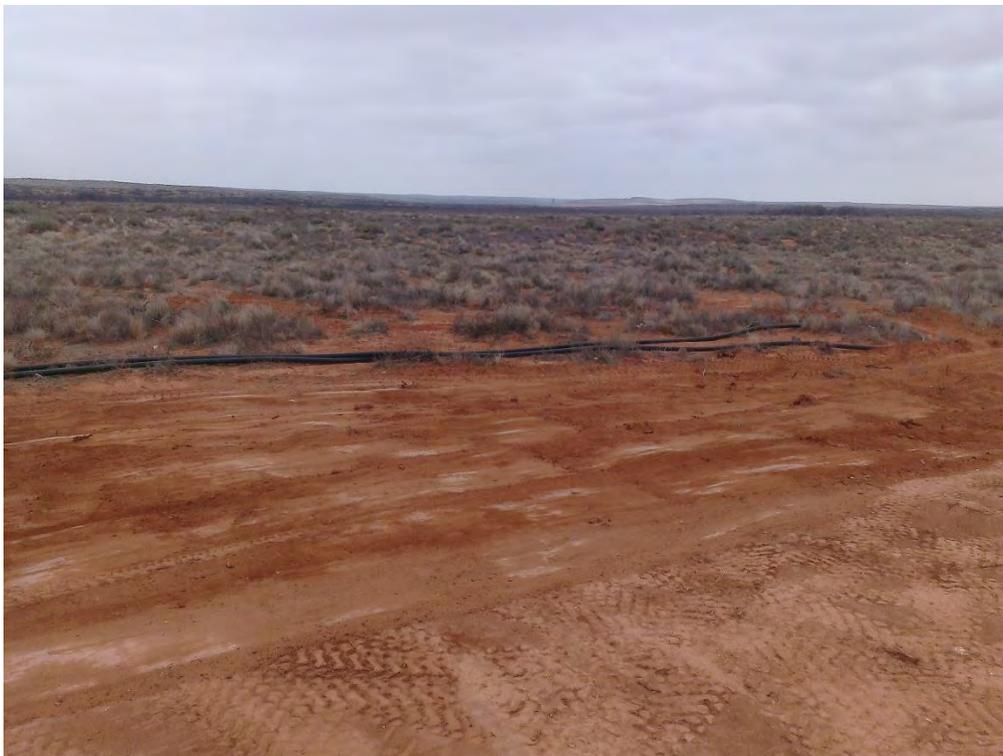
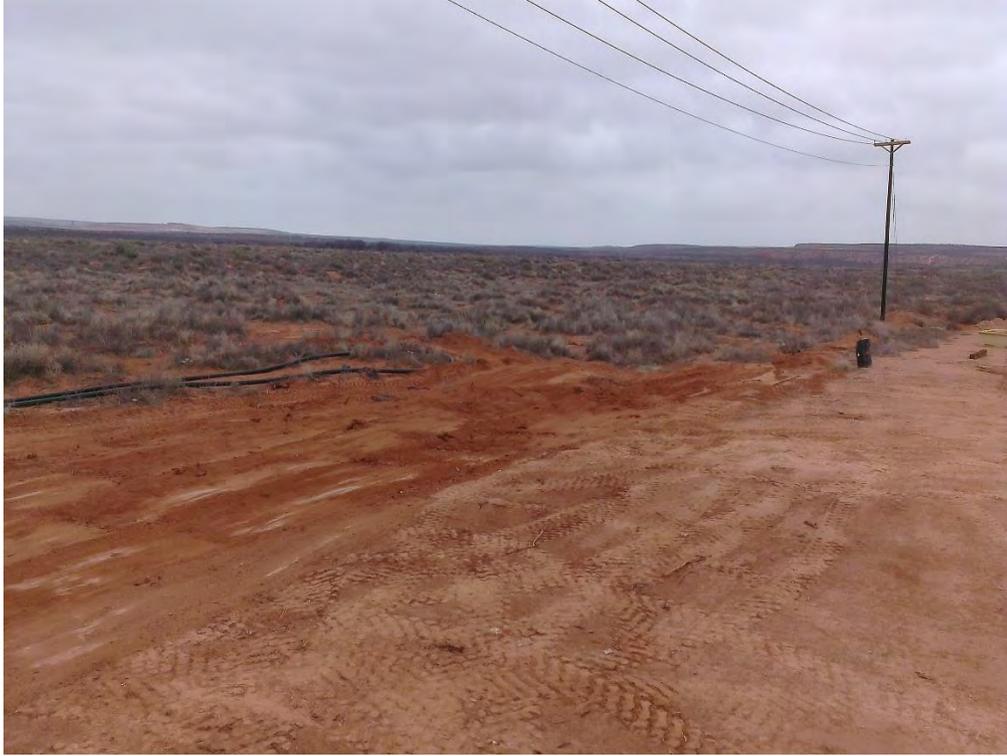
Big Eddy Unit DI-9 #35H – Backfilled Excavation
