SOIL REMEDIATION WORKPLAN FOR INCIDENT 2RP-2834

COG OPERATING LLC
JENKINS B FEDERAL #007
API# 30-015-29451
SECTION 20, T17S R30E, NM
EDDY COUNTY, NM

May 29, 2015
Reference 5B23978 BG4

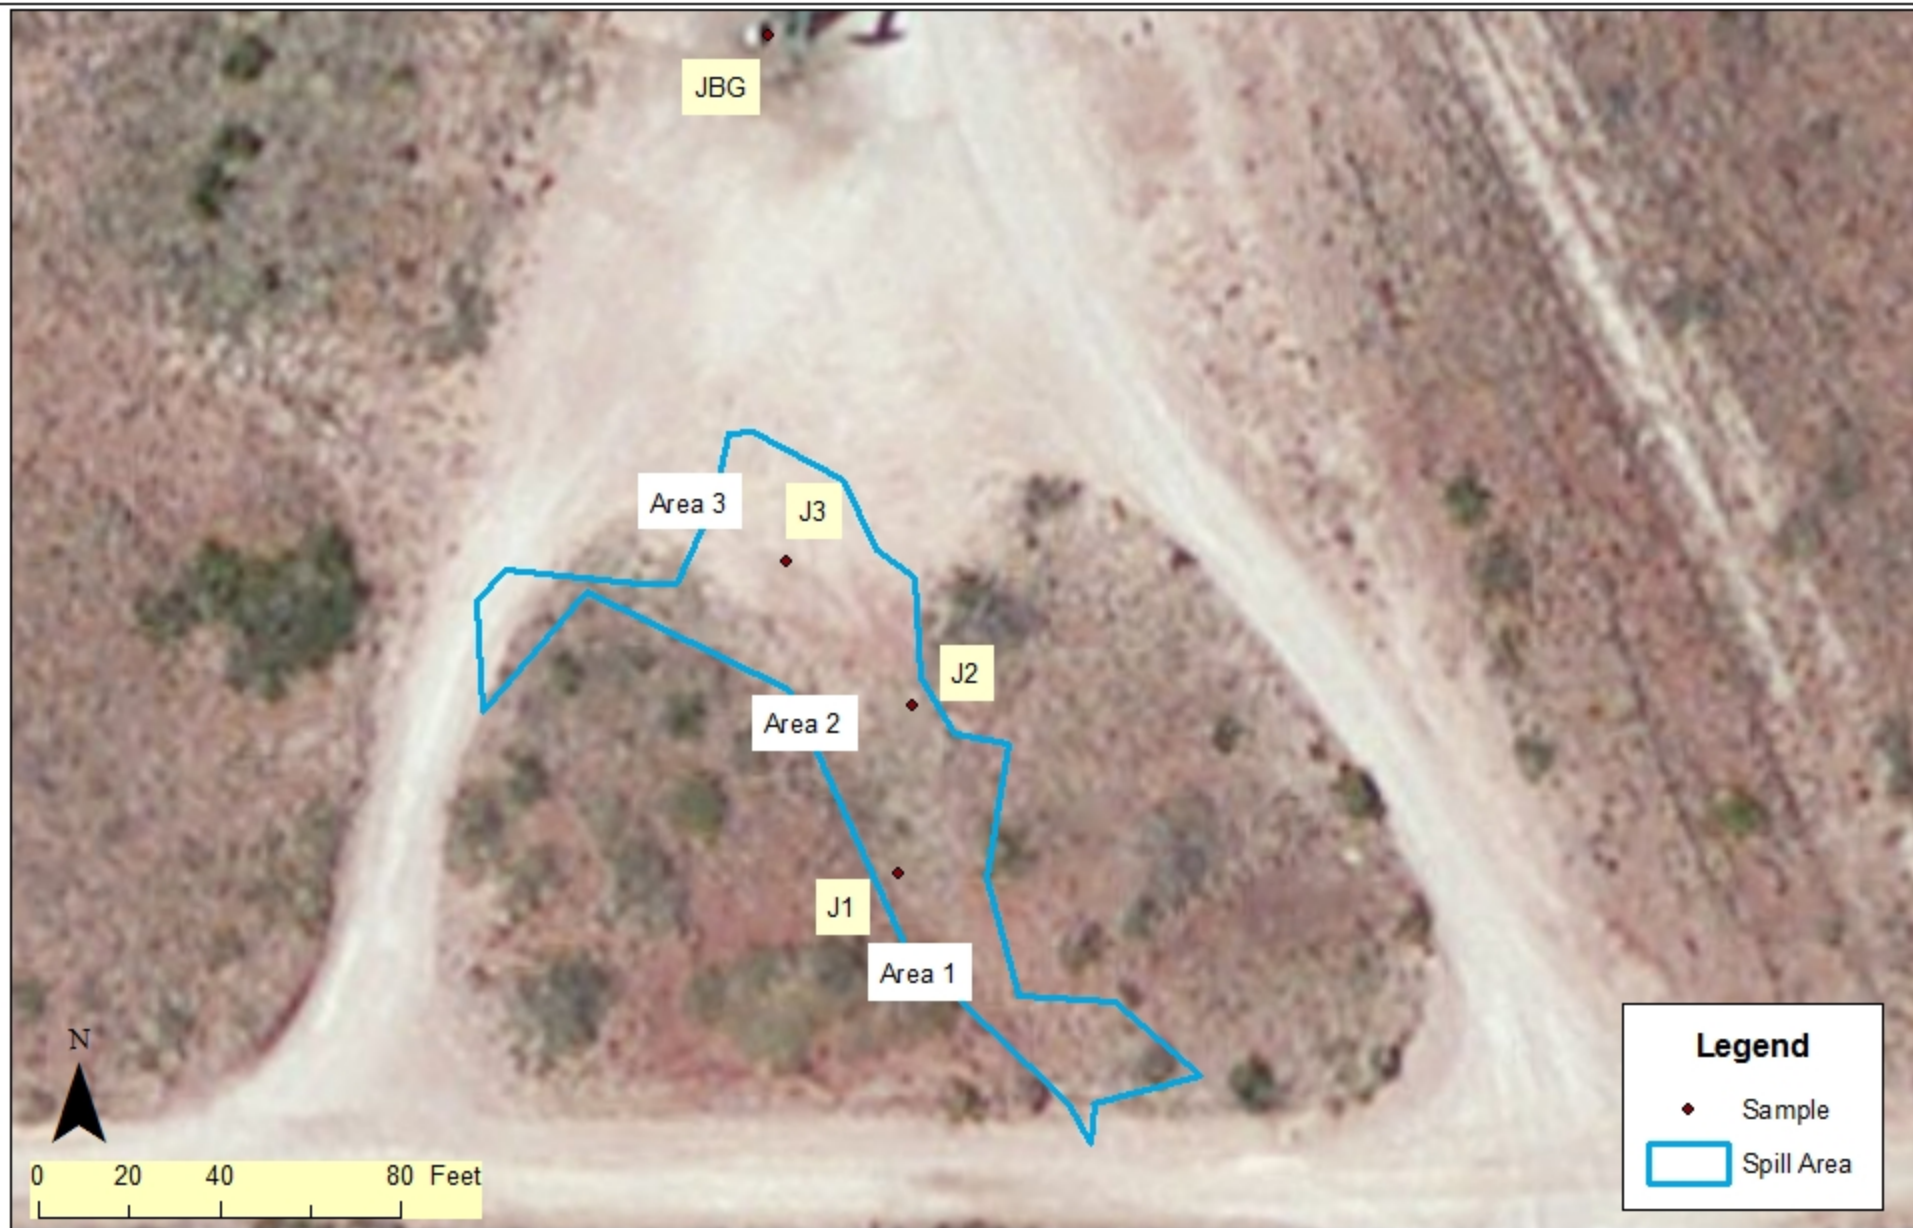
Soil samples were taken at depths ranging from 24 inches below surface grade (bsg) to 33 inches bsg. Specific sample locations for all samples are depicted on Figure 2 (Sample Location Map) along with sampling details. All samples were collected and processed according to NMOCD soil sampling procedures. The samples were sent under chain-of-custody protocols to Hall Environmental Analysis Laboratory for analysis for Benzene and Total BTEX using EPA Method 8021B, DRO and GRO by EPA Method 8015D, and total Chlorides using EPA Method 300.0.

SITE DETAILS AND SAMPLE LOCATIONS MAP

Sample Location Map
Jenkins B Federal #7 - COG
Loco Hill, New Mexico

The initial soil assessment activities performed by SMA effectively delineated the horizontal and vertical extent of Chloride and hydrocarbon affected soils in accordance to NMOCD regulatory guidance. The excavation will be guided by SMA personnel in the field, using EPA Method 4500 titrations along with a properly calibrated Photoionization Detector in accordance with the NMOCD Guidelines for Remediation of Leaks, Spills and Releases. Excavation will occur at different depths within the spill area. In Area 1, excavation will be to 12-18 inches bsg. In Area 2, excavation will be performed to 12-18 inches bsg. In Area 3, the excavation will go to 24 inches bsg. Samples will be taken in the sidewalls and bottom to ensure contaminated soils have been removed. All soil will be hauled to an NMOCD approved waste facility. A tractor will rip the bottom of the excavation and new top soil will be added to bring the excavated area to surface grade.
