## **CLOSURE REPORT**

**BOPCO, L.P.**  
**BEU Hackberry 34 Fed #1**  
**Eddy County, New Mexico**  
**Unit Letter "A", Section 34, Township 19 South, Range 31 East**  
**Latitude 32.621733 North, Longitude 103.851513 West**  
**NMOCD Reference #2RP-3001**

RE: Final Closure Report  
Bopco – BEU Hackberry 34 Fed #1  
UL-A, Section 34, Township 19 South, Range 31 East  
Eddy County, New Mexico  
NMOCD Reference # 2RP 3001

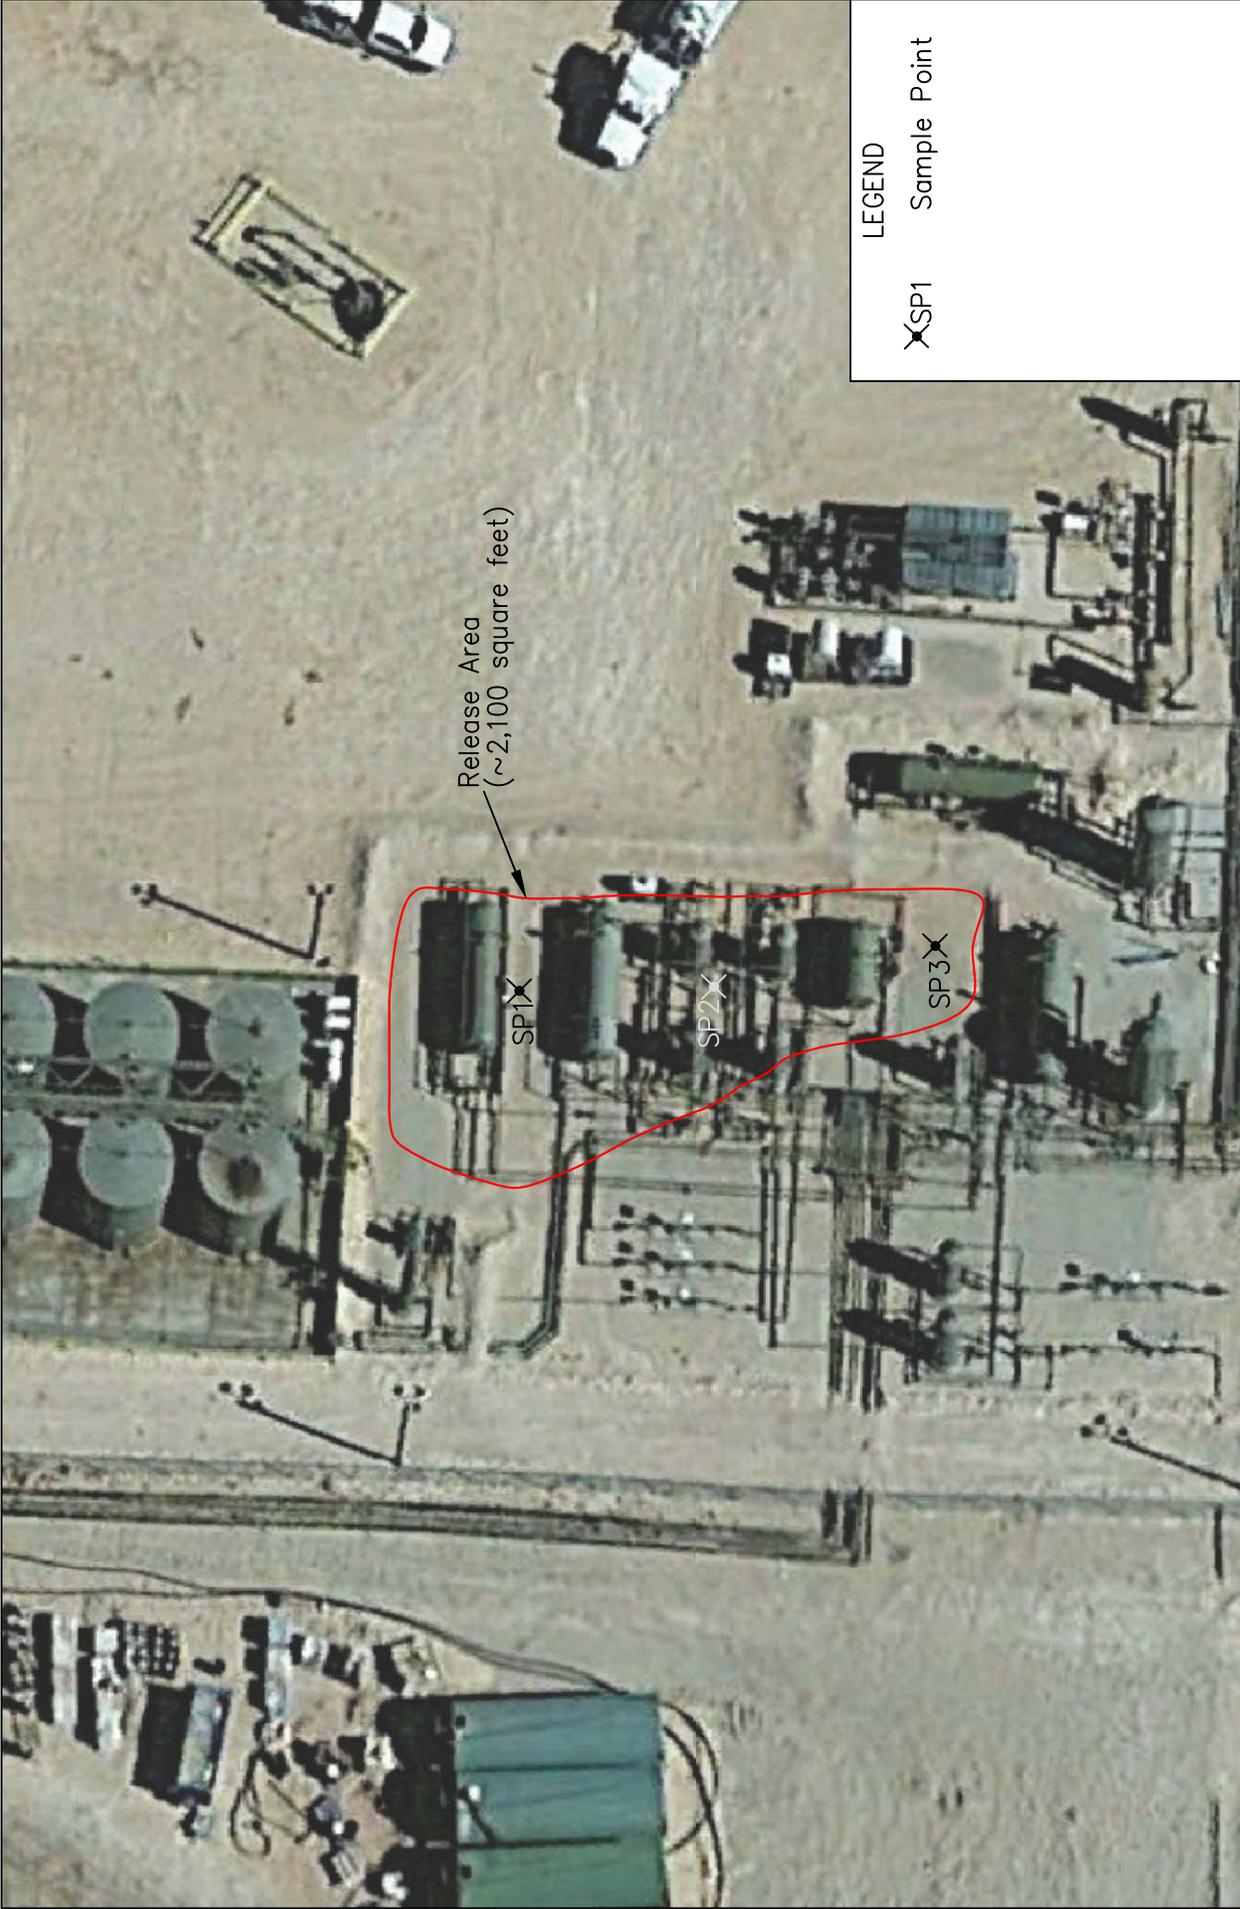
Figure 3  
 Site/Sample Map  
 Bopco, L.P.  
 BEU Hackberry 34 Fed #1

EPI personnel mobilized on the site on May 7, 2015 to collect soil samples via hand auger to determine the vertical extent of contamination. A total of five (5) soil samples were collected from three (3) sample locations; SP1 – SP3. All samples were sent to Cardinal Labs in Hobbs, New Mexico, for testing. Laboratory analytical results indicate that the release area is void of Benzene, BTEX, TPH, and Chloride concentrations in excess of NMOCD Recommended Remedial Action Levels (RRALs) of 10 mg/Kg, 50 mg/Kg, and 5,000 mg/Kg, and 1,000 mg/Kg respectively (reference *Figure 3* and *Table 2*).

Release Area  
(~2,100 square feet)

The release area was excavated via Hydro-Vac truck to a depth of eight (8) inches bgs with approximately 36.91 tons of contaminated soil excavated and hauled to a state approved facility for disposal.

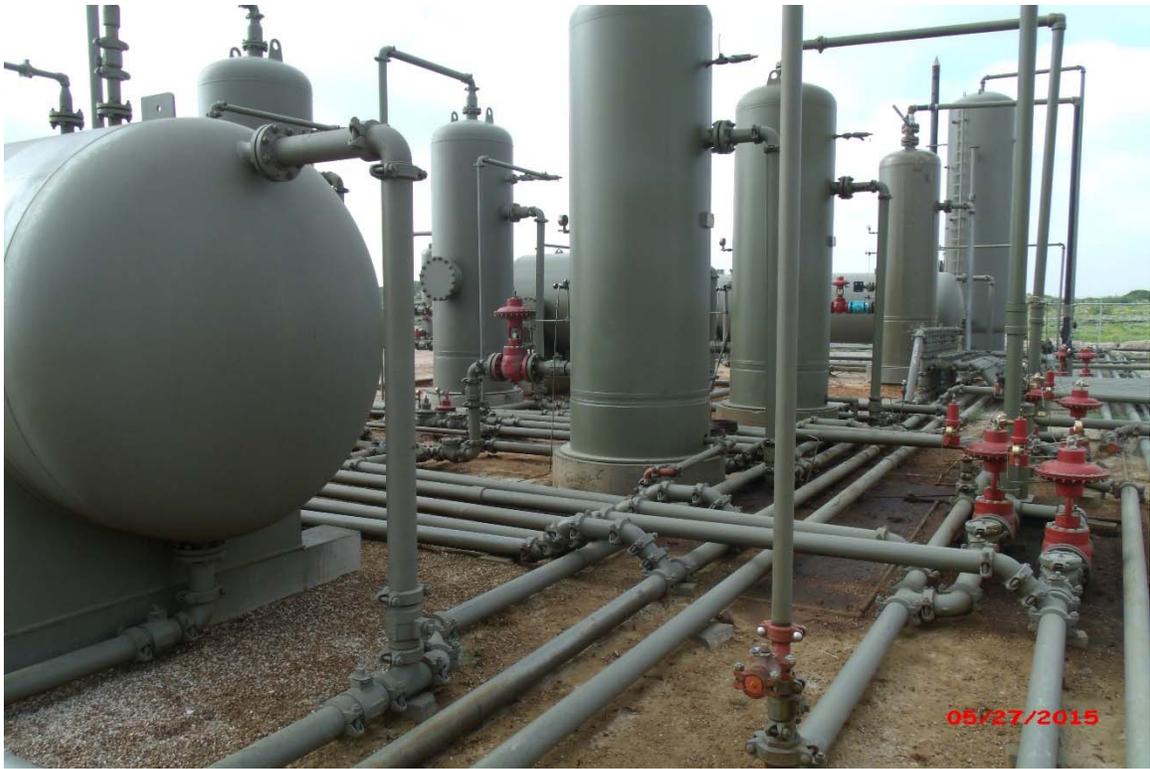
The sight glass on the heater-treater broke, unknown reason. The sight glass valve was closed until the sight glass could be replaced. The spill impacted approximately 2,100 sq. ft. of caliche pad area around the process equipment with standing fluid, and approximately 2200 sq. ft. of pad area was lightly misted. The free standing fluid was recovered with a vacuum truck. EPI environmental crew worked on removing the saturated soil with a hydro-vac; 28 cubic yards of material was hauled to R-360 for disposal. Soil samples were collected and delivered to the lab for confirmation analysis.

Photograph #1 – Release area

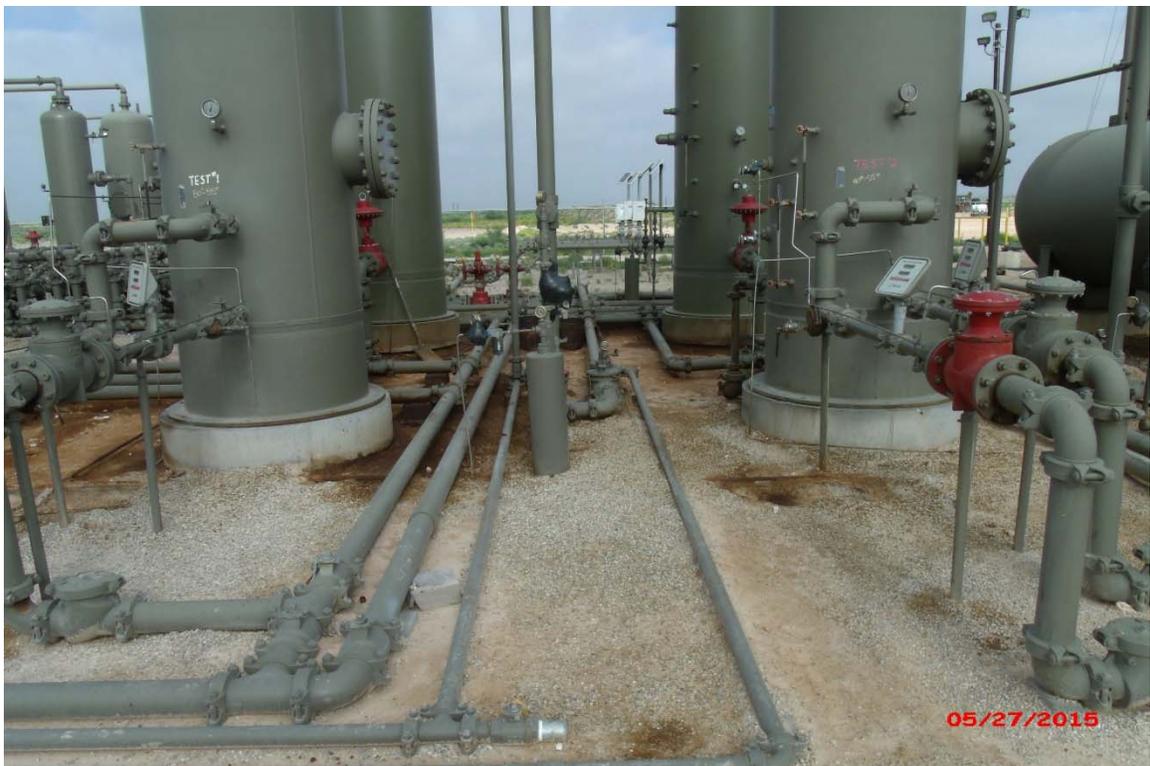
Photograph #2 – Release area

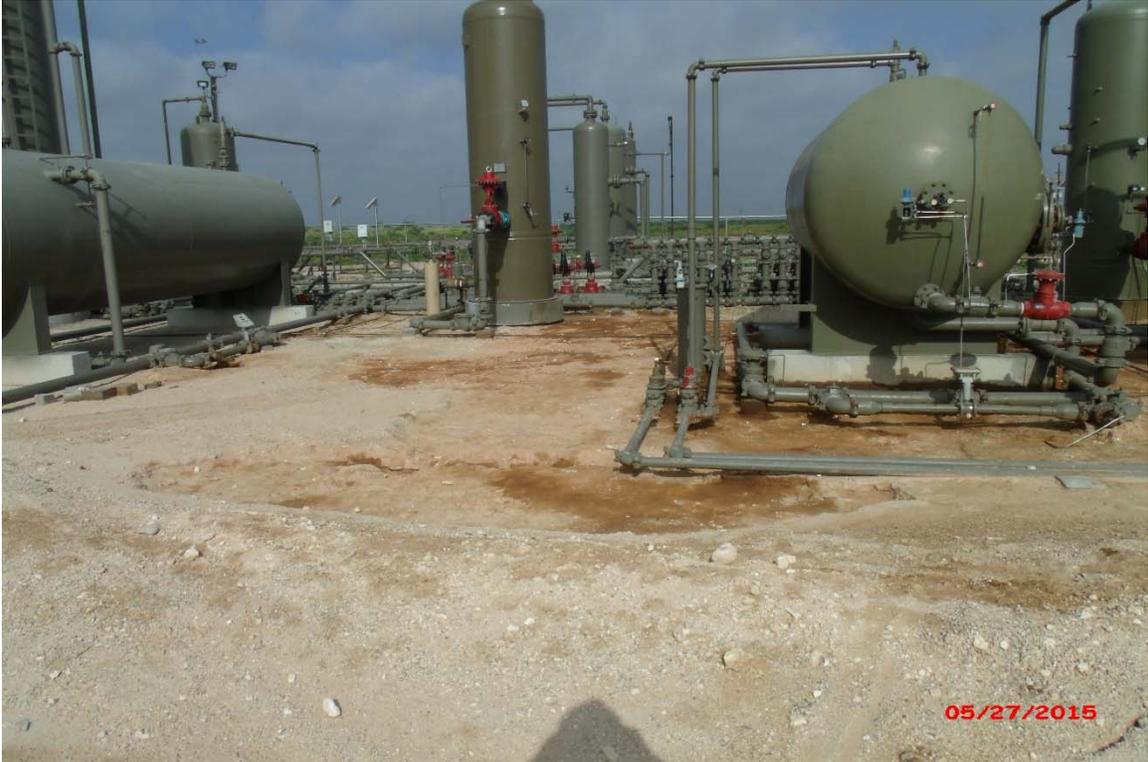
Photograph #3 – Release area excavated with Hydro-Vac

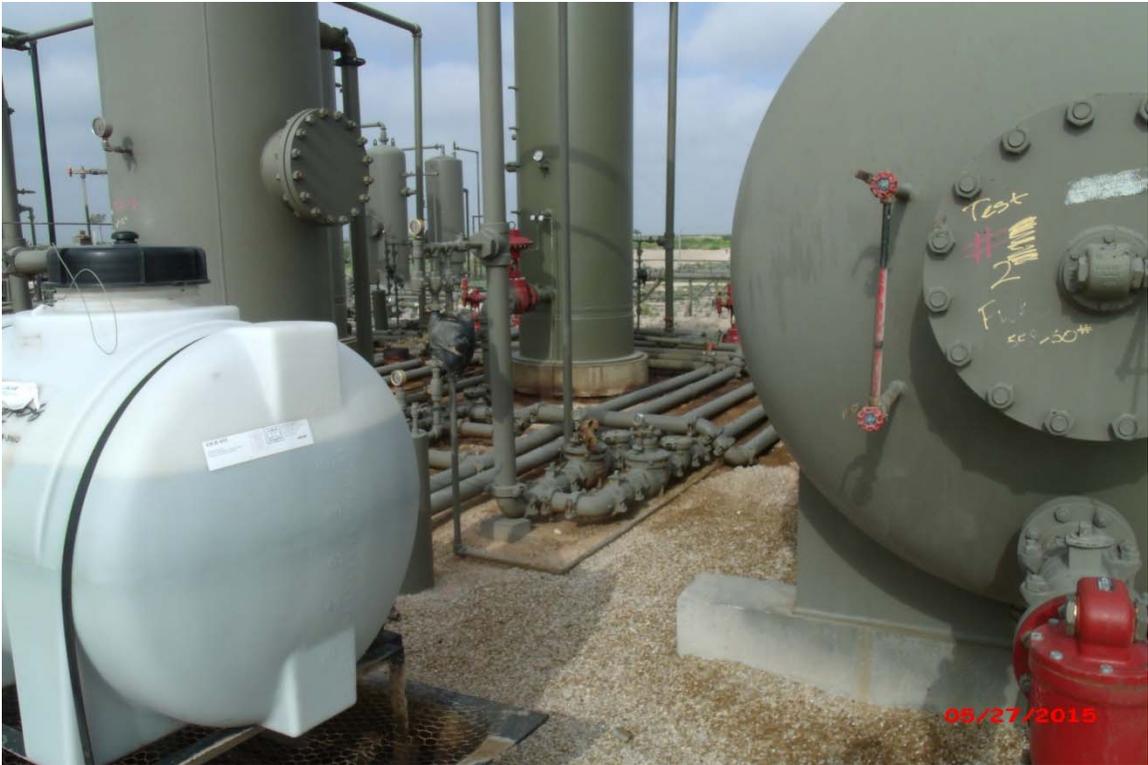
Photograph #4 – Release area excavated with Hydro-Vac

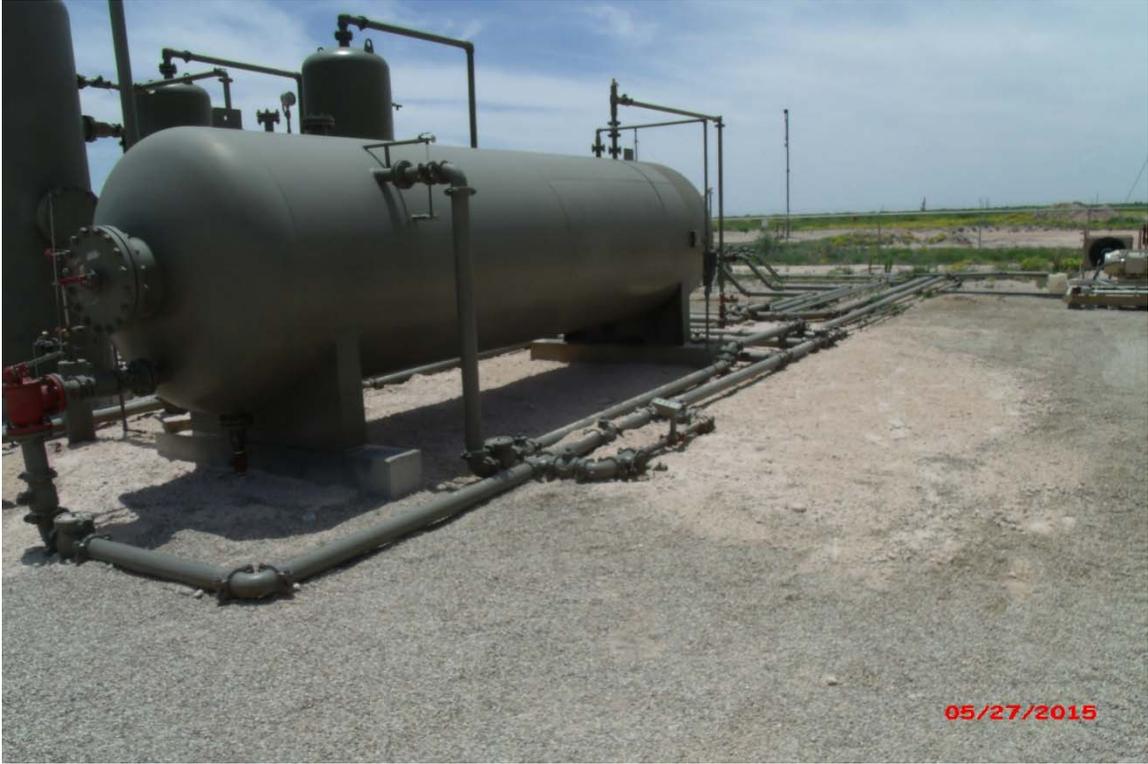
Photograph #5 – Backfilled

On May 27, 2015 the excavation was backfilled with approximately 36.91 tons of clean soil free of rocks, clumps or deleterious material. The entire disturbed area was then contoured to blend with existing pad area and protected against wind/water erosion.

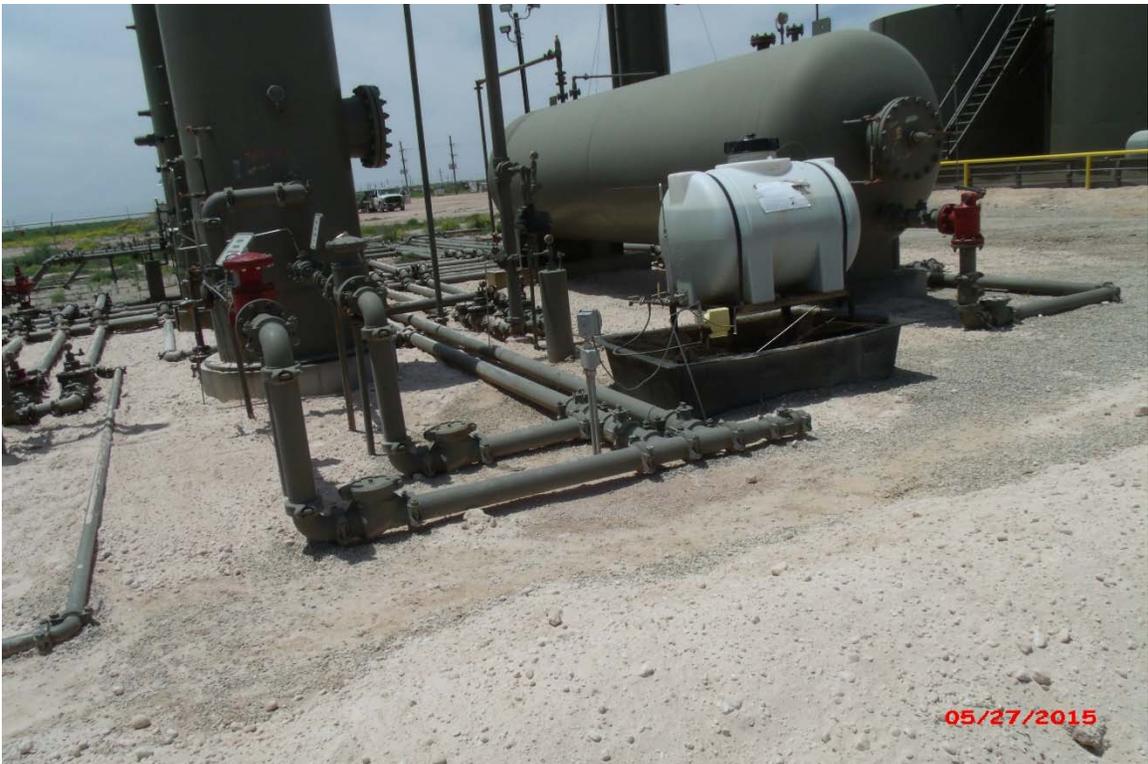
Photograph #6 – Backfilled

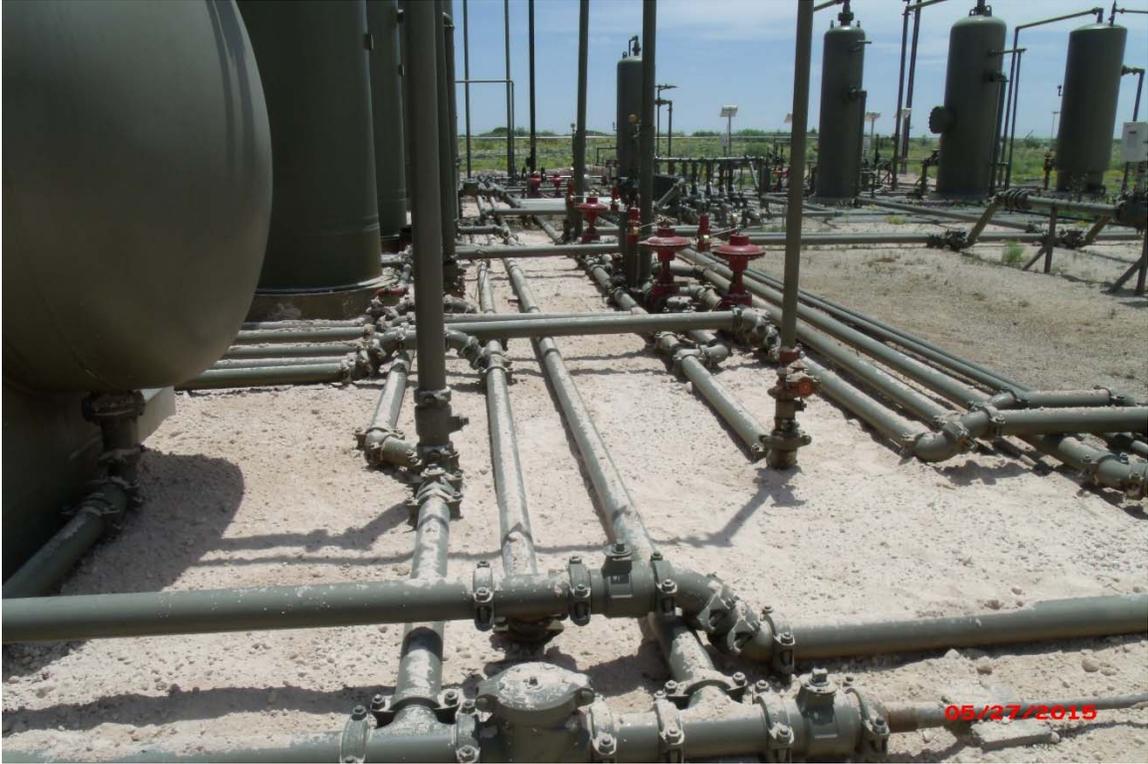
Photograph #7 – Backfilled

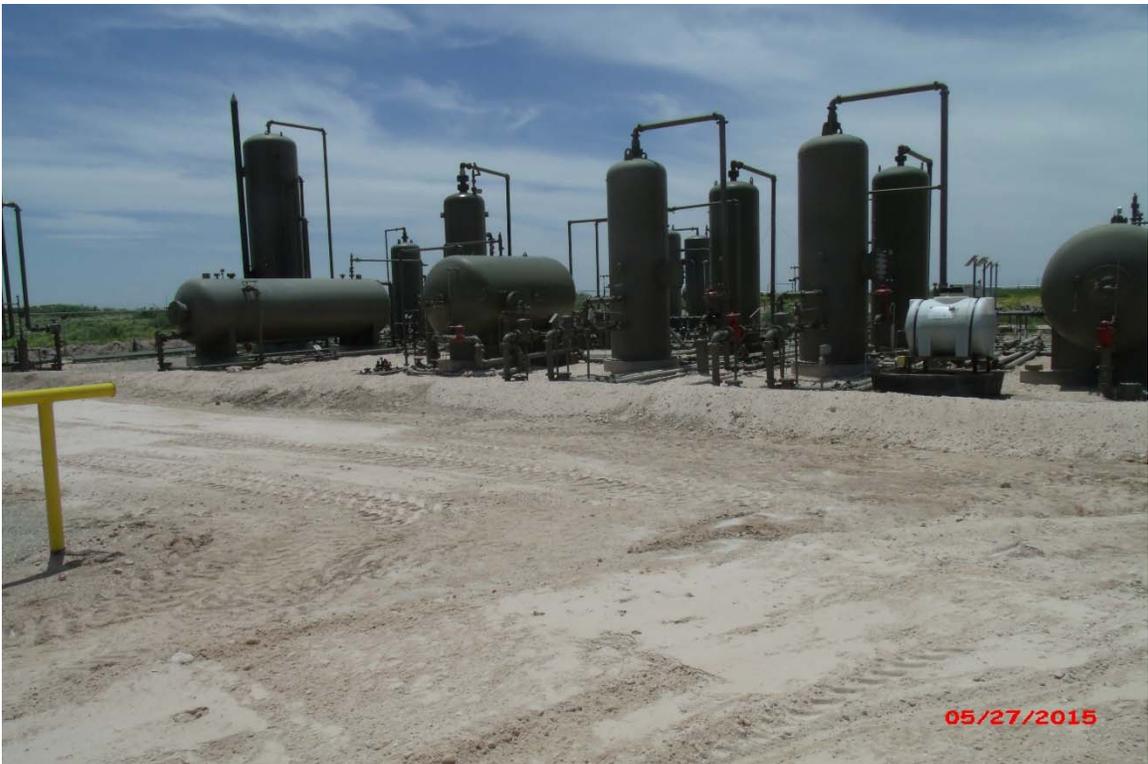
Photograph #8 – Backfilled
