# Bonnie Fed Com

## REMEDIATION WORK PLAN

**RE: Cimarex, Bonnie 35 Fed Com – Remediation Work Plan**  
UL/P, Section 35, T25S, R26E  
API No. 30-015-42956

## PHOTO PAGE

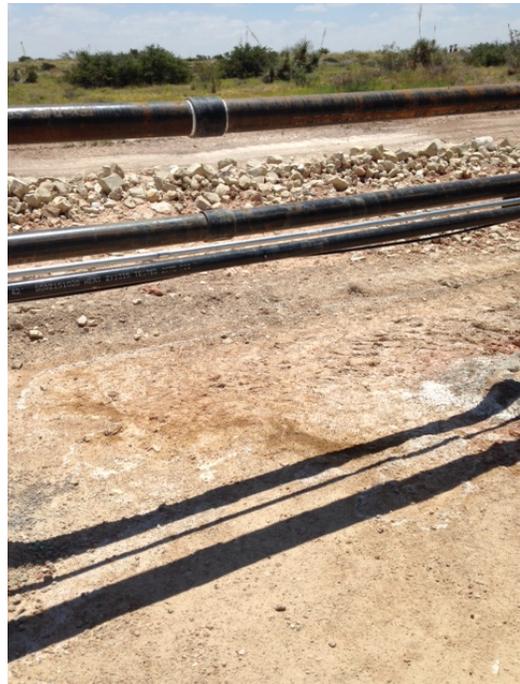
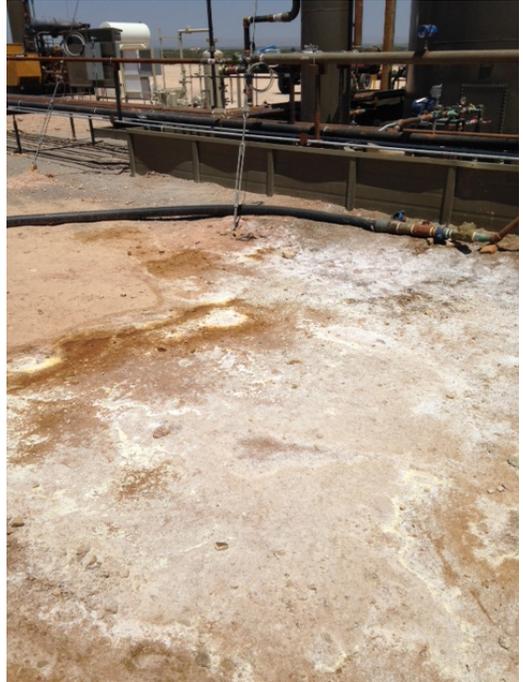
The site is located southeast of Whites City NM, in Eddy County. The leak site resulted from a hammer union coming loose due to vibration. The impacted area is on the back side of the battery. Approximately 15 bbls of produced water was released, and 5 bbls recovered. A C-141 was submitted to the NMOCD on June 19<sup>th</sup>, 2015. The C-141 is attached.

Remove 1' bgs of the contaminated soil on the backside of the facility. Haul all contaminated material to an approved NM state disposal. Then backfill with caliche.
