Release Notification and Corrective Action

Name of Company: Holly Energy Partners	Contact: Allison Stockweather, Senior Manager, EHS
Address: 1602 West Main Street, Artesia, NM 88210	Telephone No.: 575-746-5475
Facility Name: N. Artesia to Beeson 6" Pipeline	Facility Type: Pipeline

**SITE CLOSURE REPORT
2RP-2362
N. ARTESIA TO BEESON 6" PIPELINE
RELEASE**

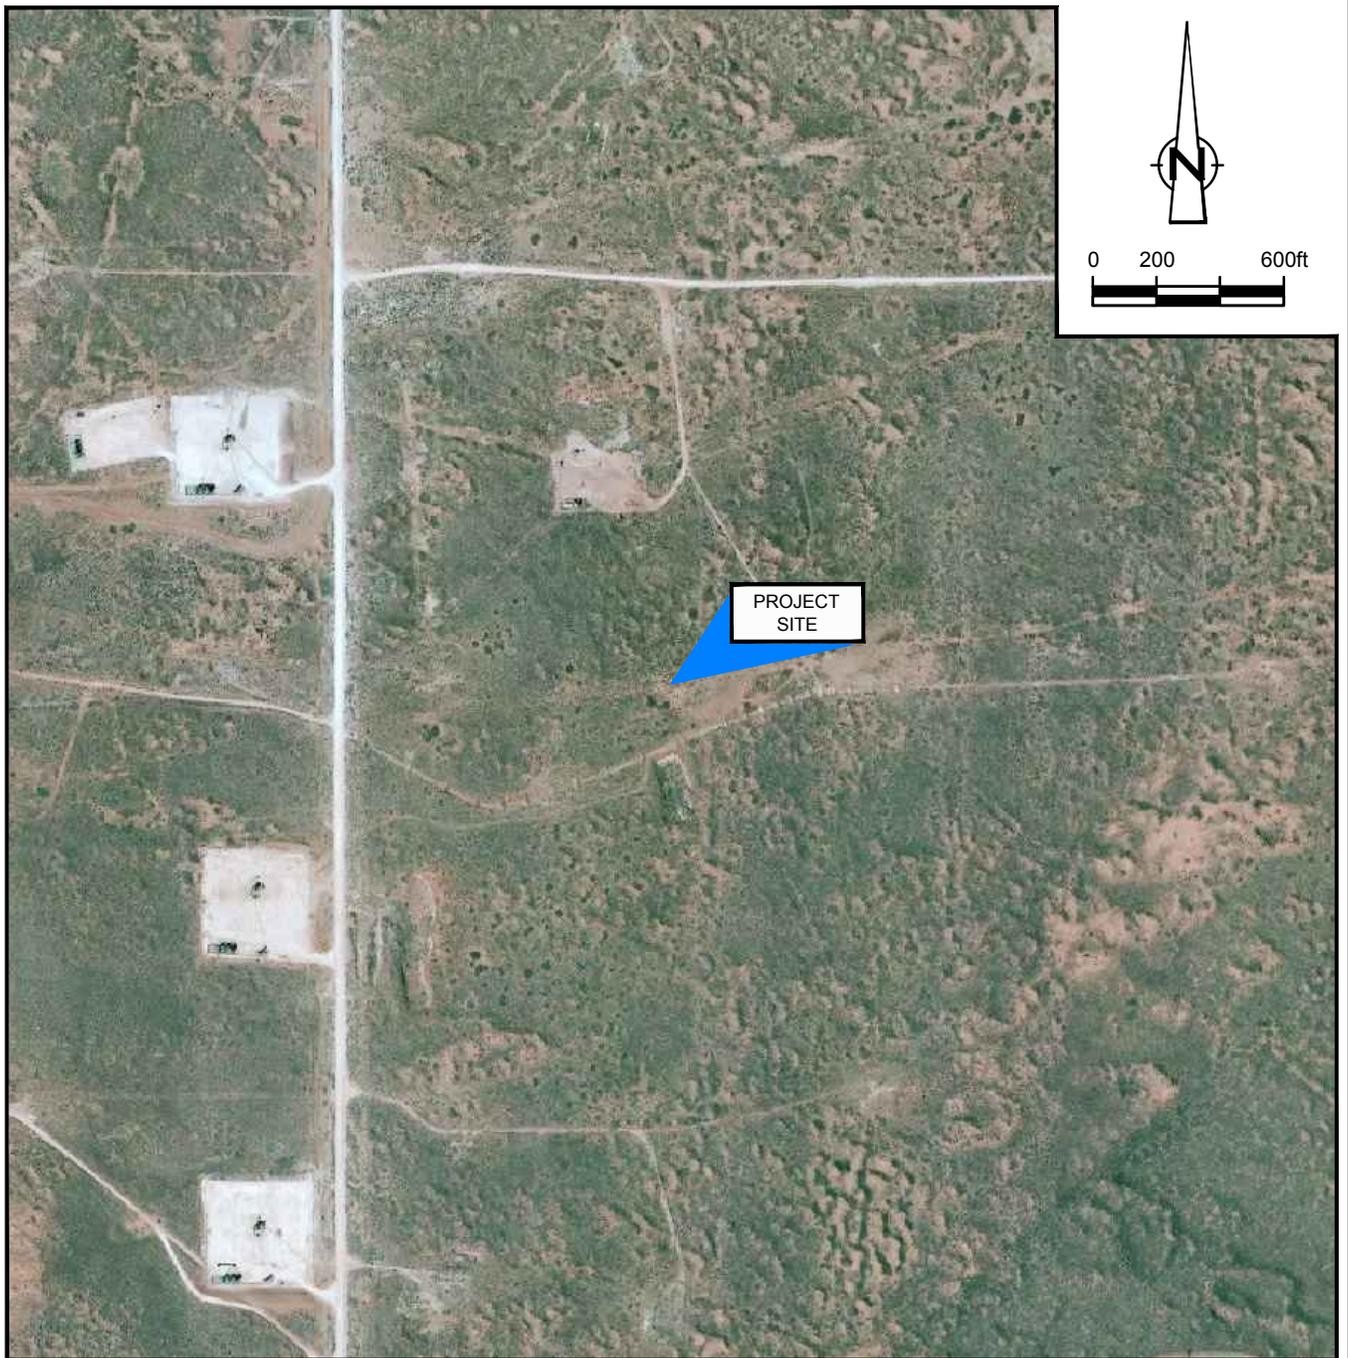
Figure 2

1. Release point GPS: 32.775578,-104.016272
2. Release date: April 23, 2014
3. Yellow shaded cells indicate soil concentration exceedance of OCD RRALs (1993 Guidance).

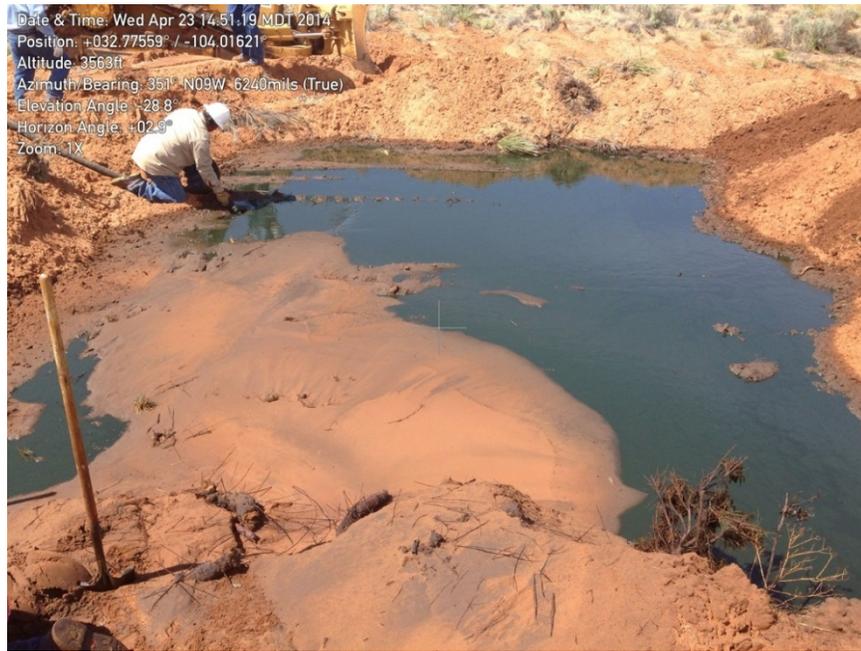
Photo 1 – April 23, 2014: Site location looking northwest as vacuum trucks remove the crude oil.

Vacuum trucks recovered approximately 15 barrels of crude oil from the release area. The remaining fluids saturated the soil around the release point. Surface soils at the site were primarily loose, wind-blown sand deposits that were effective in absorbing the released liquids. The Petroleum Recovery Research Center (PRRC) Web Mapping Portal was utilized to research the depth to groundwater in the general area. No groundwater wells or depth to groundwater (DTW) data was available within a 5-6 mile radius of the release. Beyond the 5-6 mile radius, the DTW ranged from 79 to 246 feet below the ground surface.

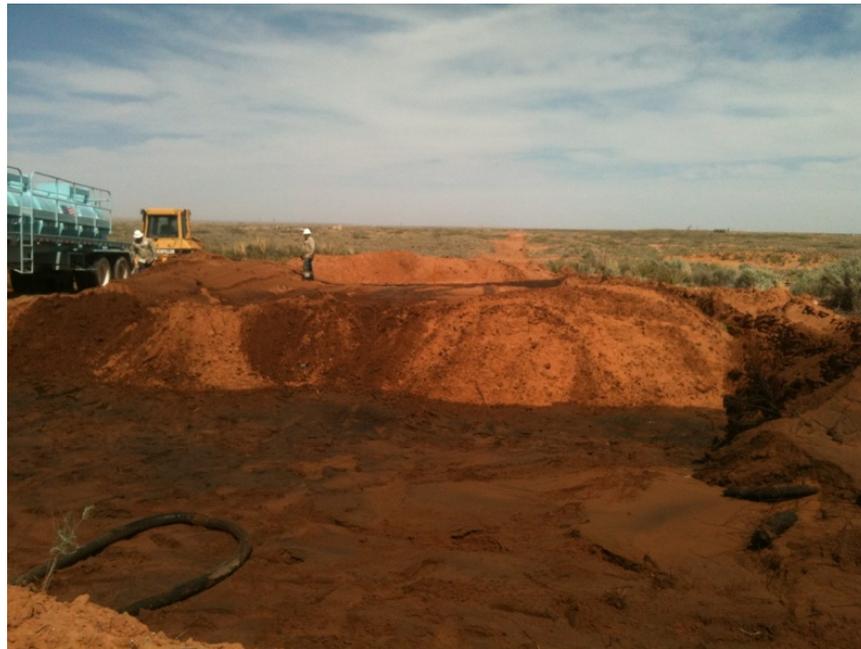
Photo 2 – April 23, 2014: Site location, looking northeast, following removal of the crude oil.

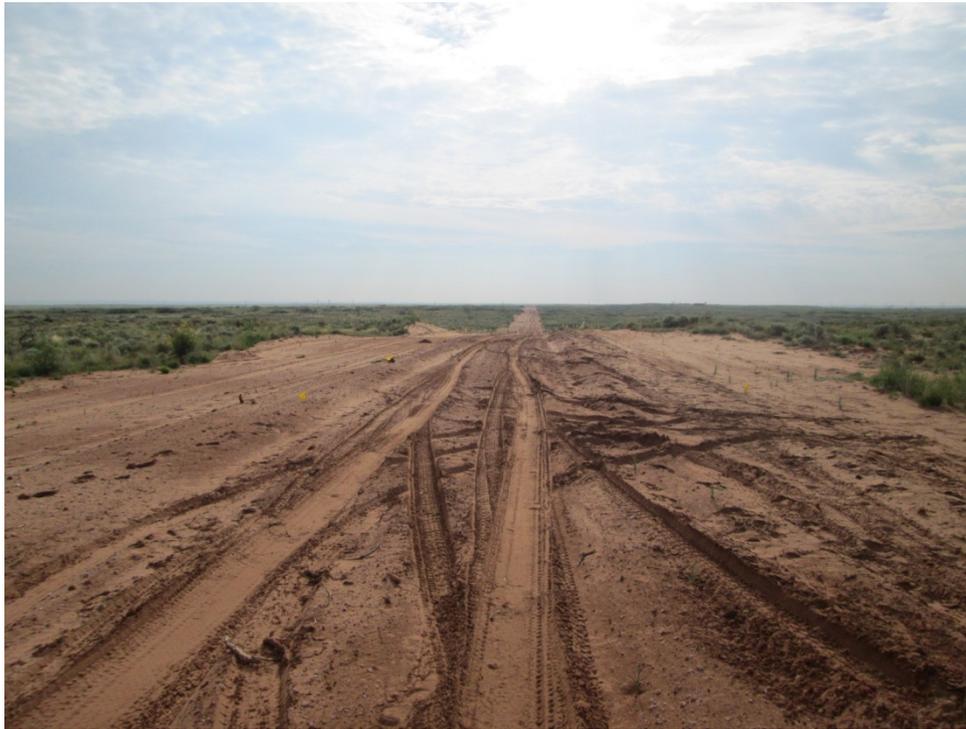
Photo 3 – August 5, 2015 looking northeast along the pipeline right-of-way.

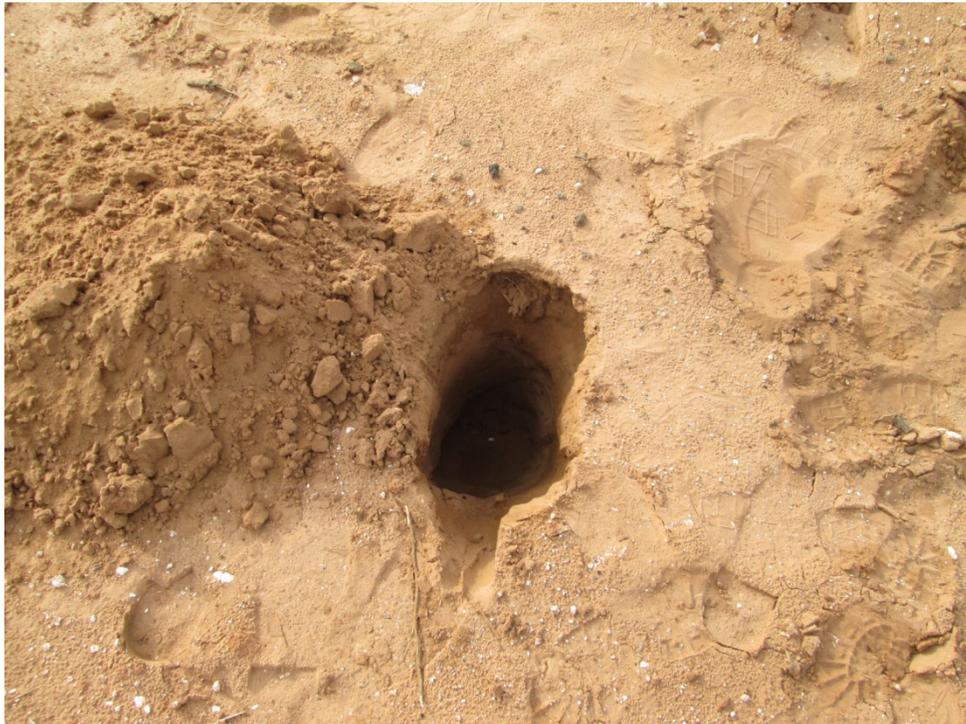
Photo 4 – August 5, 2014: Spotting of the 6" pipeline.

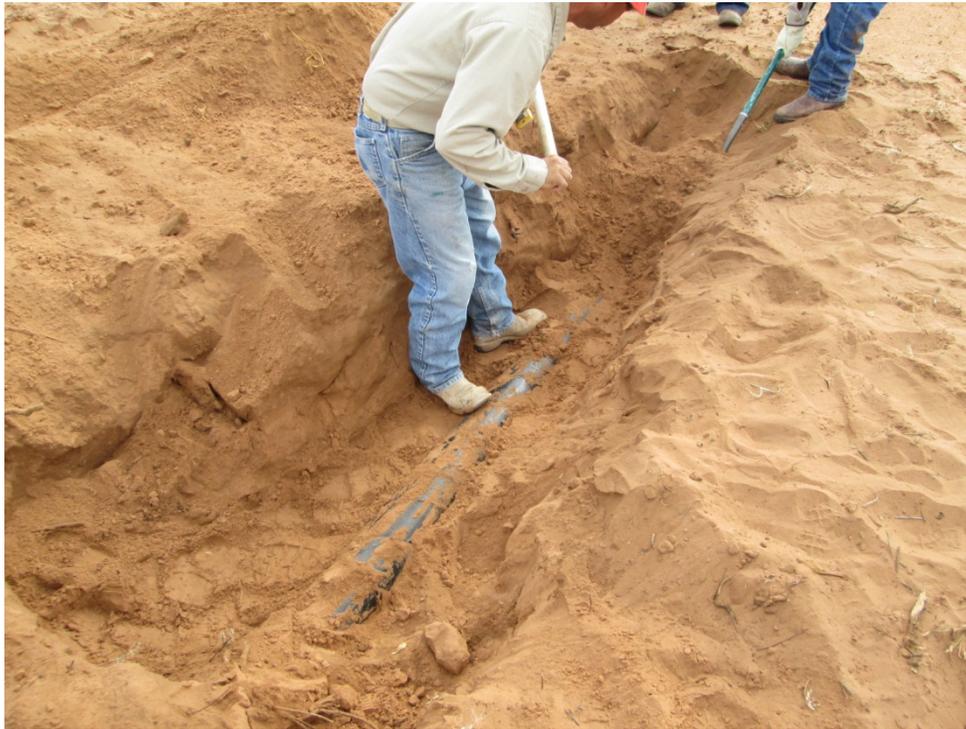
Photo 5 – August 5, 2014: Spotting of the pipeline.

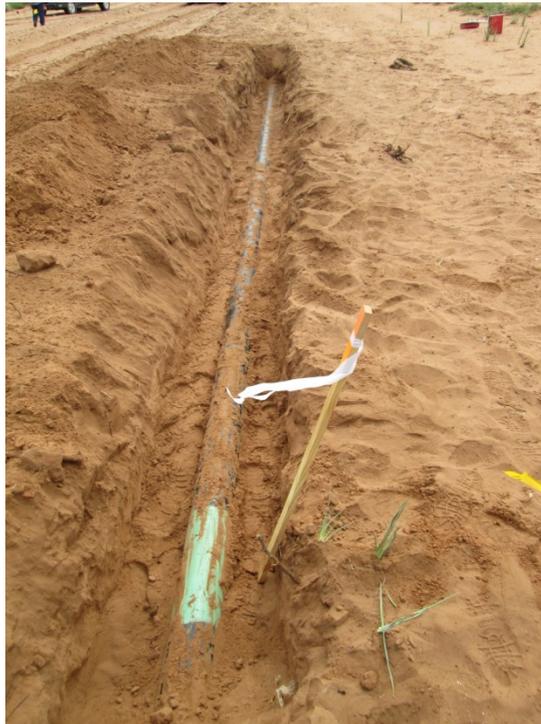
Photo 6 – August 5, 2014: Completion of spotting the pipeline.

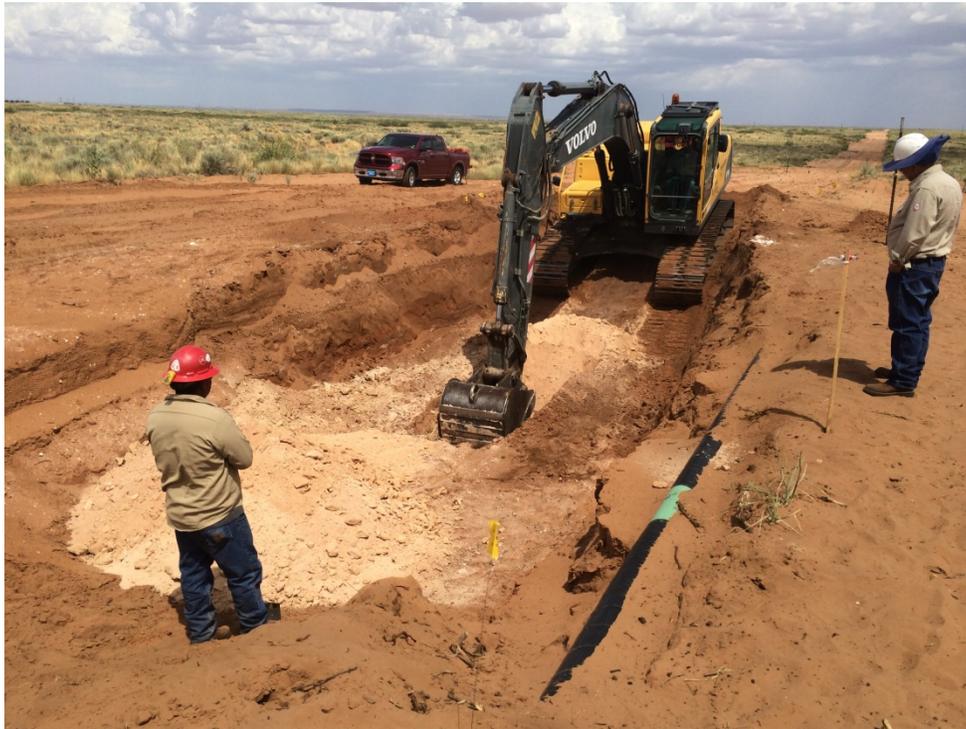
Photo 7 – August 25, 2014: Excavation to the north of the 6" pipeline.

Soil excavating operations were conducted at the Site between August 5 and August 7, 2014 and re-commenced on August 25 and August 26, 2014. The heavily stained soil around the affected area was removed for disposal to the R360 waste facility in western Lea County, New Mexico.

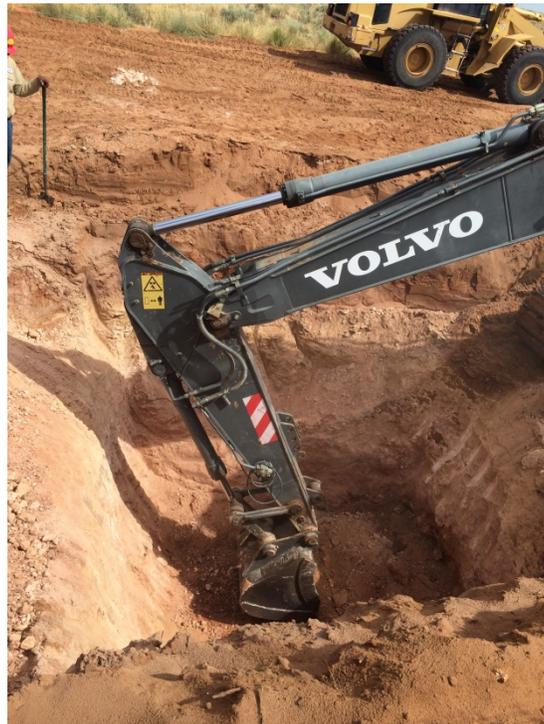
Photo 8 – August 26, 2014: Deepening of the excavation to 18 feet.

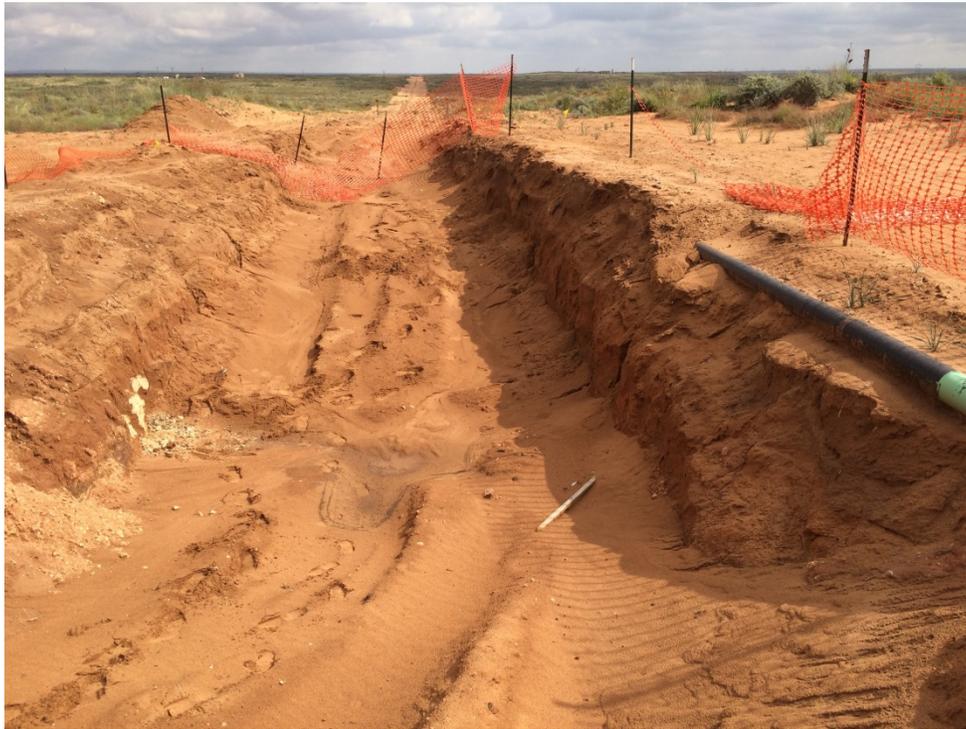
Photo 9 – October 22, 2014: looking northeast along the pipeline right-of-way.

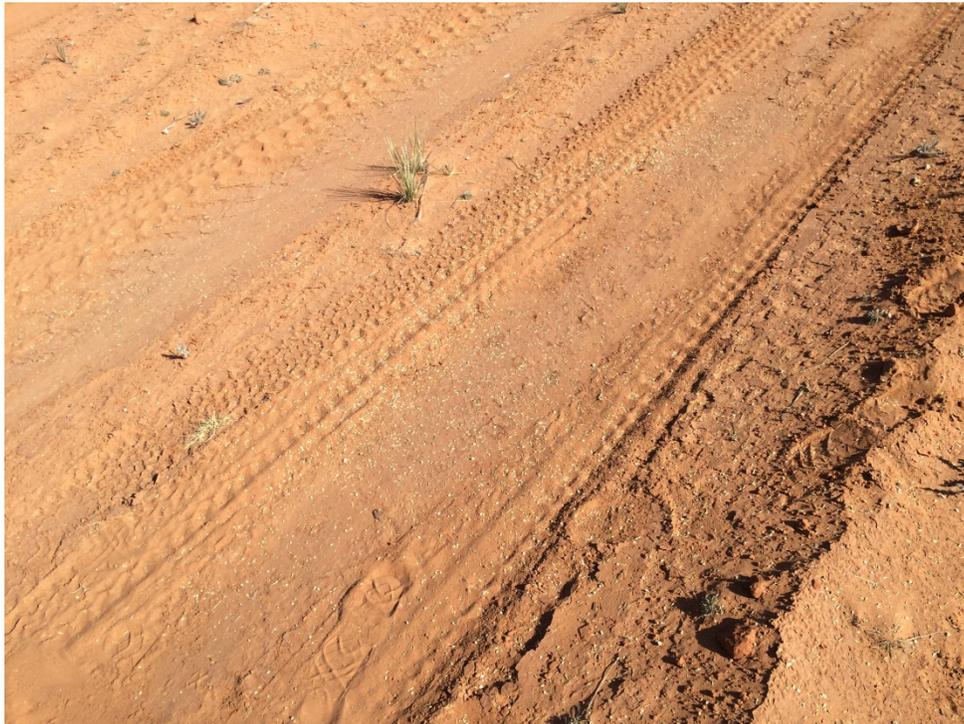
Photo 10 – December 16, 2014: Hand-broadcasting of BLM-approved Lesser Prairie Chicken (LPC) seed mix.

<p>September 18-20, 2014 (Thursday-Saturday)</p>	<p>Heavy rainfall in and around the site location caused wide scale flooding. Site visits delayed due to the heavy rainfall accumulations.</p>
<p>October 22, 2014 (Wednesday)</p>	<p>BLM representative, Randy Pair, unable to make it to site. Randy verbally confirmed that work could take place. One confirmation sample from the east sidewall was collected and field screened using PetroFlag.</p>
<p>December 16, 2014 (Tuesday)</p>	<p>Backfilling activities commenced by hauling in 140 cubic yards of soil from a BLM borrow pit approximately two miles away. The area was capped with native topsoil from within the project area. The excavation was graded back to the natural landscape and the BLM-approved seed mixture was hand-broadcast across the excavation area and right-of-way leading to site. A harrow was then used to till the seed into the topsoil.</p>

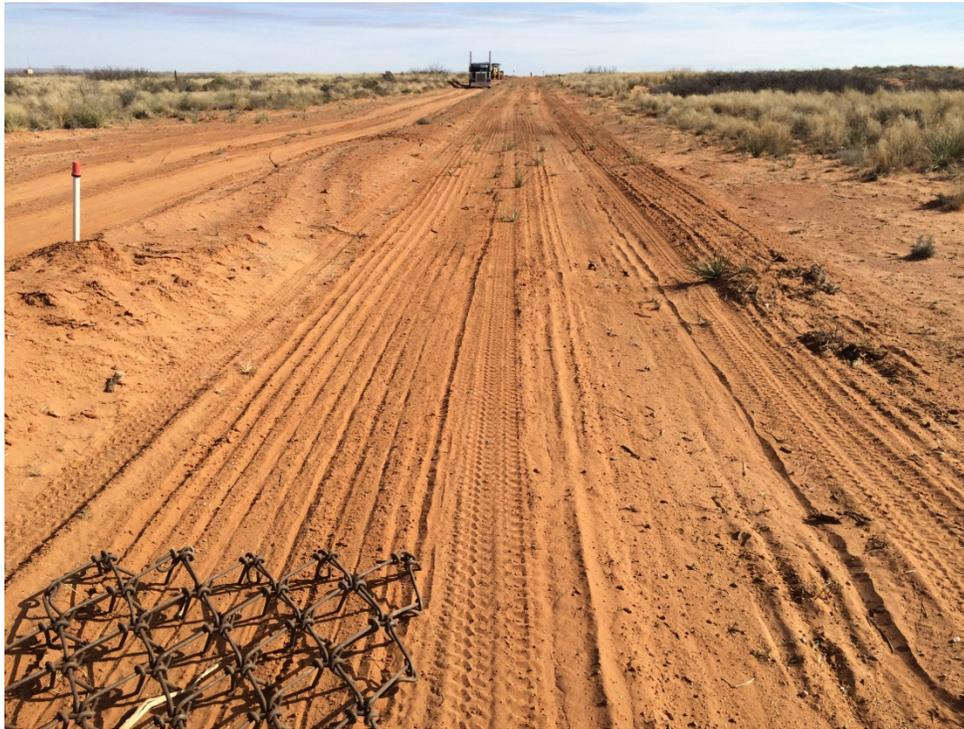
Photo 11 – December 16, 2014: Harrow used to till the BLM seed mix into the topsoil.

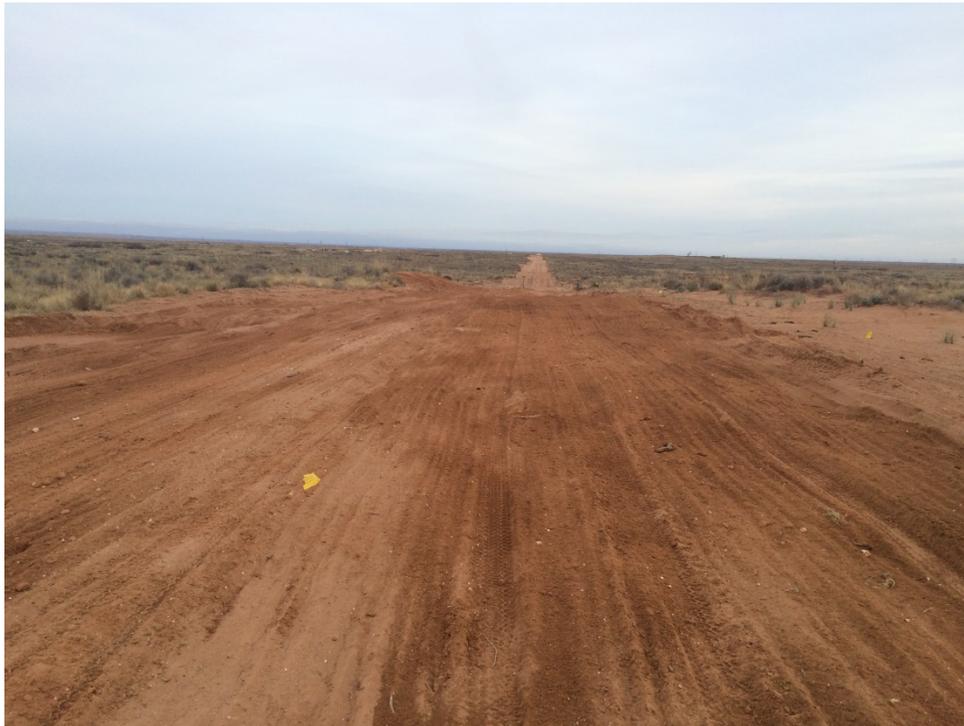
Photo 12 – December 16, 2014: looking northeast at the backfilled excavation.
