SUBJECT: FINAL CLOSURE REPORT FOR INCIDENT 2RP-2834 JENKINS B FEDERAL #007, EDDY COUNTY, NEW MEXICO

FINAL CLOSURE REPORT FOR INCIDENT 2RP-2834

COG OPERATING LLC

JENKINS B FEDERAL #007

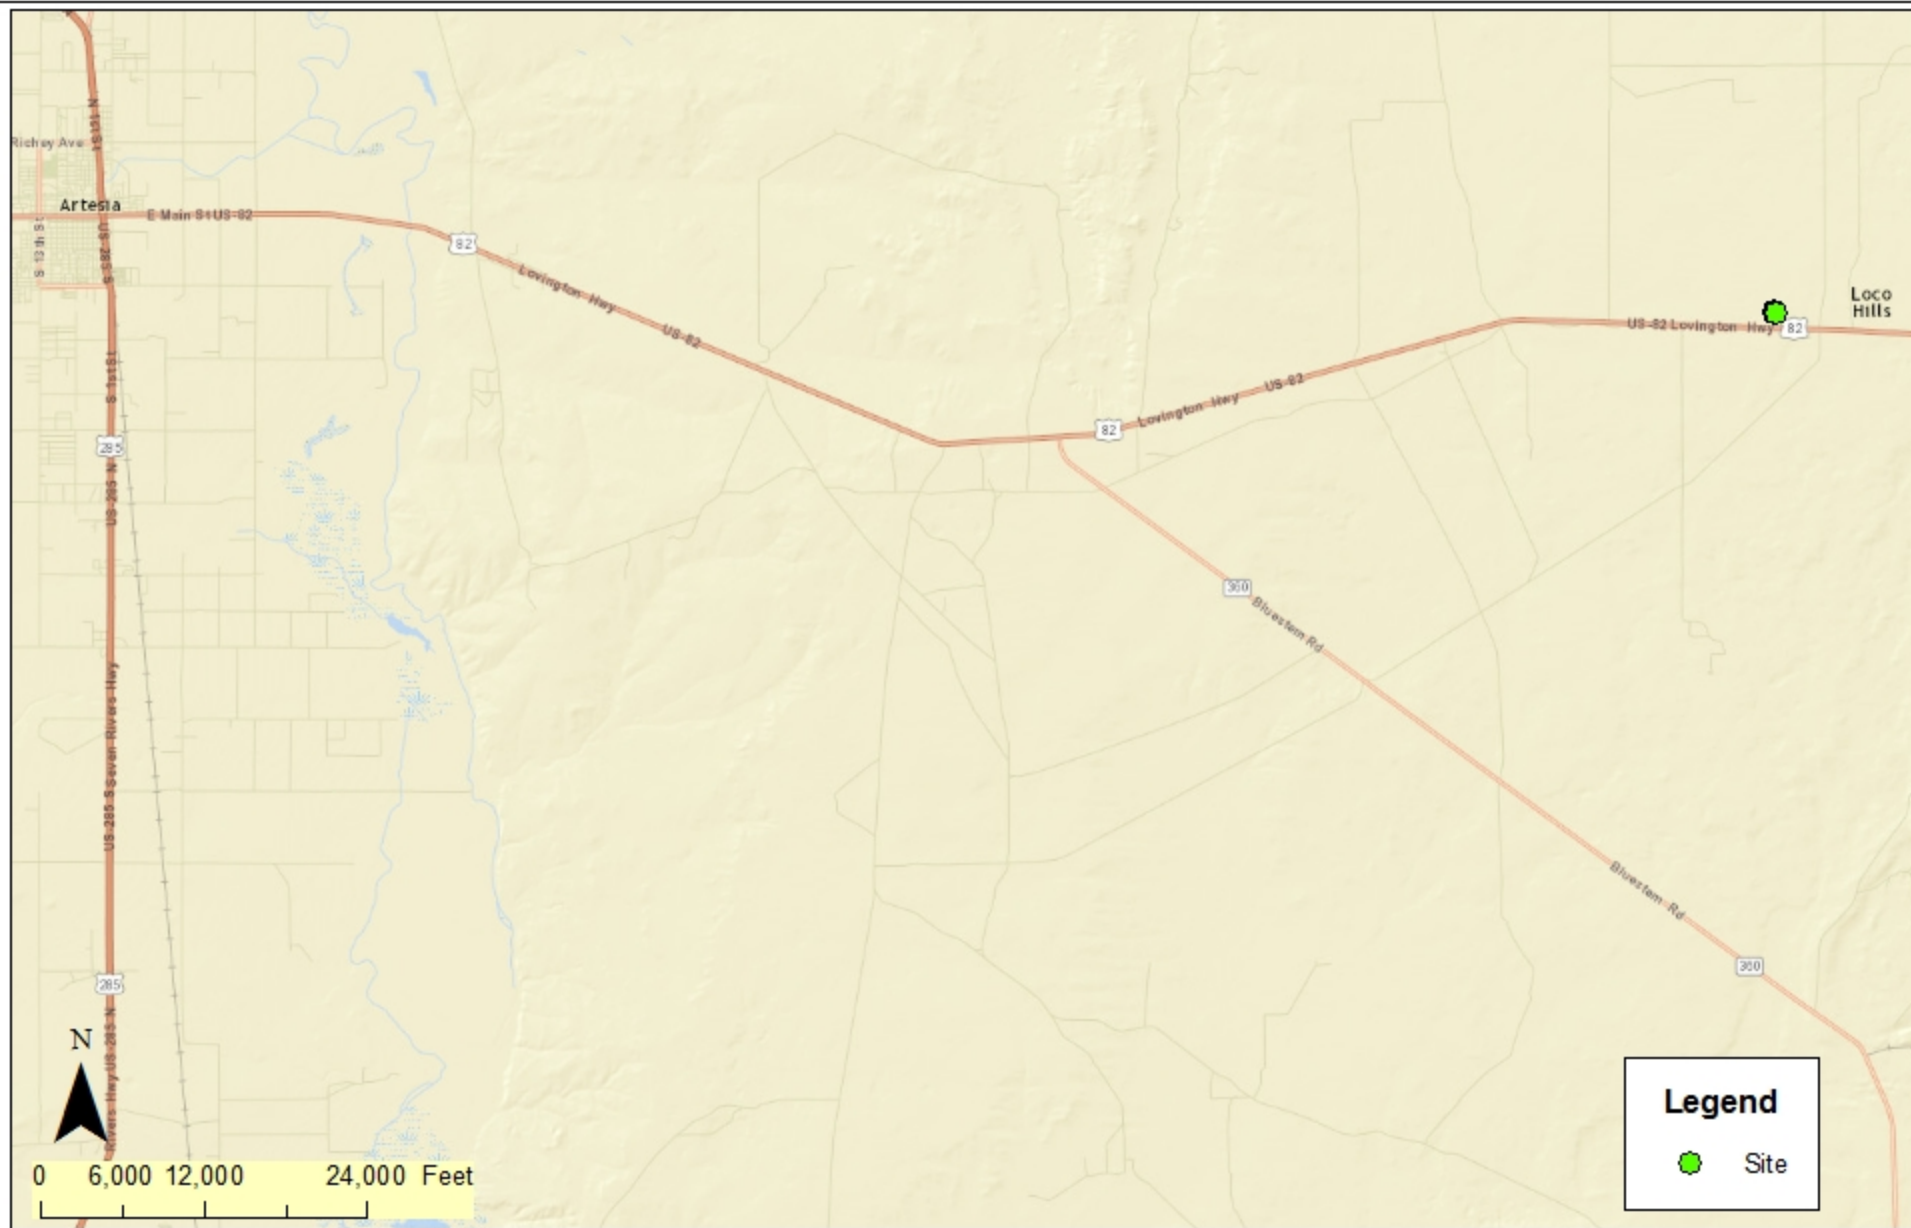
FIGURE 1 VICINITY MAP

Site Location Map
Jenkins B Federal #7 - COG
Loco Hill, New Mexico

On behalf of COG Operating LLC (COG), SMA has prepared this report that describes the assessment, initial delineation, and mitigation of a release associated with the JENKINS B FEDERAL #007 release site. The site is located in Section 20, T 17S, R 30E NMPM, Eddy County, New Mexico, on land owned by the BLM. Figure 1 illustrates the vicinity and location of the site.

SMA searched the New Mexico State Engineer's Office online water well database for water wells in the vicinity of the release. No wells were located within a one mile radius of the site. Figure 1 depicts the site vicinity and Figure 2 shows the site itself. The physical location of this release is within the jurisdiction of BLM and NMOCD.

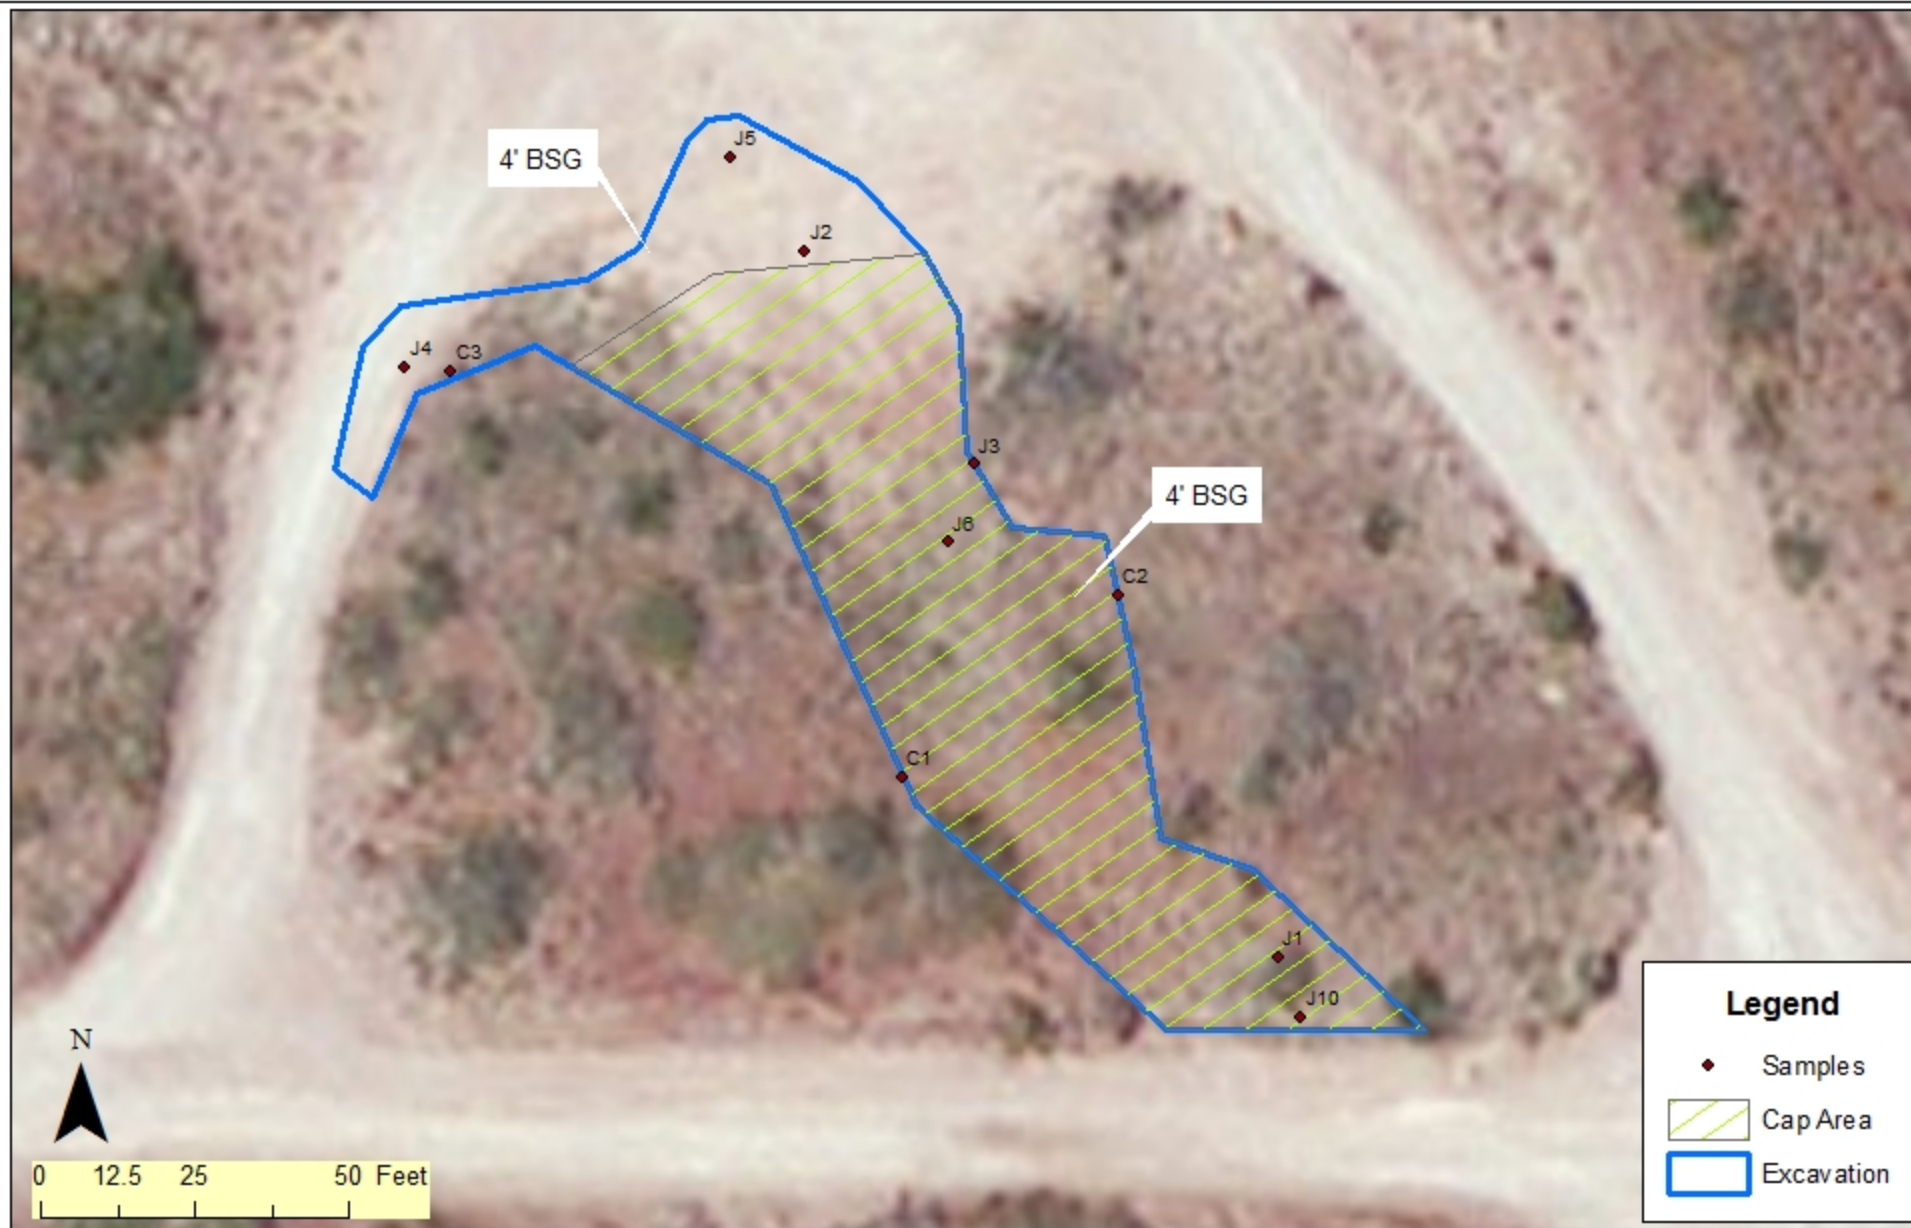
FIGURE 2 SITE MAP

A total of 9 soil samples were submitted for closure confirmation by laboratory analysis per EPA Methods: 8021 for benzene, toluene, ethylbenzene, and xylenes (BTEX) and 418.1 for Total Petroleum Hydrocarbons. All samples were analyzed by Hall Environmental Analytical Laboratory in Albuquerque, New Mexico. Figure 2 illustrates the extent of the excavation, location of the cap, laboratory soil sample locations, and laboratory results.

Soil contaminant concentrations are illustrated in Figure 2. A summary of laboratory analytical results is included in Table 3. Laboratory reports are included in Appendix C.
