**TRANSMITTAL
SOIL ABATEMENT COMPLETION REPORT
TURNER B SOUTH TANK BATTERY
SECTION 29, TOWNSHIP 17 SOUTH, RANGE 31 EAST
LOCOC HILLS, EDDY COUNTY, NEW MEXICO**

**Soil Abatement Completion Report
Turner B South Tank Battery
Section 29, Township 17 South, Range 31 East
Loco Hills, Eddy County, New Mexico**

Project No. 12009-0005

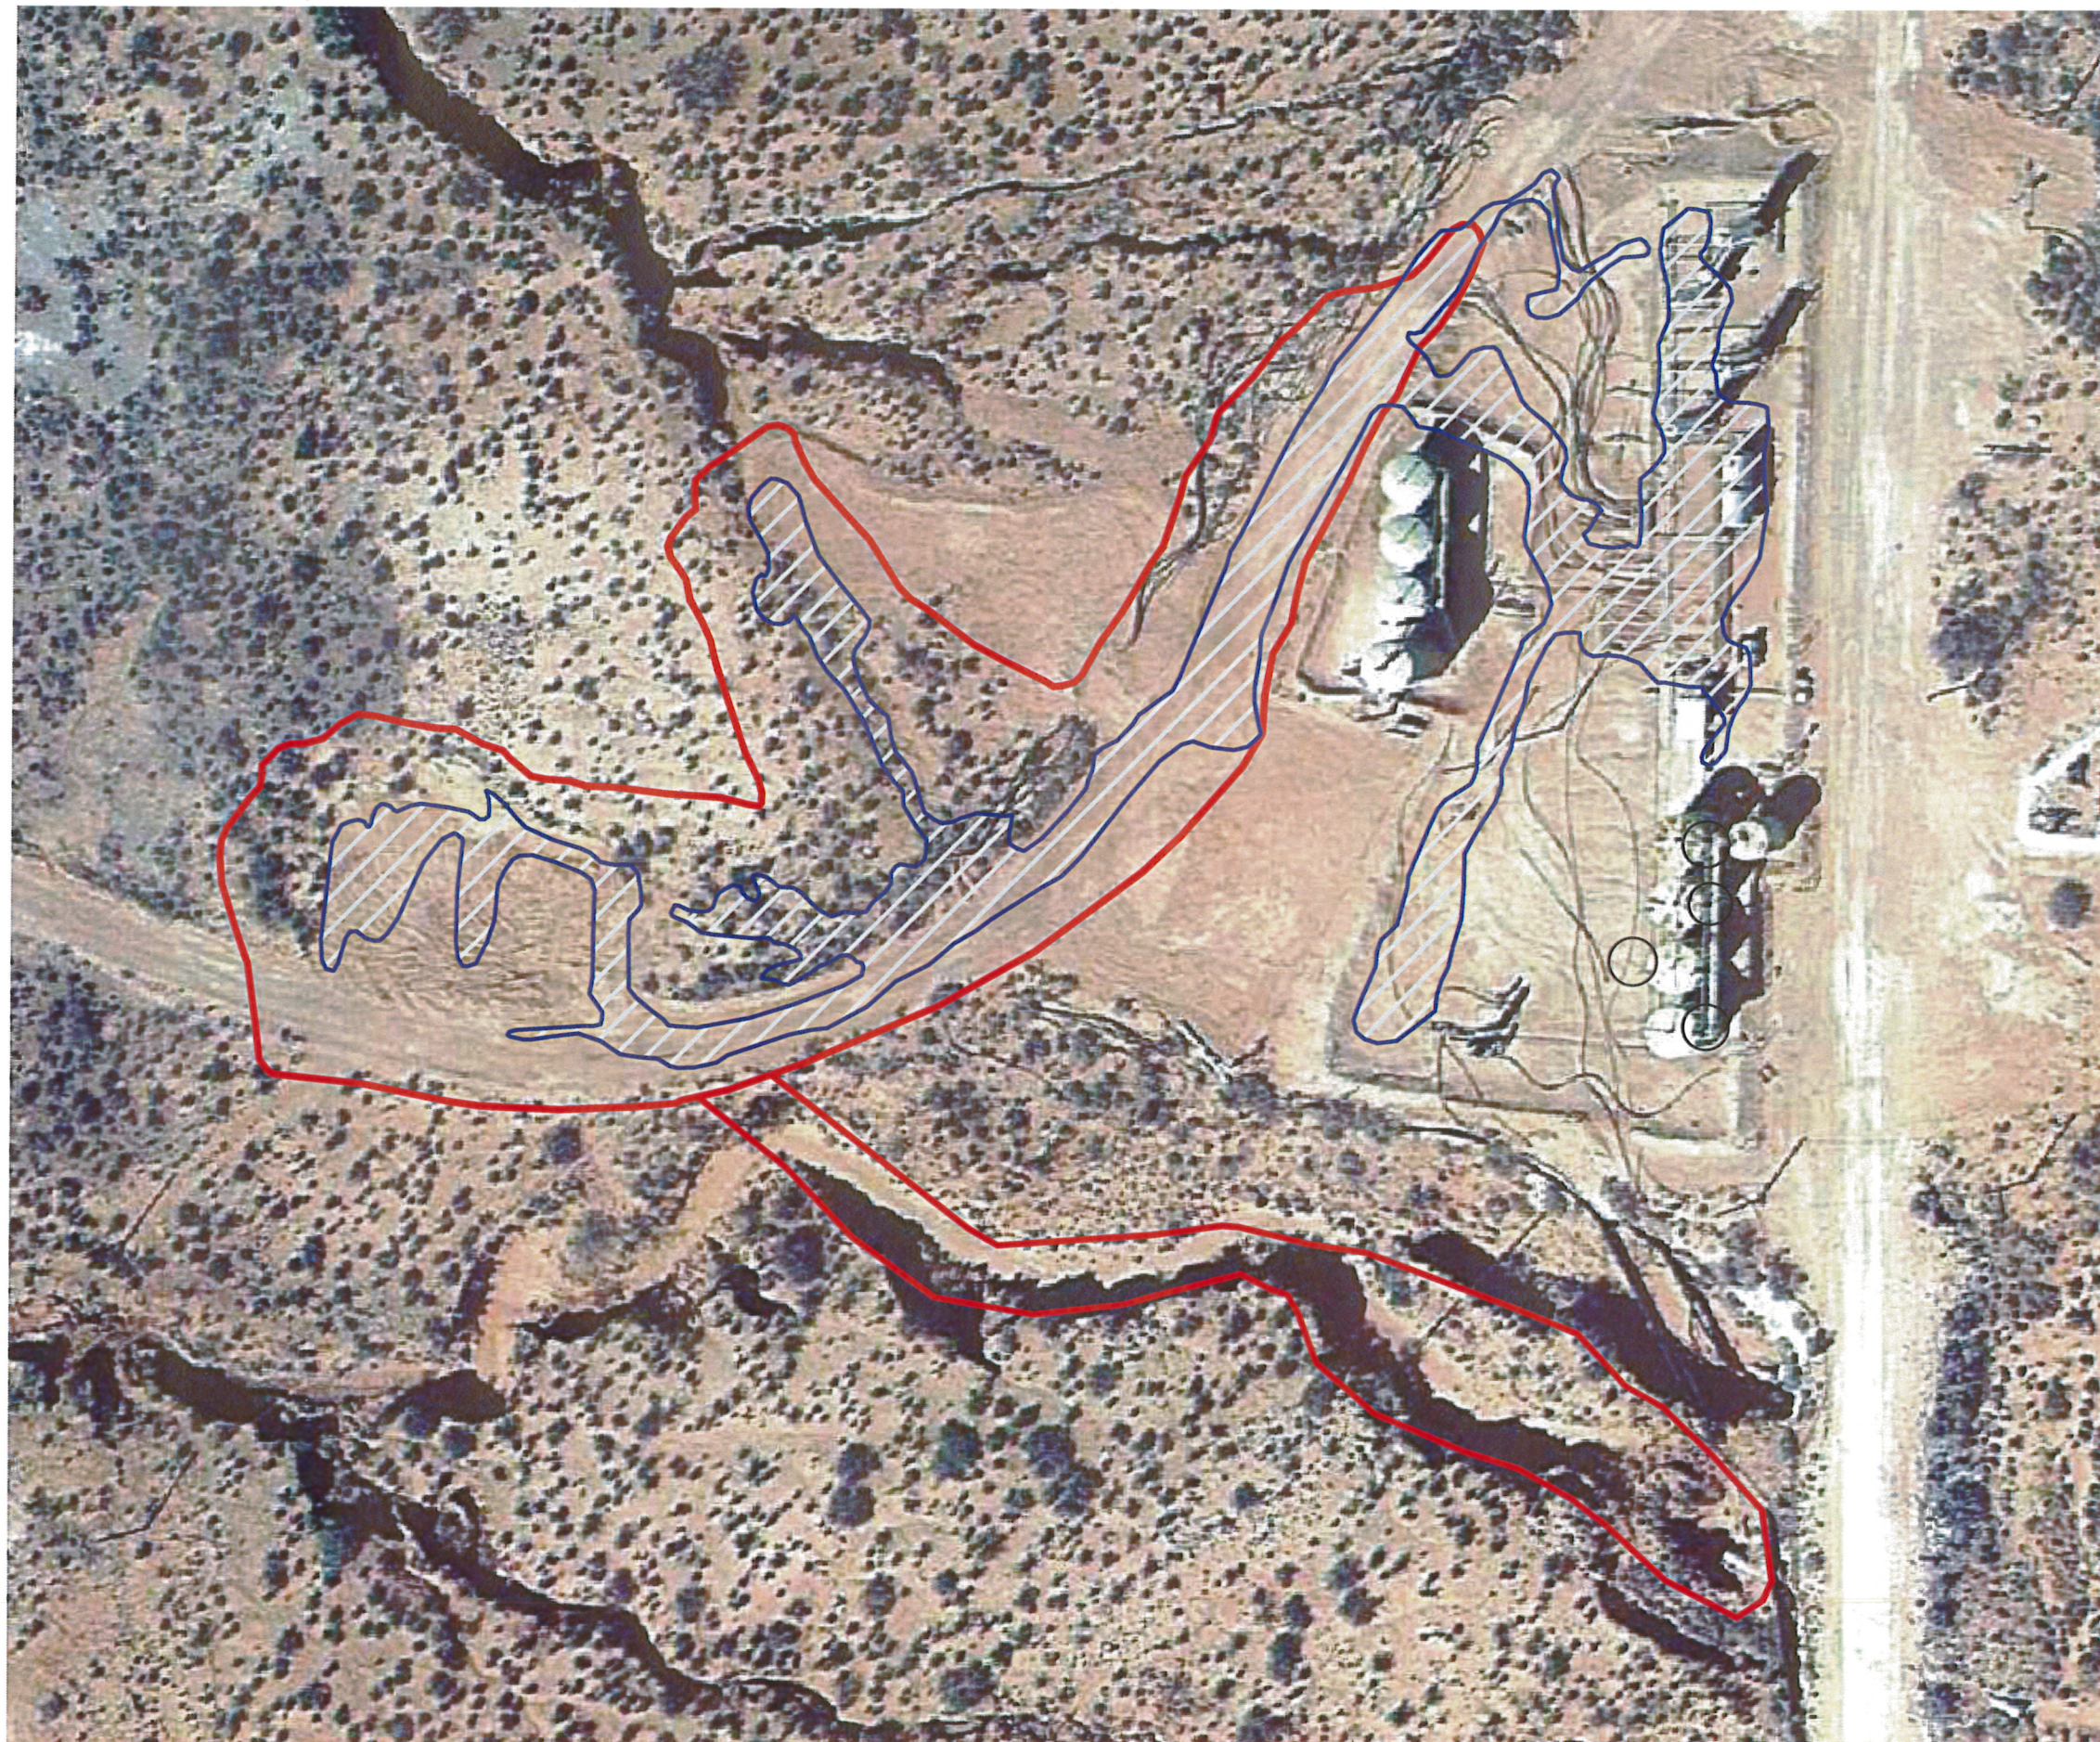
FIGURE 2
SITE PLAN

On October 15, 2012, LINN reported a release of 256 barrels (bbls) of produced water to the New Mexico EMNRD - OCD and United States Department of the Interior BLM. Specifically, LINN verbally notified Mr. Randy Dade with the OCD and Ms. Terry Gregston with the BLM. The source of the release was immediately identified to be a hole within a steel pipe that was slightly buried belowground. Since the steel pipe was slightly buried belowground, this caused the pipe to corrode and eventually develop a hole. The steel pipe and subsequent hole were located within the limits of secondary containment at the tank battery and not at the wellhead. The release was initially contained within the secondary containment berms but ultimately washed-out a section of berm and flowed down-gradient along the western-most side of the lease road and onto the adjacent lands further west. Based on the natural topography surrounding the tank battery, the produced water release was confined to an area measuring approximately 24,255 square feet (10,189 square feet within the secondary containment berms and 14,066 square feet outside the secondary containment berms). More specifically, Ms. Terry Gregston with the BLM immediately mobilized to the subject property once notified and mapped the full extent of the produced water release with a global positioning system (GPS). The resulting map the BLM produced was provided to SKA and has been utilized for the site assessment and subsequent soil abatement activities (**Figure 2**).

On May 28, 2014, Blade Services, LLC, a subcontractor of SKA, initiated soil excavation activities on the subject property. Blade Services utilized a rubber-tire excavator (i.e., backhoe) to excavate soils within the three AOCs. Since the AOCs were contained within BLM lands with known archeological features and in accordance with the BLM-approved Archeological Data Recovery Plan, the strictest of care and precision was maintained during all phases of the excavation activities. As such, each AOC was excavated more cautiously in small cuts under the direct supervision of SKA. Mr. Scott Drewry, Environmental Scientist with SKA, performed all soil excavation oversight and confirmation soil sampling activities during the response actions. In addition, Dr. Jim A. Railey, Mr. Ryan Brucker, and Mr. Andy Larson, Archeologists with SKA, also performed all soil excavation oversight for purposes of compliance with the Archeological Data Recovery Plan. Photographs taken by our on-site personnel during the soil excavation activities are included in **Appendix 5**. A Site Plan is included as **Figure 2**.

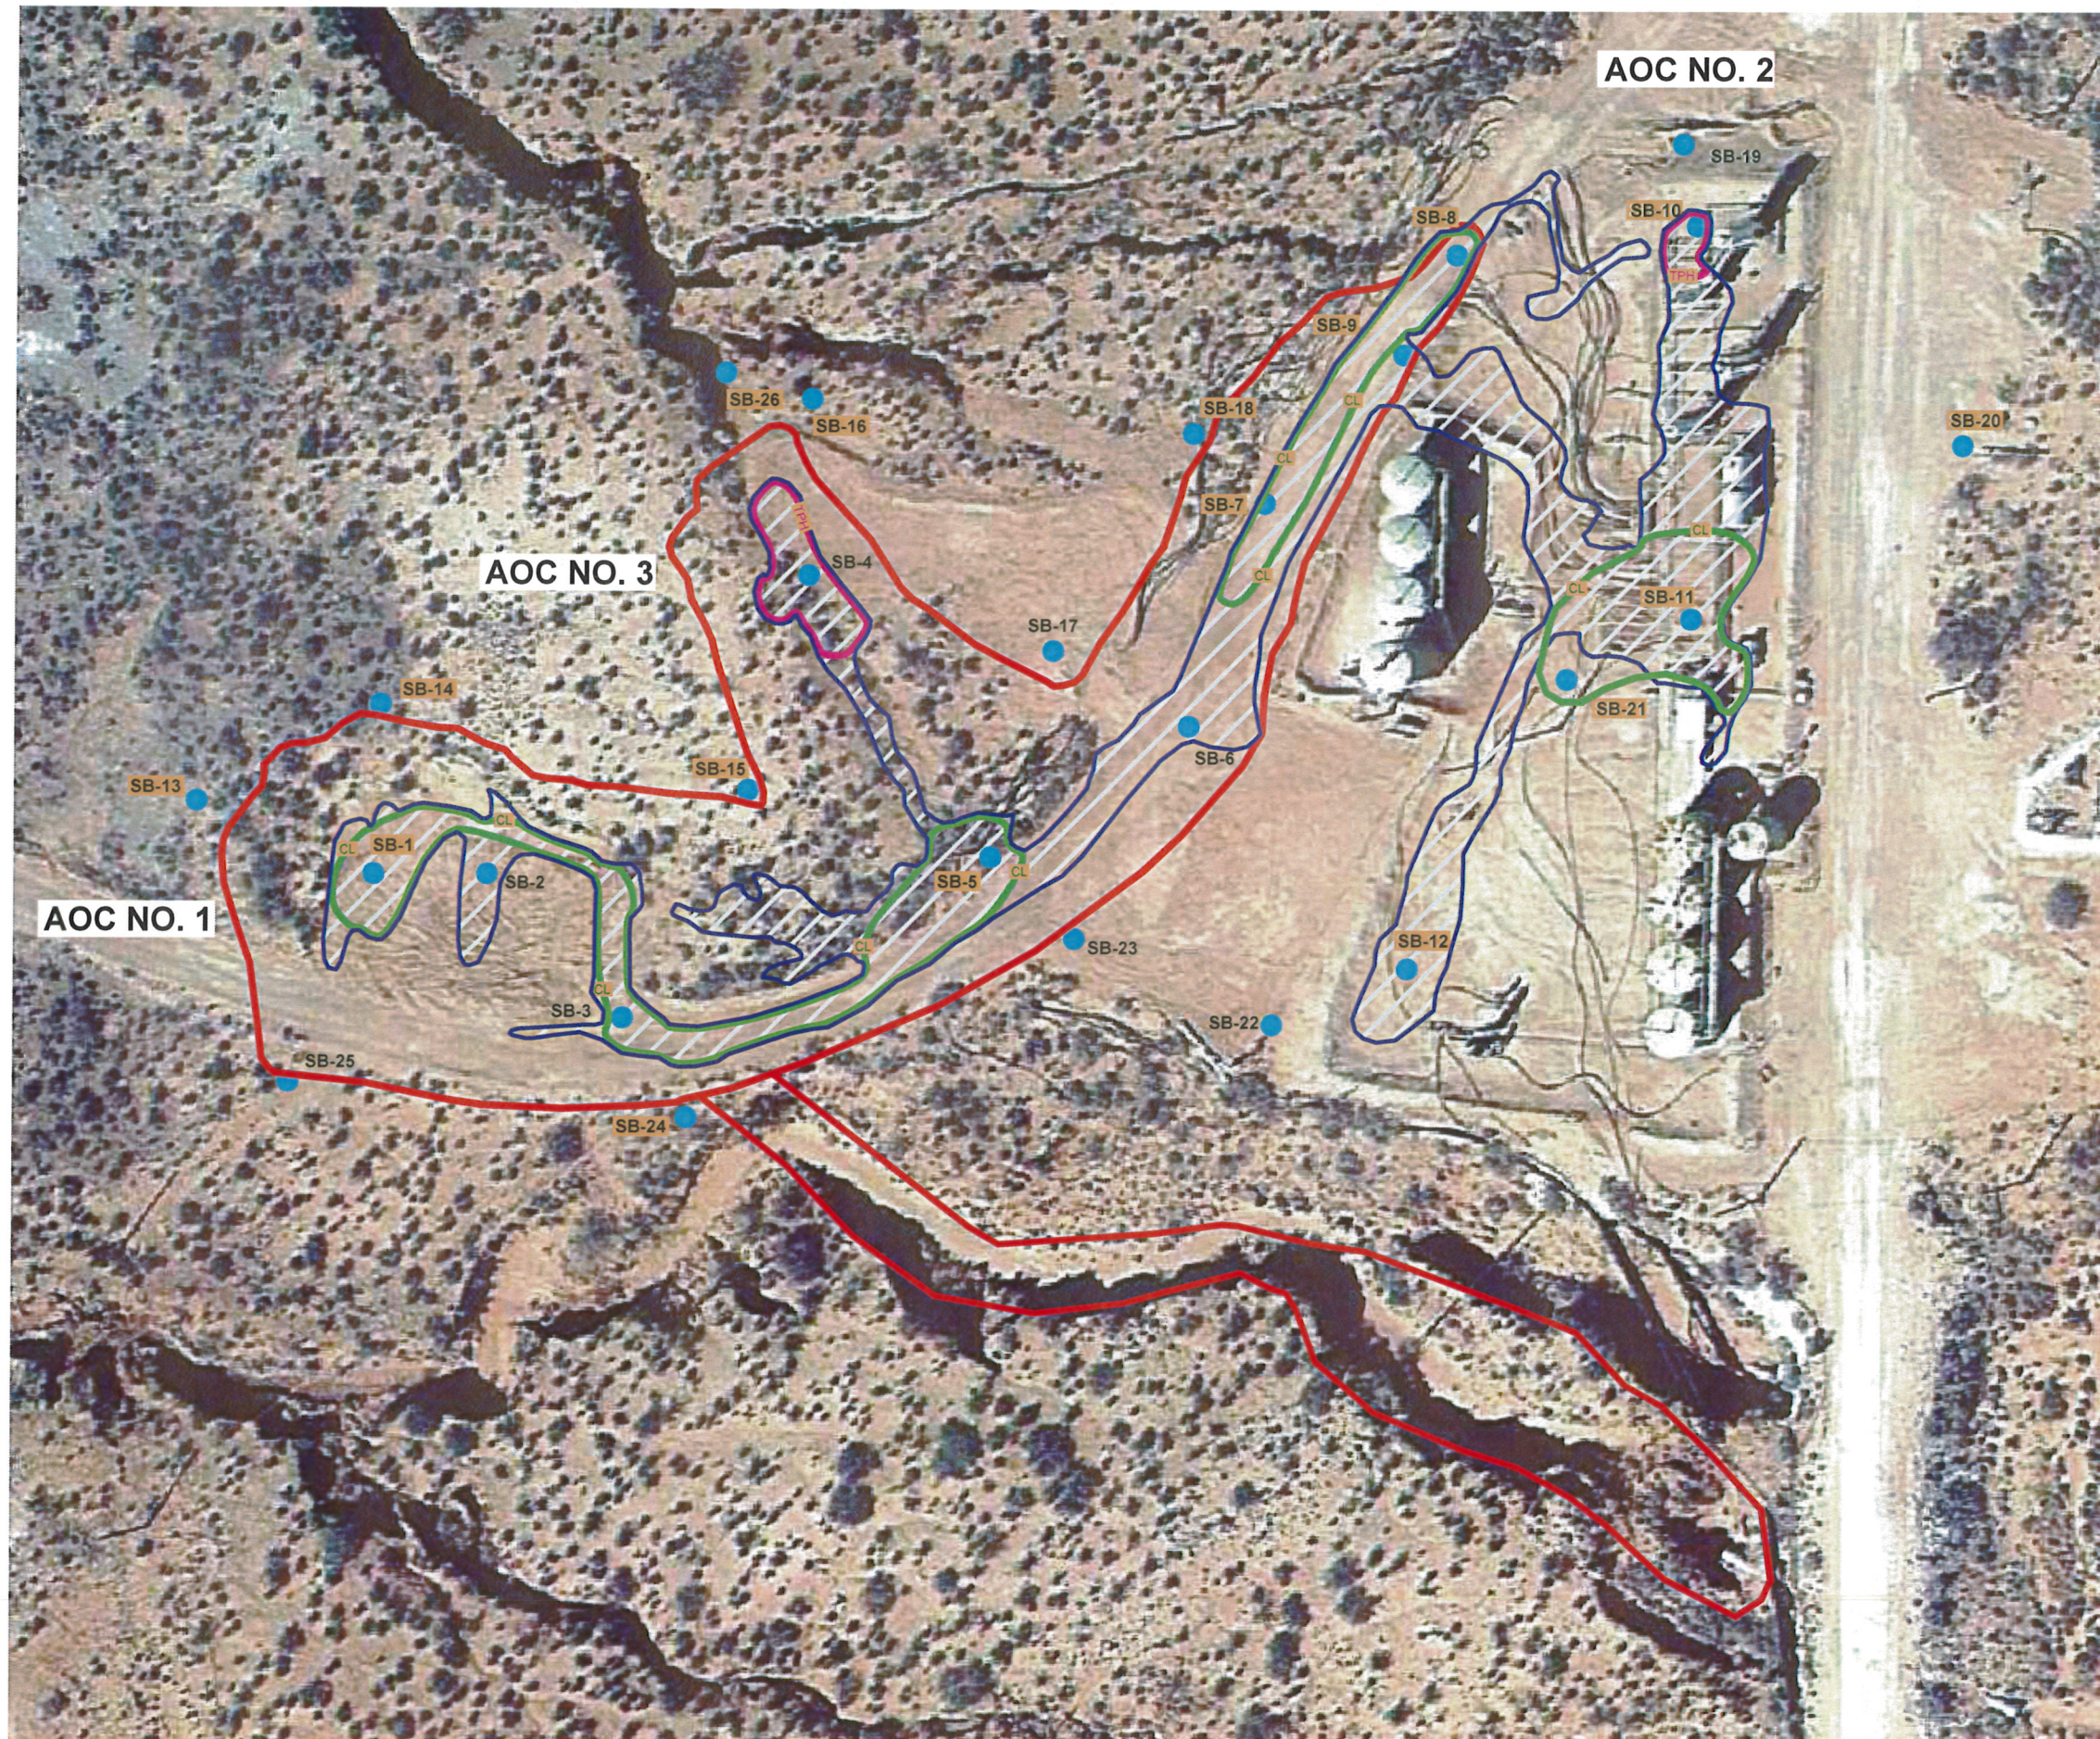
FIGURE 3
SITE INVESTIGATION MAP

On August 13 and 14, 2013, Mr. Chris Brown and Mr. Scott Drewry, Staff Environmental Scientists with SKA, supervised the installation of 26 soil borings (SB-1 through SB-26) across the subject property. A total of twelve soil borings (SB-1 through SB-12) were installed within the limits of the produced water release as previously mapped by the BLM to assess the magnitude of impacts and obtain vertical delineation, while fourteen soil borings (SB-13 through SB-26) were installed beyond the extent of the produced water release as previously mapped by the BLM for the purpose of horizontal delineation. Soil boring locations are shown on **Figure 3**.

The AOCs with their extent of in-situ soils with chloride and TPH concentrations greater than 1,000 mg/kg and 5,000 mg/Kg, respectively, is estimated on **Figure 3**.

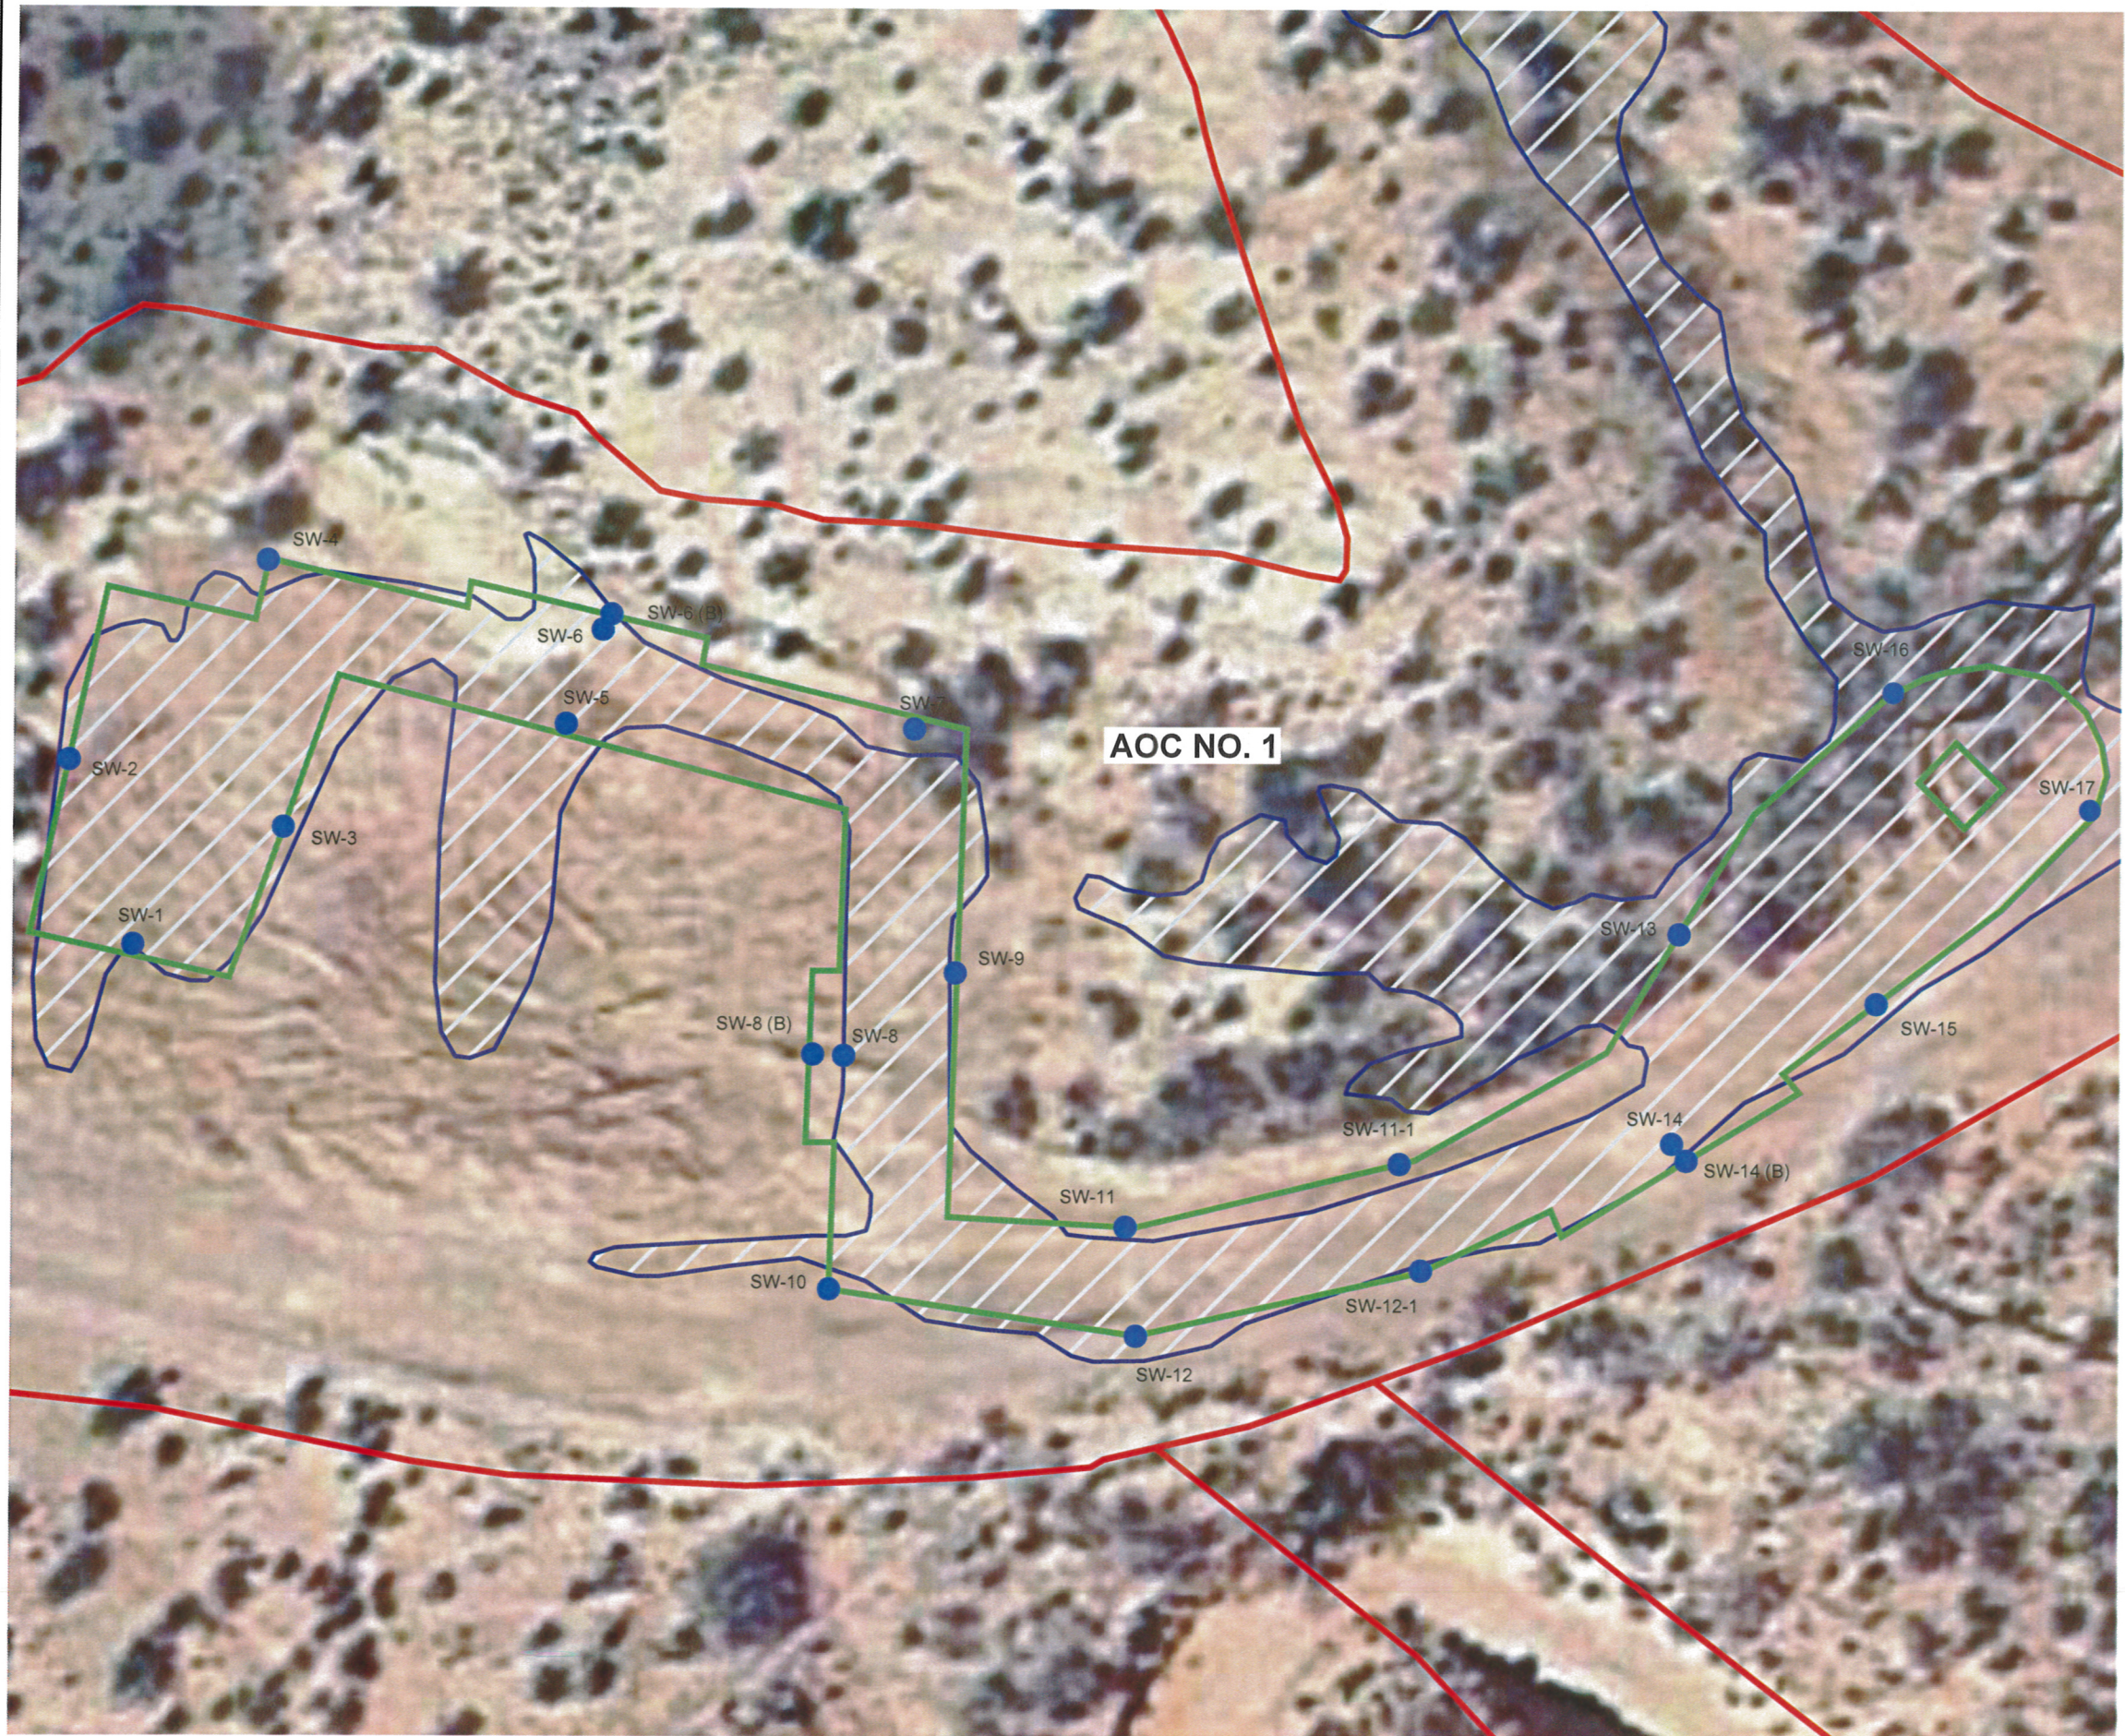
FIGURE 4
AOC NO. 1

AOC No. 1 was a chloride-impacted area that included soil borings SB-1, SB-3, and SB-5 measuring approximately 4,300 square feet located mostly within the lease road in proximity to the tank battery (**Figure 4**). Elevated concentrations of chlorides above 1,000 mg/Kg were reported at depths up to 8 ft-bgs. As a result, SKA concluded that the response actions (i.e., excavating and properly disposing/recycling of chloride-impacted soils offsite) were warranted on this portion of the subject property in an effort to obtain regulatory closure. These response actions are further described in **Section 4.0** of this report.

SKA conducted response actions by excavating a total of 697 tons of chloride-impacted soil from AOC No. 1 to a depth of approximately 4 ft-bgs at previous soil borings SB-1, SB-3, and SB-5 (see **Figure 4**). Photographs taken by our on-site personnel during the soil response actions are included in **Appendix 5**.

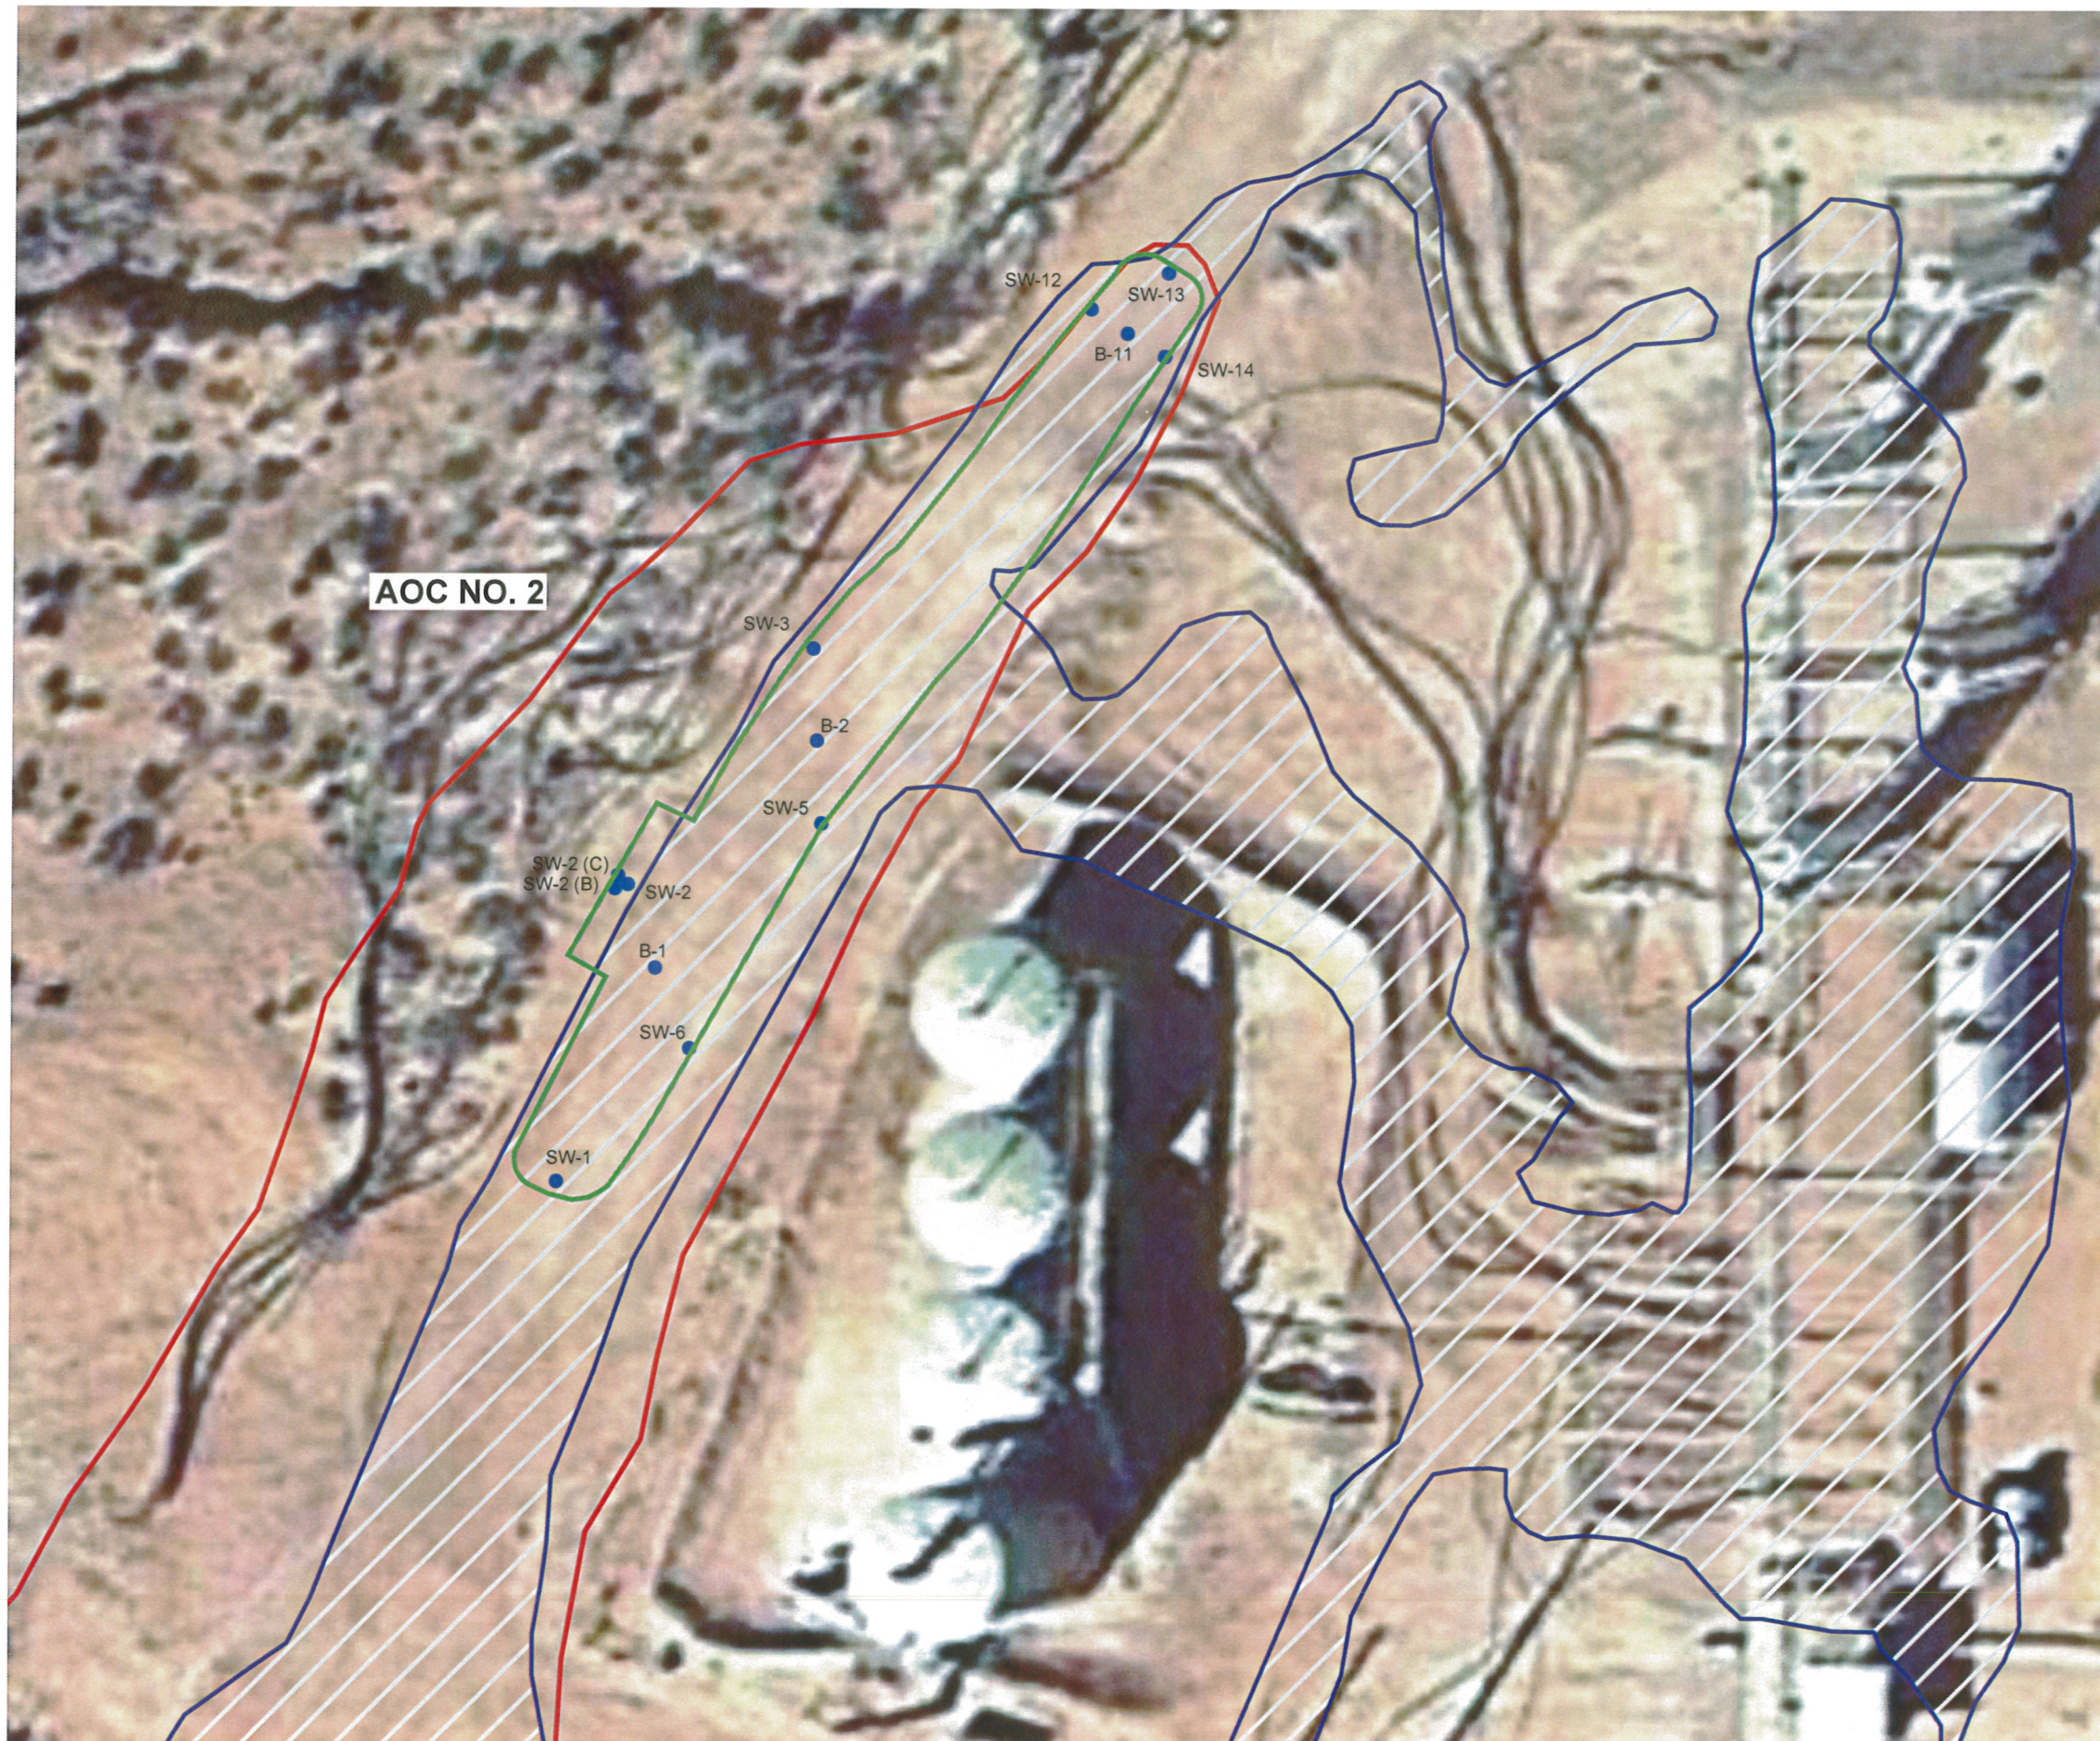
FIGURE 5
AOC NO. 2

AOC No. 2 was a chloride-impacted area that included soil borings SB-7 and SB-8 measuring approximately 1,850 square feet located within the lease road adjacent to the tank battery (**Figure 5**). Elevated concentrations of chlorides above 1,000 mg/Kg were reported at depths up to 3 ft-bgs. As a result, SKA concluded that the response actions (i.e., excavating and properly disposing/recycling of chloride-impacted soils offsite) were warranted on this portion of the subject property in an effort to obtain regulatory closure. These response actions are further described in **Section 4.0** of this report.

SKA conducted response actions by excavating a total of 108 tons of chloride-impacted soil from AOC No. 2 to a depth of approximately 2 ft-bgs at previous soil borings SB-7 and SB-8 (see **Figure 5**). Photographs taken by our on-site personnel during the soil response actions are included in **Appendix 5**.

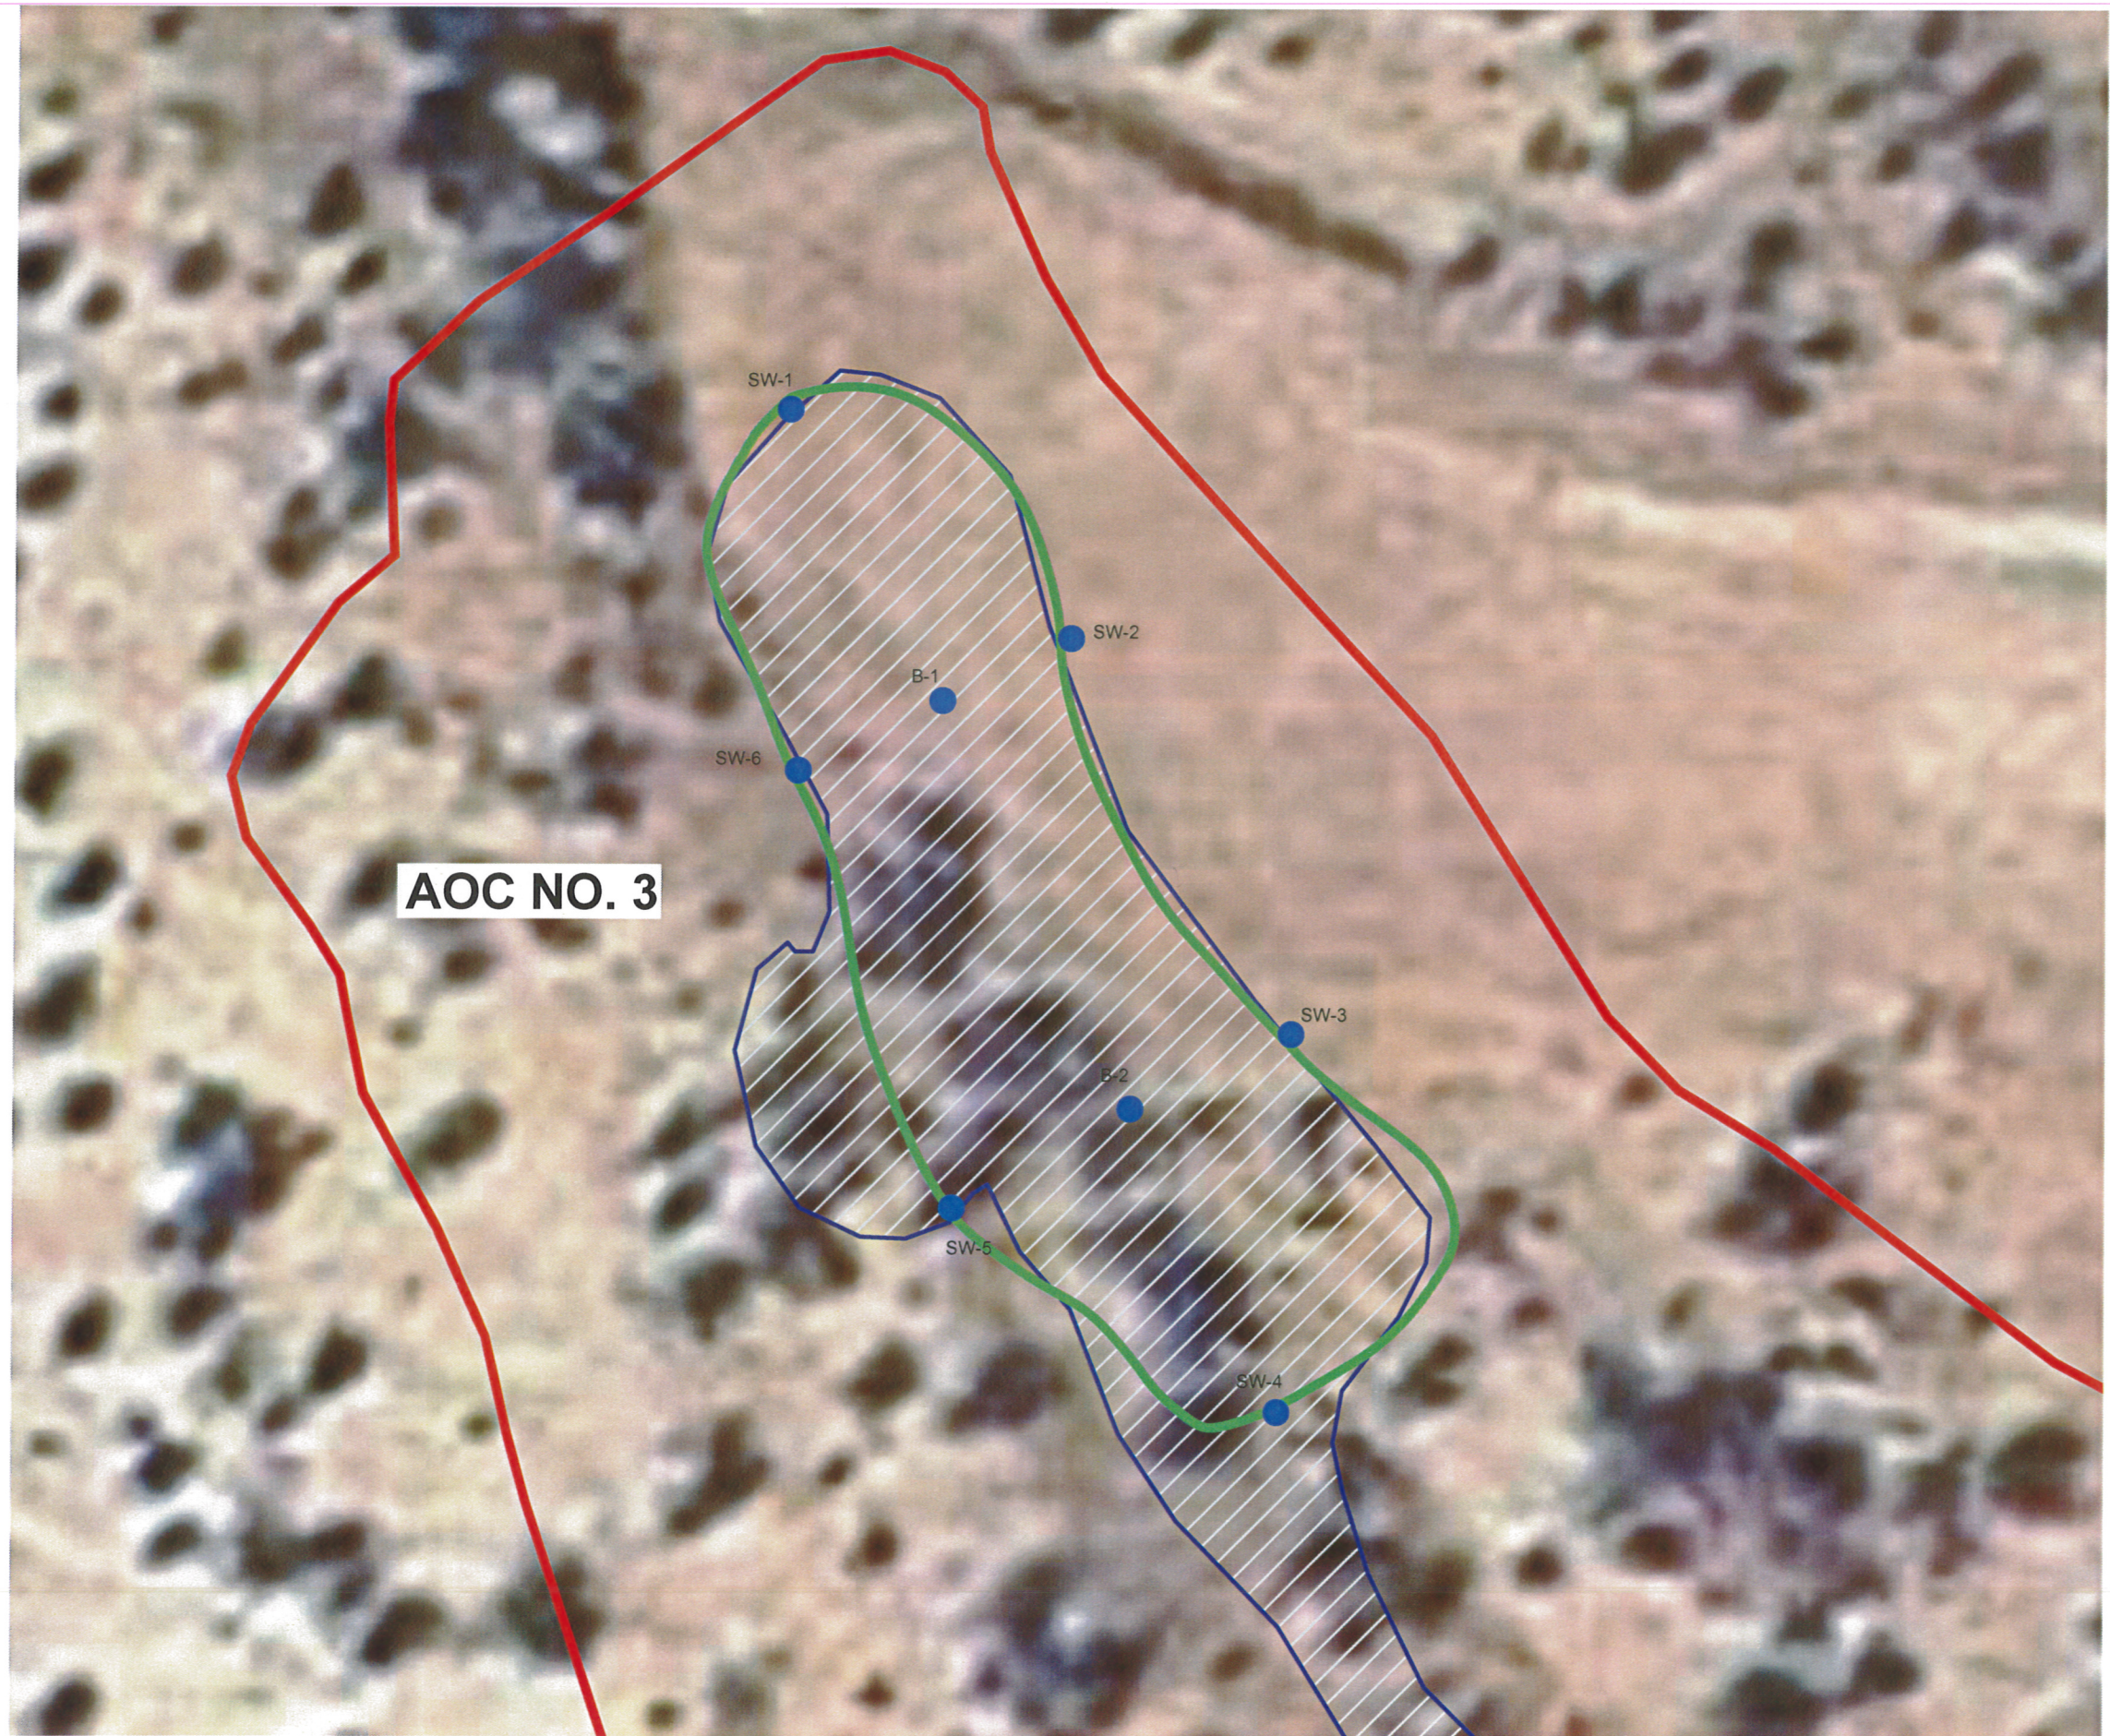
FIGURE 6
AOC NO. 3

AOC No. 3 was a TPH-impacted area that included soil boring SB-4 measuring approximately 1,075 square feet located with a natural drainage swale in proximity to the tank battery (**Figure 6**). An elevated concentration of TPH above 5,000 mg/Kg was reported at a depth of 2 ft-bgs. As a result, SKA concluded that the response actions (i.e., excavating and properly disposing/recycling of chloride-impacted soils offsite) were warranted on this portion of the subject property in an effort to obtain regulatory closure. These response actions are further described in **Section 4.0** of this report.

SKA conducted response actions by excavating a total of 84 tons of TPH-impacted soils from AOC No. 3 to a depth of approximately 2 ft-bgs at previous soil boring SB-4 (see **Figure 6**). Photographs taken by our on-site personnel during the soil response actions are included in **Appendix 5**.
