**TRANSMITTAL
SOIL ABATEMENT COMPLETION REPORT
TURNER B SOUTH TANK BATTERY
SECTION 29, TOWNSHIP 17 SOUTH, RANGE 31 EAST
LOCOC HILLS, EDDY COUNTY, NEW MEXICO**

**Soil Abatement Completion Report
Turner B South Tank Battery
Section 29, Township 17 South, Range 31 East
Loco Hills, Eddy County, New Mexico**

Project No. 12009-0005

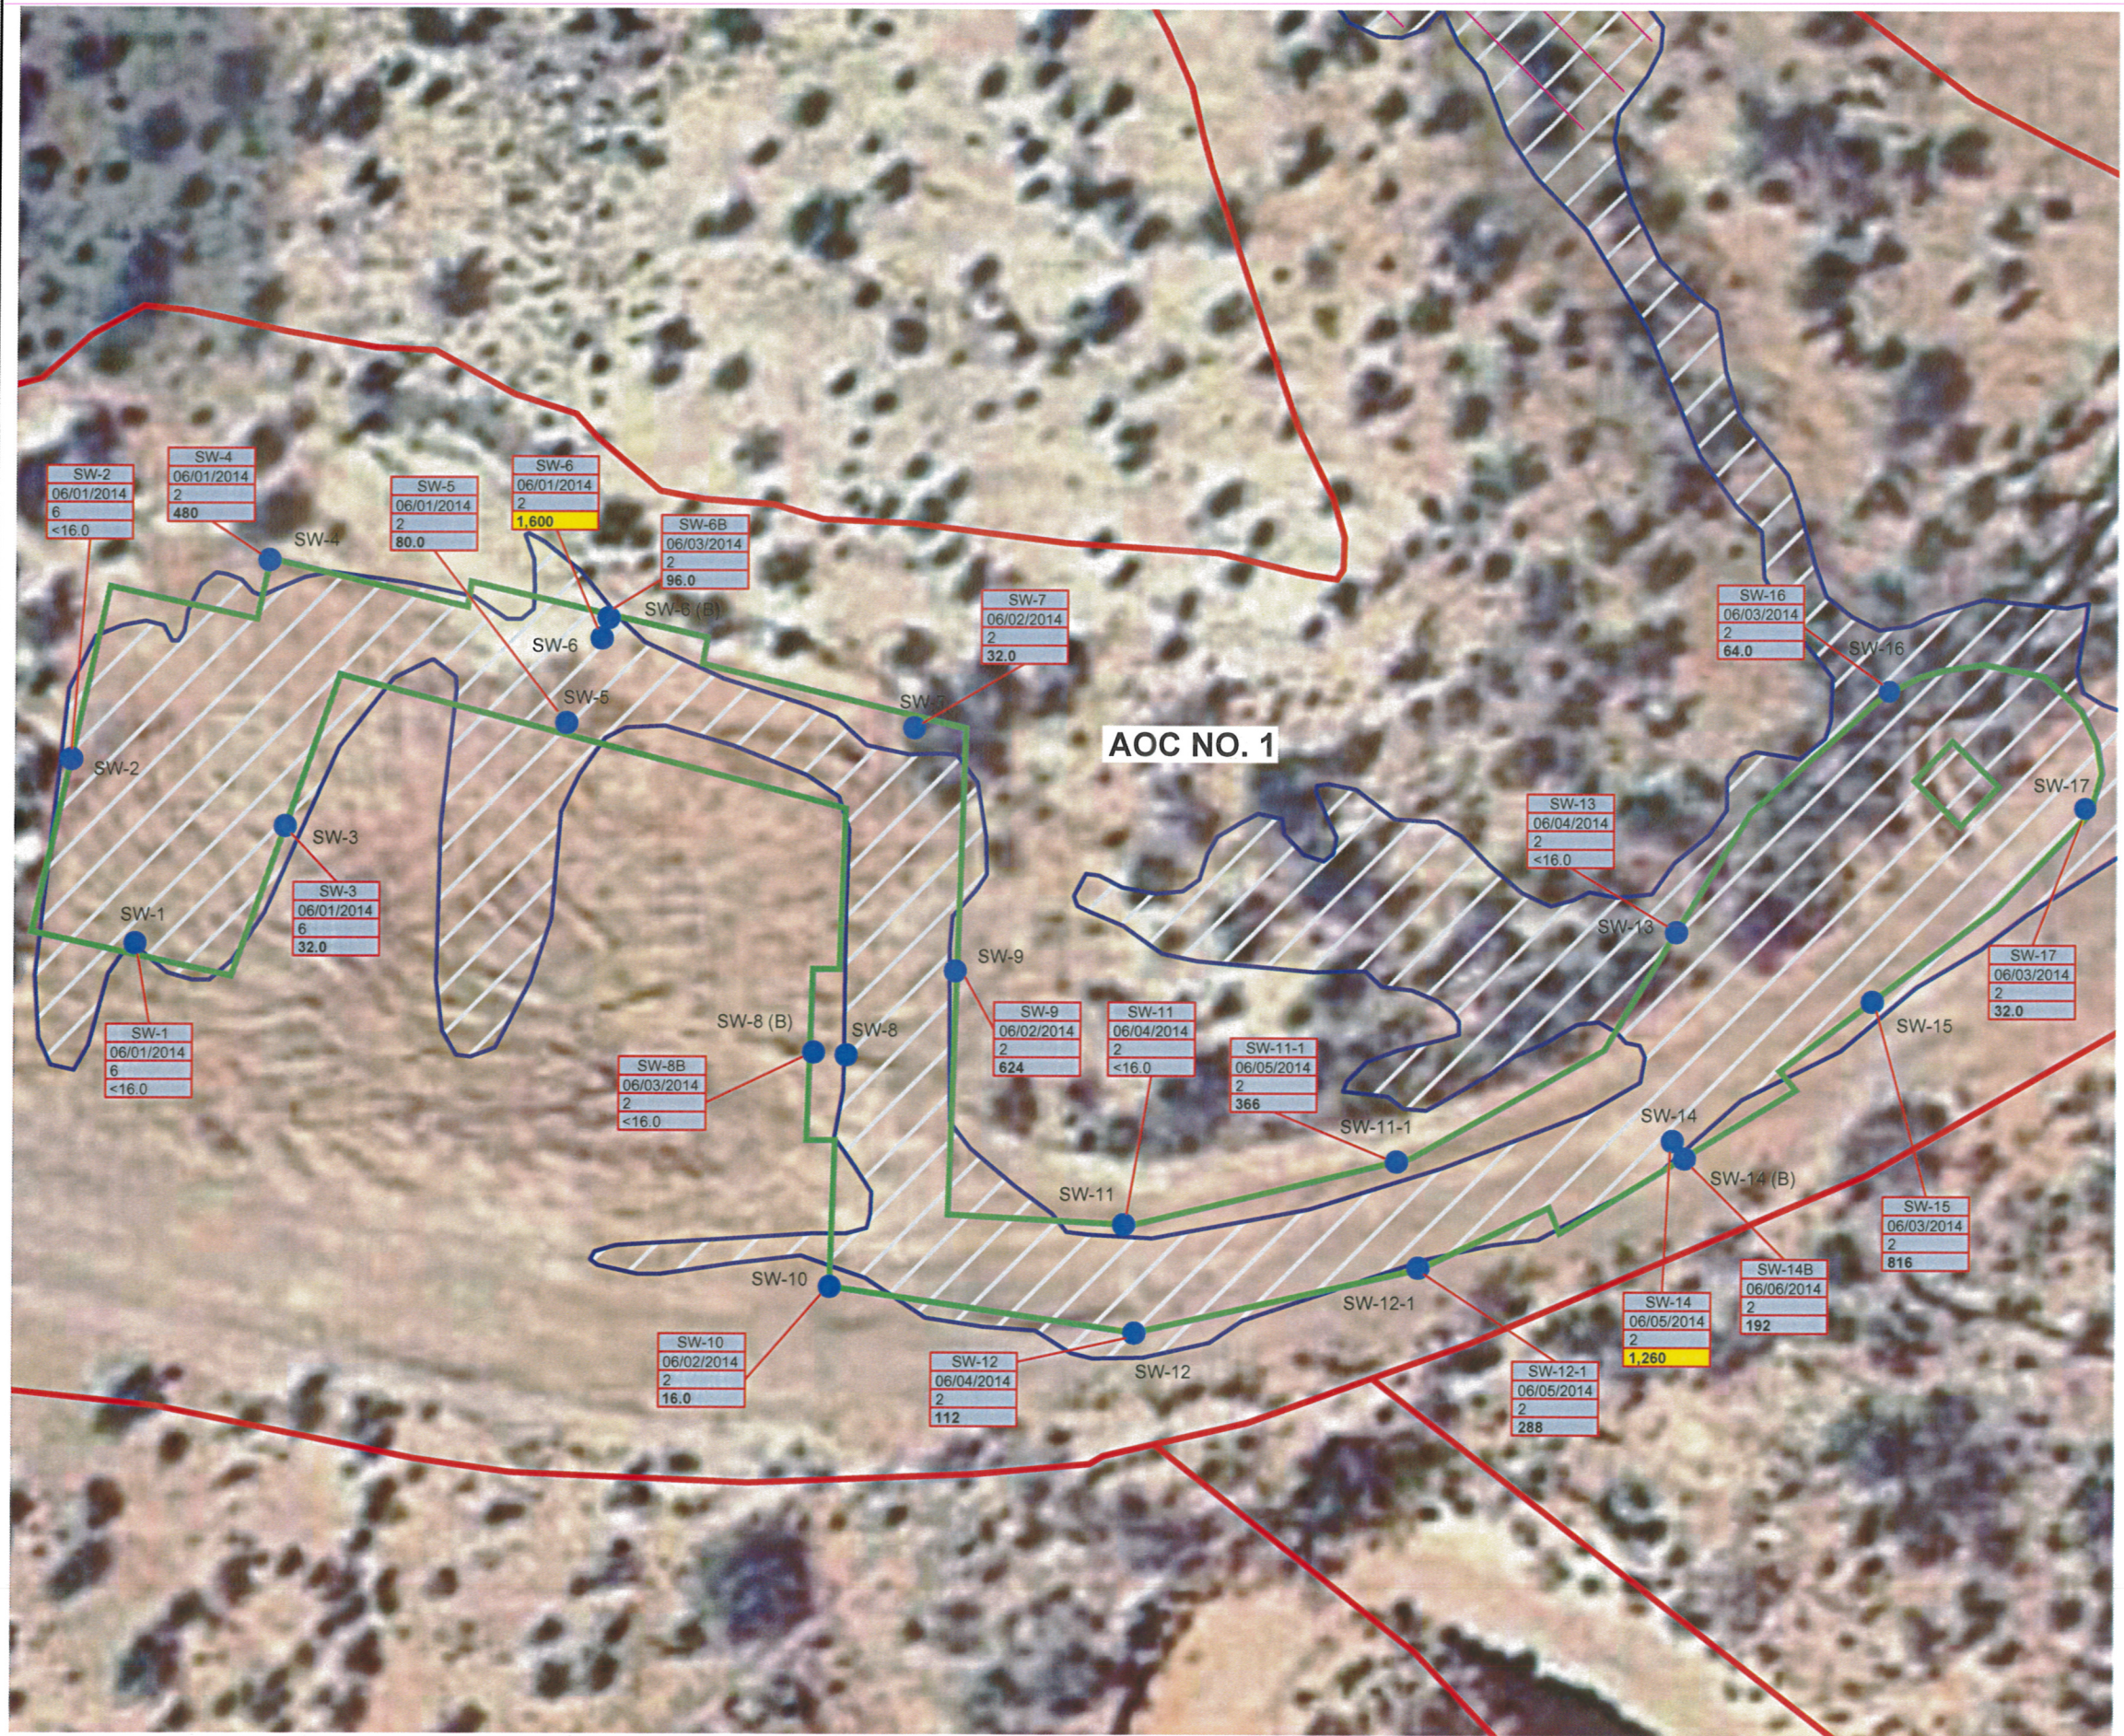
FIGURE 7
AOC NO. 1 SOIL CONCENTRATION MAP

AOC NO. 1 COC CONCENTRATION MAP

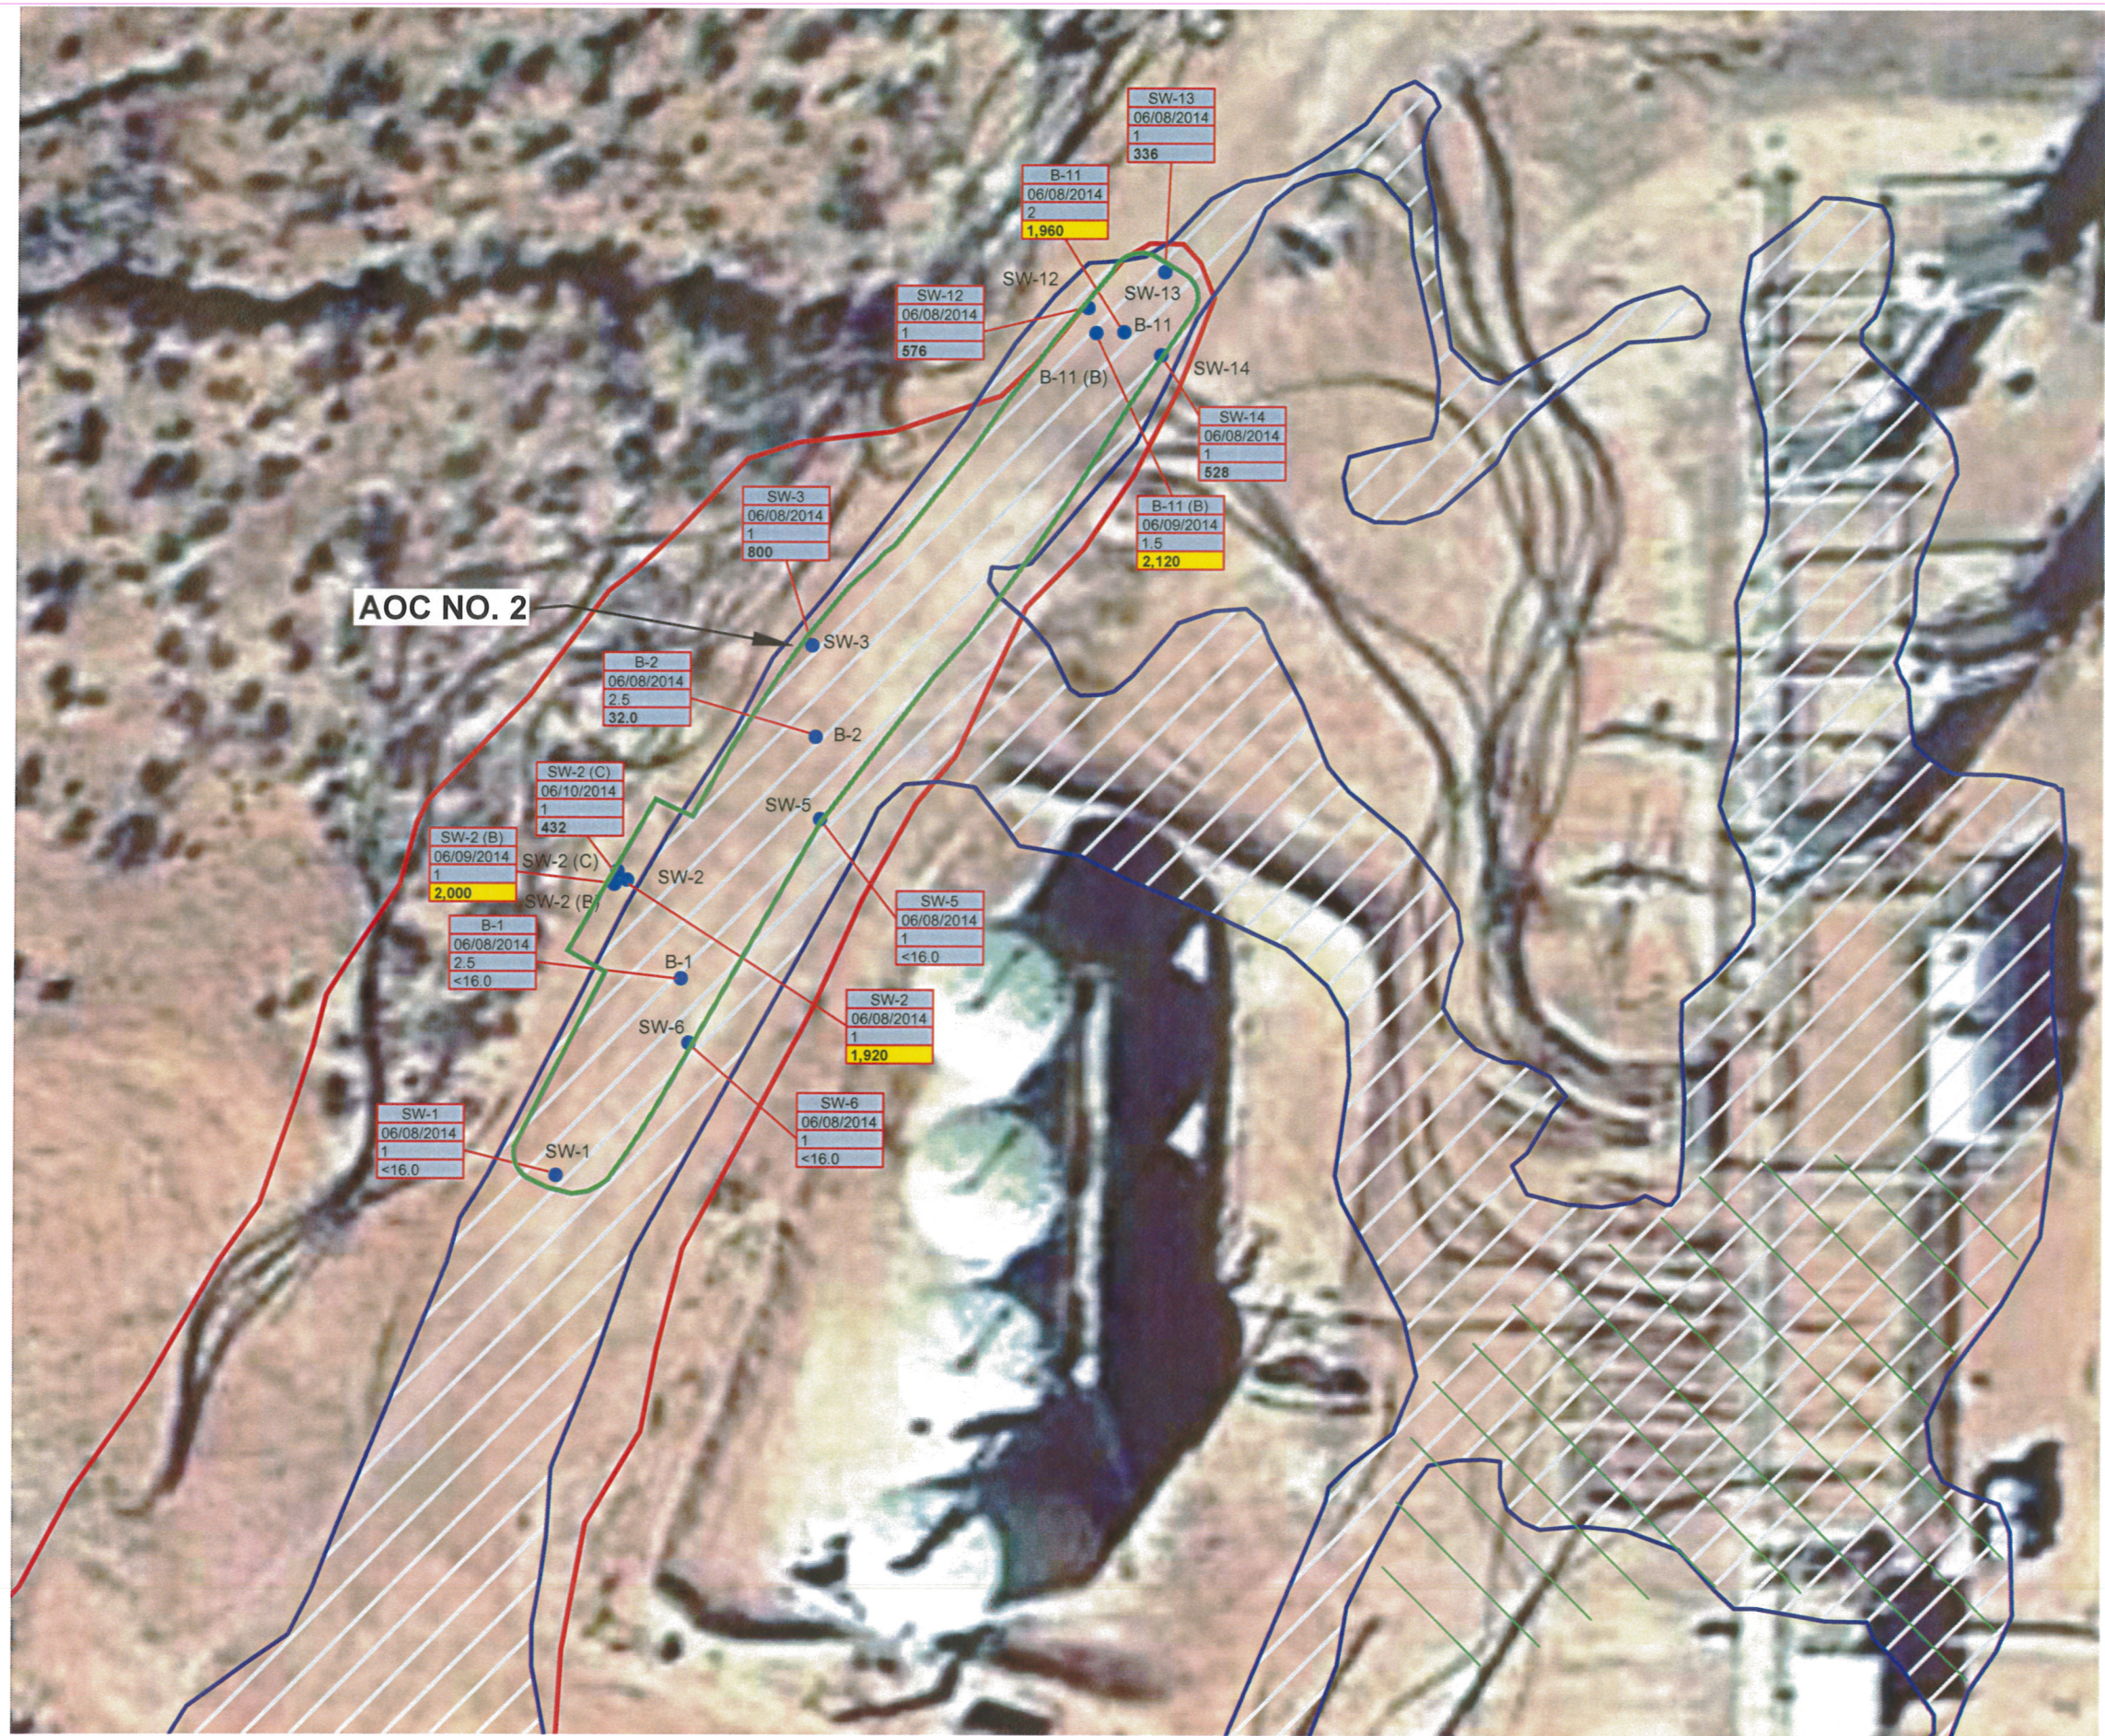
FIGURE 8
AOC NO. 2 SOIL CONCENTRATION MAP

AOC NO. 2 COC CONCENTRATION MAP

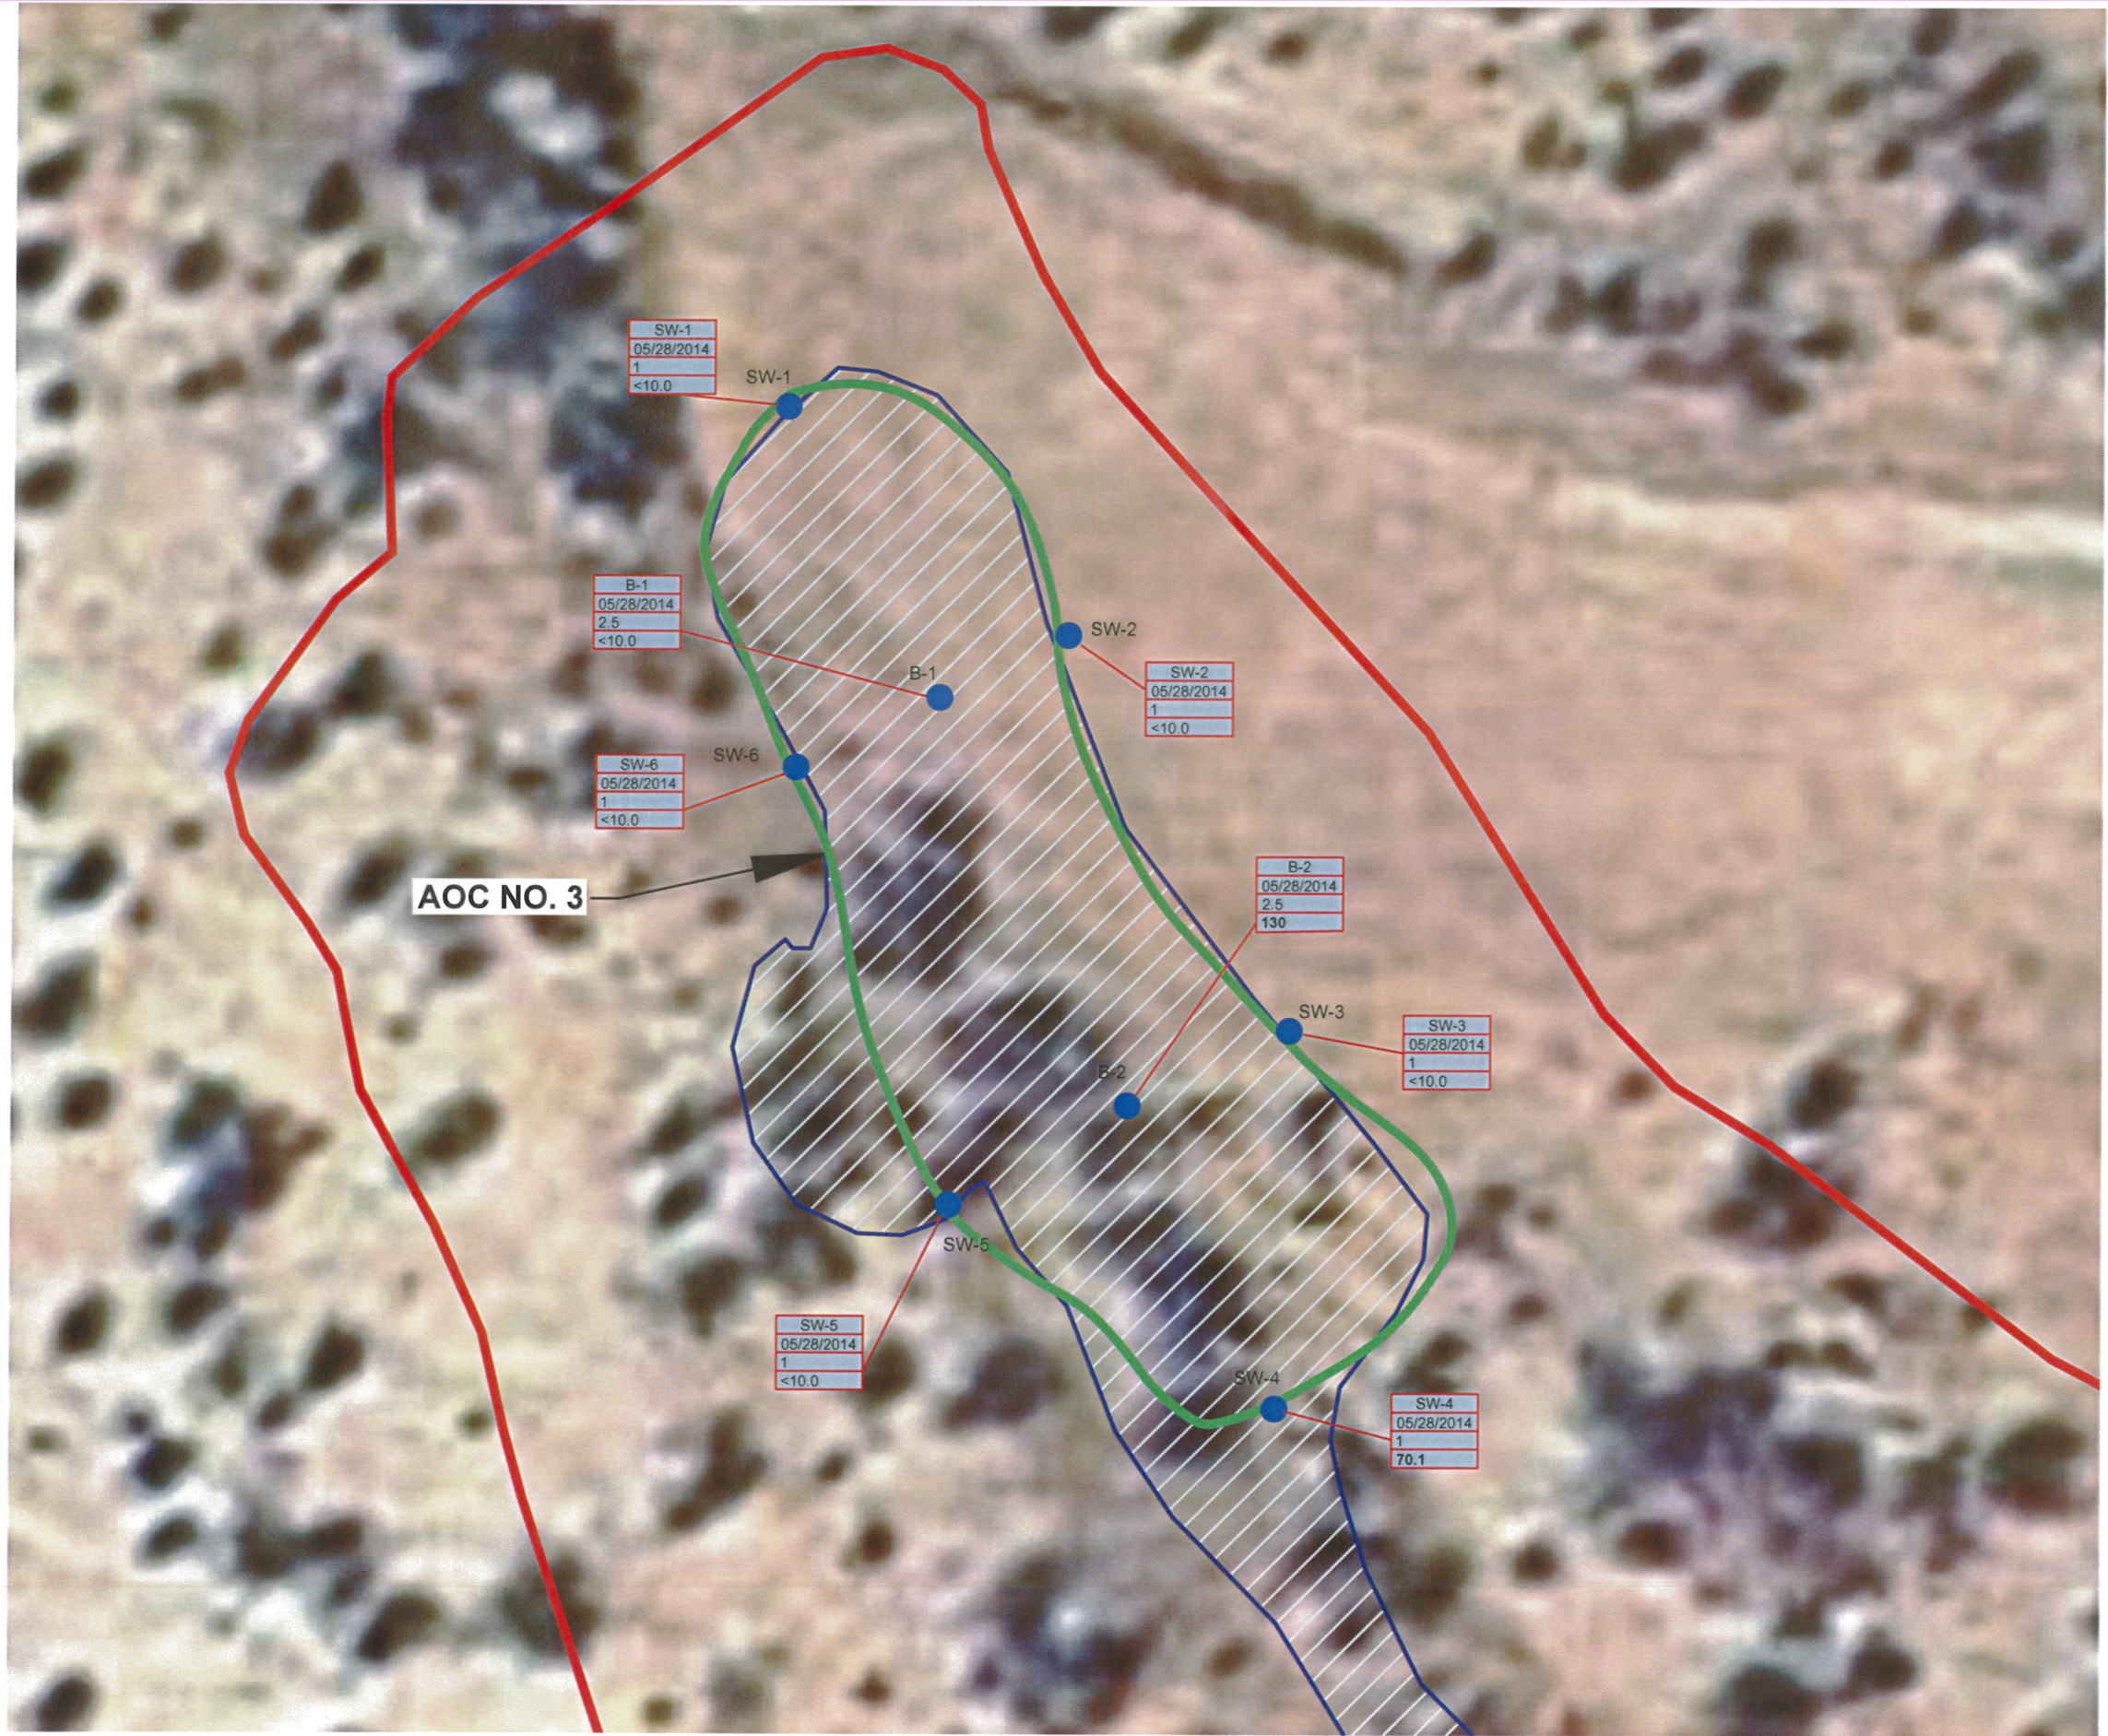
FIGURE 9
AOC NO. 3 SOIL CONCENTRATION MAP

AOC NO. 3 COC CONCENTRATION MAP
