June 2015

Staley State-Williams Federal Remediation Plan

**Prepared For:
LRE Operating LLC.**

**Prepared by
R.T. Hicks Consultants, Ltd.
Albuquerque, New Mexico**

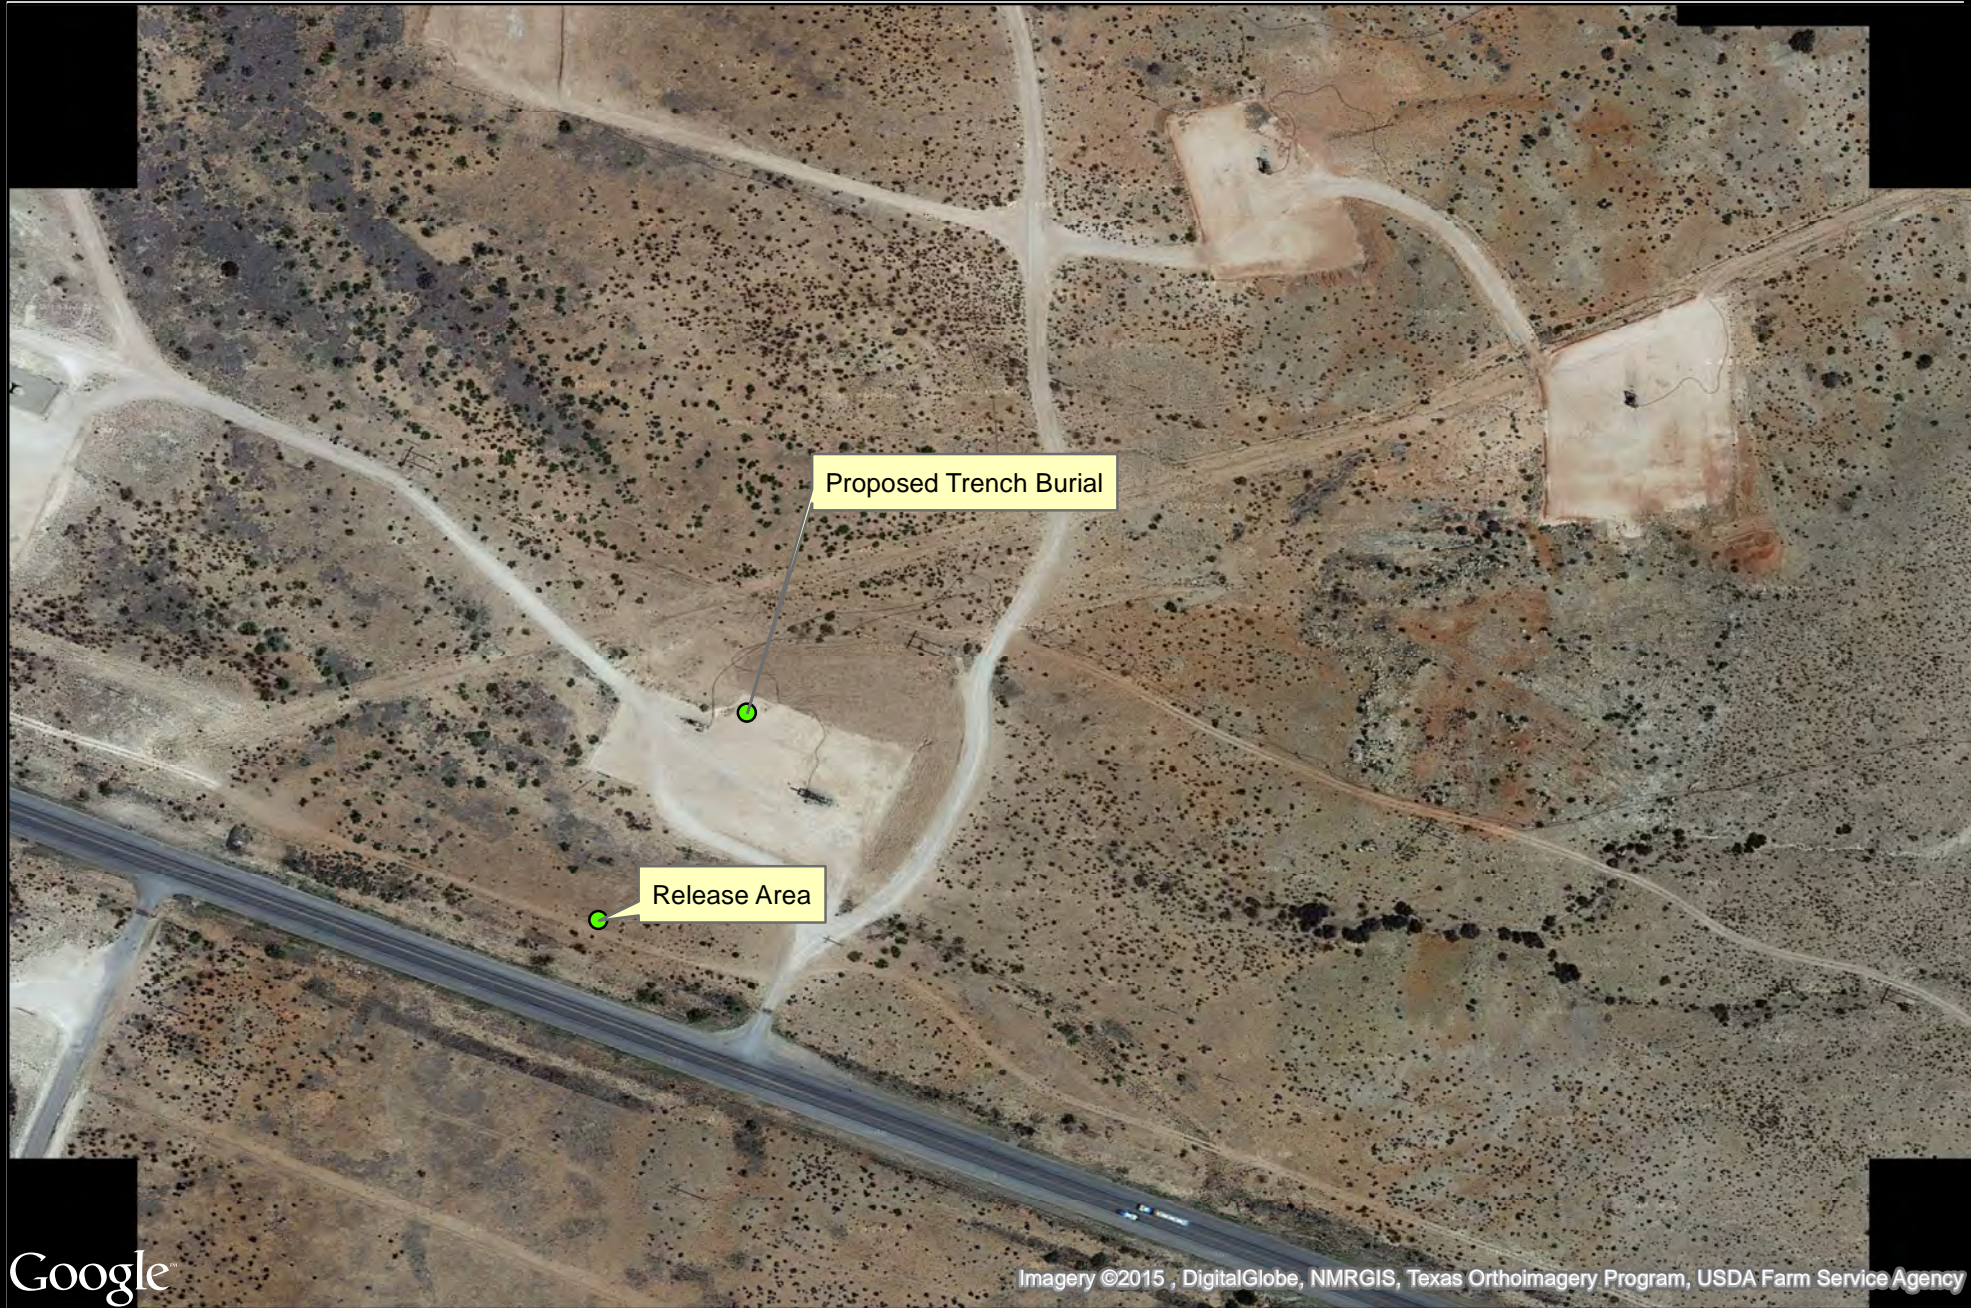
Plate 9

Trench and Release Location

1. Excavate a trench with dimensions of 30 feet wide by 80 feet long by 11 feet deep on the north side of the production pad shared by the Williams A Federal #5 and Williams A Federal #10 wells (see Plate 9).. This trench area will be staked by Lime Rock or their representatives with the selected contractor on site.
