**Devon Energy
Cotton Draw Unit #214 H
Closure Report**

**Section 36, T24S, R31E
Eddy County, New Mexico
2RP-2904**

July 17, 2015

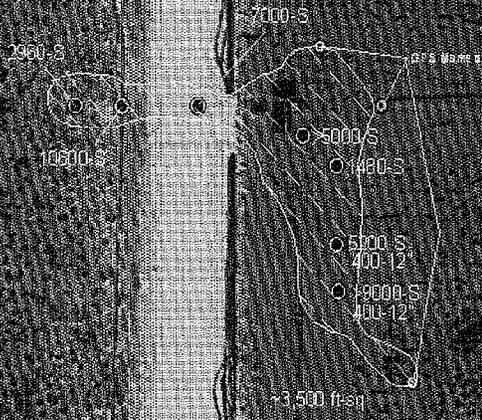
**Figure 2
Site Plan**

Devon Cotton Draw 214 PW Flowline Release

U.L.C Section 36 T24S R31E
N32deg 10.654' W108deg 43.993'

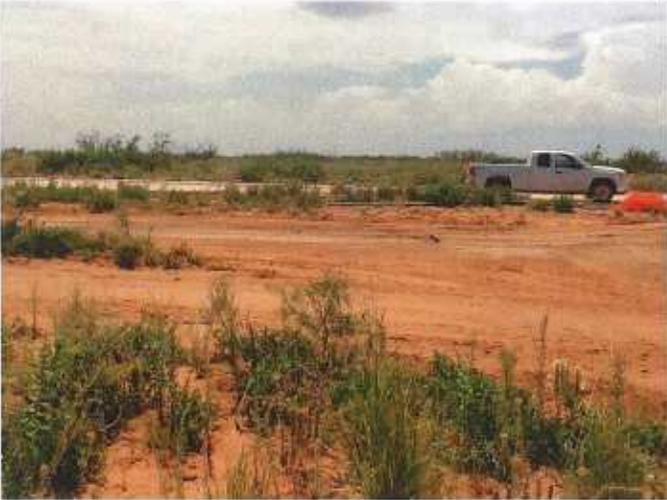
Location looking West

Based on the above confirmation of field analysis; the excavated area was backfilled with fresh topsoil and the area returned to grade. All impacted soils were removed to an NMOCD approved facility.

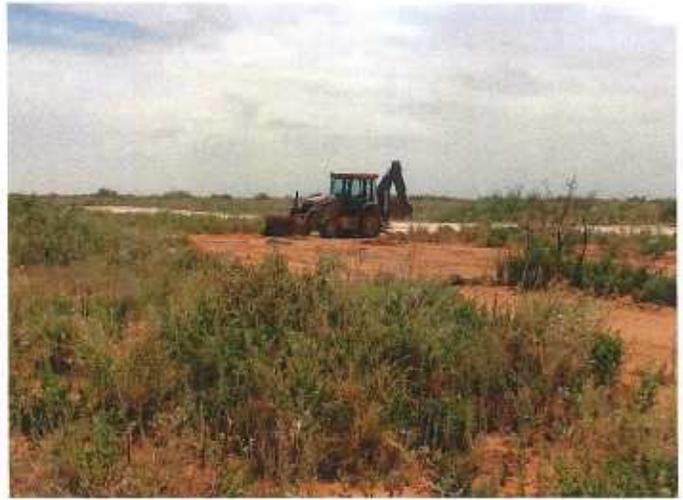
Location looking Southwest

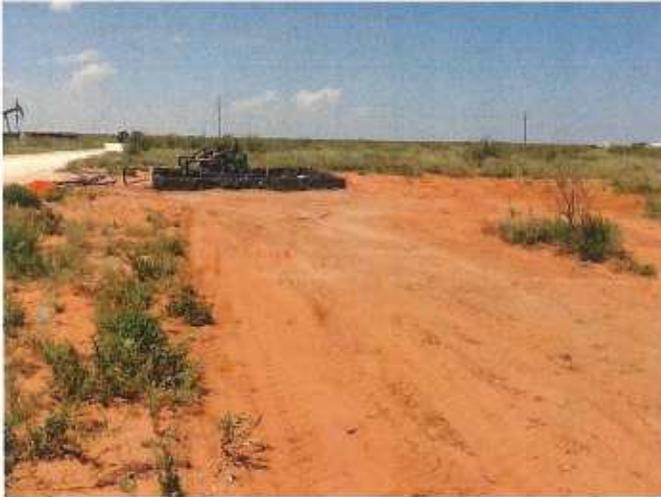
Location looking South

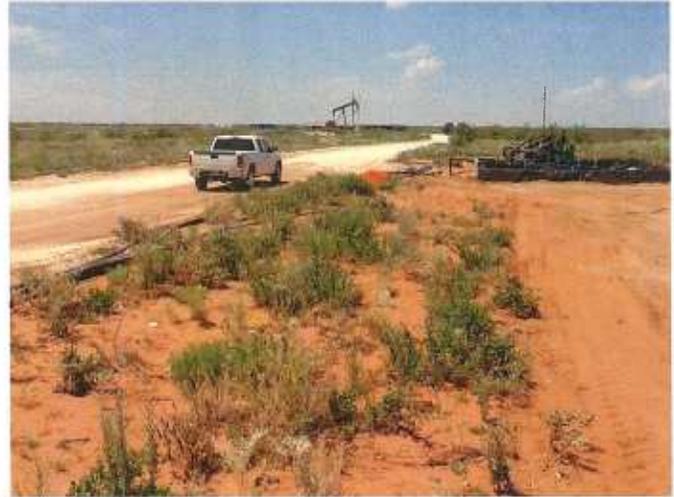
Location looking South

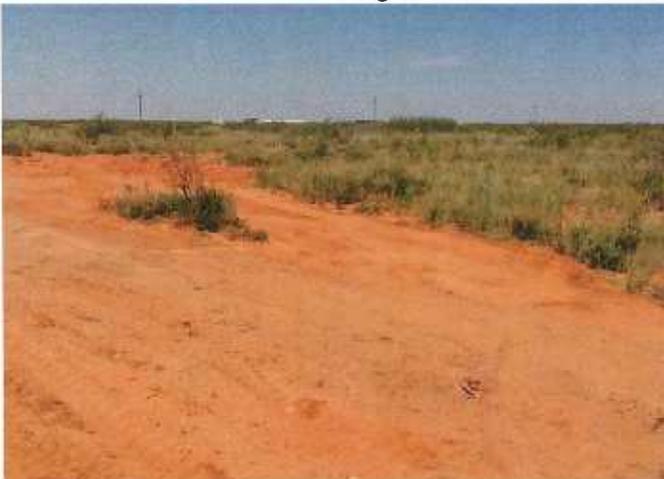
Location looking South

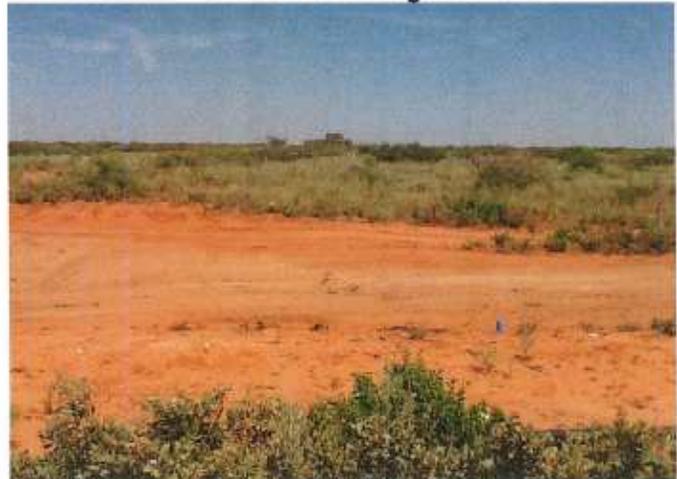
Location looking West
