Gadwall 18 Fed Com #2H

Third release

REMEDIATION WORK PLAN

RE: Cimarex, Gadwall 18 Fed Com #2H third release – Remediation Work Plan
UL/C, Section 18, T25S, R27E
API No. 30-015-39141

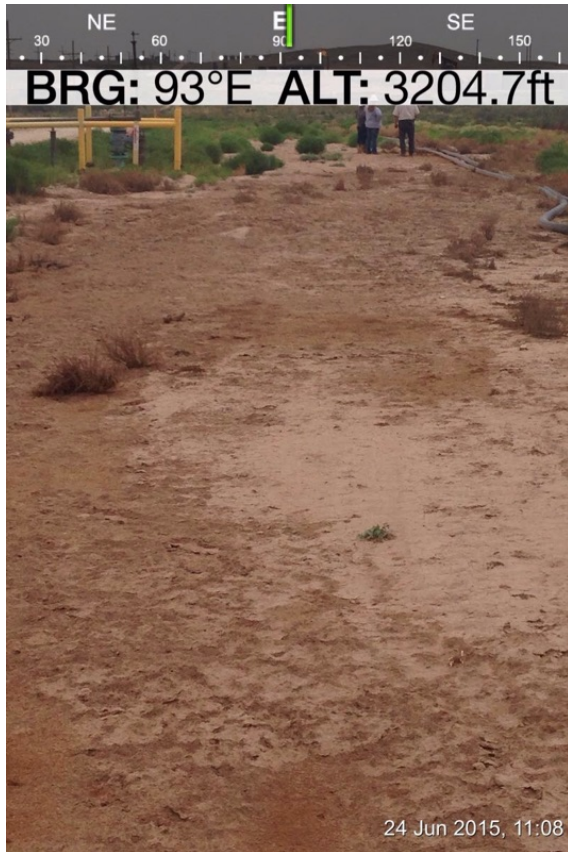
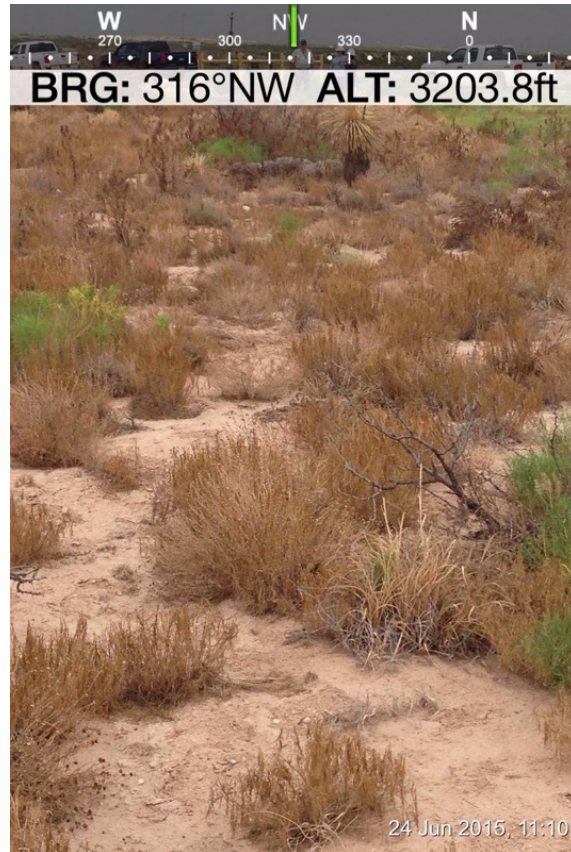
PHOTO PAGE

7/10/2015

SP Date: 7/10/2015
Rel Date:

Lab Confirmation Sample
	Field Sampling
	Needs Delineation and confirmation samples

Remove 1' to 3' bgs of the contaminated soil in the respective areas. Confirmation samples will be obtained when the excavation is started for the sample areas that came back above 100 ppm. Haul all contaminated material to an approved NM state disposal. In the areas of the spill that is wide we will backfill with clean soil. In the narrow areas we will use surrounding terrain for backfill. We will re seed using a BLM approved seed mix.
