SUBJECT: FINAL CLOSURE REPORT FOR INCIDENT 2RP-2938 SRO STATE UNIT COM #13H, EDDY COUNTY, NEW MEXICO

FINAL CLOSURE REPORT FOR INCIDENT 2RP-2938

SRO STATE UNIT COM #13H

EDDY COUNTY, NM

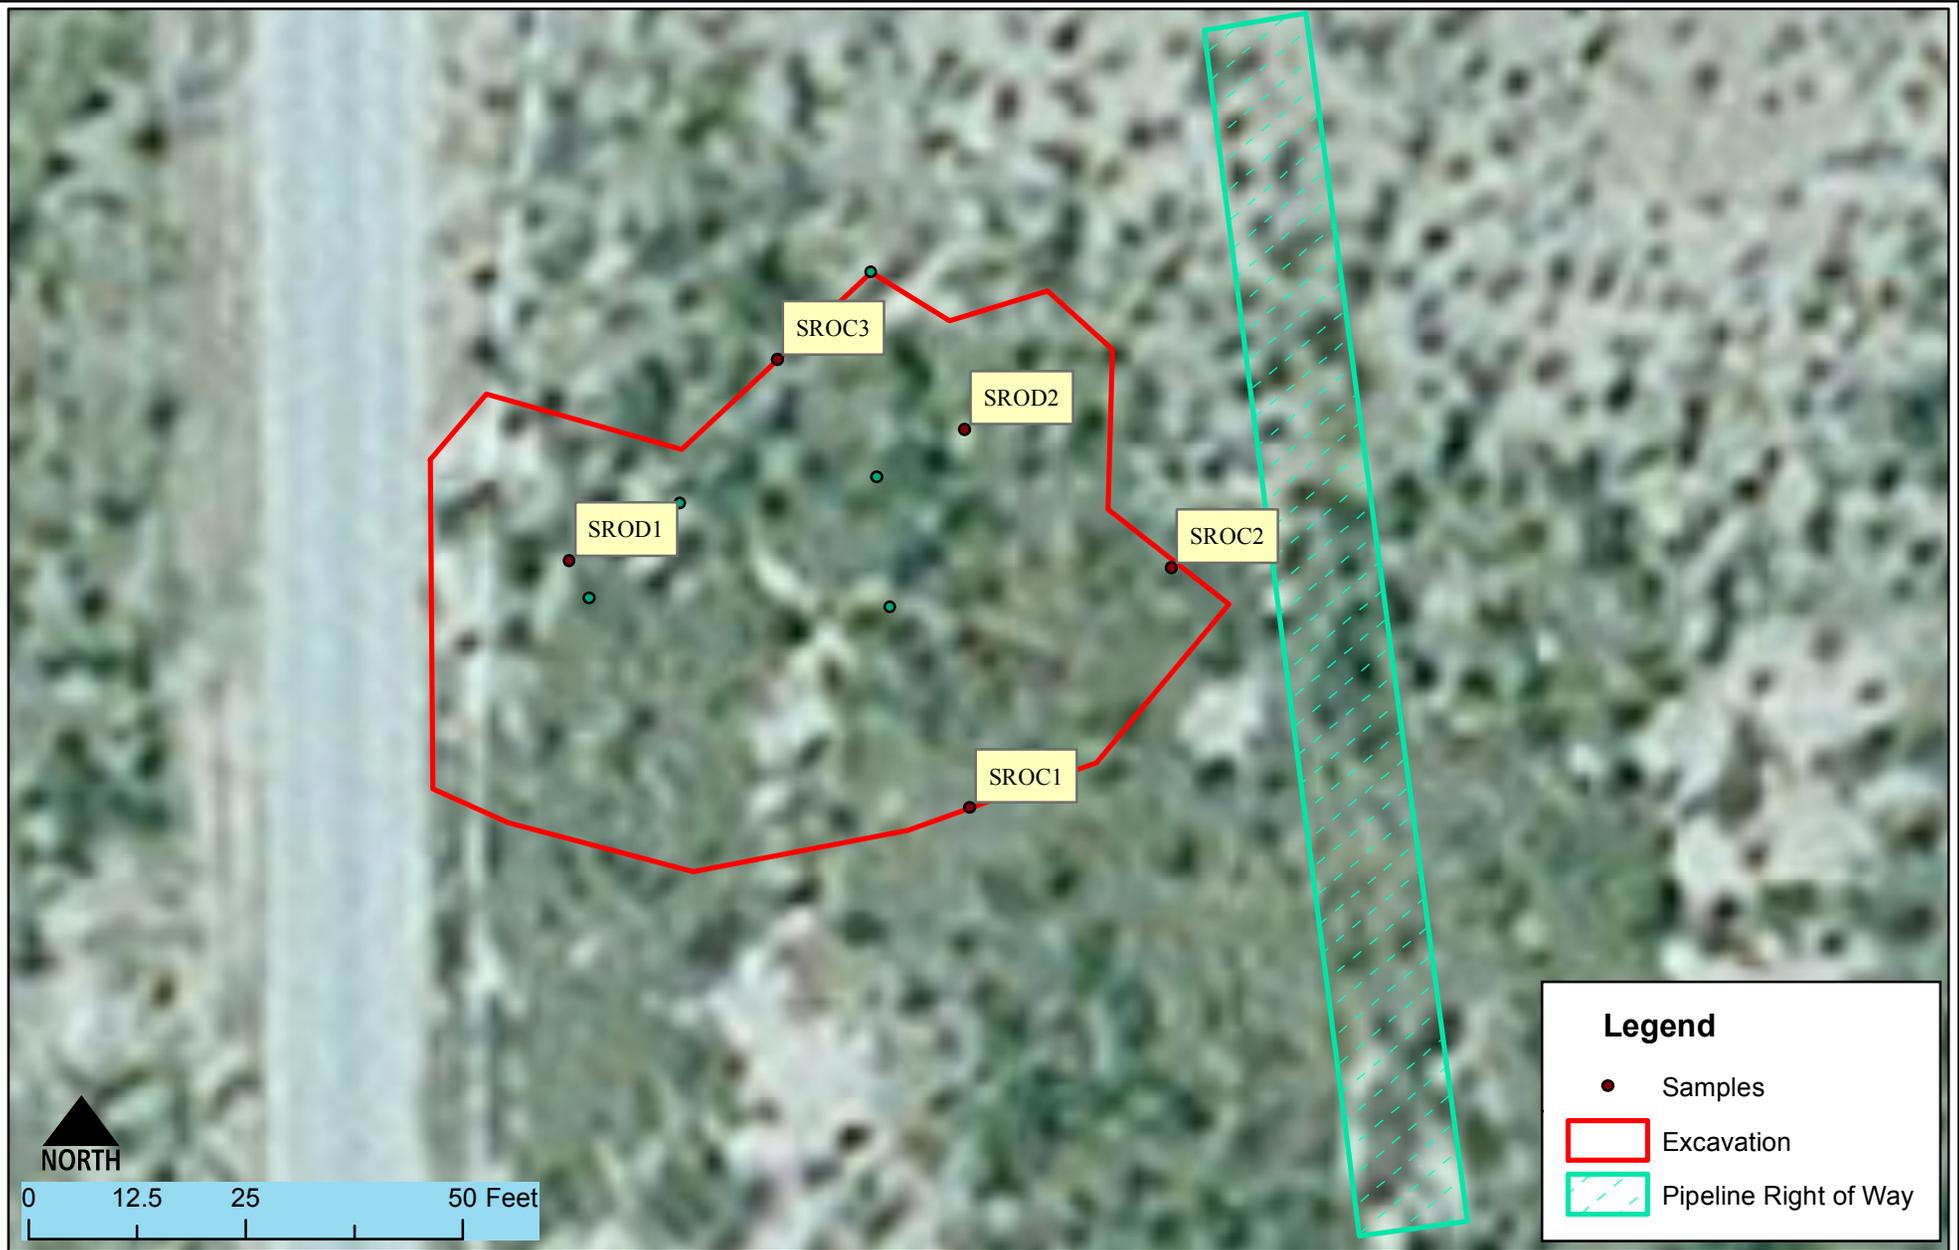
FIGURE 2

Soil contaminant concentrations are illustrated in Figure 2. A summary of laboratory analytical results is included in Table 3. Laboratory reports are included in Appendix C.

DETAILED SITE AND SAMPLE MAP

SROD2 are closure samples collected at three feet bsg in the excavation, with results shown in Table 2. Excavation was conducted to three feet bsg in the spill area to remove the soils affected by the release. An in-situ cap was constructed within the excavation. The construction of the in-situ cap (Figure #3) was designed to prevent both capillary and leaching movement of the brine affected soils contained beneath. Starting at three feet bsg, a plastic liner was added as a capillary break between the affected soils and the caliche cap. The cap consists of two feet of contaminant-free caliche material placed, and compacted. Then, a plastic liner was added along with hay above the compacted caliche cap to form an intrusion barrier. This barrier will prevent leaching and formation of deep root systems into the cap itself. Topsoil was placed on top of the cap. The plastic liner on both sides of the caliche cap will effectively break the communication of precipitation through the compacted cap. After excavation, installation of in-situ cap, and backfill, topsoil and hay were added to help with contouring of the area and to promote vegetation growth. Approximately 681 cubic yards of contaminated soil was removed and replaced with the cap and clean backfill material to bring the excavated area to surface grade. The contaminated soil was transported for disposal at Lea Land, near Carlsbad, NM.

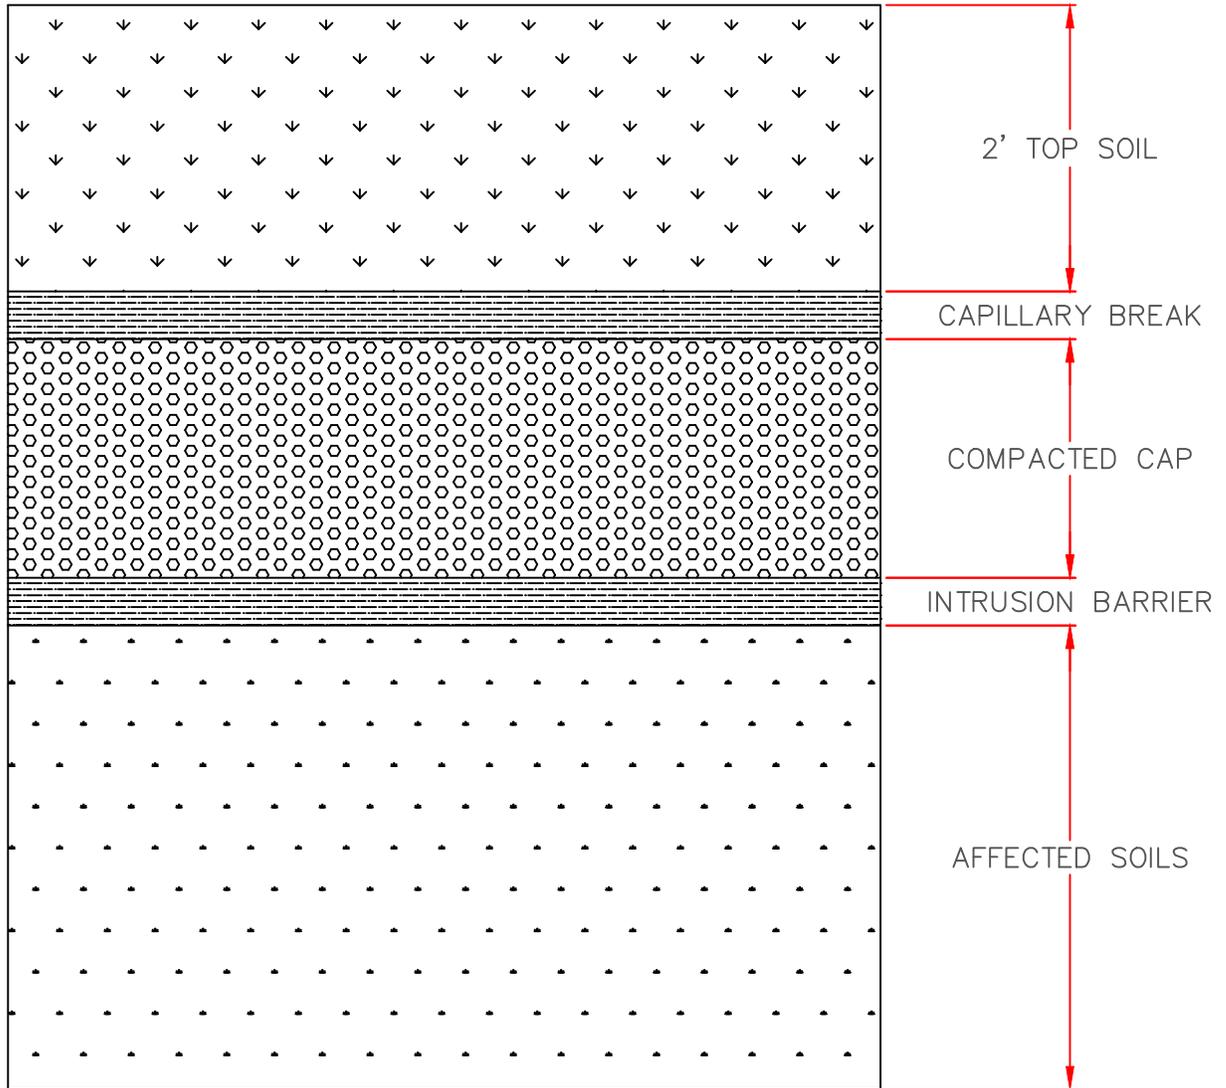
FIGURE 3

IN-SITU CAP AND BIO BARRIER DESIGN

**IN-SITU CAP
 AND BIOBARRIER DESIGN
 COG SRO STATE UNIT #13H**
