SUBJECT: FINAL CLOSURE REPORT FOR INCIDENT 2RP-2913 BOSE IKARD 4 STATE COM #18H, EDDY COUNTY, NEW MEXICO

FINAL CLOSURE REPORT FOR INCIDENT 2RP-2913

COG OPERATING LLC

BOSE IKARD 4 STATE COM #18H

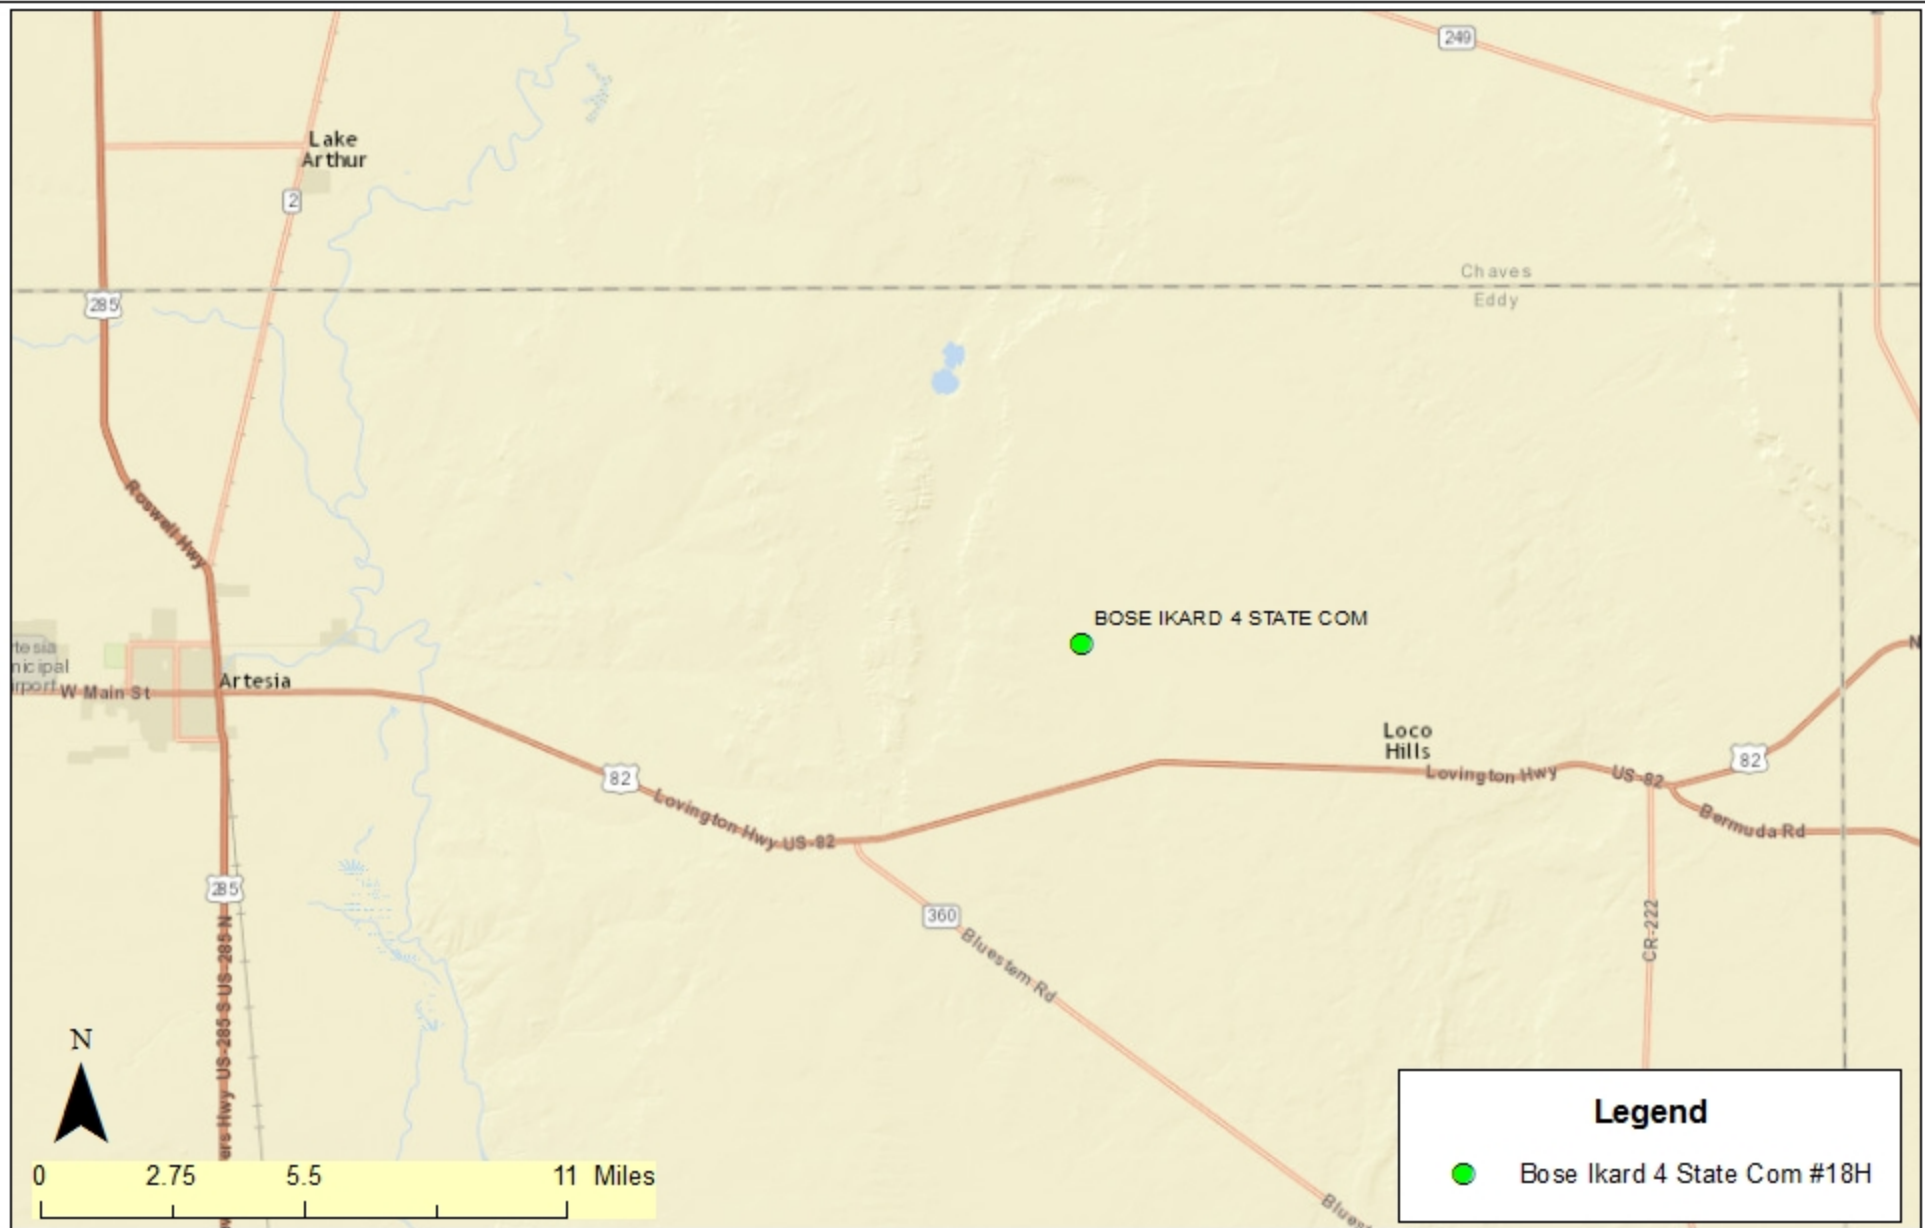
FIGURE 1 VICINITY MAP

On behalf of COG Operating LLC (COG), SMA has prepared this report that describes the assessment, initial delineation, and mitigation of a release associated with the Bose Ikard 4 State Com #18H release site. The site is located in Section 4, T 17S, R 29E NMPM, Eddy County, New Mexico, on land owned by the State of New Mexico. Figure 1 illustrates the vicinity and location of the site

Vicinity Map
Bose Ikard 4 State COM #18H-COG
Loco Hills, New Mexico

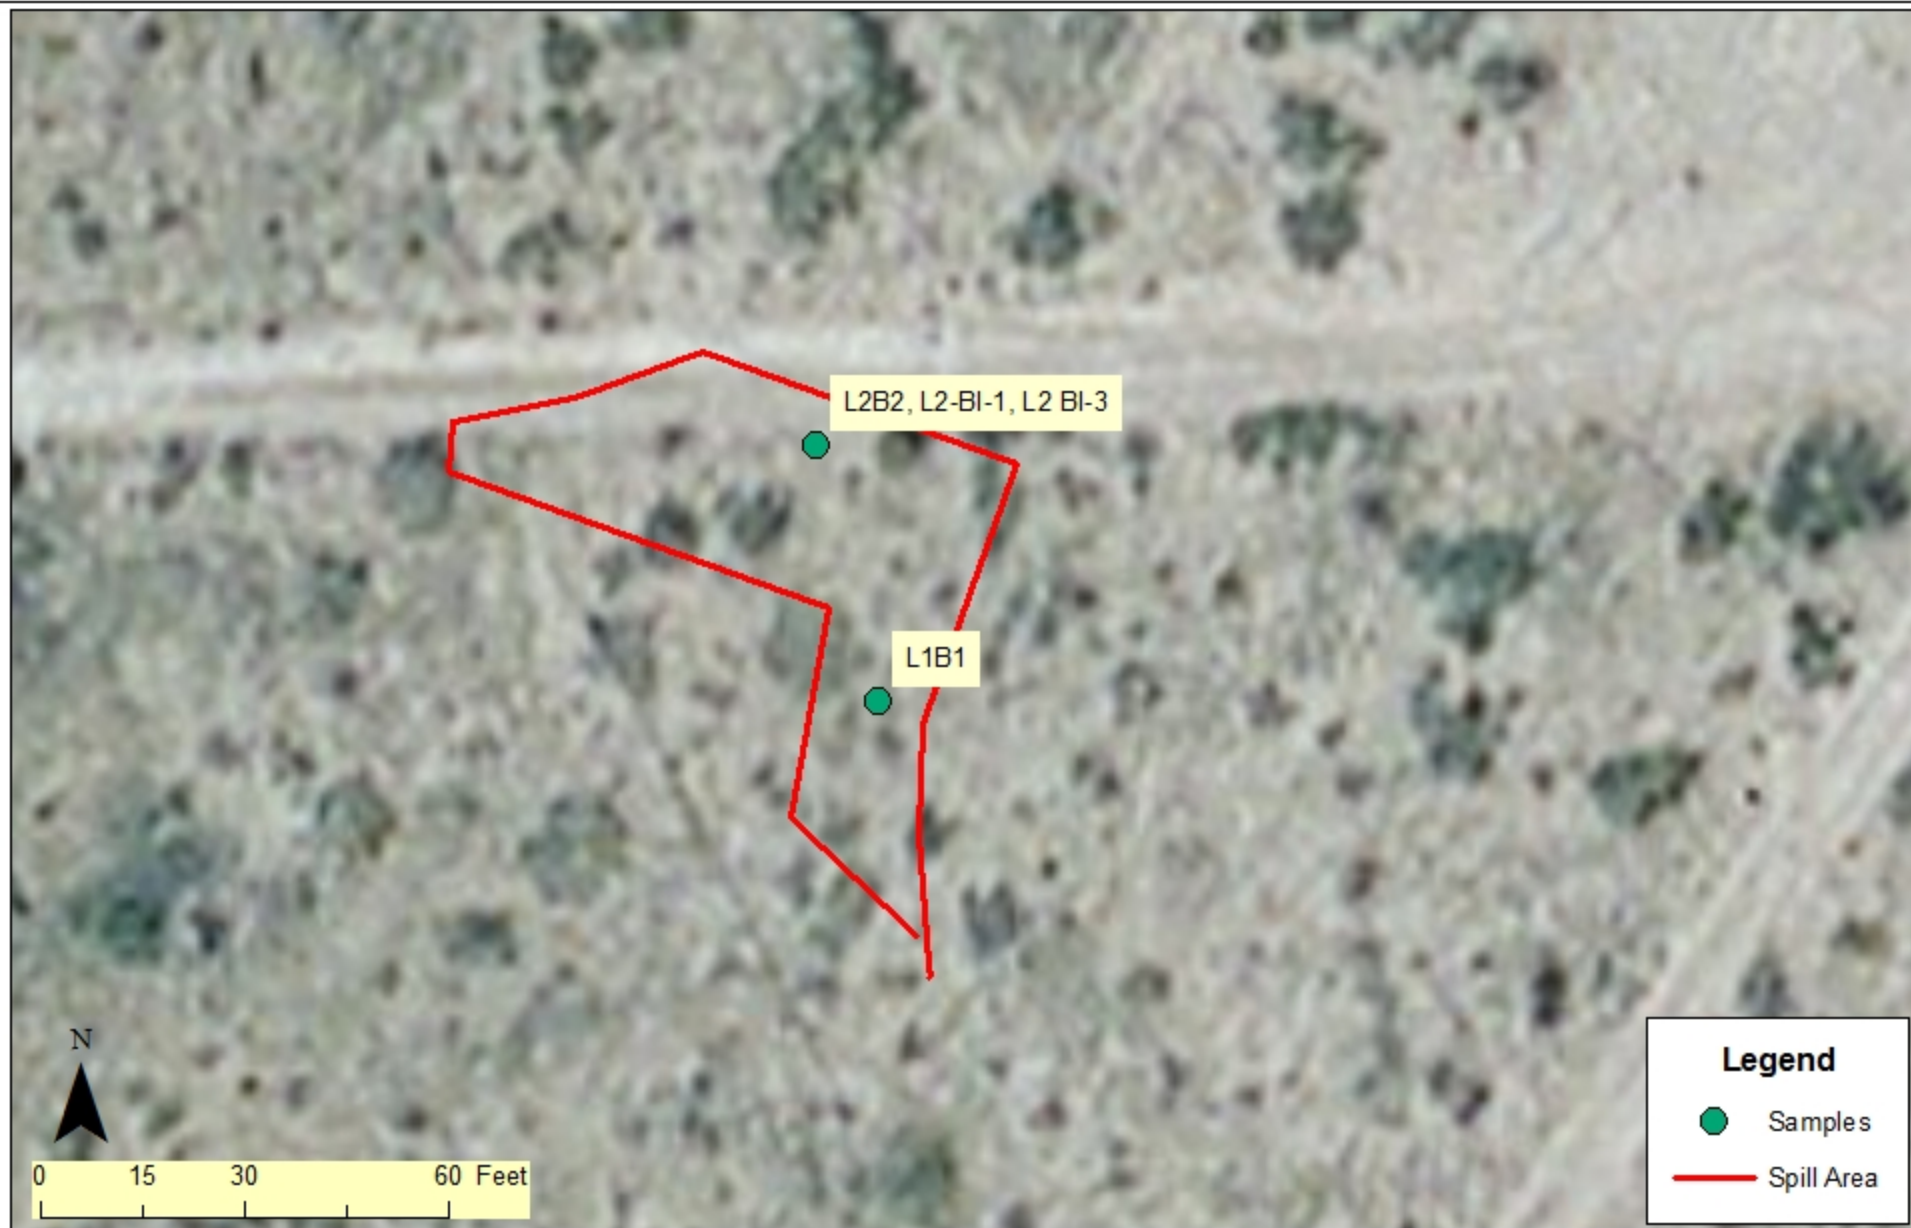
FIGURE 2

Soil contaminant concentrations are illustrated in Figure 2. A summary of laboratory analytical results is included in Table 2. Laboratory reports are included in Appendix A.

DETAILED SITE AND SAMPLE MAP

SITE DETAILS AND SAMPLE LOCATION MAP
 Bose Kard 4 State COM #18H-COG
 Loco Hills, New Mexico

SMA returned to the site on July 20, 2015 to supervise and guide excavation of affected soils, with approval from area utilities owners via 811 and the NMOCD. The samples that were taken on June 5, 2015 are the closure samples. Closure samples locations are shown in Figure 2 with laboratory results shown in Table 2. Initial sample result (1506542) show that the thickness of contaminated soil was less than one foot. Excavation was conducted to one foot bgs in the northern area of the spill. The southern area was scraped to 6 inches bgs. Excavation activities removed the soils affected by the release. After excavation, the area was backfilled with topsoil

to help with contouring of the area and promote vegetation growth. Approximately 50 cubic yards of contaminated soil were removed and replaced with clean backfill material to bring the excavated area to surface grade. The contaminated soil was transported for proper disposal at Lea Land, LLC near Carlsbad, NM.

Laboratory analytical results for all final closure samples collected were below NMOCD action levels for Benzene, BTEX, and TPH as well as below laboratory detection limits for the methods used. No further remedial activities are recommended.
