SUBJECT: FINAL CLOSURE REPORT FOR INCIDENT 2RP-2918 SCARED HAWK STATE COM #1, EDDY COUNTY, NEW MEXICO

# FINAL CLOSURE REPORT FOR INCIDENT 2RP-2918

## COG OPERATING LLC

SCARED HAWK STATE COM #1  
API# 30-015-35102  
SECTION 4, T25S R28E, NMPM  
EDDY COUNTY, NM

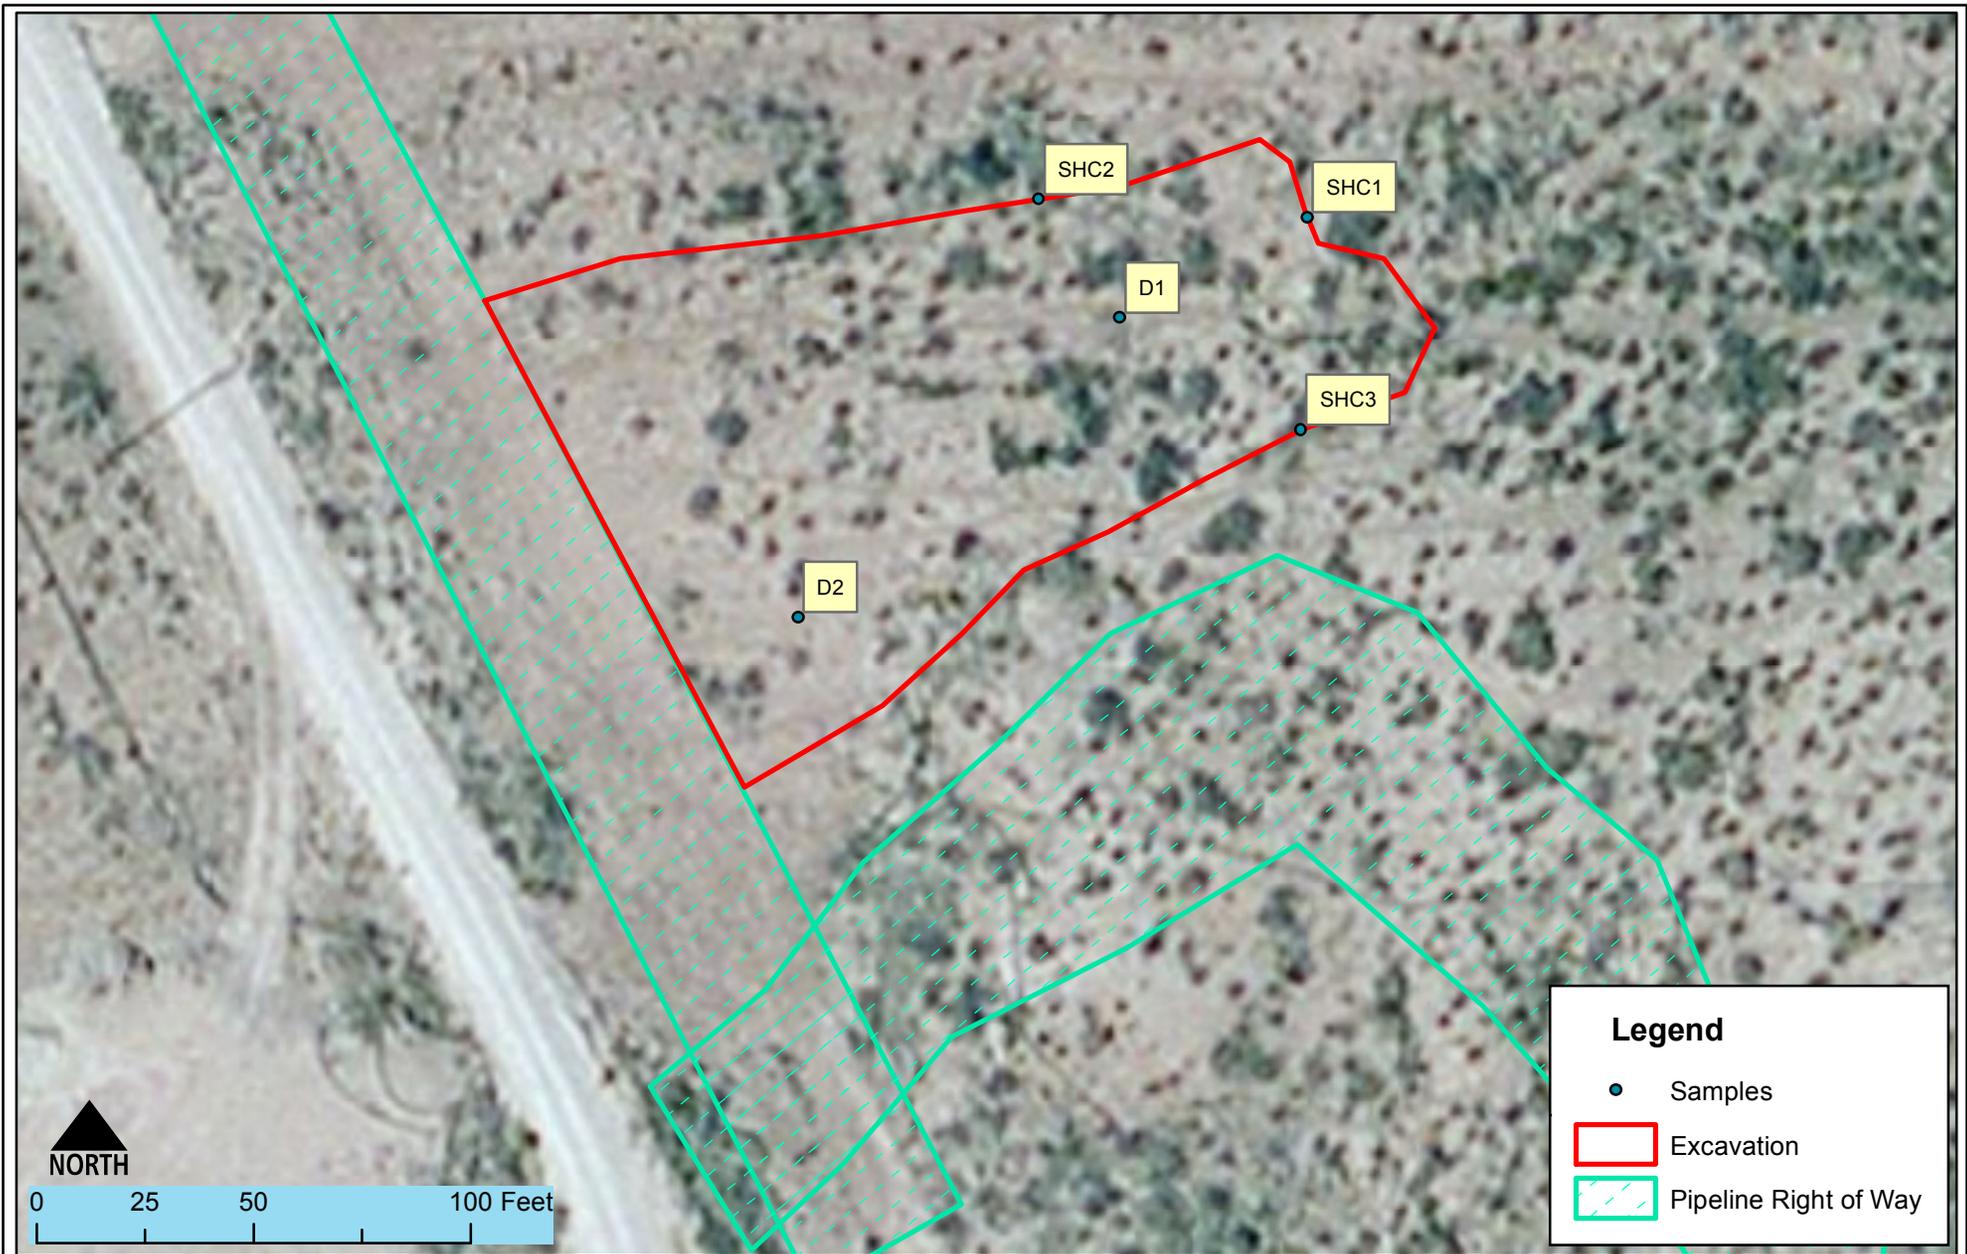
Figure 2

D1 shown in Figure 2, were taken as close to the pipeline as possible documenting the level of contamination in the soils left next to pipeline. Samples were taken in the sidewalls in the rest of the excavation to ensure contaminated soils had been removed in the horizontal extent. Sample location D1 and D2 are closure samples collected at three feet bsg in the excavation. Excavation was conducted to three feet bsg in the spill area to remove the soils affected by the release. An in-situ cap has been constructed within the excavation. The construction of the in-situ cap (Figure #3) has been designed to prevent both capillary and leaching movement of the brine affected soils contained beneath. Starting from three feet below surface grade, a plastic liner was added as a capillary break between the affected soils and the caliche cap. The cap consist of two feet of contaminant-free caliche material placed, and compacted. Then, a plastic liner was added along with hay above the compacted caliche cap to form an intrusion barrier. This barrier will prevent leaching and formation of deep root systems into the cap itself. Topsoil was placed on top of the cap. The plastic liner on both sides of the caliche cap will effectively break the communication of precipitation through the compacted cap. After excavation, installation of in-situ cap, and backfill, a minimum of 18 inches of topsoil and hay was added to help with contouring of the area and to promote vegetation growth. Approximately 1,800 cubic yards of contaminated soil was removed and replaced with the cap and clean backfill material to bring the excavated area to surface grade. The contaminated soil was transported for disposal at Lea Land, near Carlsbad, NM.

Soil contaminant concentrations are illustrated in Figure 2. A summary of laboratory analytical results is included in Table 3. Laboratory reports are included in Appendix C.

Detailed Site and Sample Map  
 COG- Scared Hawk State Com #1  
 Malaga, New Mexico

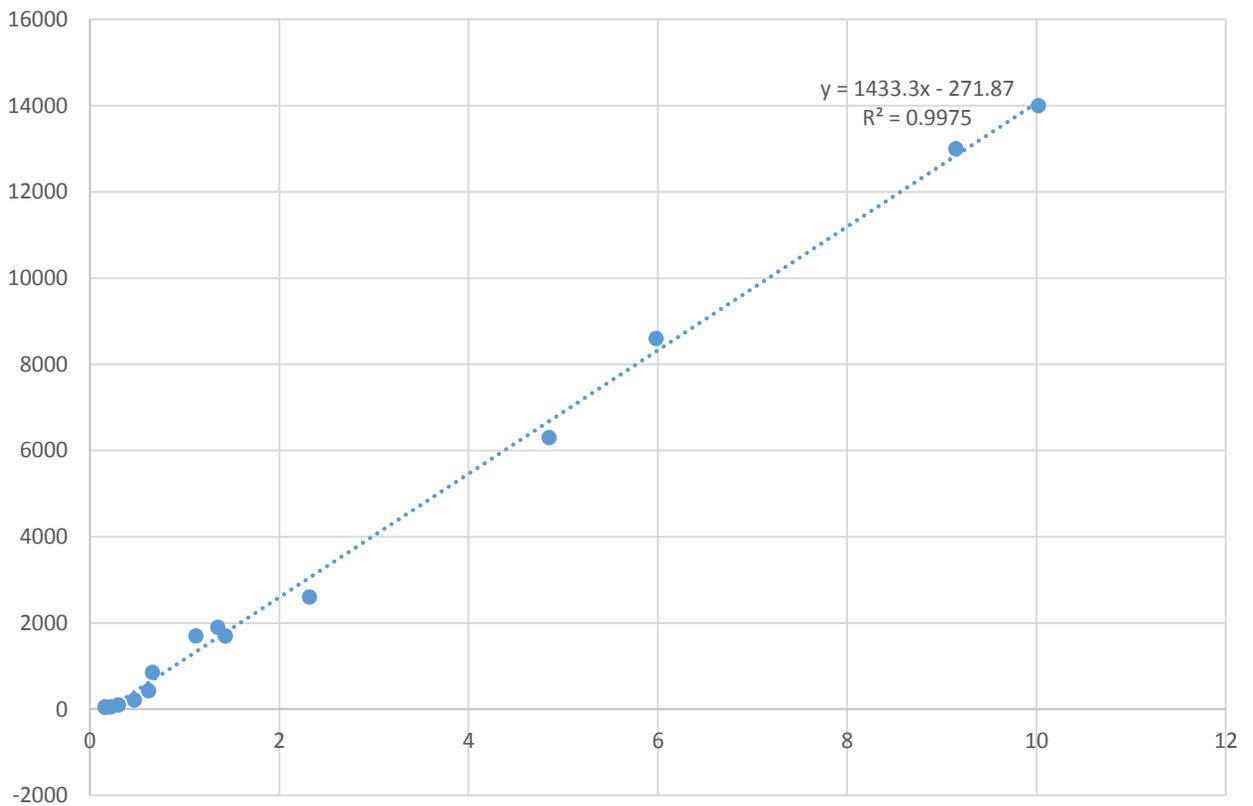
## Figure 4: Electrical Conductivity Correlation to EPA Method 300 Graph

EPA Method 300 vs Electrical Conductivity (EC)
