WORK PLAN FOR INCIDENT 2RP-2532

MEWBOURNE OIL COMPANY
SAN LORENZO SWD #001
API# 30-015-23067
SECTION 34, T25S R28E, NM
EDDY, NM

March 25, 2015
Reference 5B23672 BG1

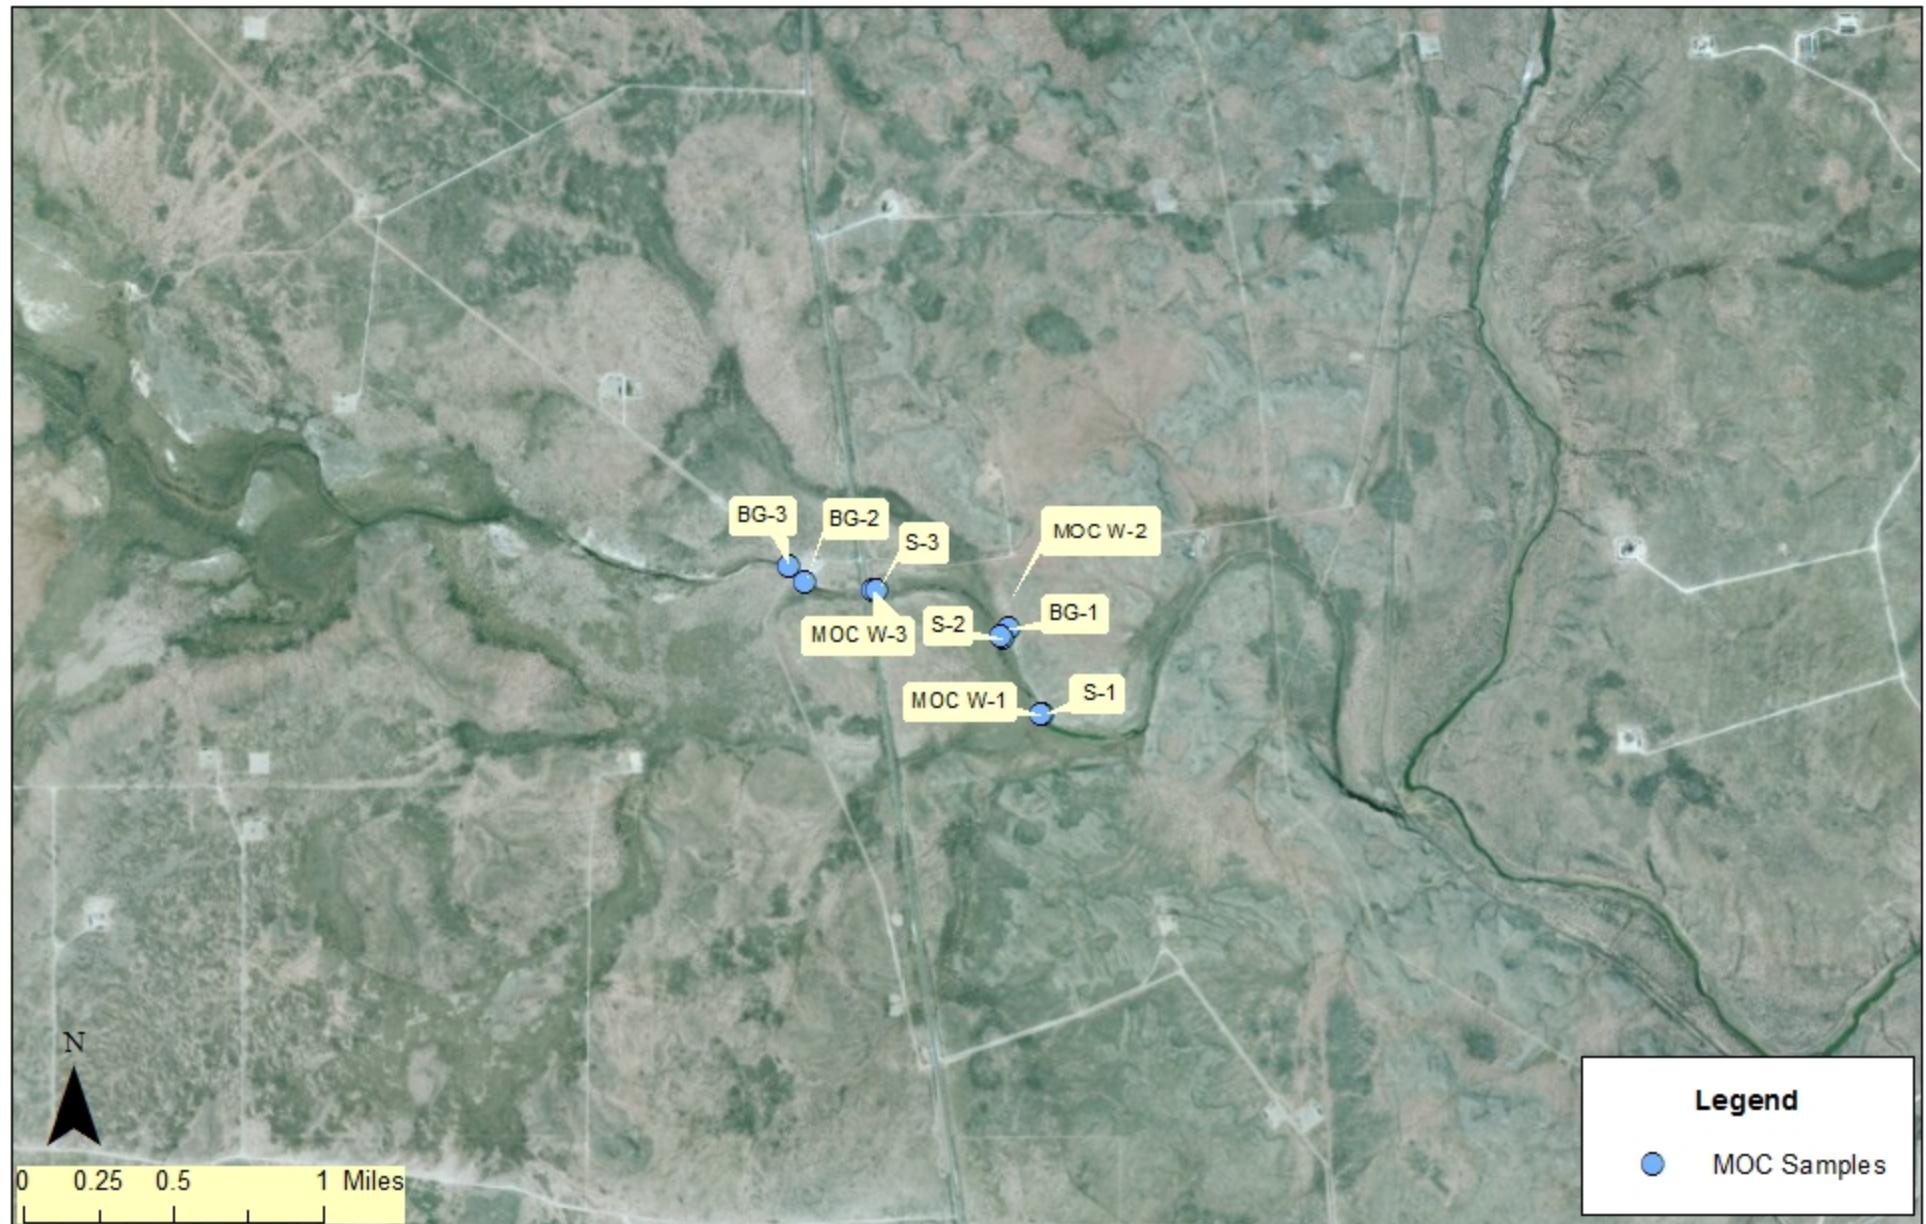
Figure 2

SITE DETAILS AND SAMPLE LOCATIONS MAP

On November 6, 2014 Talon/LPE mobilized personnel to obtain surface water samples and on November 26, 2014 soil sampling from bank sediments was completed. See Table 1 below for resulting lab data analysis. A site map presenting surface water (W-1), soil/sediment (S-1) and background (BG-1) soil sampling is attached hereto in Appendix I.
