Site Sampling Plan of Oil and Gas-Related Spills in Red Bluff Draw

May 19, 2015

THE NEW MEXICO STATE LAND OFFICE

GL Environmental, Inc.

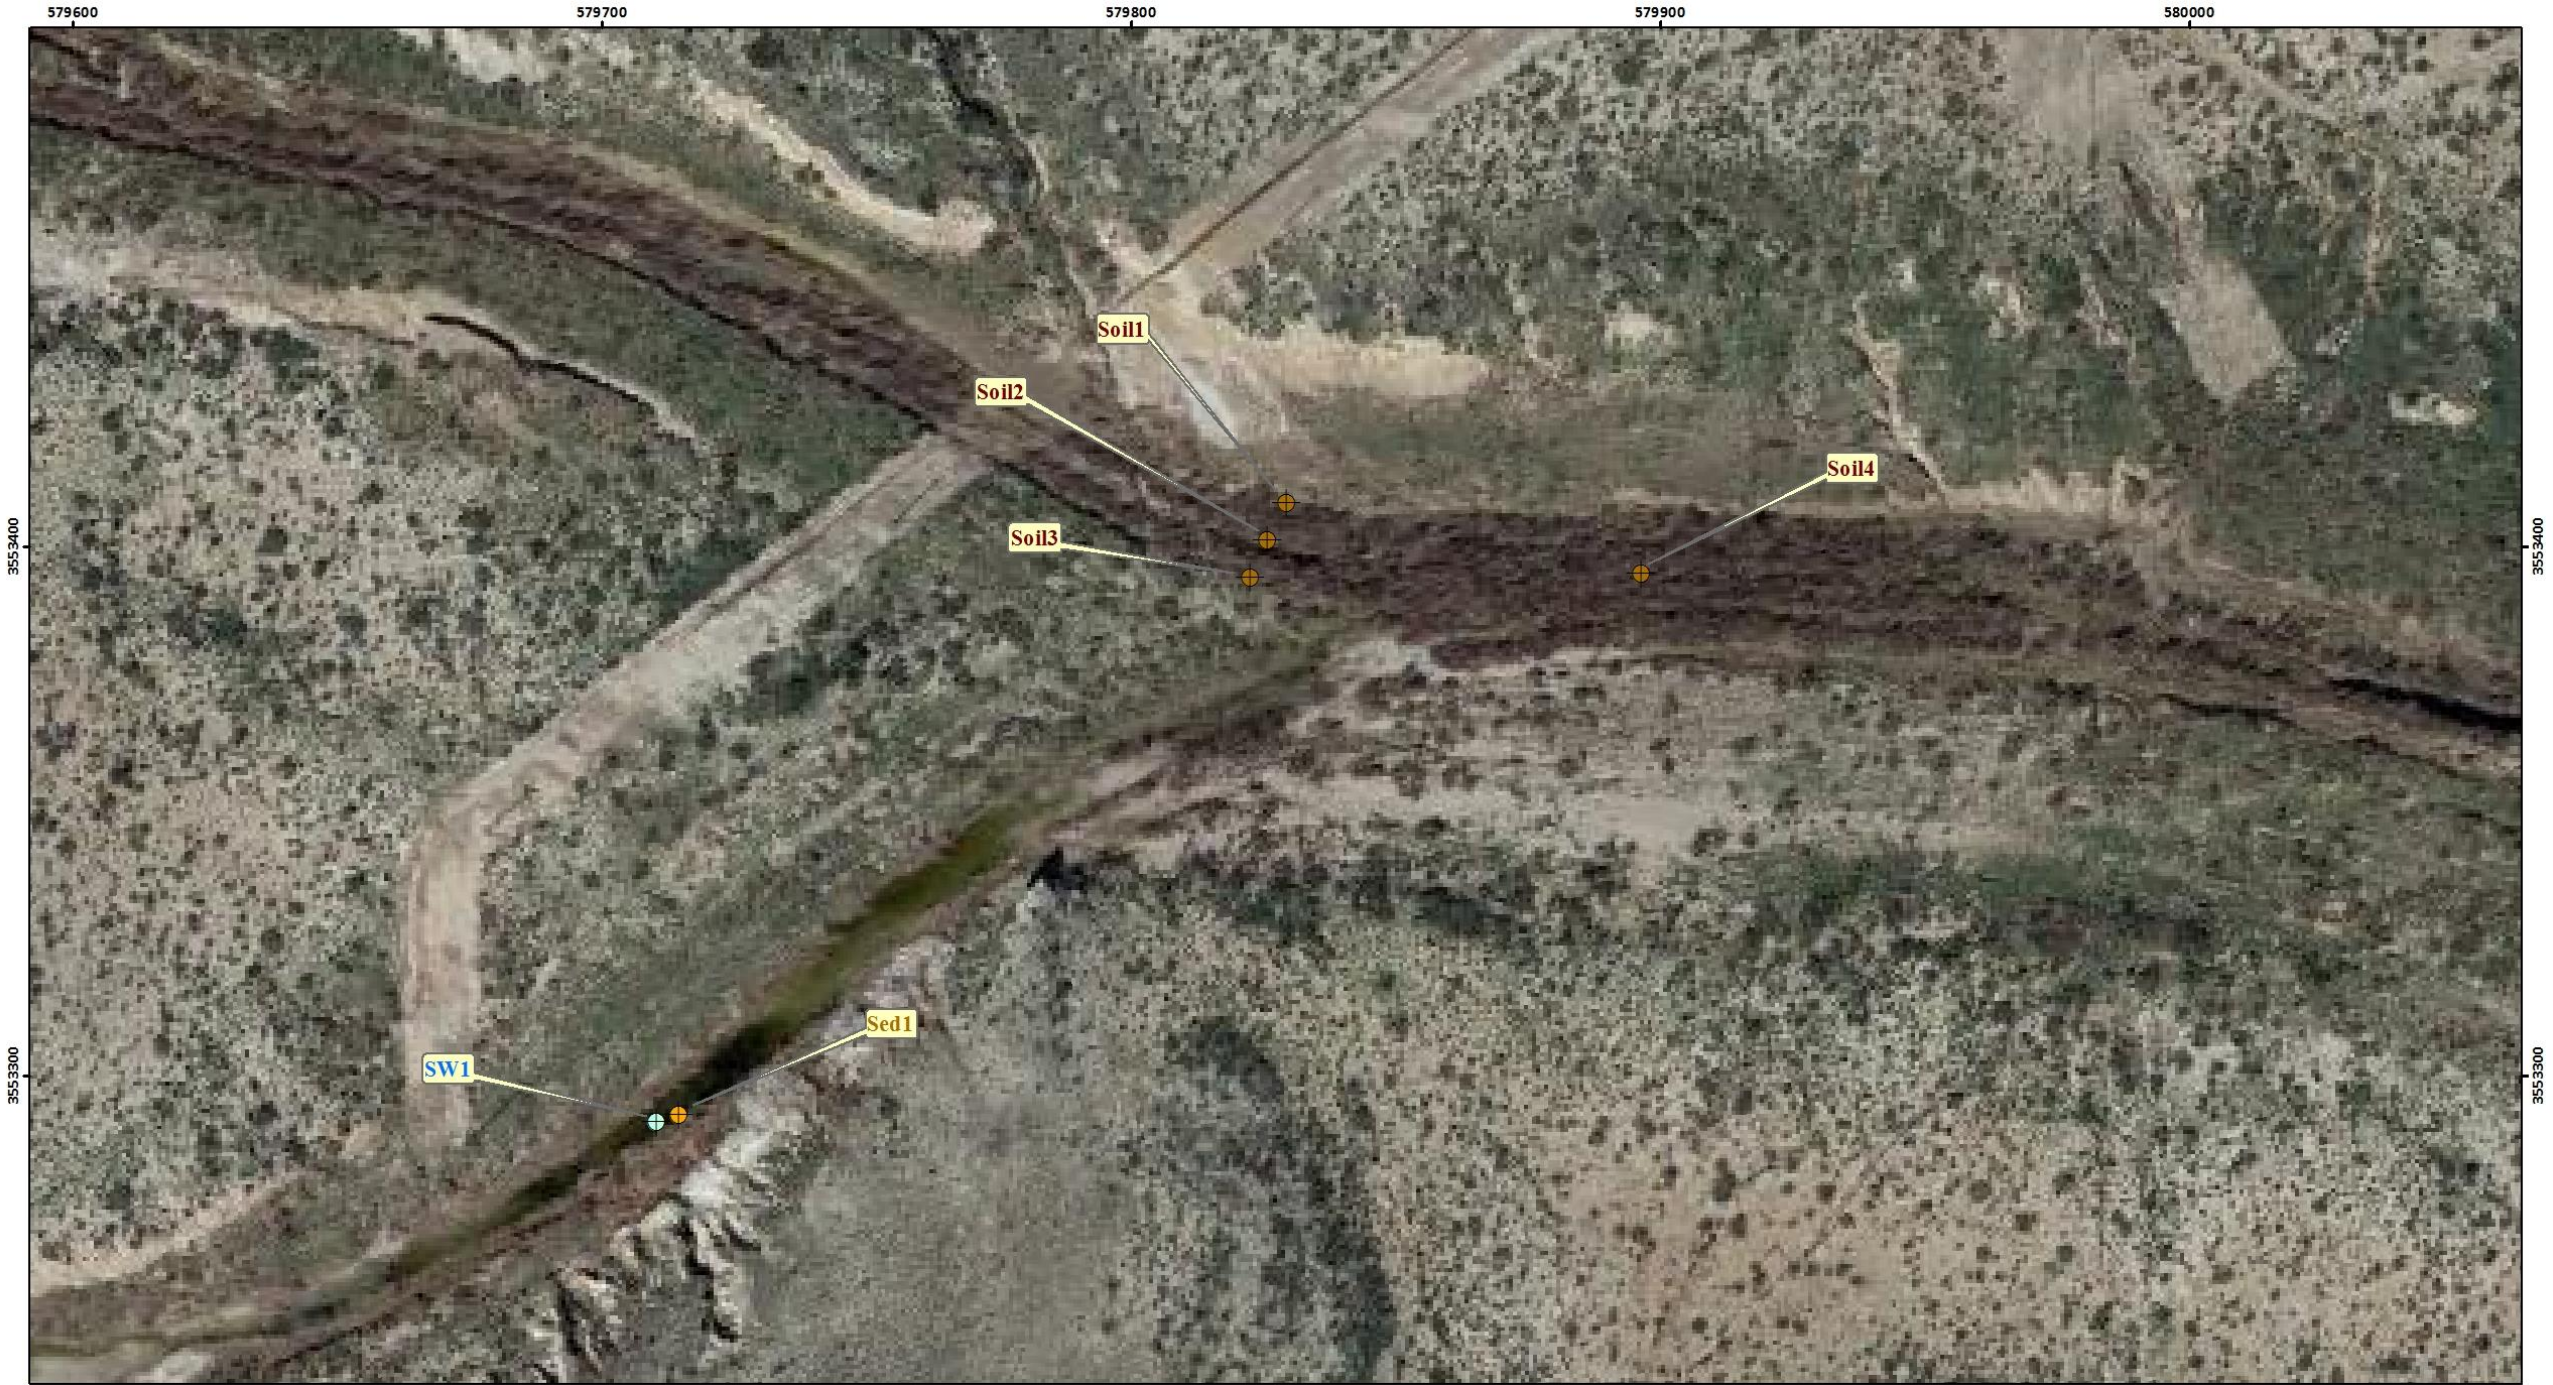
Map 2

Red Bluff Draw - Reference Area Sampling

Soils along the channel banks and adjacent floodplain consist of fine sand/silty soils. The channel bottom is sandy with evaporite and sedimentary gravel and cobbles. Some white precipitates were observed on the banks. Three soil samples will be collected at Soil1, Soil2, and Soil3 in order to characterize soil conditions in cross-section across the draw. A fourth soil sample (Soil4) will be collected downstream along the channel bottom (Map 2. Red Bluff Draw – Reference Area Sampling).

An open stretch of water is present just south of the reference area soil sample location. The water was flowing slowly and had a slight brown tinge. A surface water and sediment sample (SW1 and Sed1) will be collected from this location.

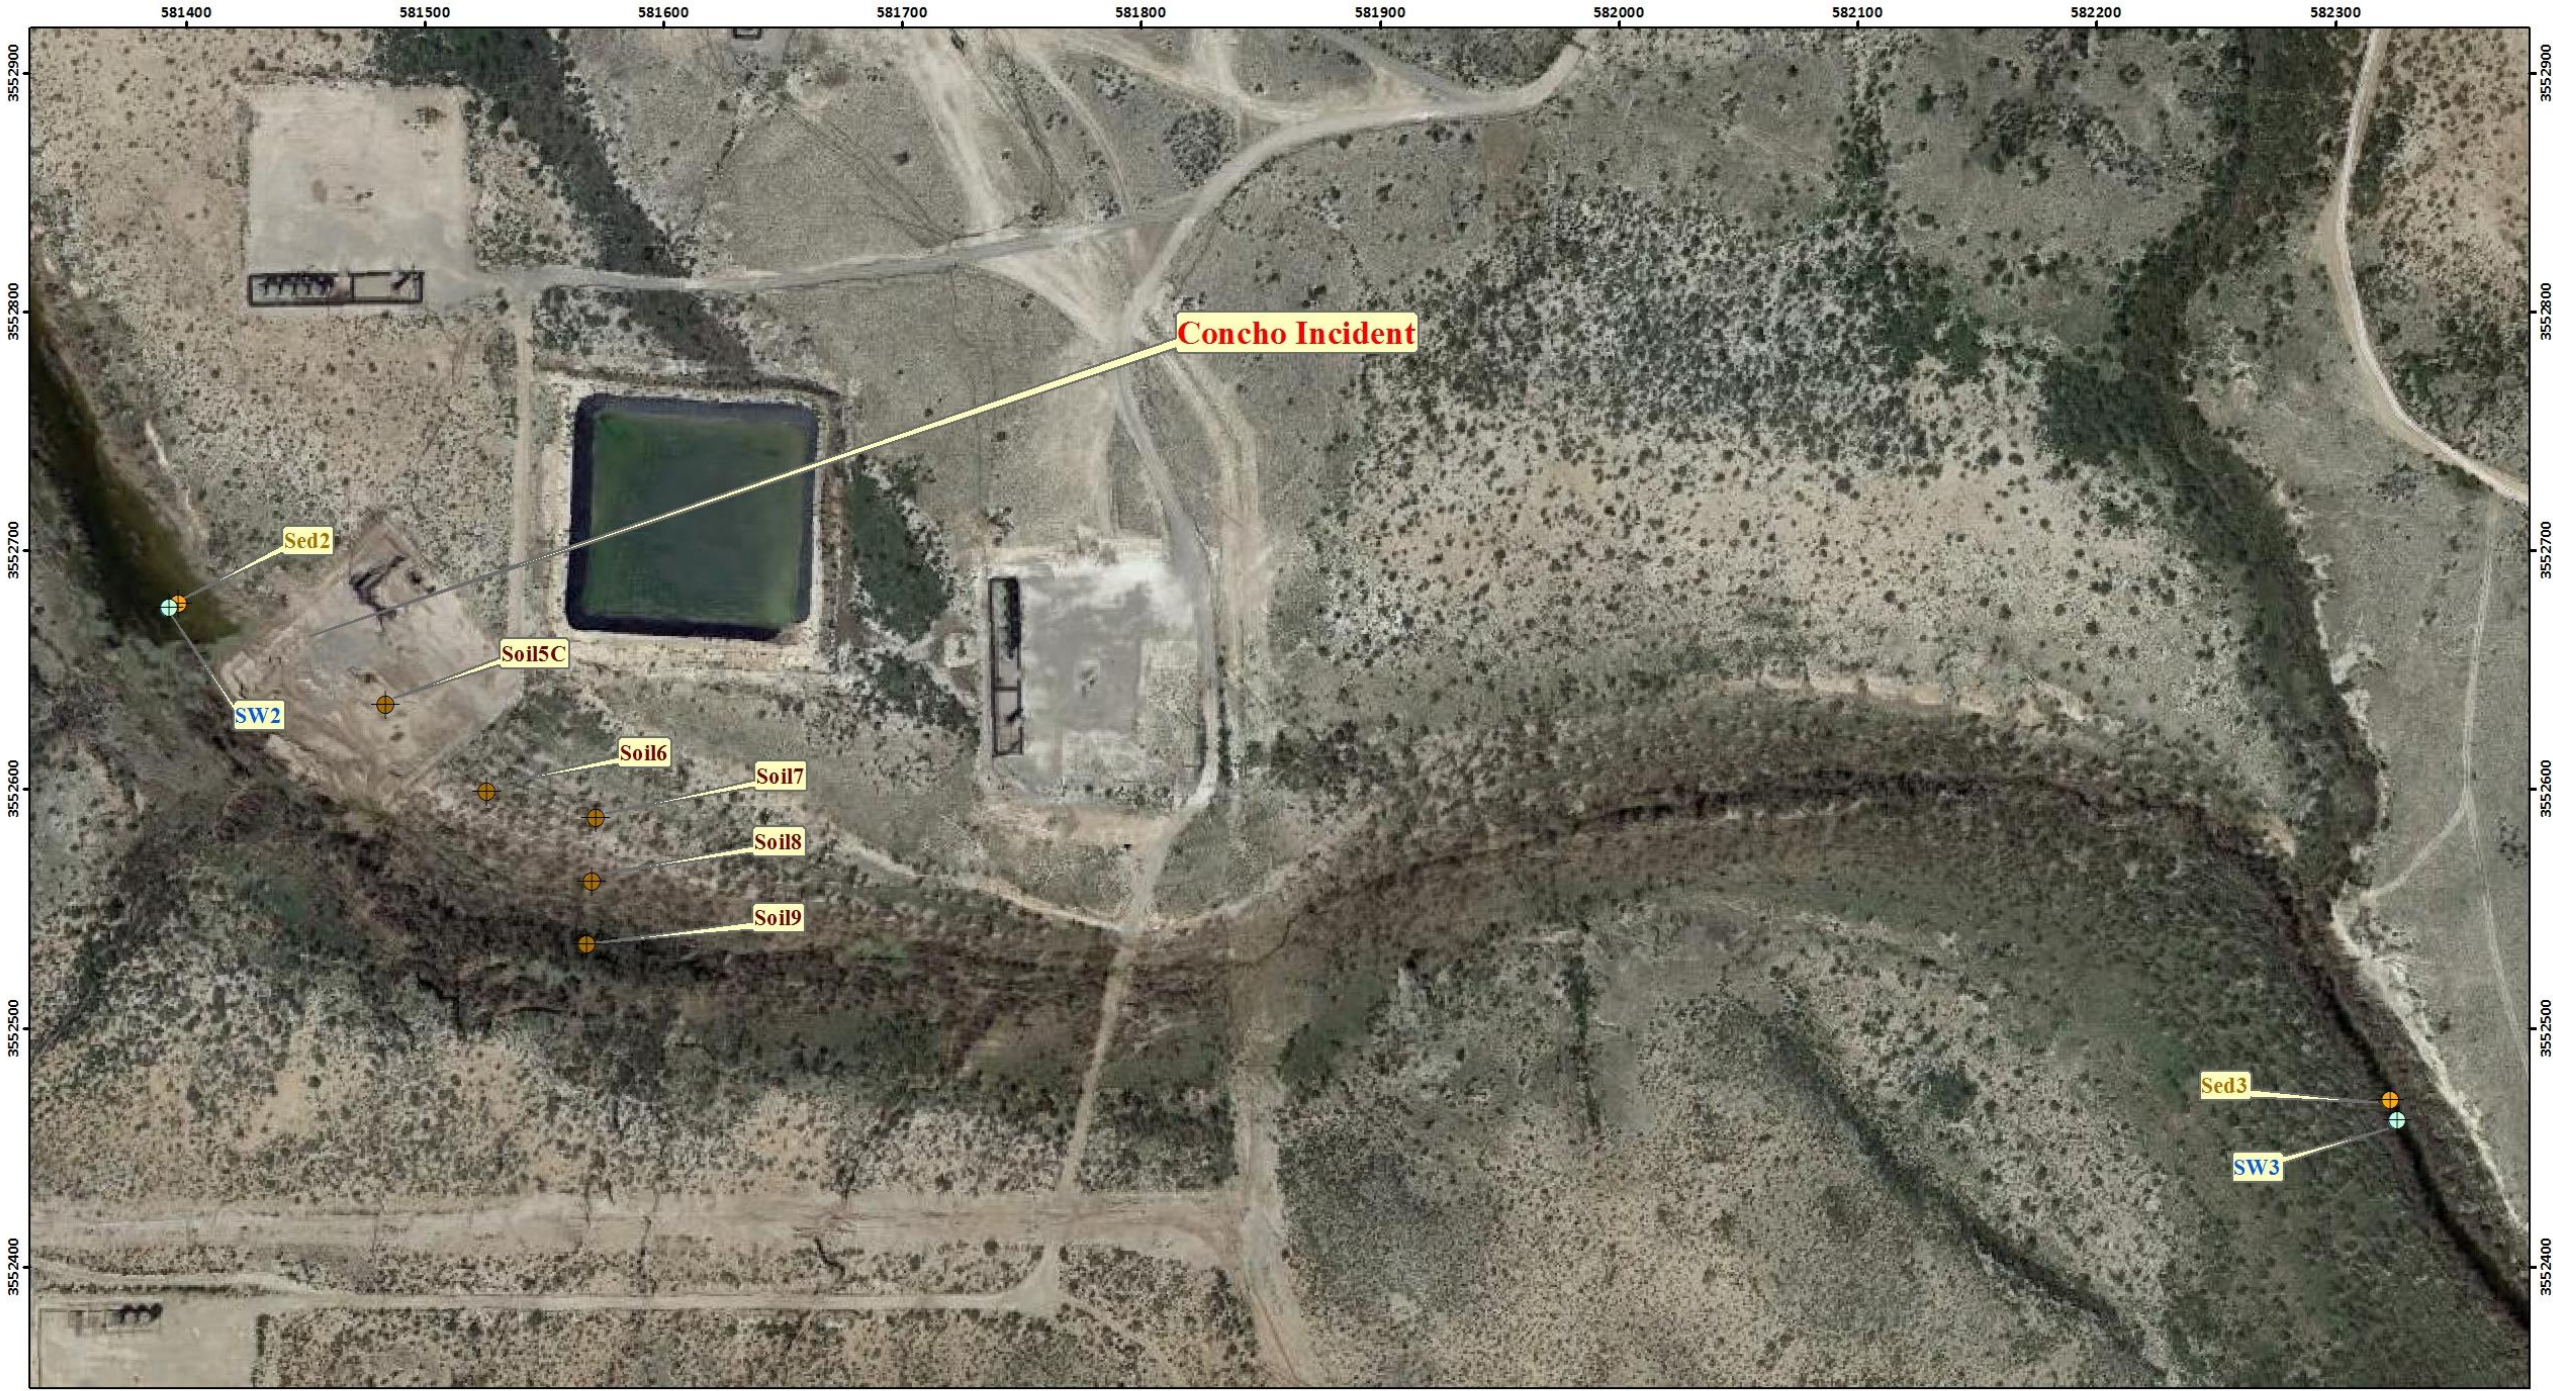
Map 3

Red Bluff Draw - Concho Well Pad Sampling

One composite soil sample (Soil5C) will be collected from the well pad (Map 3. Red Bluff Draw – Concho Well Pad Sampling). One soil sample (Soil6) will be collected from the braided channels east and directly down-gradient of the well. Three soil samples will be collected at Soil7, Soil8, and Soil9 in order to characterize soil conditions in cross-section. A surface water and sediment sample (SW2 and Sed2) will be collected from the pool immediately west of the well pad. A surface water sample and sediment sample (SW3 and Sed3) will also be collected at the nearest downstream surface water location approximately 3,500ft to the east.

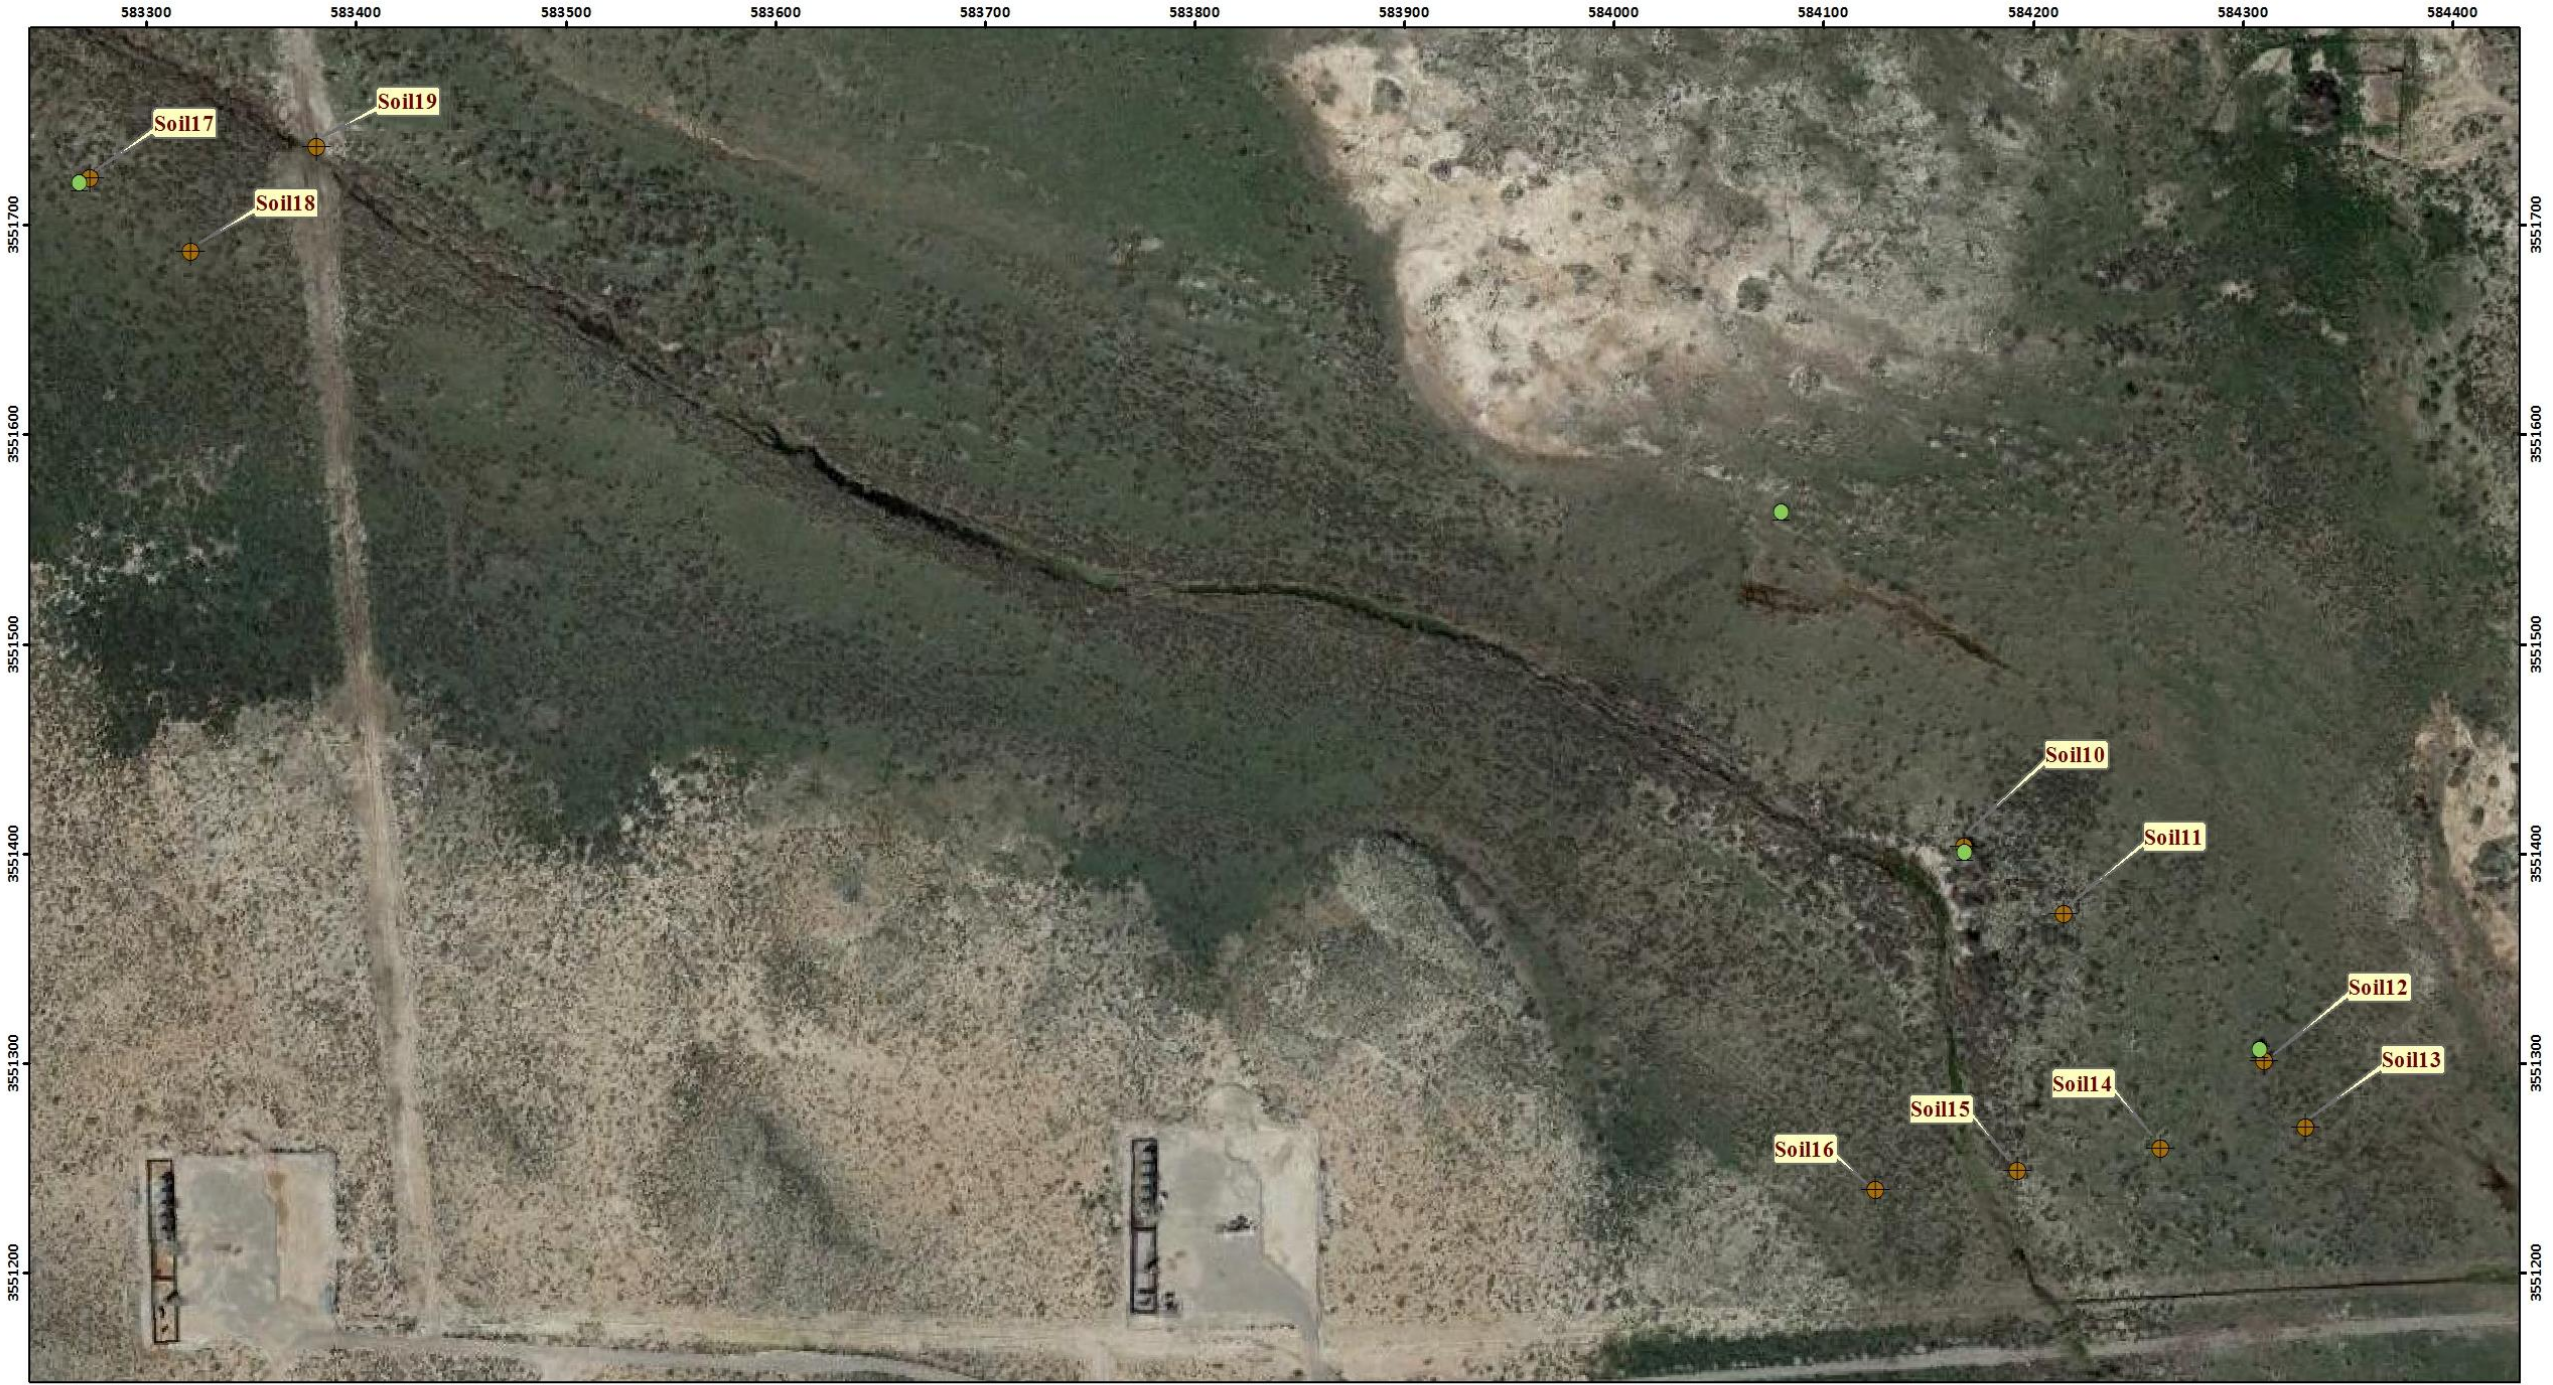
Map 4

Red Bluff Draw - Concho Tank Location Sampling

Two of the three displaced Concho steel oil tanks came to rest within 550ft of each other approximately 1.8mi downstream of the well pad within the floodplain, but north and east of the deeper channel. Small amounts of petroleum product were present at the tank locations as well as in vegetation down-gradient (downstream) of the tanks (Map 4. Red Bluff Draw – Concho Tank Location Sampling).

One soil sample will be collected directly up-gradient of tank #1 (Soil10), one in between the tanks (Soil11), one directly up-gradient of tank #2 (Soil12), and one down-gradient of the tanks (Soil13). Soil13 and three additional soil samples will be collected at Soil14, Soil15, and Soil16 in order to characterize soil conditions in cross-section across the draw.

One soil sample will be collected directly up-gradient of the tank site and one down-gradient (Soil17 and Soil18). A third soil sample (Soil19) will be collected within the channel bottom near the location where the tank's contents were drained during removal activities.

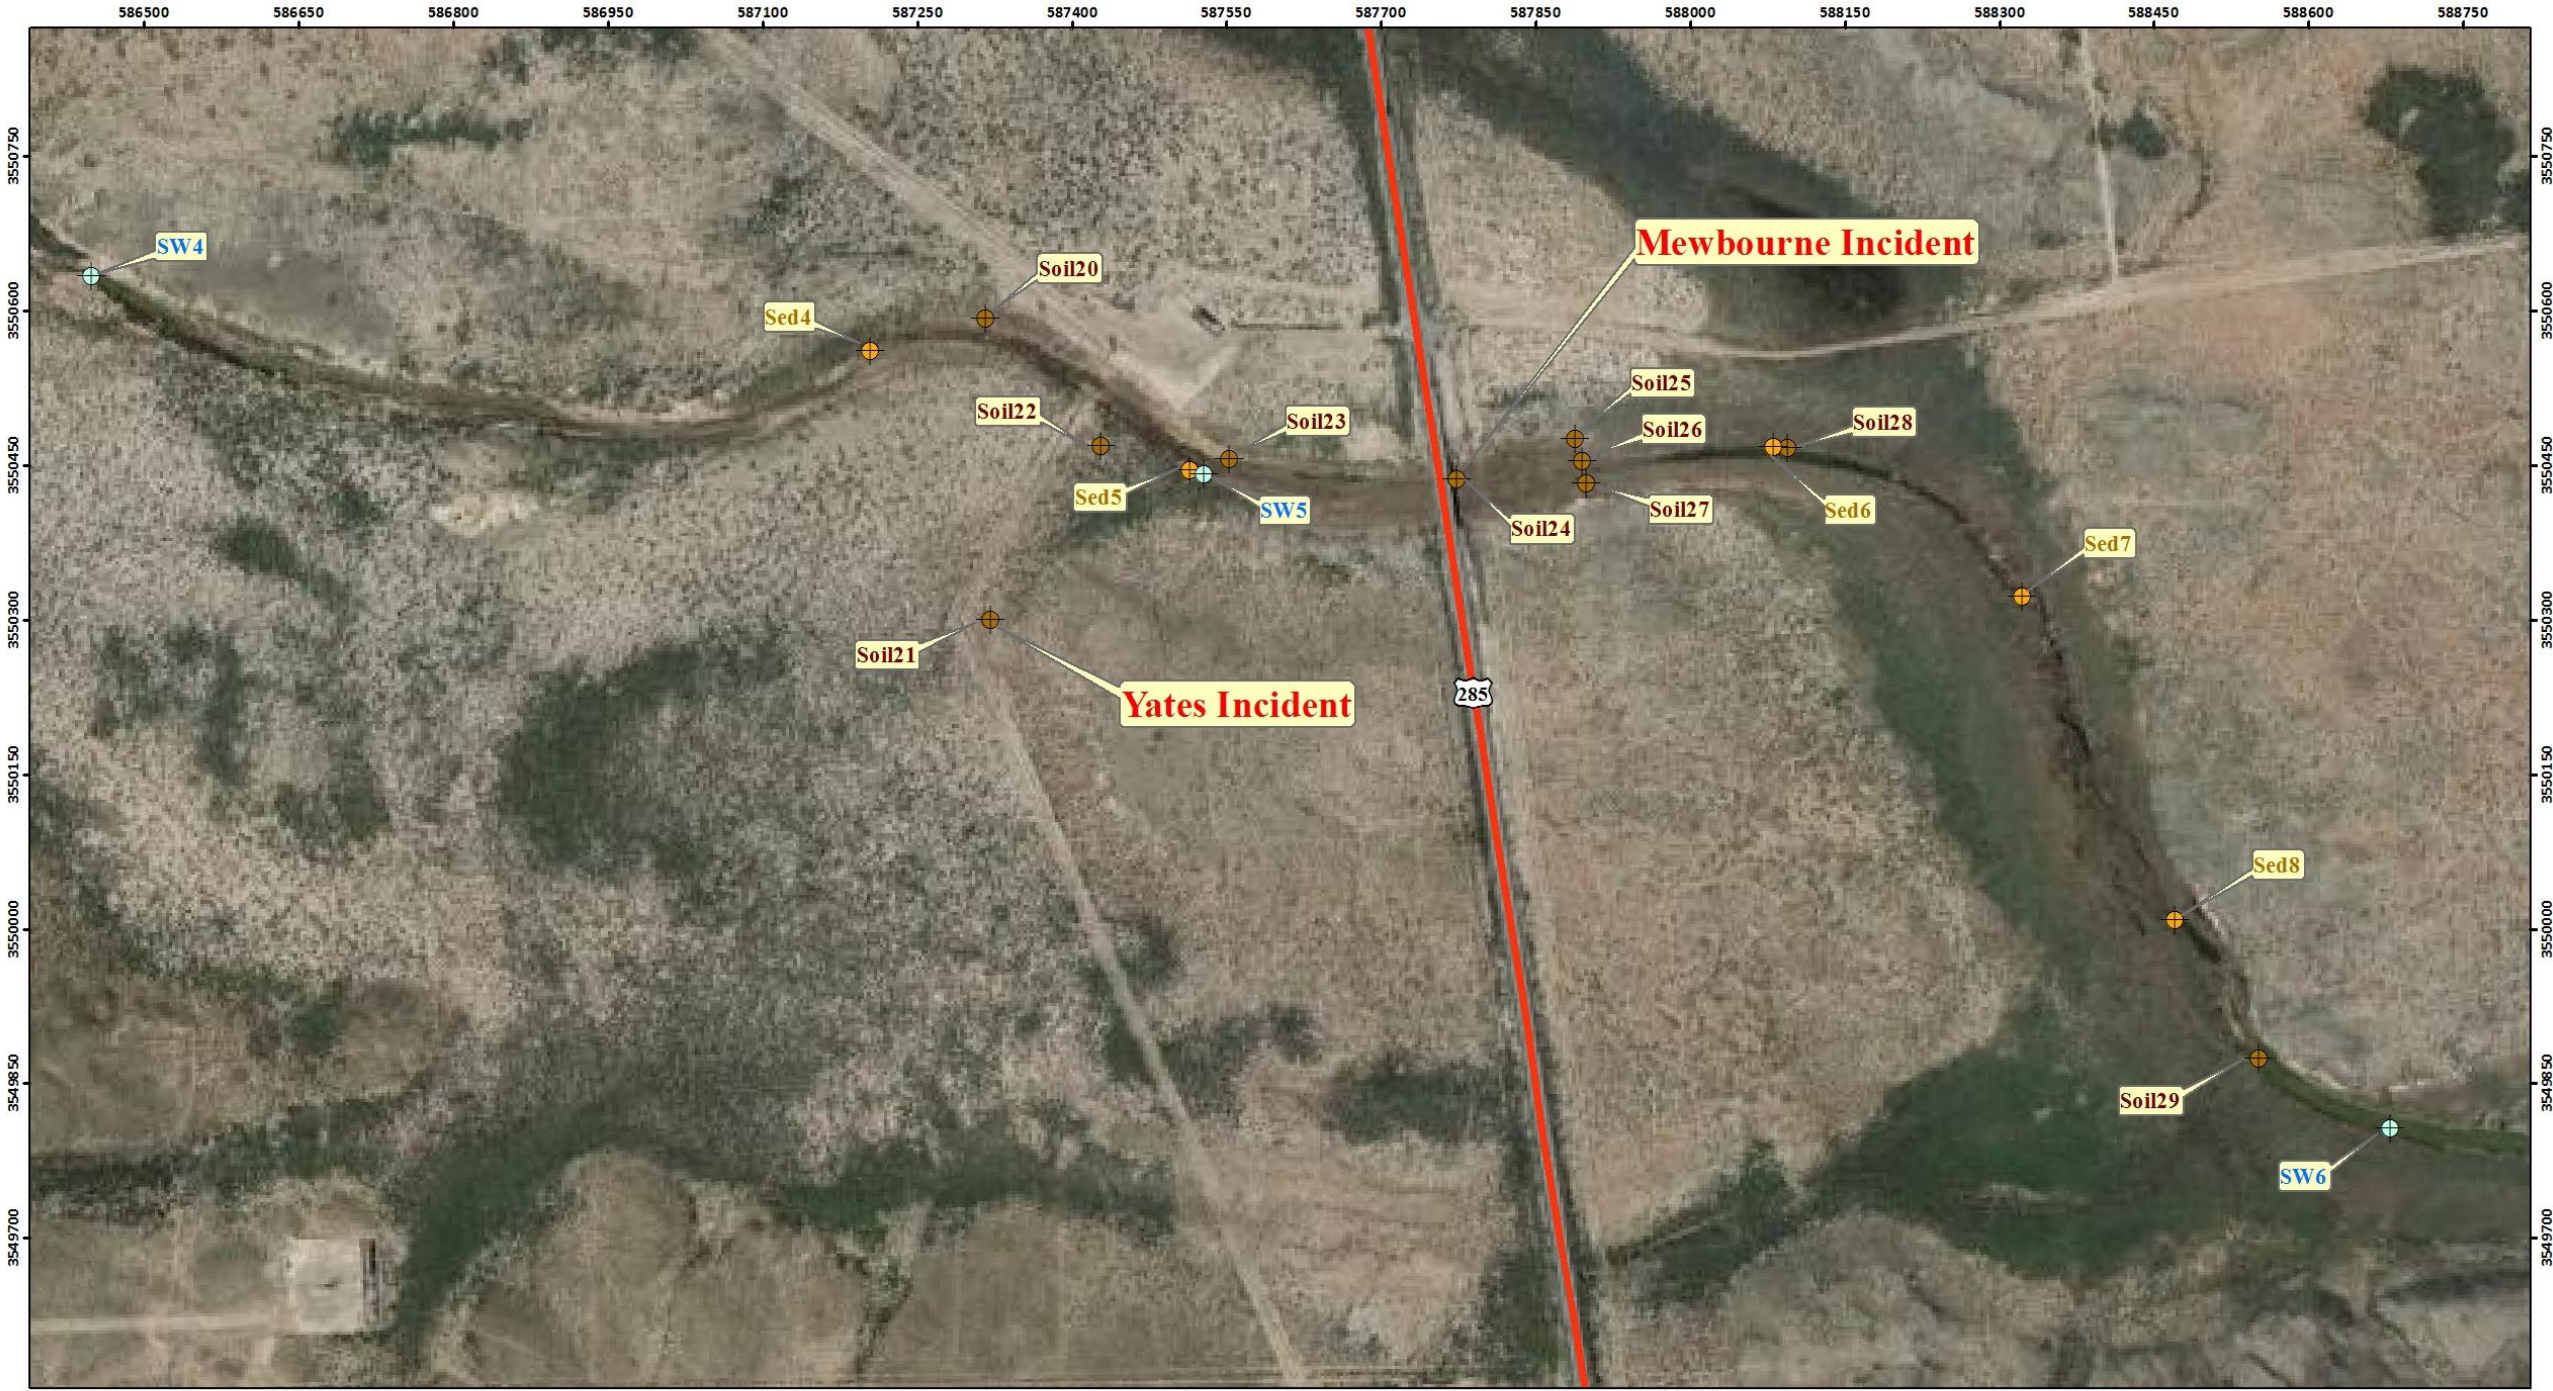
Map 5

Red Bluff Draw - Yates/Mewbourne Sampling

Two soil samples (Soil21 and Soil22) will be collected from between the release location and the earthen berm (Map 4. Red Bluff Draw – Yates/Mewbourne Sampling). Sample locations have been placed in order to avoid duplication of previous sampling efforts.

A soil sample and sediment sample (Soil20 and Sed4) will be collected within the channel bottom upstream of where the Yates release entered into the draw. One soil sample (Soil23) will be collected from the channel within the bermed area. The sample location within the bermed area has been placed to avoid duplication of previous sampling efforts. A surface water sample will be collected from a spring upstream of the Yates release (SW4) and a surface water and sediment sample (SW5 and Sed5) will be collected in the canal outside of the bermed area and upstream of the bridge.

Six soil samples and three sediment samples will be collected downstream of the bridge (Soil24-29 and Sed6-8). Three of the soil samples (Soil25, Soil26, and Soil27) will be collected in order to characterize soil conditions in cross-section across the draw. A water sample will be collected at the Big Water (SW6) and at a second location 1.75mi downstream from the big water above the confluence of Red Bluff Draw and the Pecos River (SW7, Map1 – Environmental Sampling Plan).
