Site Remediation Plan for Oil and Gas-Related Spills in Red Bluff Draw, New Mexico

August 5, 2015

THE NEW MEXICO STATE LAND OFFICE

GL Environmental, Inc.

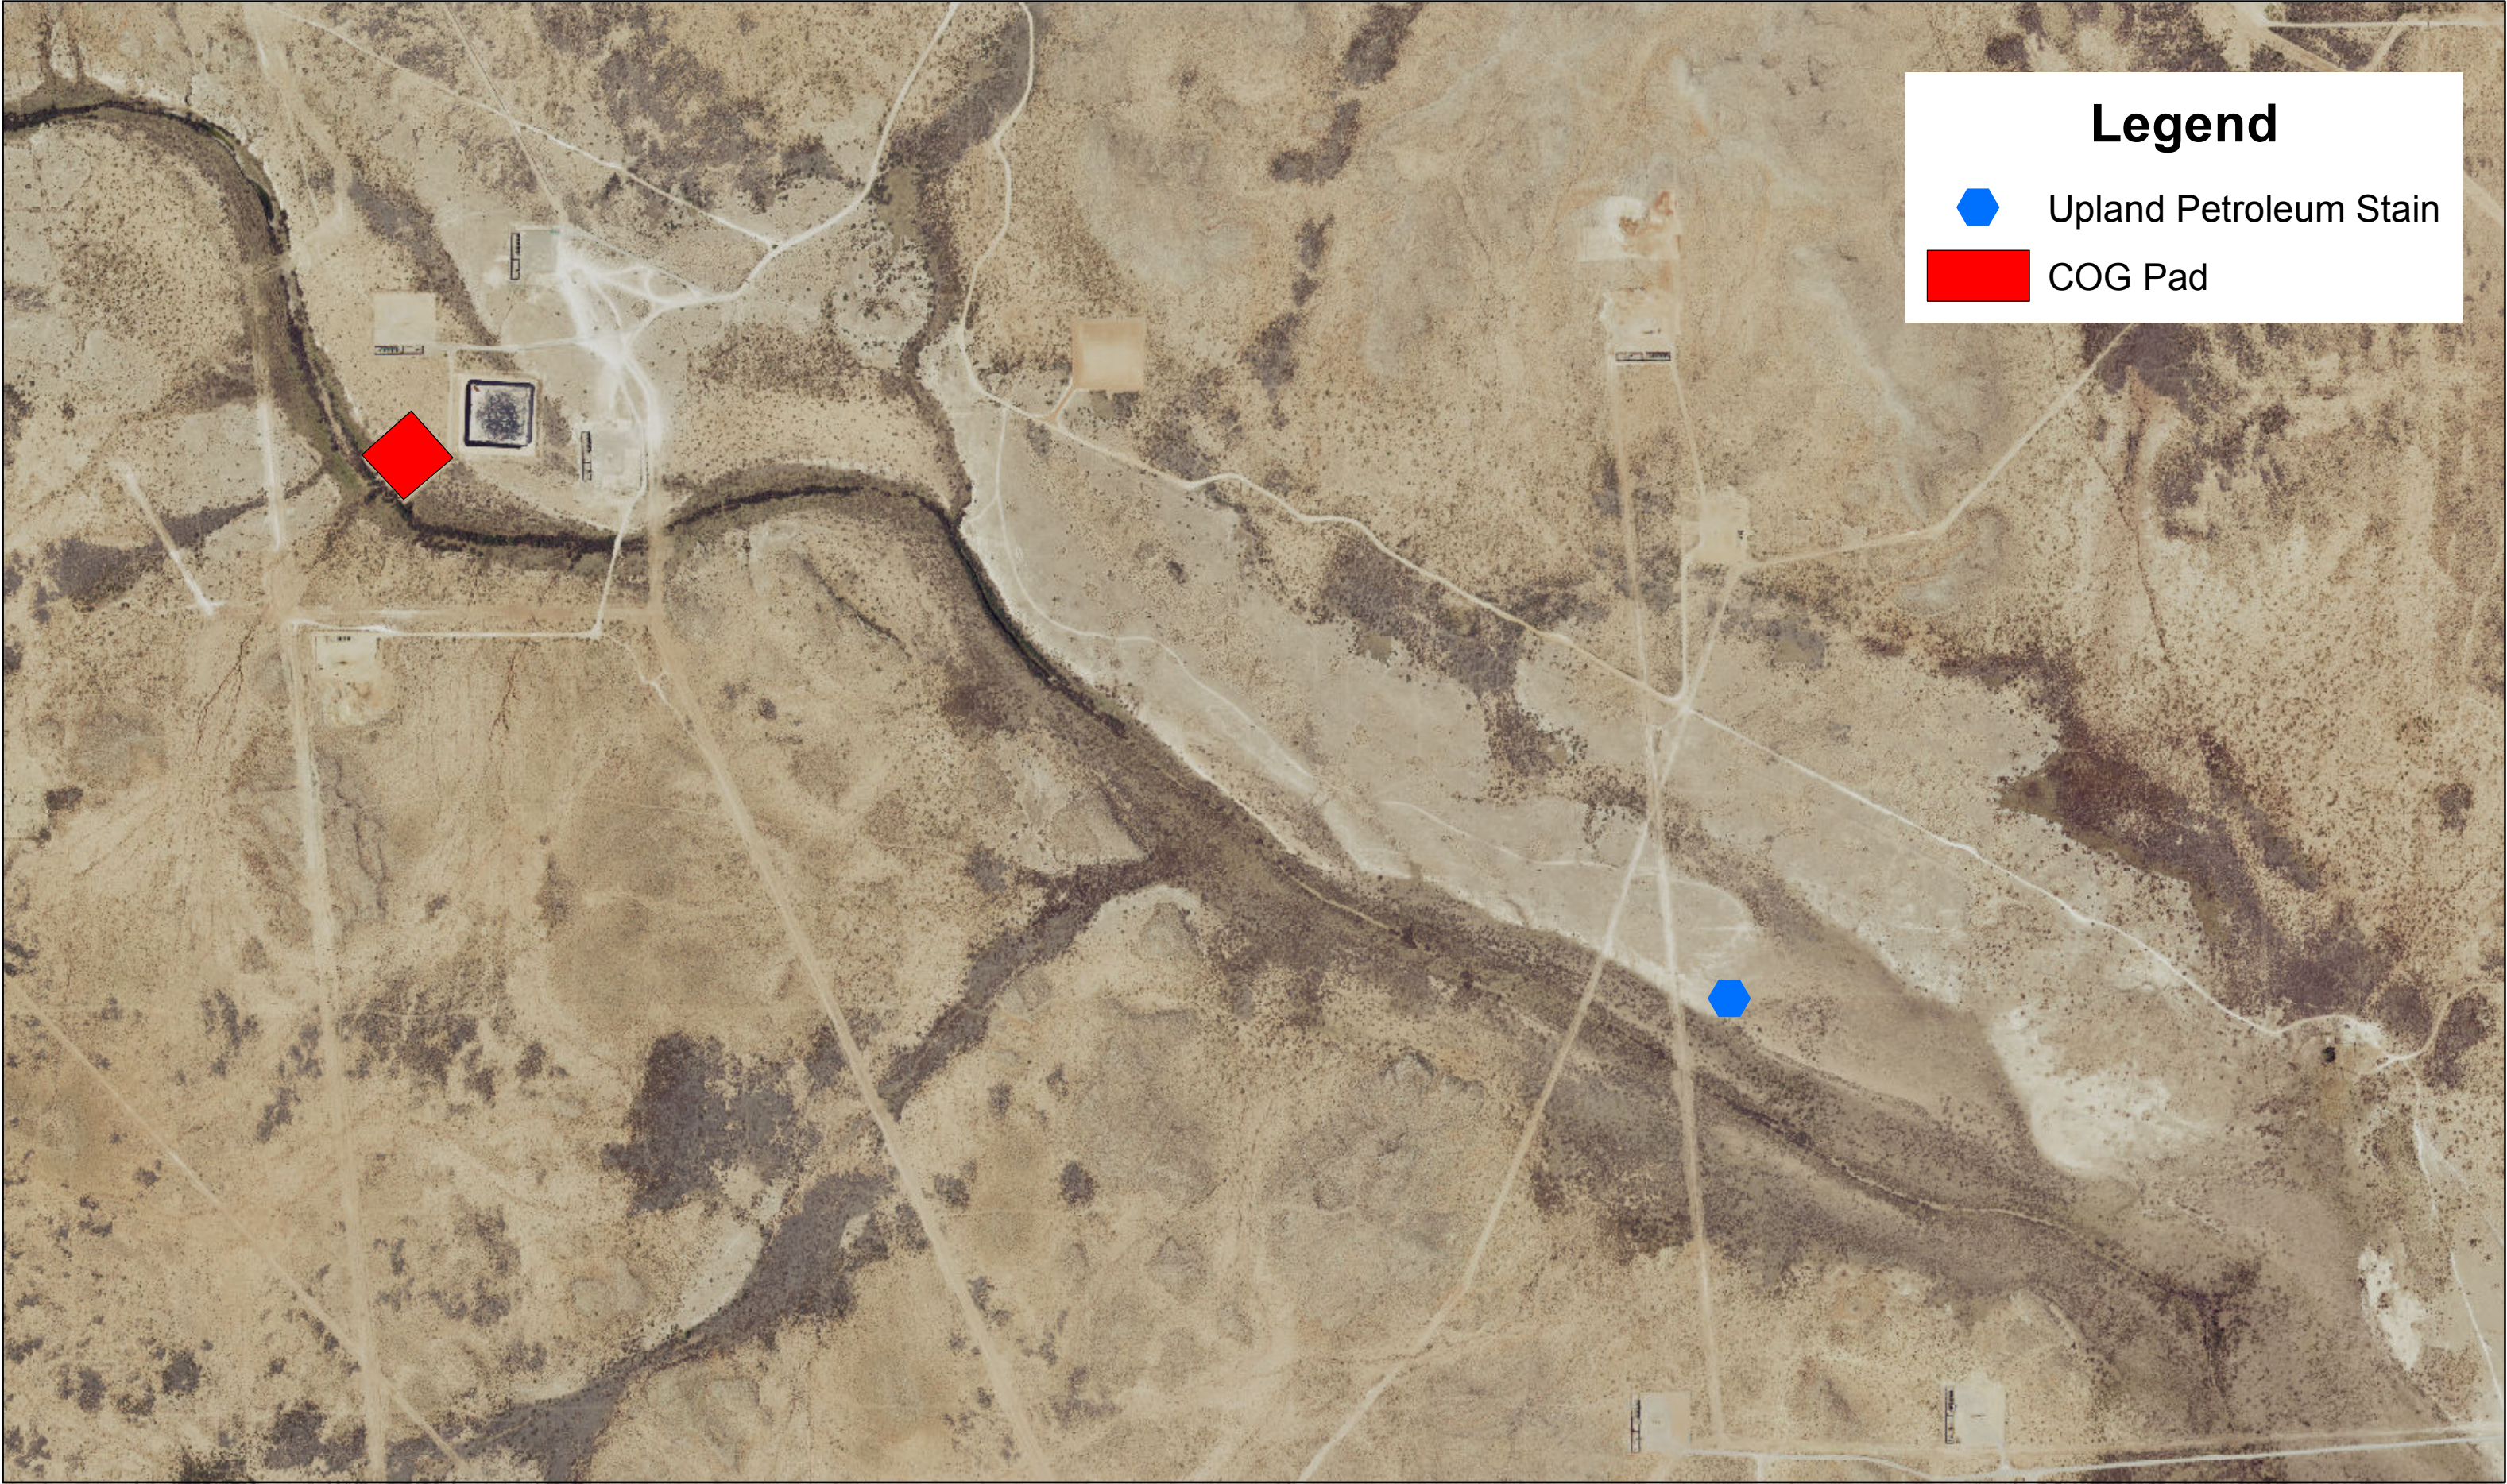
Red Bluff Draw - Map 1
Remediation Plan

Legend

Upland Petroleum Stain

COG Pad

A single location is recommended for excavation of petroleum contaminated material in this remediation area. An approximate 30 ft² petroleum stain is located in an upland area to the north of the tank locations (Appendix 1 - Map 1). The site should be excavated to a depth that removes impacted material. Costs associated with the removal of this material will depend on the total depth of the contamination. Unit costs for loading, hauling and disposal are presented in Appendix 4. Disposal costs at a permitted landfill are in the \$30 yd³ range.

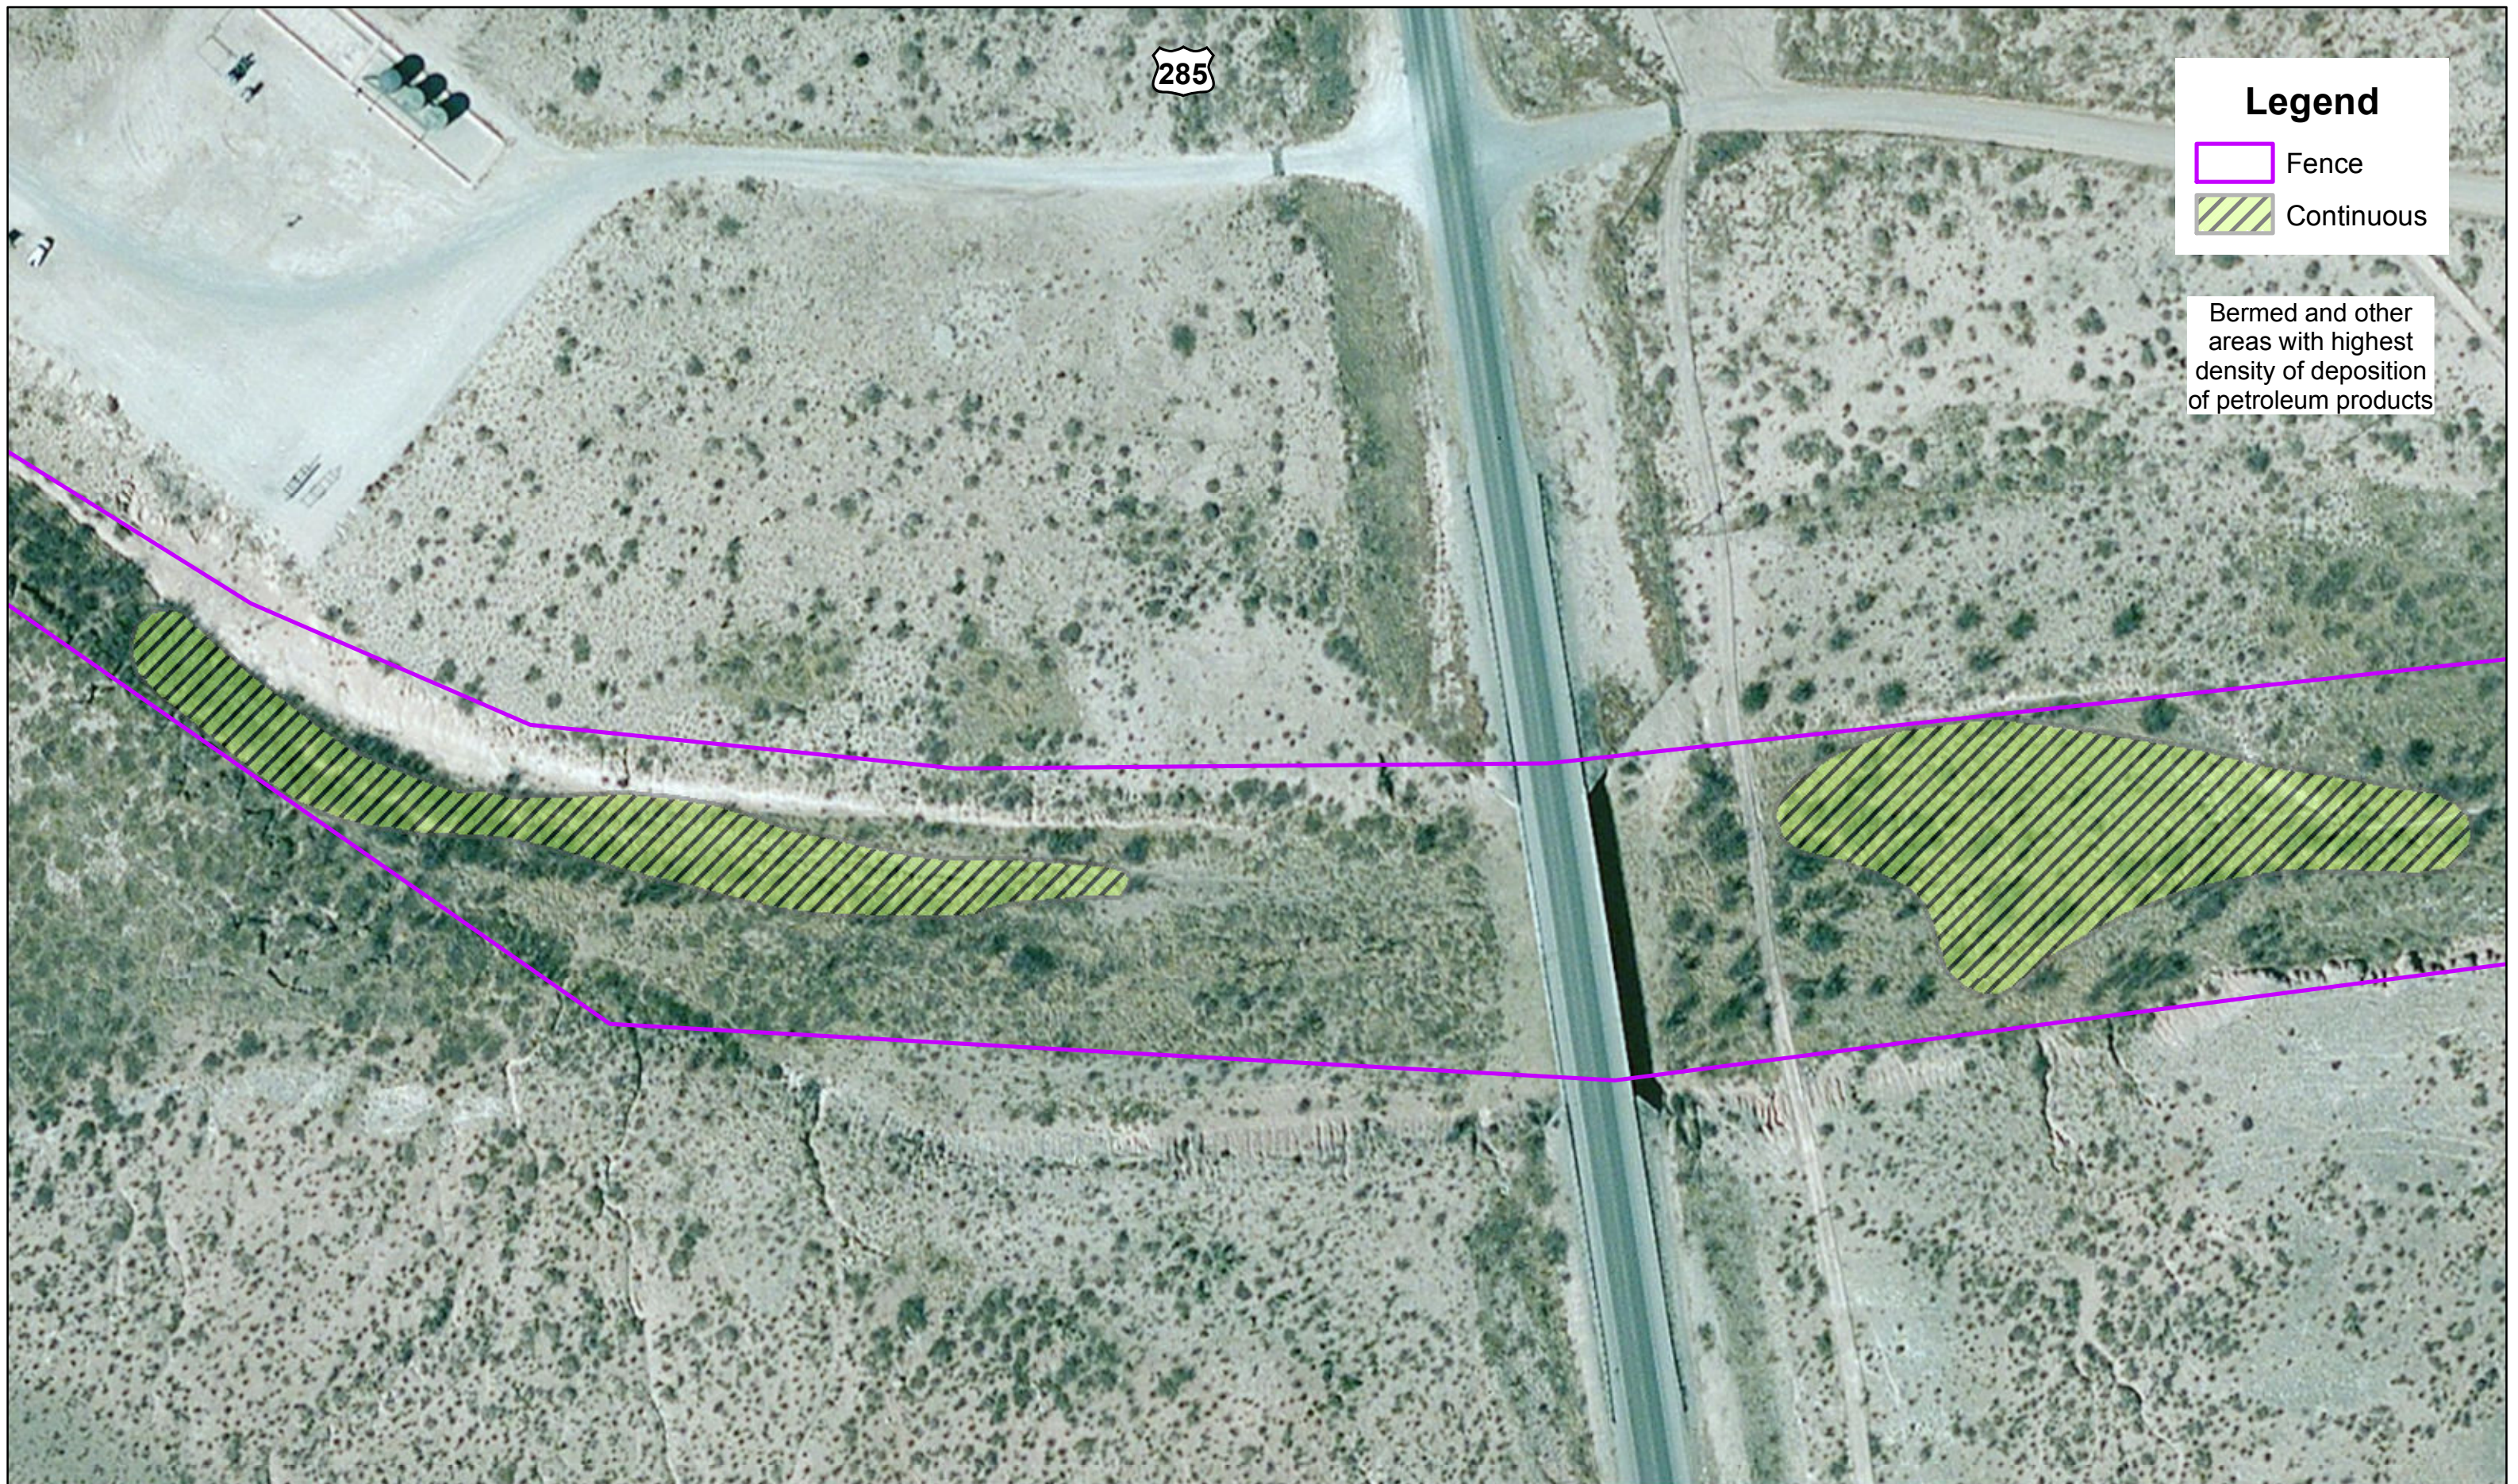
Red Bluff Draw - Map 3
Remediation Plan

Legend

Fence

Continuous

Bermed and other areas with highest density of deposition of petroleum products

It is recommended that a fence be installed in consultation with the NM SLO and the grazing lessee. The fence should enclose the channel area throughout this section of the draw to exclude

Visible deposits of petroleum products on the ground surface within the bermed area and immediately east of the bridge should be excavated and hauled off-site for disposal. Identified areas with concentrated surface deposits are approximately 1.5 acres in size and are depicted in Appendix 1 - Map 3. Contaminated sediments should also be excavated from the channel pools within the bermed area. Unit costs associated with loading (backhoe with bucket or bucket loader), hauling and disposing of the contaminated material are presented in Appendix 4. Disposal at permitted landfills are in the \$30 yd³ range. The approximated total volume of material to be disposed is 1,200 yd³ cubic yards.
