## **REMEDIATION SUMMARY & RISK-BASED SITE CLOSURE REQUEST**

**BOPCO, LP**  
**POKER LAKE UNIT #212 Flow Line Release**  
**Eddy County, New Mexico**  
**API 30-015-33915**  
**Unit Letter "P" (SE/SE), Section 18, Township 24 South, Range 30**  
**East Latitude 32.212869° North, Longitude 103.914300° West**  
**NMOCD Reference #2RP-2871**

**September 2015**

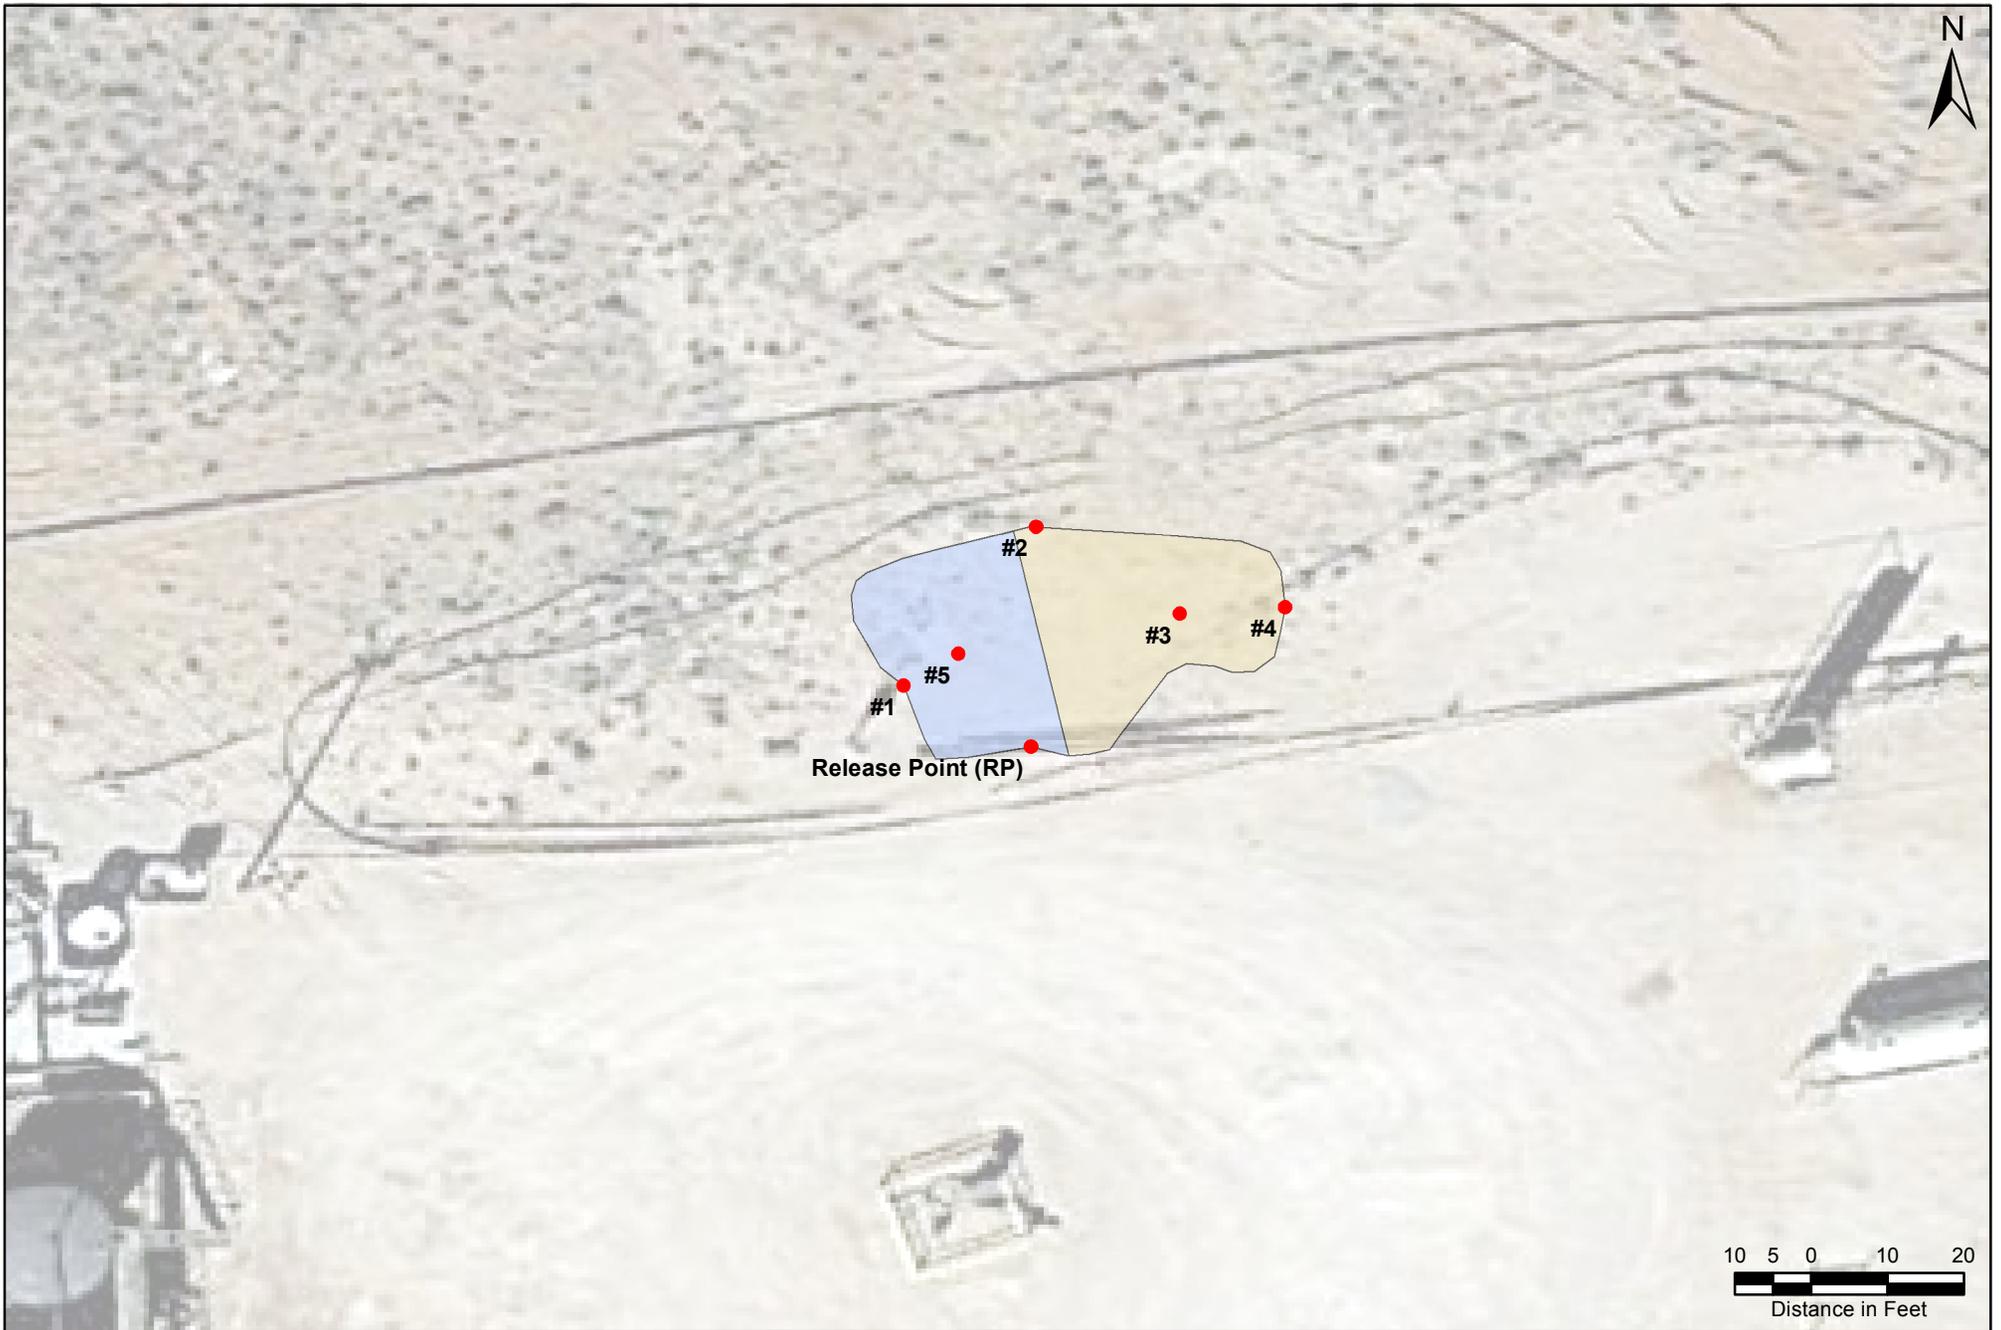
**Figure 2**  
**Sample Location Map**  
**BOPCO, LP**  
**Poker Lake Unit #212**  
**Eddy County, New Mexico**  
**NMOC Reference #: 2RP-2871**

A summary of "Concentrations of Benzene, BTEX, TPH & Chloride in Soil" is provided in Table 1. A "Sample Location Map" is provided as Figure 2. Laboratory analytical reports are provided in Appendix C.

From March 30 through April 1, 2015, the excavation was backfilled with locally acquired, non-impacted material, compacted, and contoured to fit the surrounding topography. Prior to backfilling, a twenty (20) mil, polyethylene liner measuring approximately thirty feet (30') by twenty feet (20') was installed on the floor excavation. The final dimensions of the excavation were approximately forty-two feet (42') in length, sixteen (16) to thirty feet (30') in width, and three feet (3') in depth.

A twenty (20) mil, impermeable, plastic liner was installed on the floor of the excavation prior to backfilling. This engineered control will help mitigate potential releases and effectively inhibit vertical migration of contaminants to groundwater. In-situ soil exhibiting chloride concentrations above the RRAL established for the site will be remediated upon decommission and/or abandonment of the currently active SWD system, pipelines, and/or electrical utilities.

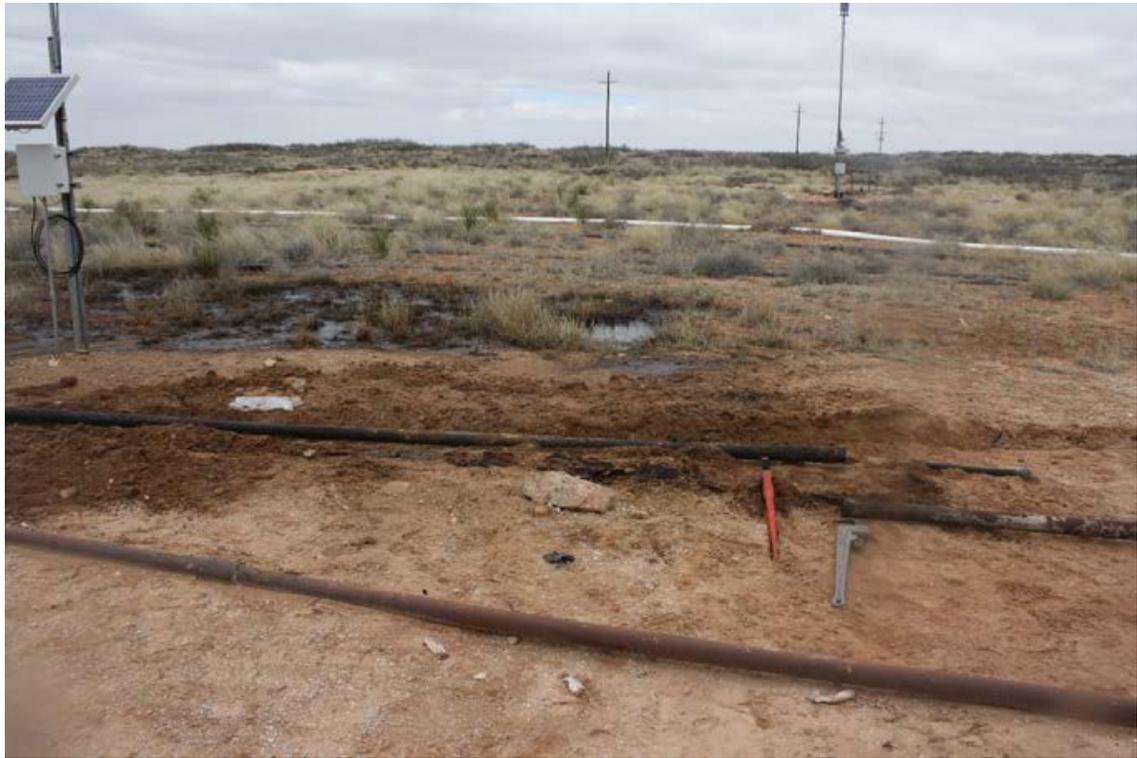
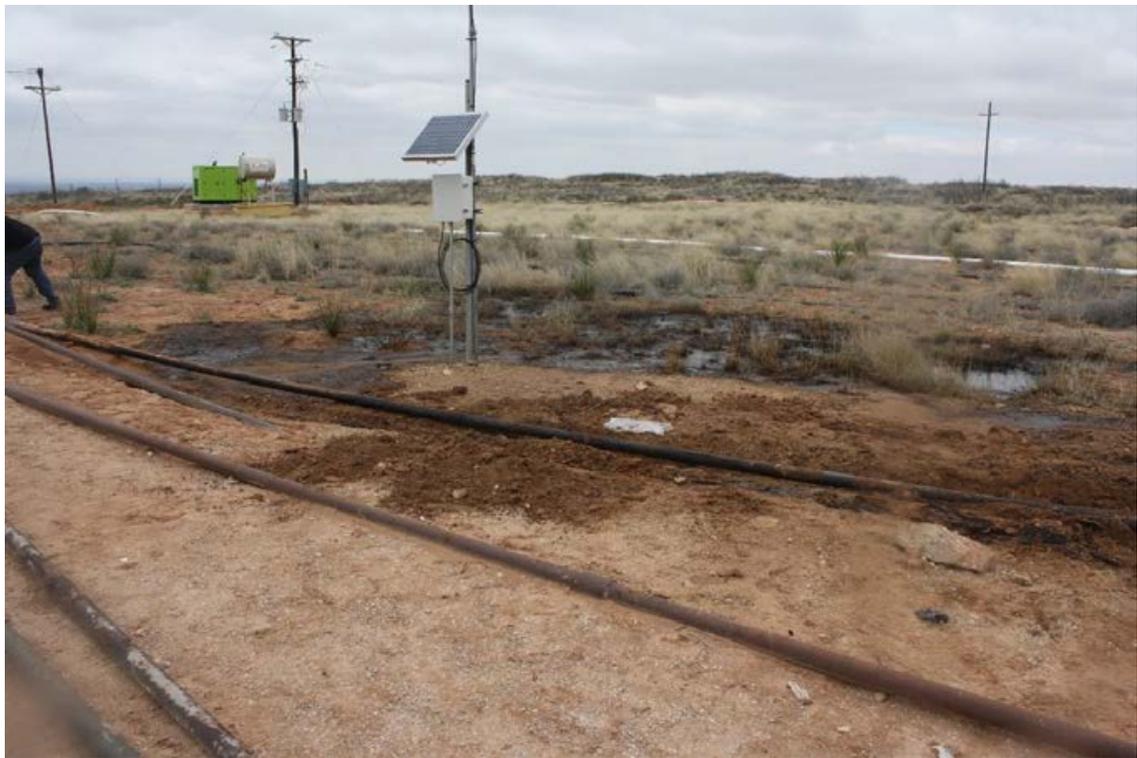
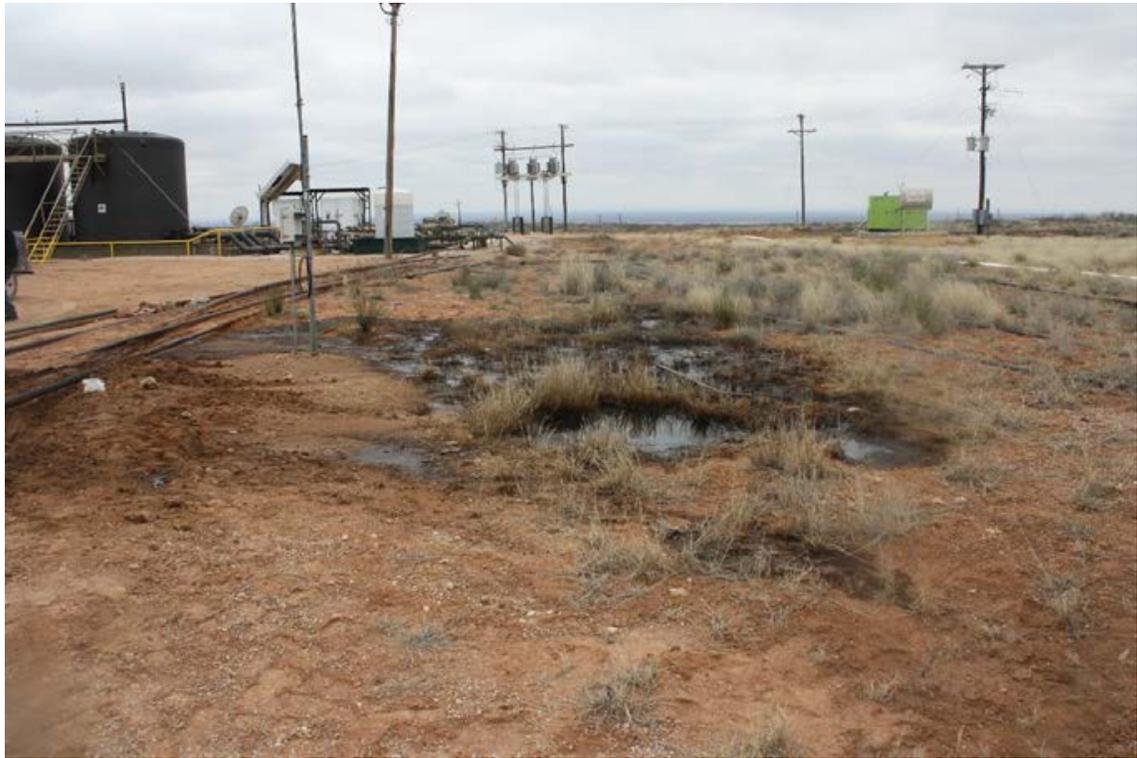
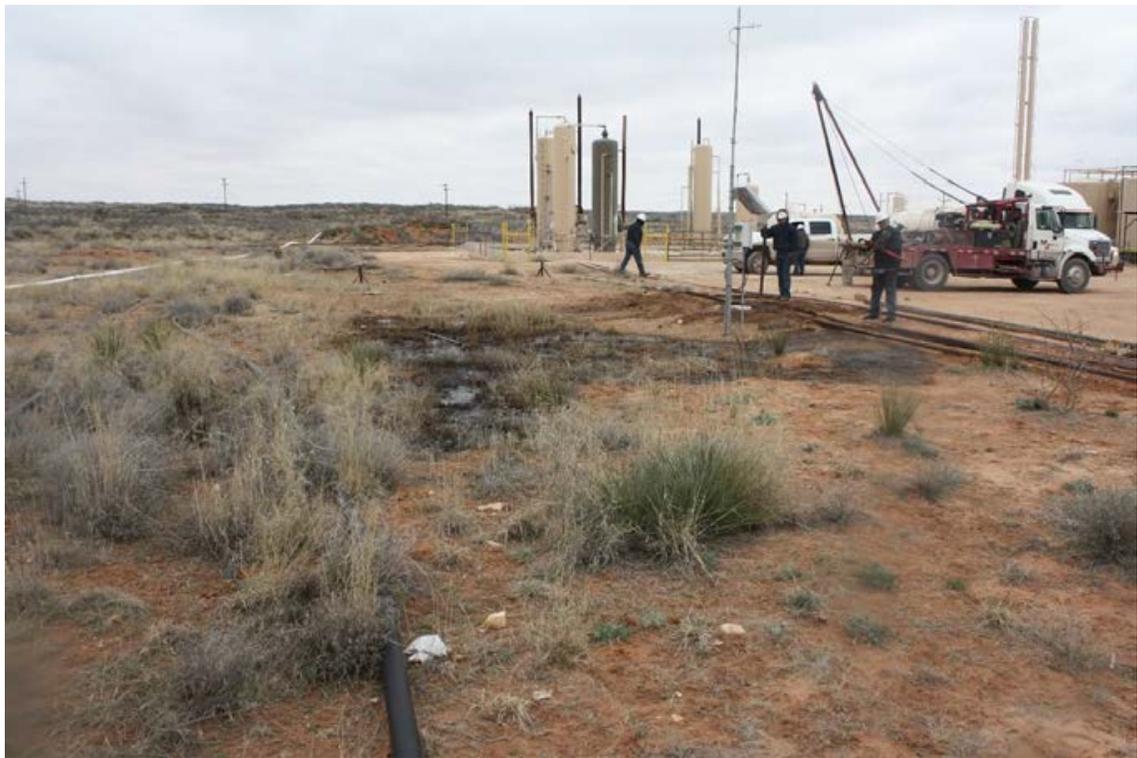
Poker Lake Unit #212 - Release Site

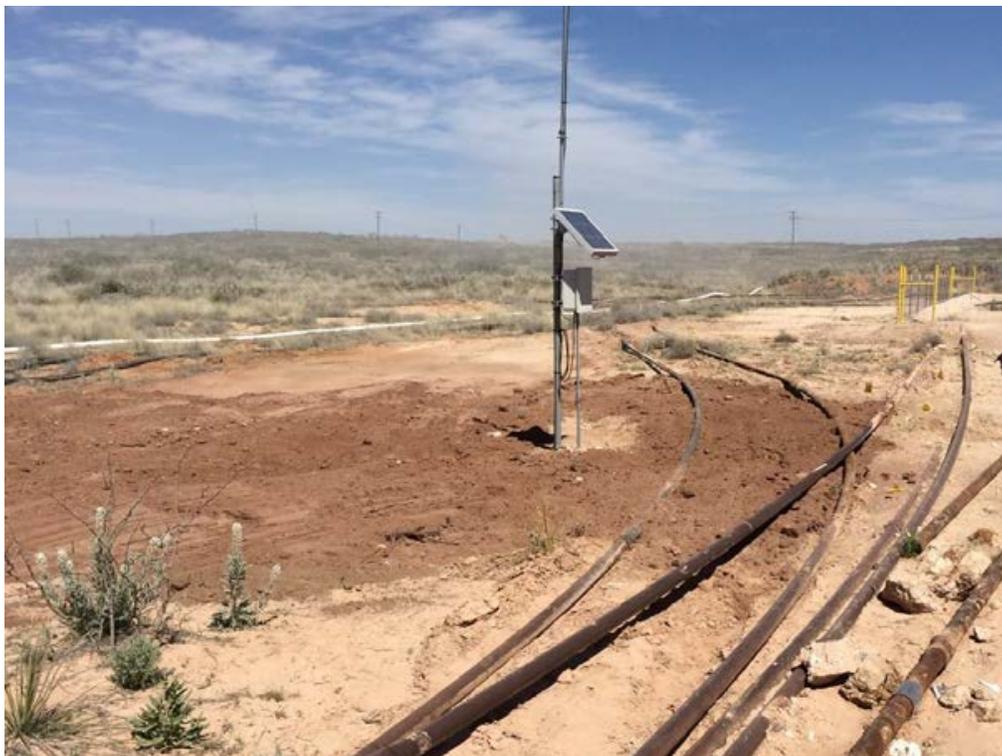
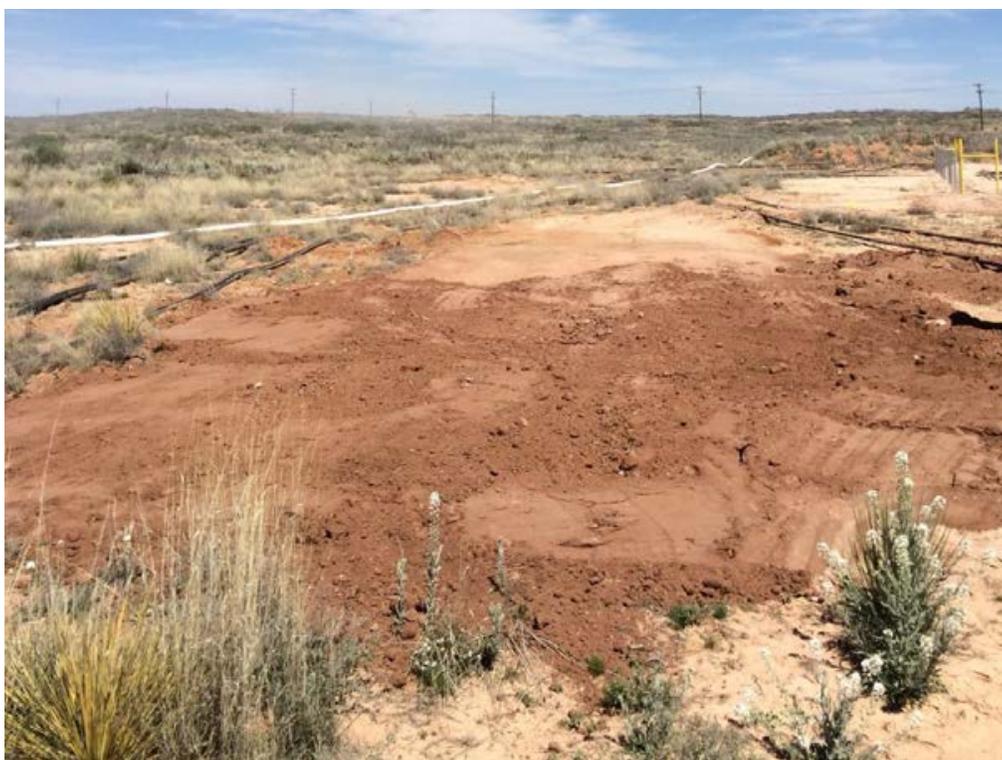
Poker Lake Unit #212 - Excavation
