REMEDIATION SUMMARY & SITE CLOSURE REQUEST

**BOPCO, LP
POKER LAKE UNIT #213 TRUCK LINE SPILL
Eddy County, New Mexico
API 30-015-33859
Unit Letter "P" (SE/SE), Section 18, Township 24 South, Range 30
East Latitude 32.21252° North, Longitude 103.91408° West
NMOCD Reference #2RP-2953**

September 2015

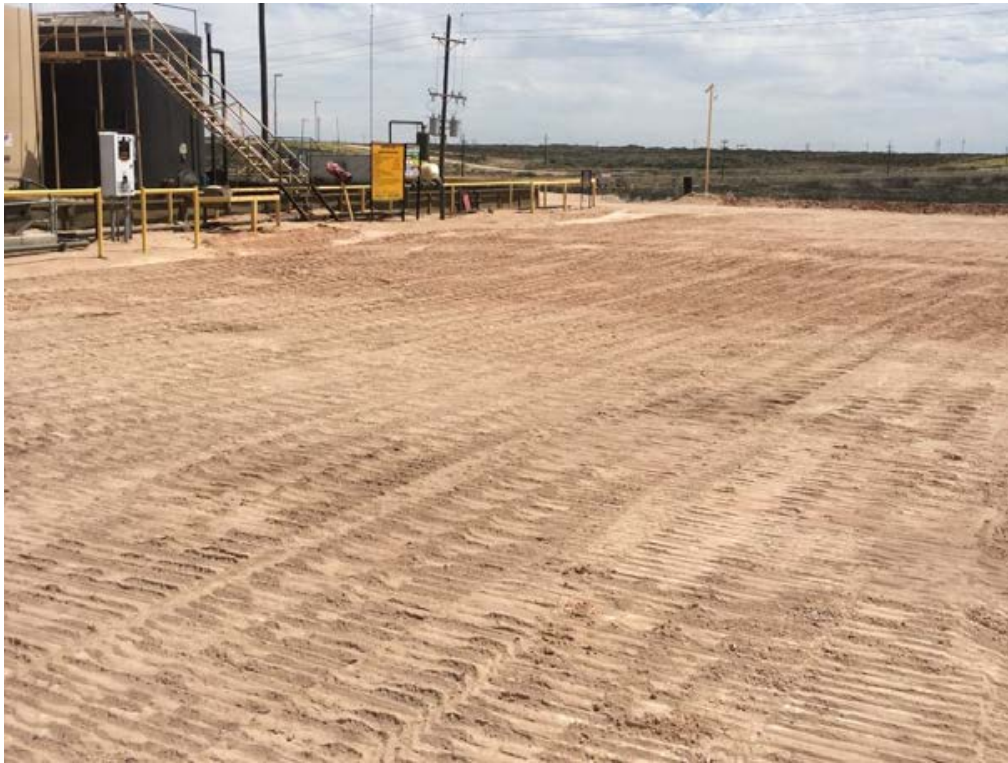
Poker Lake Unit #213 Truck Line Spill - Excavation

On April 2, 2015, Basin Environmental commenced excavation of impacted soil at the site. A chloride field-test kit and olfactory/visual senses were utilized to determine the vertical and horizontal extent of impacted soil and to guide the excavation. Excavated soil was stockpiled on plastic on the caliche pad, pending final disposition.

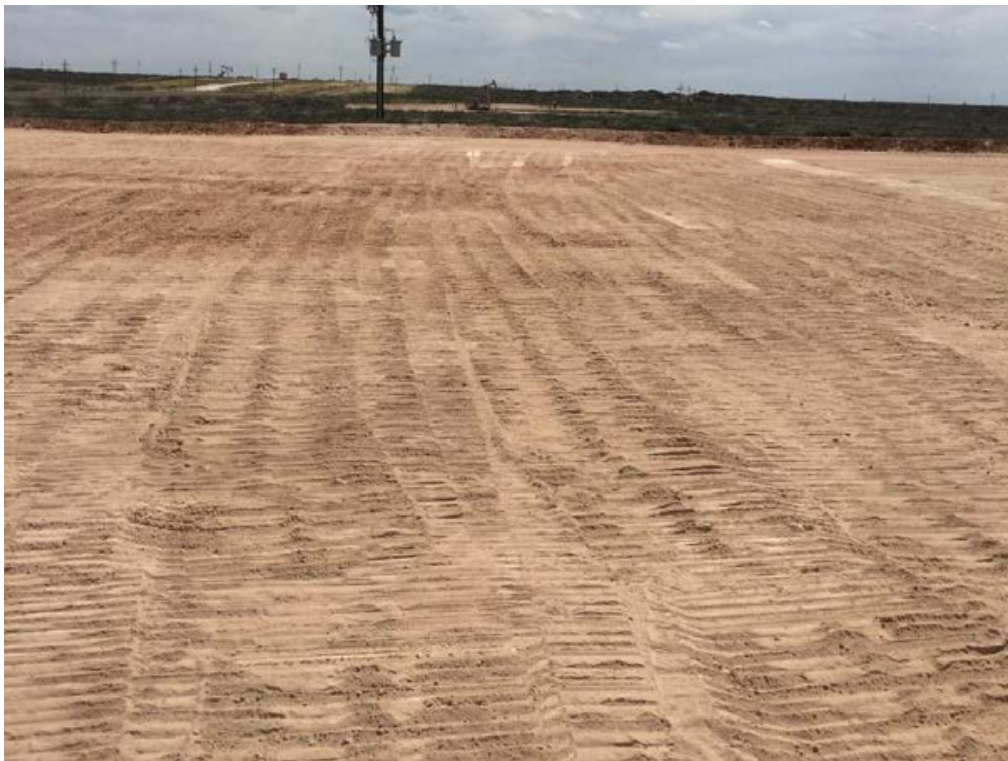
Poker Lake Unit #213 Truck Line Spill - Excavation
