REMEDIATION SUMMARY

SITE CLOSURE REQUEST

BOPCO, LP

BIG EDDY UNIT DI-4

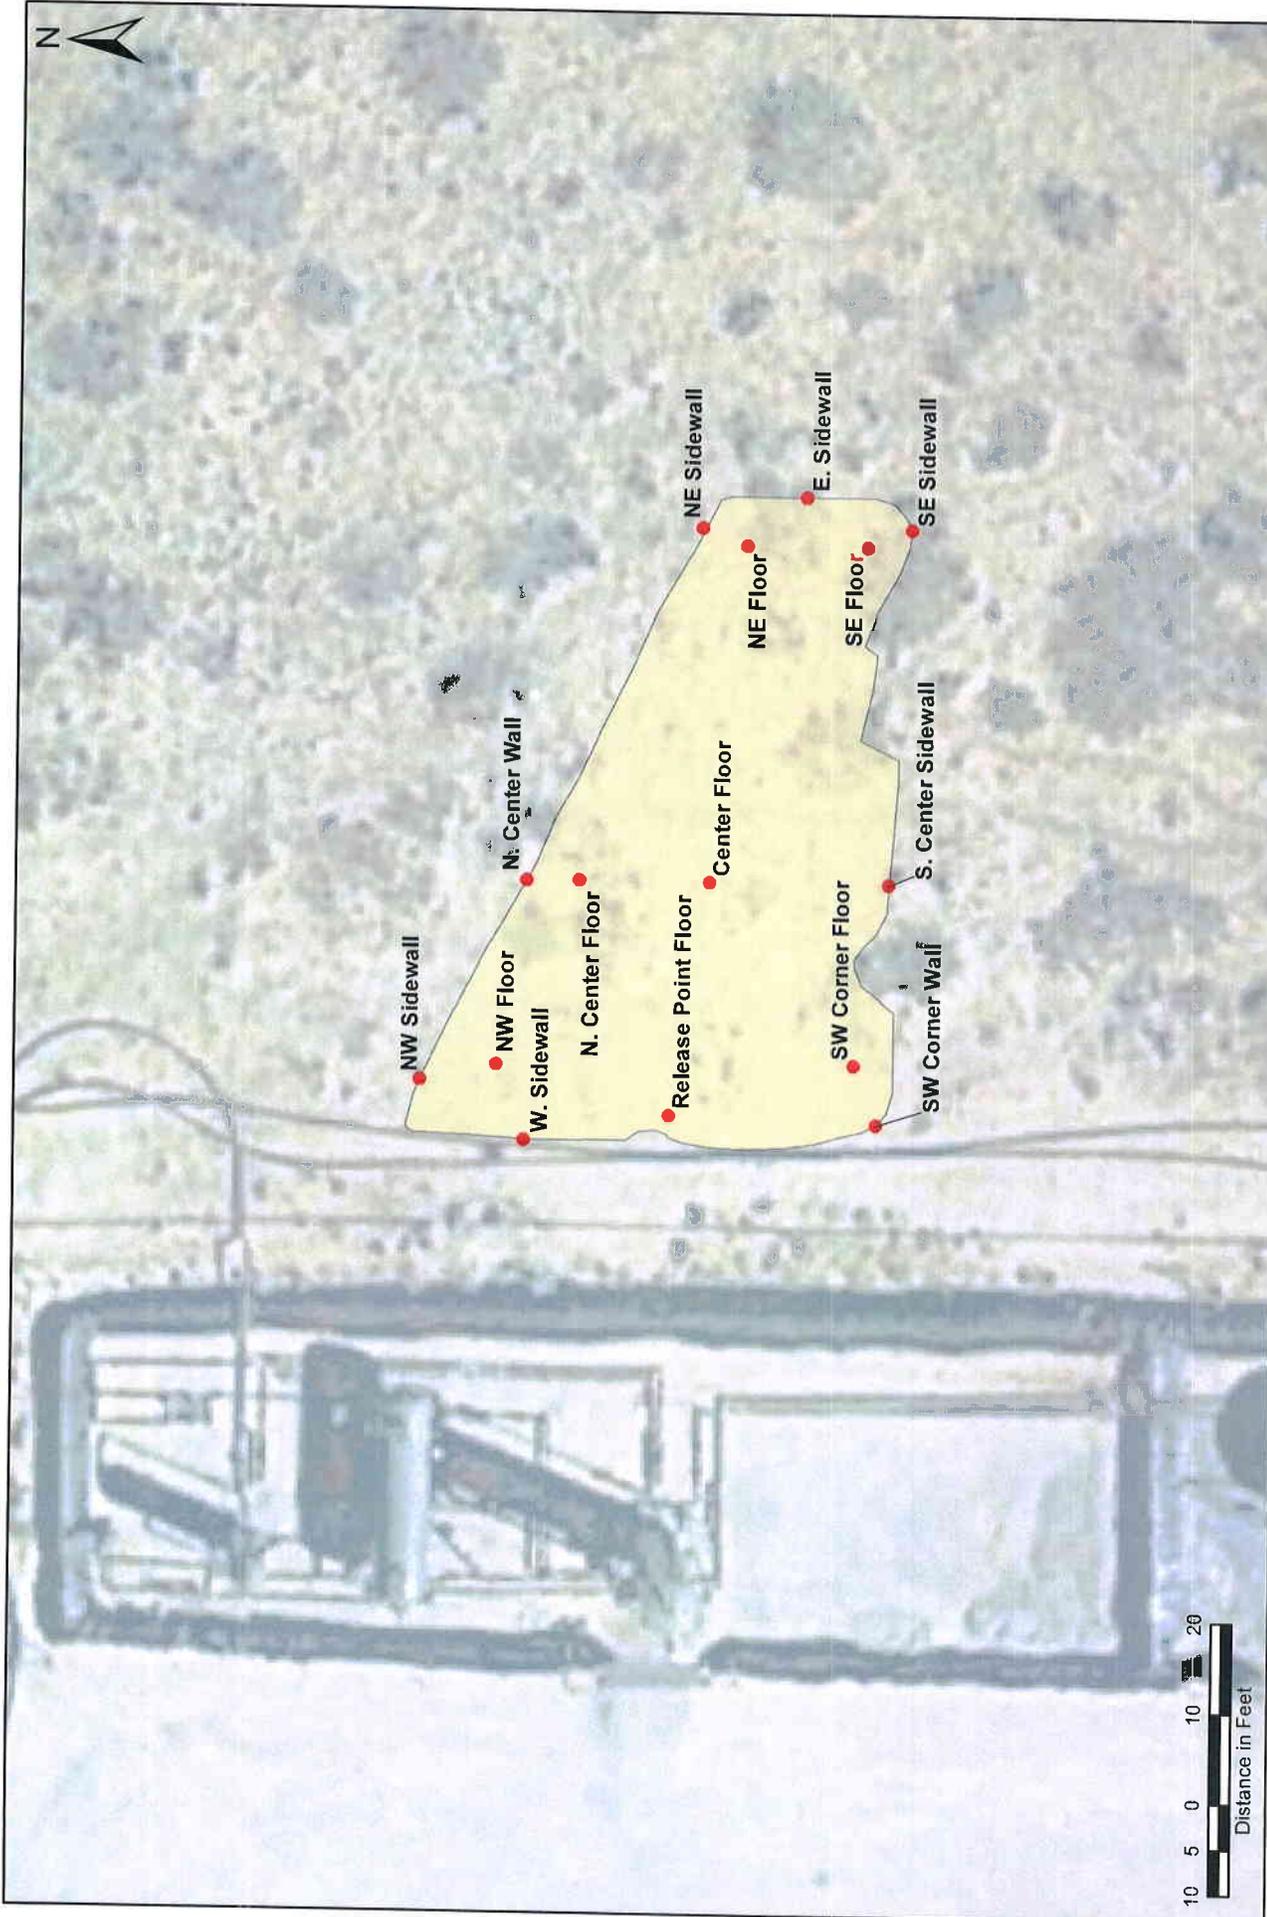
Figure 2
Sample Location Map
BOPCO, LP
Big Eddy Unit DI-4
Eddy County, New Mexico

A summary of “Concentrations of Benzene, BTEX, TPH & Chloride in Soil” is provided in Table 1. A “Sample Location Map” is provided as Figure 2. Laboratory analytical reports are provided in Appendix C.

Based on laboratory analytical results, field-screens, and olfactory/visual senses, from March 6 through March 10, 2015, the excavation was backfilled with locally acquired, non-impacted material, compacted, and contoured to fit the surrounding topography. Prior to backfilling, the final dimensions of the excavation were approximately seventy feet (70') in length, twenty-one (21) to fifty-five feet (55') in width, and one (1) to four feet (4') in depth.

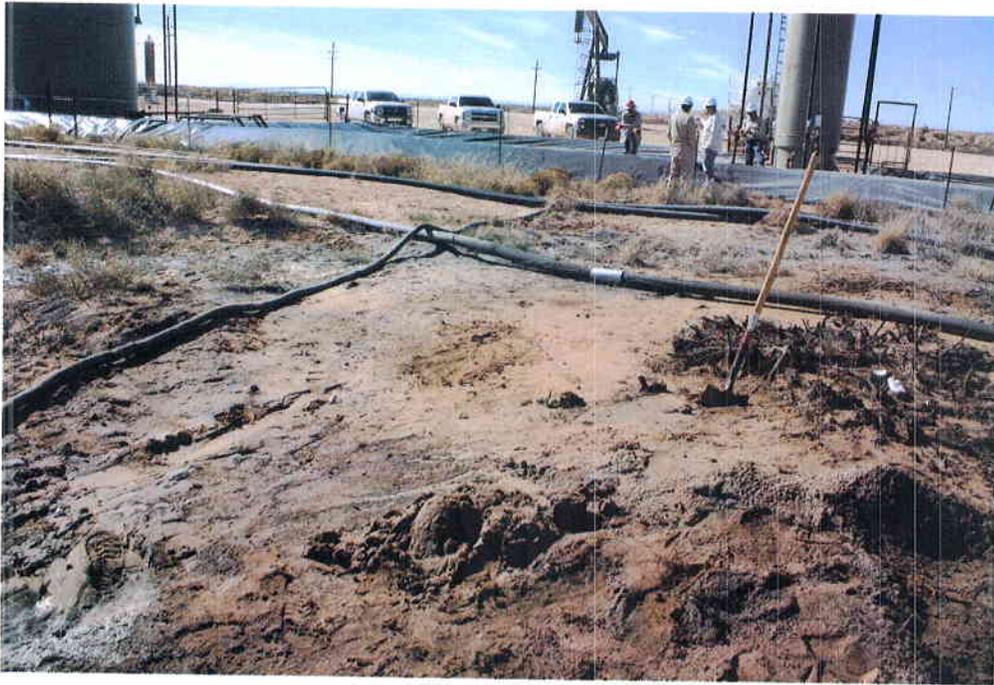
On 1/15/15, BOPCO discovered a release had occurred approximately 1120 feet north of the Big Eddy Unit (BEU) Drilling Island (DI) #4 tank battery. The release was due to a gas poly-line rupture and subsequent fire that melted a temporary produced water transfer line, resulting in the release of approximately 88 bbls) of produced water, and 4.9 MCH natural gas. The gas line and produced water line were shut in, replaced and re-routed around the spill area. A vacuum truck was utilized to recover approximately 15 bbls. of produced water. There was a fresh water line in the vicinity that melted due to the fire. It was also replaced and re-routed.

Initial Photo 1/15/15

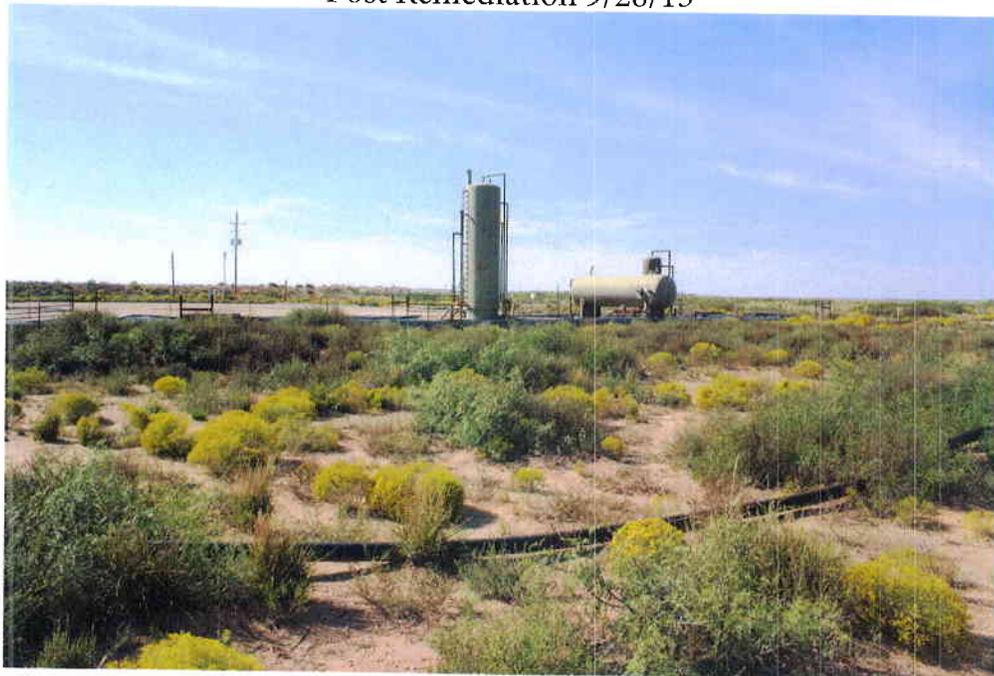
The site was re-seeded with the appropriate BLM seed mix and photographed for compliance on 9/28/15

Post Remediation 9/28/15

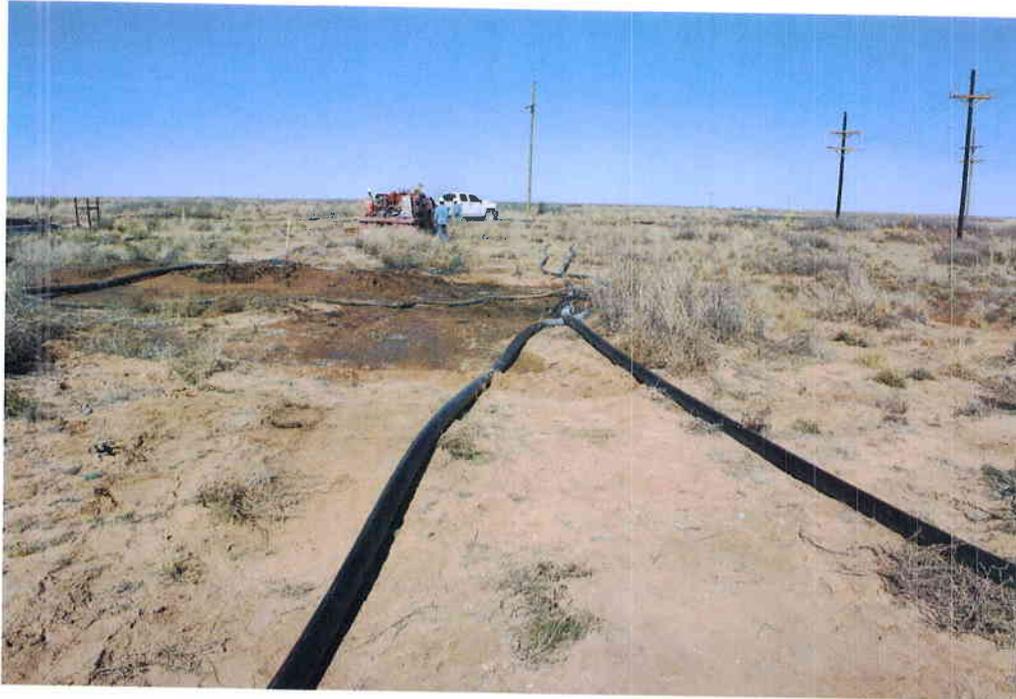
Initial Photo 1/15/15

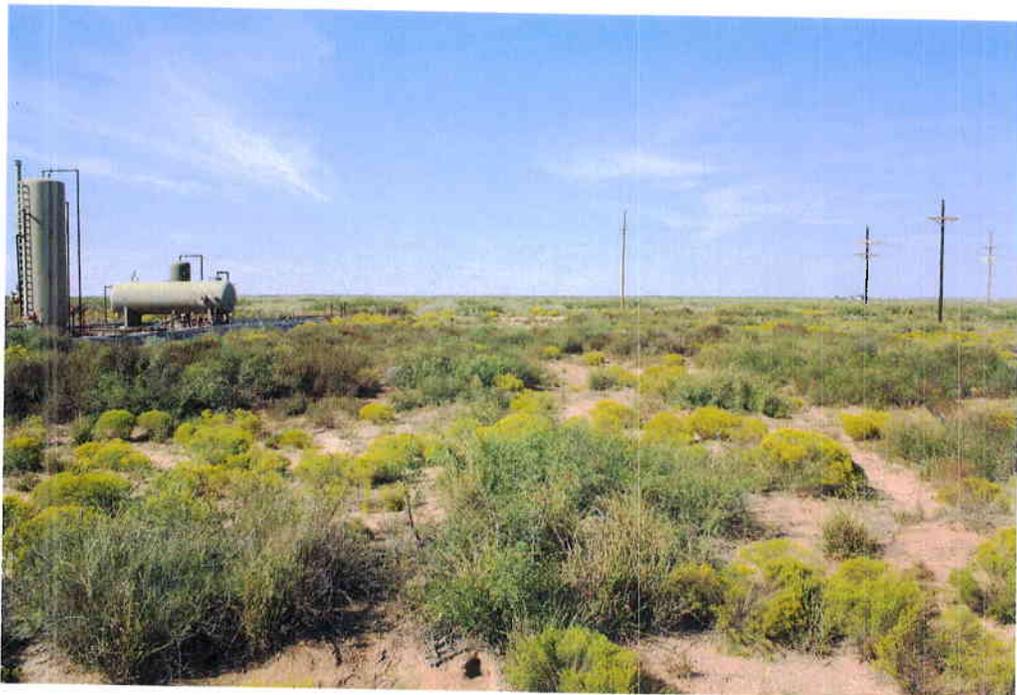
Post Remediation 9/28/15

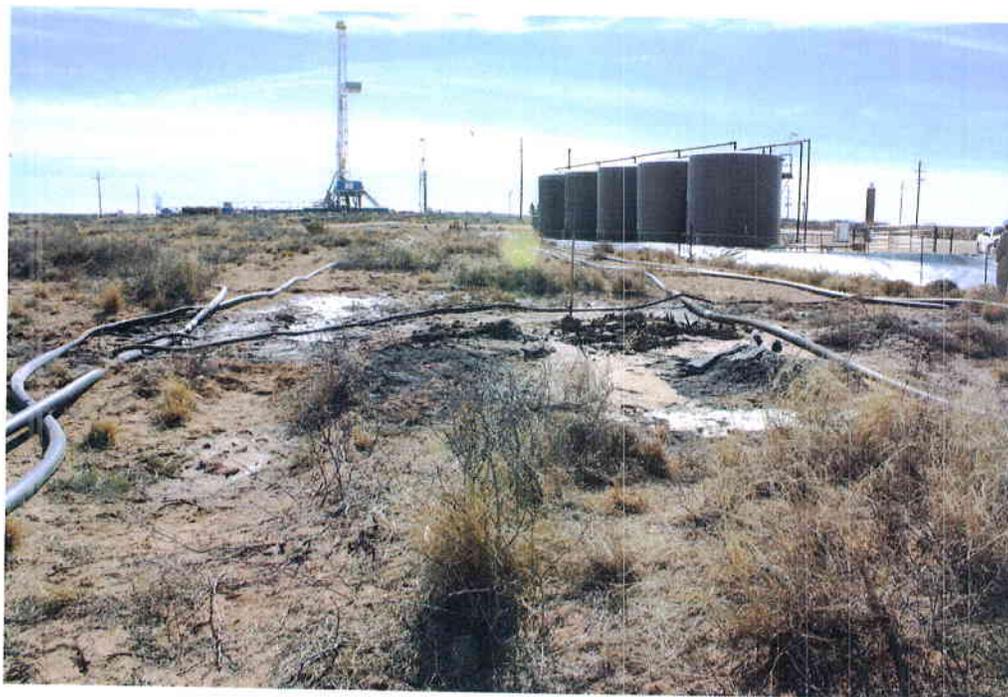
Initial Photo 1/15/15

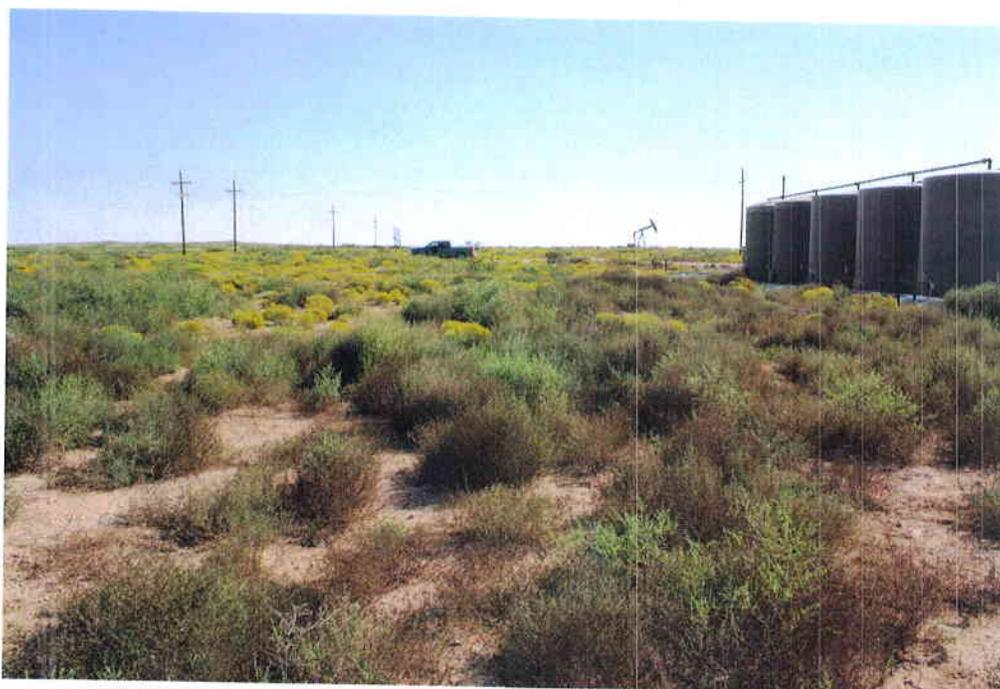
Post Remediation 9/28/15
