**REMEDIATION SUMMARY
&
SITE CLOSURE REQUEST**

**BOPCO, L.P.
POKER LAKE UNIT #213 (SWD)
(Spill dated 10/28/13)
API-30-015-33859
Eddy County, New Mexico
UL-P, Section 18, Twns. 24 South, Range 30 East
Latitude N 32.212505° Longitude W 103.914199°
NMOCD Spill reference #2RP-2042**

**BOPCO, L.P.
522 W. Mermod, Suite 704
Carlsbad, N.M. 88220**

September 2015

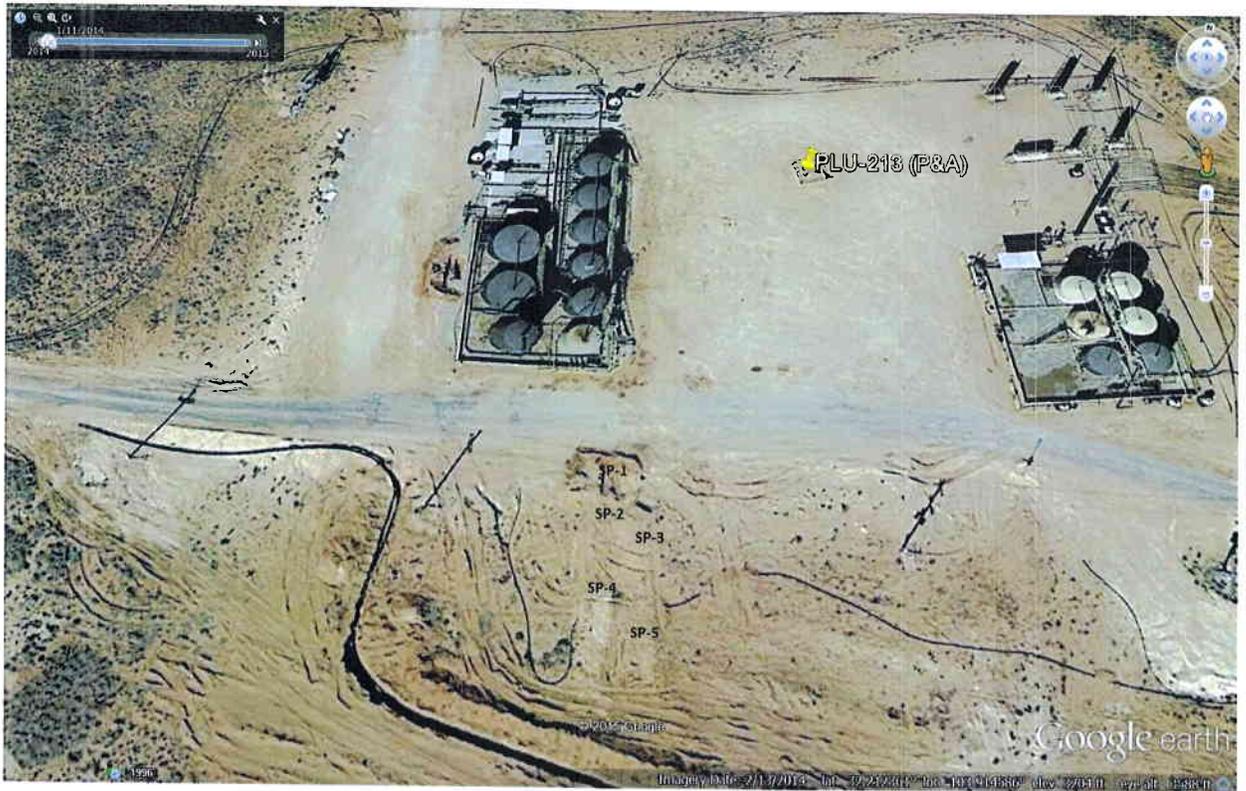
Sample location map with Lab Analysis

A sample was collected from the floor of the excavation and a hand auger was used to collect another sample at 6 ft. below the ground surface, referenced to as SP#1 in the attached site map and soil chemistry table. Four additional sample locations were randomly selected in what was considered to be the potential flow path area south of the release point. Samples were collected from the surface and 2 ft. below ground surface, referenced to SP#2 through SP#5.

Date	Lab ID	Sample Location	Status	TPH C-6-C-10 Mg/kg	TPH C-10-C-28 Mg/kg	TPH C-28-C-35 Mg/kg	TPH C-6-C-35 Mg/kg	BTEX Mg/kg	Chlorides Mg/kg
1/19/15	H-500363-01	SP-1 Excavation floor At 4 ft.	In-situ						<16
1/19/15	H-500363-02	SP-1 Excavation floor At 6 ft.	In-situ						<16
1/19/15	H-500363-03	SP-2 Surface	In-situ						<16
1/19/15	H-500363-04	SP-2 At 4 ft.	In-situ						<16
1/19/15	H-500363-05	SP-3 Surface	In-situ						16
1/19/15	H-500363-06	SP-3 At 2 ft.	In-situ						<16
1/19/15	H-500363-07	SP-4 Surface	In-situ						<16
1/19/15	H-500363-08	SP-4 At 2 ft.	In-situ						<16
1/19/15	H-500363-09	SP-5 Surface	In-situ						<16
1/19/15	H-500363-10	SP-5 At 2 ft.	In-situ						<16

A site map with the sample locations and soil chemistry table is attached with this report. The entire disturbed area resulting from remediation and construction activities was re-seeded with BLM seed mix #2. Photo documentation 9/29/15.

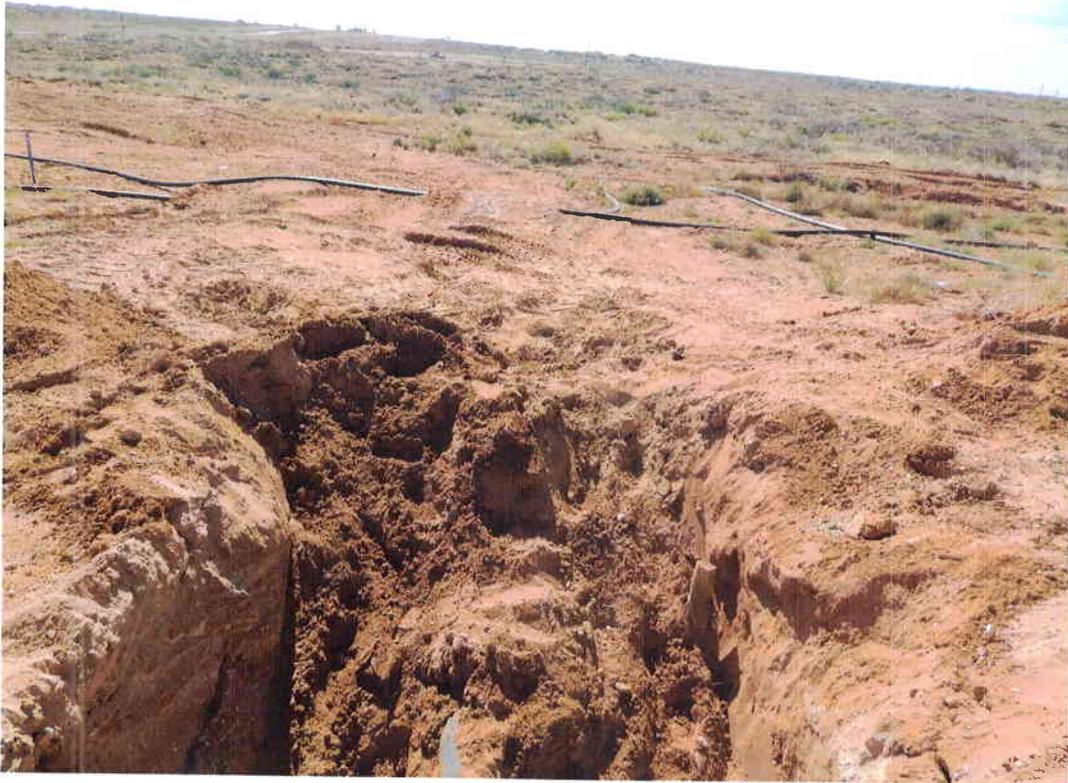
Initial Photo 10/28/13

On the 10/28/13 the pumper at the PLU discovered a release due loose flange bolts on a transition fitting from 10" poly to 10" steel. The area was excavated, the soil was placed on plastic on the SWD pad pending disposal, no fluid was recovered. A C-141 spill report was submitted to the NMOCD on 11/1/13 stating that 12 bbls of produced water had been released that impacted approximately 240 square ft. of pasture area. The spill was given spill report #2RP-2042. The excavation was left open pending the final remediation. The initial Form C-141 is included with this report.

Beginning on 1/19/15 Basin Environmental began a sampling event of the release point and pasture area just to the south of the SWD road and pad area. As mentioned earlier the excavation was left open at the time of discovery and the permanent repair on the transition fitting. The excavation was approximately 4 ft. deep and measured approximately 8 ft. wide and 10 ft. long.

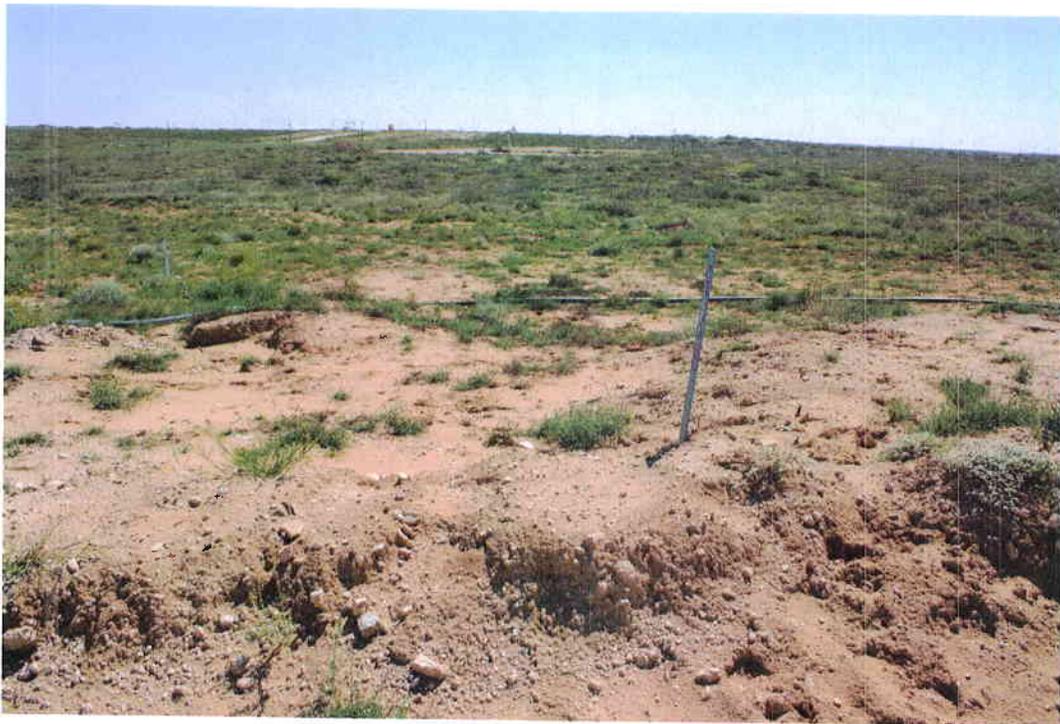
Post Remediation Photo 9/28/15

The excavation and sample location points were backfilled with clean soil that had been previously pushed up during construction activities or purchased soil used for the other remediation projects.
